Client: Doux Chanton  
Project: 265-267 Deansgate Terrace, Manchester, M3 4EW

Date: 02.01.25  
Issue: 202393\_M1NT\_XX\_PS\_0102(P2)

**1. Introduction**

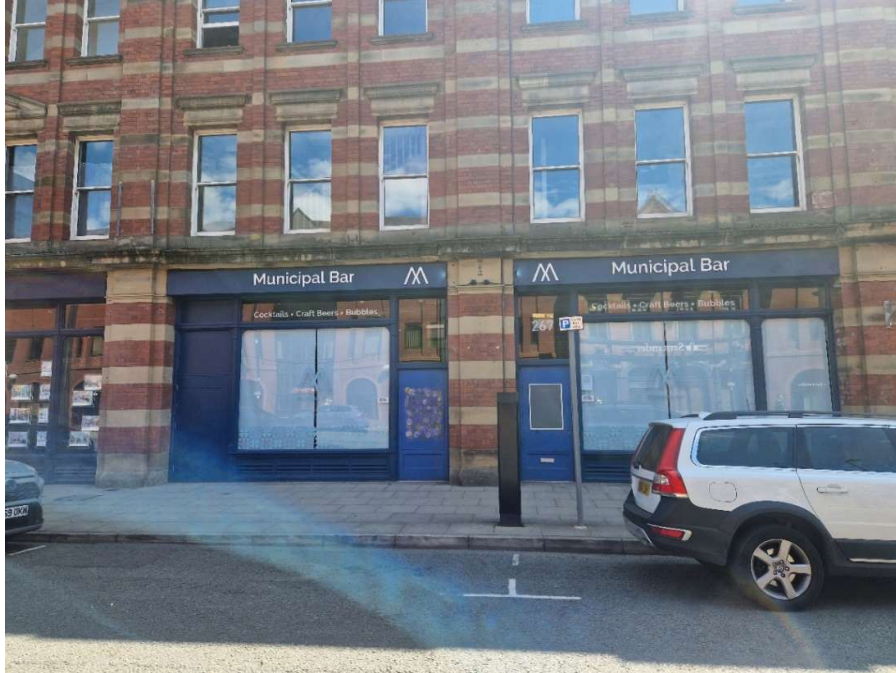
**Image 1:** Present Shopfront Elevation, Deansgate, Manchester

| 3. Demolition | |
|---|---|
| 4.1 | The appearance of the existing timber shopfront fascia's, frames, plinths, louvres and doors are to be maintained, receiving RAL 3013 paint finishes to match Doux Chaton's branding. |
| 4.2 | Fixing of new non-illuminated signage of brushed gold stainless steel pin letters to existing timber fascia boards via new collar and sleeve fixings to be minimised. |
| 4.3 | Fixing of replacement projecting sign to match surrounding buildings, fixed to existing historic brick piers via new collar and sleeve fixings, existing fixing locations to be utilised where possible. |
