# Listed Building Consent Condition 8 Methodology

Dragonfly Contracts Ltd

Project: Pall Mall Court – Redevelopment

Location: Pall Mall, 61-67 King Street, Manchester M2  
4PD

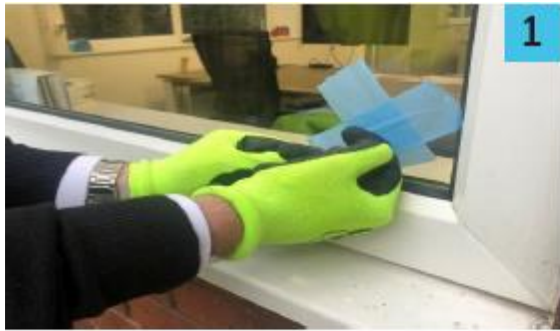
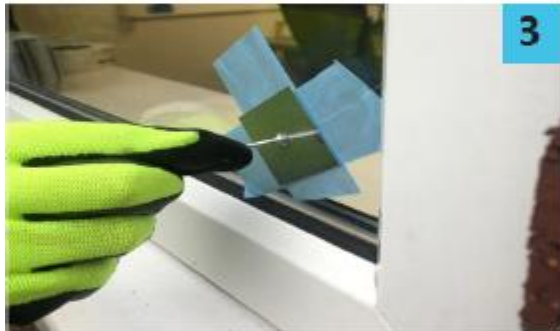
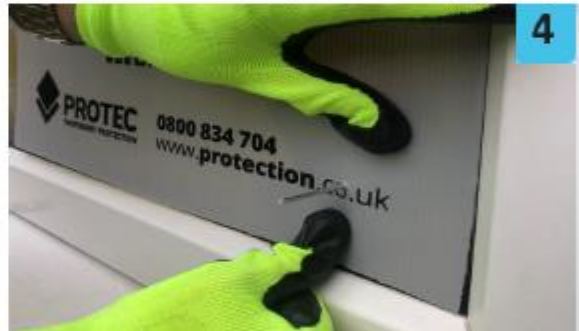
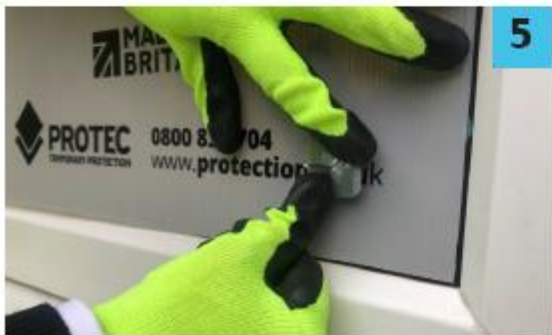
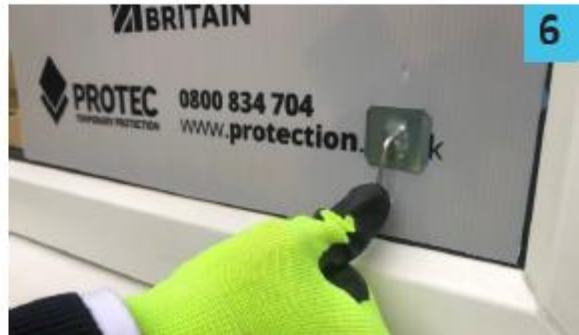
Temporary protection will be used using self-adhesive pins. Low tack tape is to be installed onto the heritage finishes, with pins adhered to this and temporary protection placed over these to be held in place. The tape will aid removal of the protection and minimise disruption to the existing finish, images below:

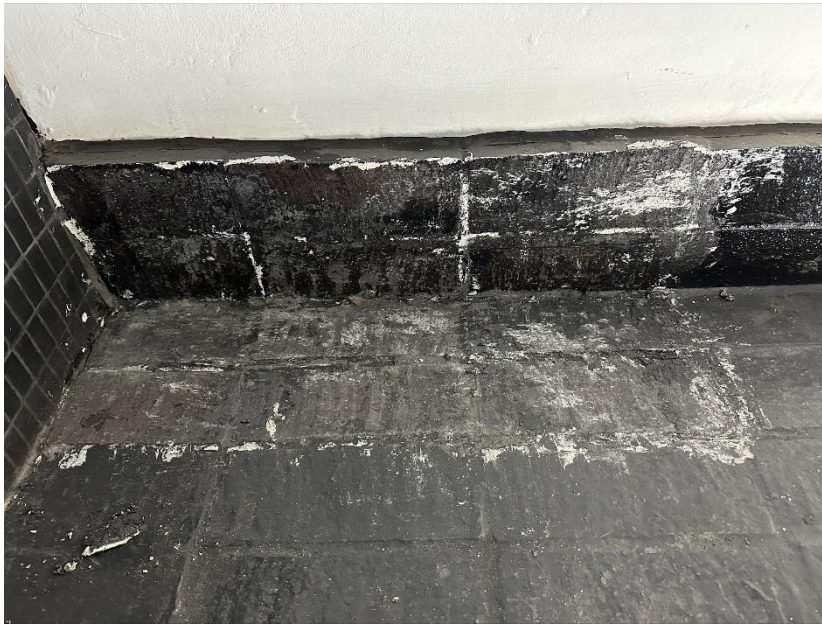
Image A

To provide a sample of paint removal and to expose the original finishes beneath the paint, we used Peelaway paint stripper and left this to work for 72 hours: the maximum recommended amount of time. Please refer to **Image A** for the result of this.

This method proved to be unsuccessful.

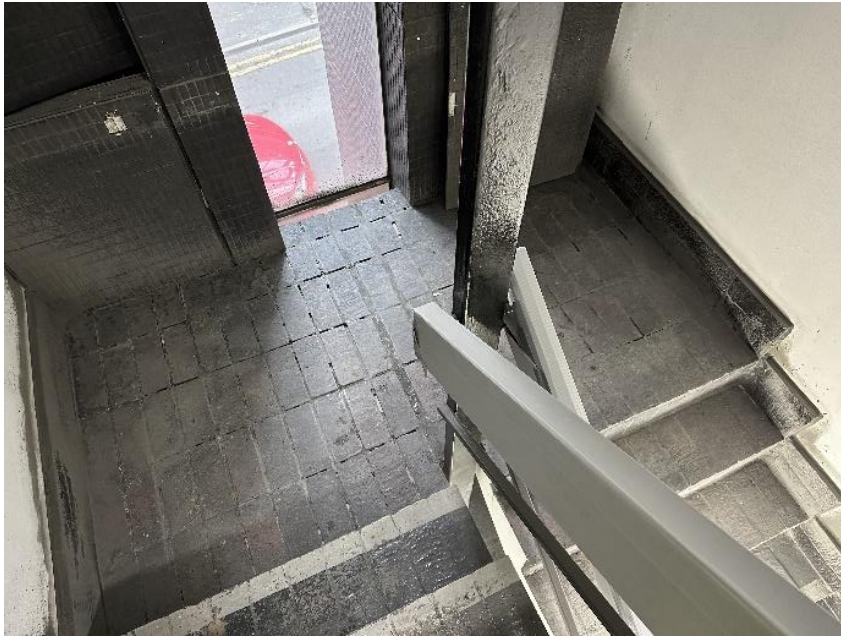
Image B

Ice Blasting was completed on one half landing and three stairs of Stair 3, please refer to the **Image B** below.

Whilst this method was successful in removing paint from this surface, it caused significant damage to the grout between tiles. It is important to note that the historic grout appears to be defective due to its original application, as a void beneath the grout was exposed following the Ice Blasting procedure. Please see the **Images C** and **D** below for an example of this.

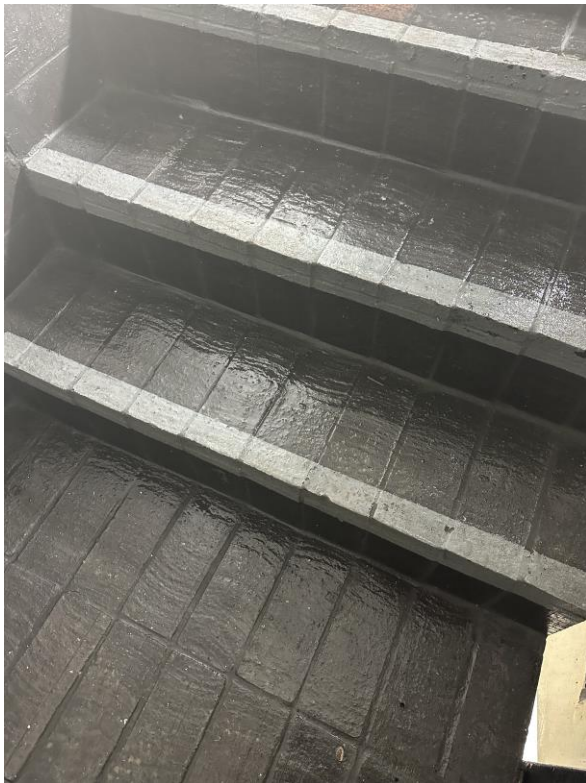
Image E

There are two staircases that retain their original tile finish, please see **Image E** and **F** below (Stair 1 & 4). It is undeniable that our efforts to revert the sample area back to the original finish, have been unsuccessful.

Stairs 1 & 4 to be cleaned back to Staffordshire blue tiles, with new nosings painted onto the stairs.

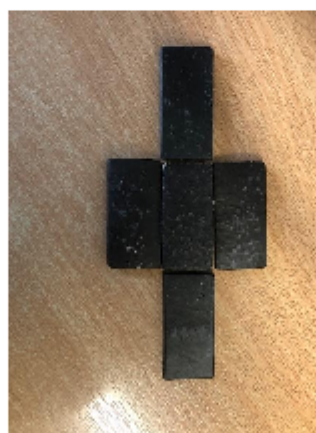
## Pall Mall Court - Lift Lobby Mosaic Proposals

A "blue grit" type of bonding agent has been applied to the original mosaic tiles to the lift lobbies to floors Ground, 1, 3, 4 and 9 at Pall Mall Court. The blue grit has been used as a key for plasterboard adhesive to be applied to, before the plasterboard has then been "dot and dabbed", skimmed and painted. The plasterboard is therefore very well stuck to the tiles and is almost impossible to remove without causing damage.

The plasterboard finishes will be removed using hand tools and with care to reduce the risk of any damage being caused. If mosaic tiles are damaged as a result of these works, the following reinstatement methodology is to be adopted:

- If mosaic tiles cannot be repaired in-situ, damaged tiles are to be carefully removed using hand tools. No power tools to be used under any circumstances.
- Replacement tiles are to be supplied by Craven Dunnill Jackfield Ltd and affixed using heritage putty and colour matched heritage lime grout to finish.
- The below image shows an original mosaic tile sat centrally in the photograph, surrounded by 4 sample tiles provided by Craven Dunnill Jackfield Ltd. Orders have not been placed for reinstatement materials at this stage as damage is not anticipated to be caused, however, the likeness in terms of material, colour, form, texture and size will be matched as closely as possible if required as shown below. No repair/replacement/reinstatement works will be undertaken without prior review, consent and approval from the appointed conservation officer:

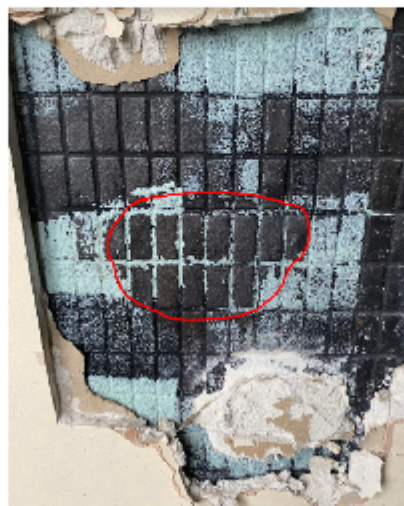
**Blue grit removed. Sample area circled in red. 30 minutes to remove to this standard:**

Taking the above into account, it is not deemed to be practical from an aesthetic, time or cost perspective to remove the plasterboard coverings, particularly considering there would still be a significant amount of making good and replacement tiles required. It should also be noted that patching in with new tiles to such large areas would risk somewhat of a patchwork finish being achieved.
