**Site:** St James Park, Former MMU Campus, Didsbury  
**Plots:** 40 to 42  
**Date:** 10<sup>th</sup> March 2020  
**NHBC Ref:** Phase 2 - 713376

LK Consult (LKC) has been appointed by PJ Livesey Holdings Ltd to validate the depth of the garden capping layer laid down at the development at St James Park, Former MMU Campus, Didsbury.

This validation report concerns Plots 40 to 42. These plots consist of a rear garden with a small area of soft landscaping and a paved driveway to the front of the property.

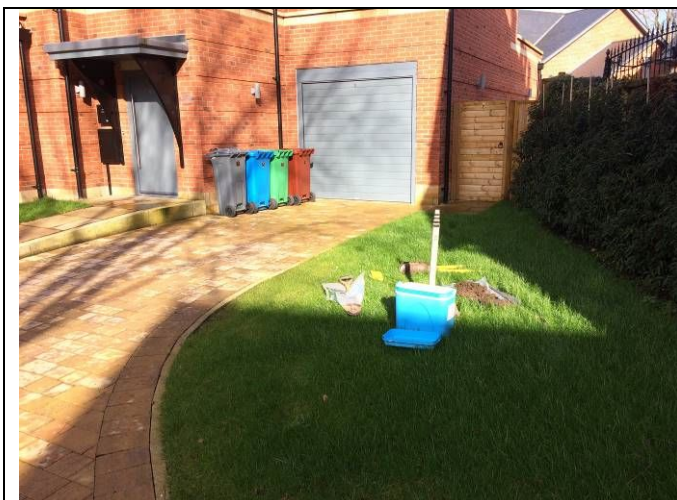
**Photograph 1:**  
View of front garden of Plot 40.

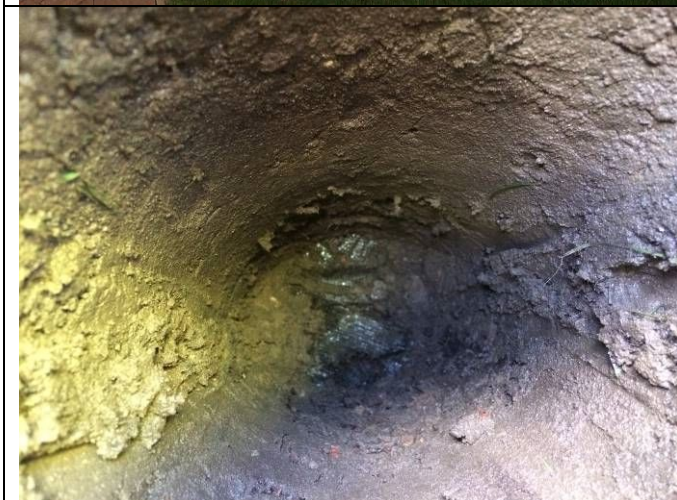
**Photograph 2:**  
View of soil in capping layer excavation in front garden of Plot 40 with geotextile membrane visible.

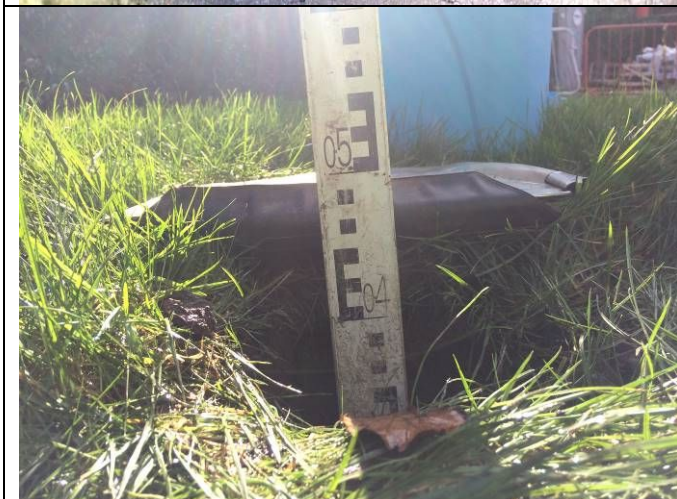
| Location | Topsoil Depth (mm) | Subsoil Depth (mm) | Membrane or 100mm MOT | Total Depth (mm) | Required Depth (mm) | Pass (✓) or Fail (x) |
|---|---|---|---|---|---|---|
| Plot 40 Front | 450 | N/A | Membrane | 450 | 300 | ✓ |

**Photograph 3:**  
Depth measurement in front garden of Plot 40.

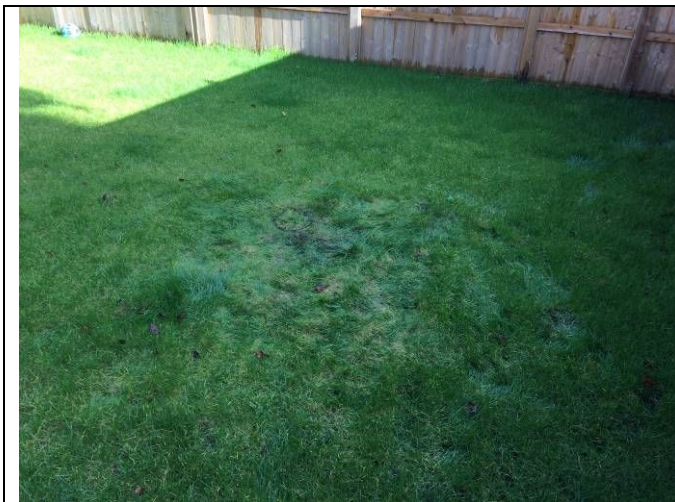
**Photograph 4:**  
View of the rear garden of Plot 40.

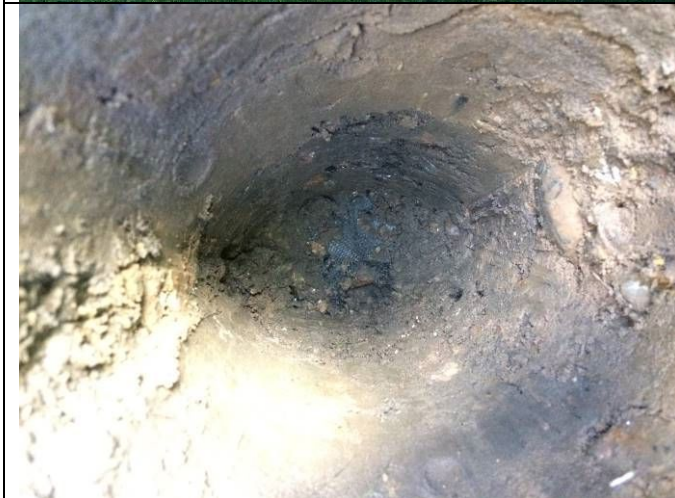
**Photograph 5:**  
View of soil in capping layer excavation in rear garden of Plot 40 with geotextile membrane visible.

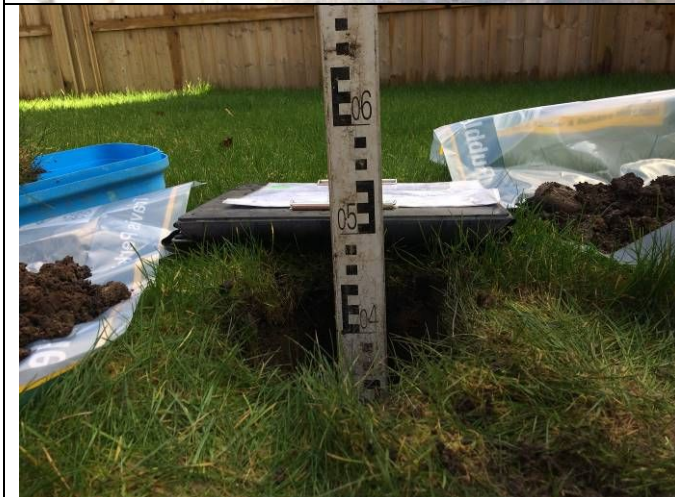
| Location | Topsoil Depth (mm) | Subsoil Depth (mm) | Membrane or 100mm MOT | Total Depth (mm) | Required Depth (mm) | Pass (✓) or Fail (x) |
|---|---|---|---|---|---|---|
| Plot 40 Rear | 180 | 320 | Membrane | 500 | 450 | ✓ |

**Photograph 6:**  
Depth measurement in rear garden of Plot 40.

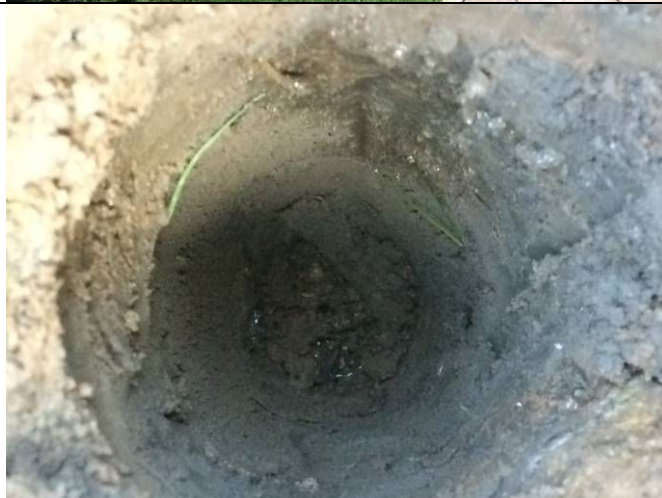
**Photograph 8:**  
View of soil in capping layer excavation in front garden of Plot 41 with geotextile membrane visible.

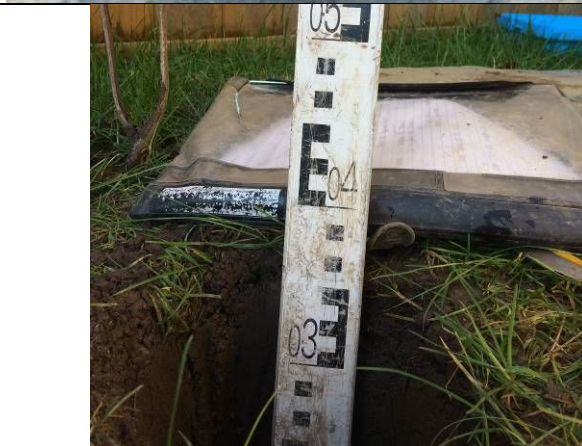
| Location | Topsoil Depth (mm) | Subsoil Depth (mm) | Membrane or 100mm MOT | Total Depth (mm) | Required Depth (mm) | Pass (✓) or Fail (x) |
|---|---|---|---|---|---|---|
| Plot 41 Front | 350 | N/A | Membrane | 350 | 300 | ✓ |

**Photograph 9:**  
Depth measurement in front garden of Plot 41.

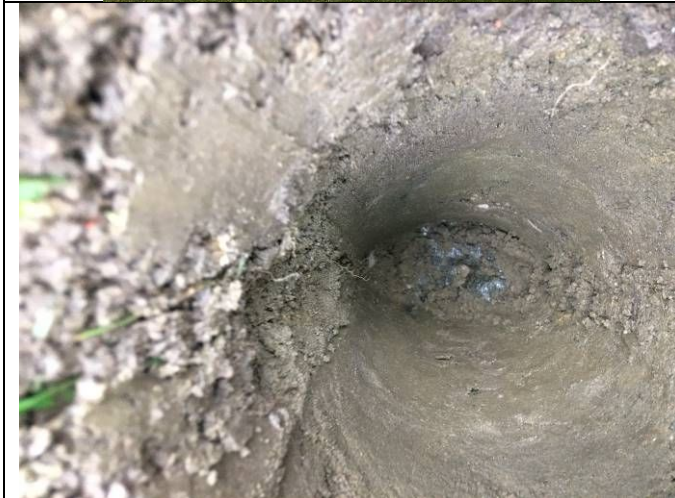
**Photograph 11:**  
View of soil in capping layer excavation in rear garden of Plot 41 with geotextile membrane visible.

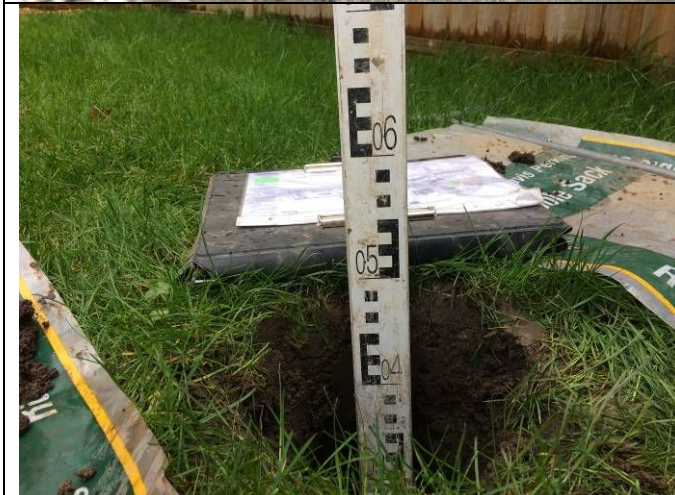
| Location | Topsoil Depth (mm) | Subsoil Depth (mm) | Membrane or 100mm MOT | Total Depth (mm) | Required Depth (mm) | Pass (✓) or Fail (x) |
|---|---|---|---|---|---|---|
| Plot 41 Rear | 300 | 200 | Membrane | 500 | 450 | ✓ |

**Photograph 12:**  
Depth measurement in rear garden of Plot 41.

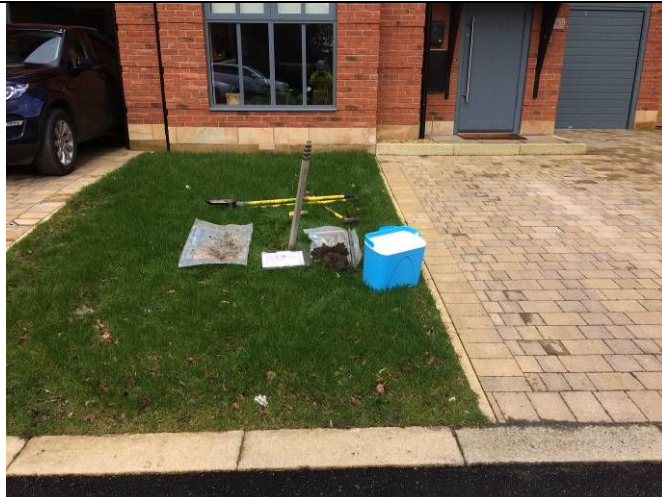
**Photograph 13:**  
View of front garden of Plot 42.

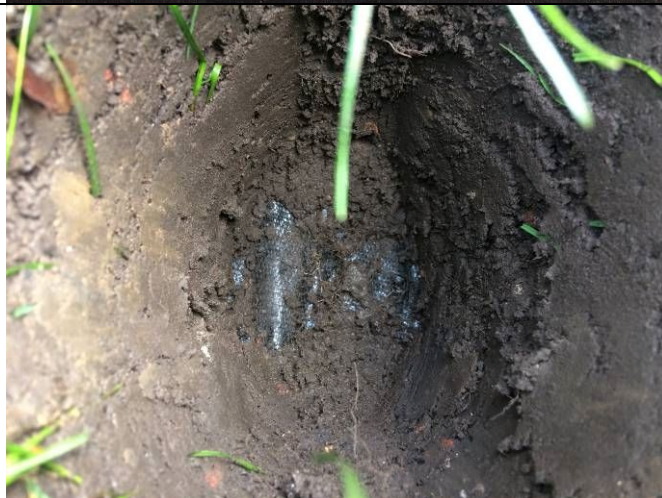
**Photograph 14:**  
View of soil in capping layer excavation in front garden of Plot 42 with geotextile membrane visible.

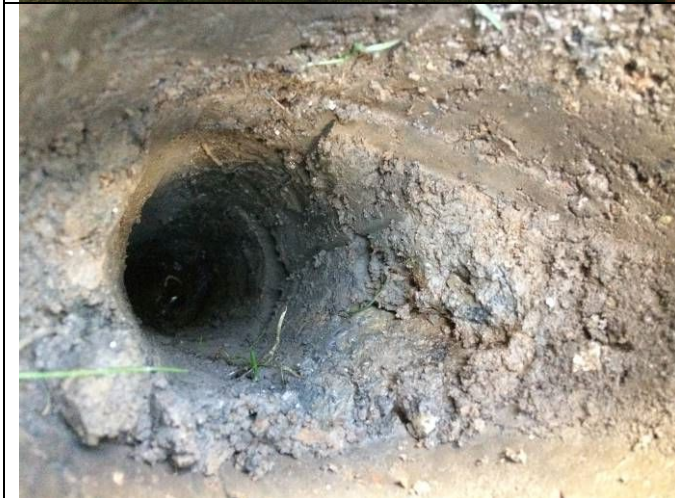
**Photograph 17:**  
View of soil in capping layer excavation in rear garden of Plot 42 with geotextile membrane visible.

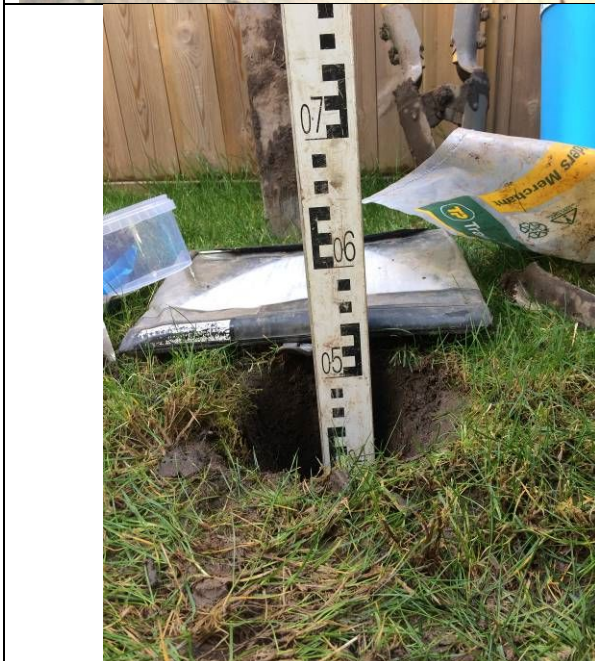
| Location | Topsoil Depth (mm) | Subsoil Depth (mm) | Membrane or 100mm MOT | Total Depth (mm) | Required Depth (mm) | Pass (✓) or Fail (x) |
|---|---|---|---|---|---|---|
| Plot 42 Rear | 500 | 300 | Membrane | 500 | 450 | ✓ |

**Photograph 18:**  
Depth measurement in rear garden of Plot 42.
