**LAND ASSESSMENT FOR  
ASBESTOS IN SOILS AT**

**PROSPECT HOUSE (CAMBERWELL PARK SCHOOL),  
BANK HOUSE ROAD,  
BLACKLEY,  
MANCHESTER,  
M9 8TL**

**March 2020**

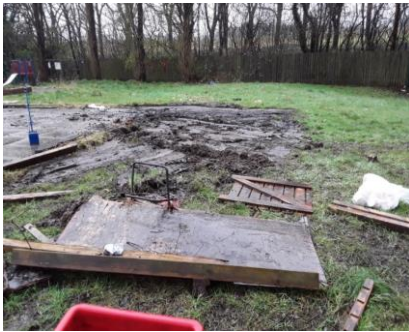
| Item No. | Sample No. | Location | Description | Asbestos type | Recommendation |
|---|---|---|---|---|---|
| 1 | FK001153 | Soils, 10.03.20 Excavation Site - External - Trial pit 1 - Soil sample taken from the top 200mm layer | The soil makeup consists of soil, hardcore crush, stones and clay. | NAD | None |

Item 1 - Trial pit 1 - Soil sample taken from the top 200mm layer

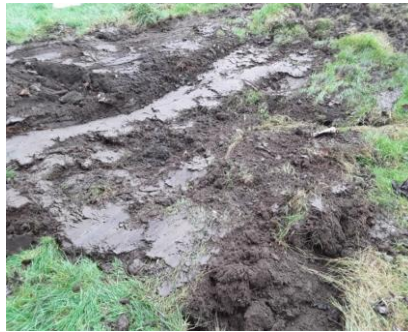
| Item No. | Sample No. | Location | Description | Asbestos type | Recommendation |
|---|---|---|---|---|---|
| 2 | FK001154 | Soils, 10.03.20 Excavation Site - External - Trial pit 2 - Soil sample taken from the top 200mm layer | The soil makeup consists of soil, general rubbish/debris, stones and clay. | NAD | None |

Item 2 - Trial pit 2 - Soil sample taken from the top 200mm layer

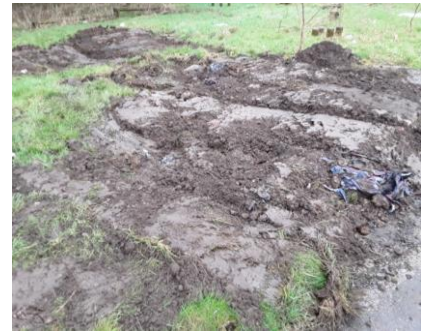
| Item No. | Sample No. | Location | Description | Asbestos type | Recommendation |
|---|---|---|---|---|---|
| 3 | FK001155 | Soils, 10.03.20 Excavation Site - External - Trial pit 3 - Soil sample taken from the top 200mm layer | The soil makeup consists of soil, general rubbish/debris, stones and clay. | NAD | None |

Item 3 - Trial pit 3 - Soil sample taken from the top 200mm layer

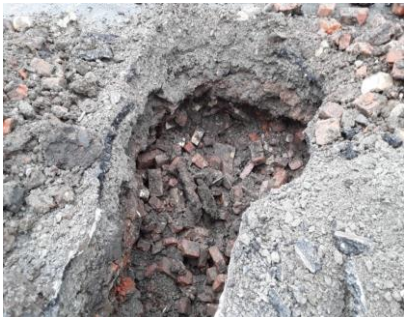
| Item No. | Sample No. | Location | Description | Asbestos type | Recommendation |
|---|---|---|---|---|---|
| 4 | FK001156 | Soils, 10.03.20 Excavation Site - External - Trial pit 4 - Soil sample taken from the top 200mm layer, beneath the tarmac layer | The soil makeup consists of soil, brick, rubble and clay. | NAD | None |

Item 4 - Trial pit 4 - Soil sample taken from the top 200mm layer, beneath the tarmac layer

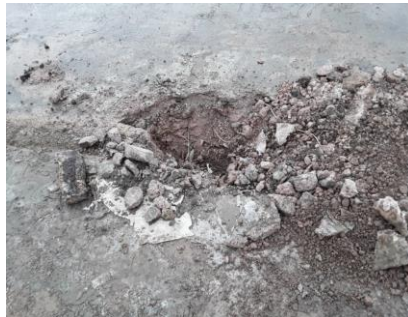
| Item No. | Sample No. | Location | Description | Asbestos type | Recommendation |
|---|---|---|---|---|---|
| 5 | FK001157 | Soils, 10.03.20 Excavation Site - External - Trial pit 5 - Soil sample taken from the top 200mm layer, beneath the concrete layer | The soil makeup consists of soil, concrete and rubble. | NAD | None |

Item 5 - Trial pit 5 - Soil sample taken from the top 200mm layer, beneath the concrete layer

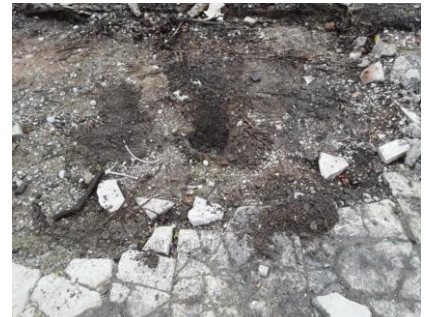
| Item No. | Sample No. | Location | Description | Asbestos type | Recommendation |
|---|---|---|---|---|---|
| 6 | FK001158 | Soils, 10.03.20 Excavation Site - External - Trial pit 6 - Soil sample taken from the top 200mm layer | The soil makeup consists of soil, concrete and rubble. | NAD | None |

Item 6 - Trial pit 6 - Soil sample taken from the top 200mm layer

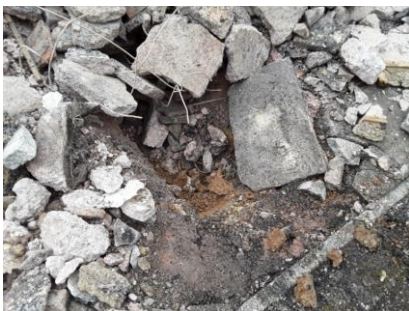
| Item No. | Sample No. | Location | Description | Asbestos type | Recommendation |
|---|---|---|---|---|---|
| 7 | FK001159 | Soils, 10.03.20 Excavation Site - External - Trial pit 7 - Soil sample taken from the top 200mm layer, beneath the concrete | The soil makeup consists of soil, concrete and rubble. | NAD | None |

Item 7 - Trial pit 7 - Soil sample taken from the top 200mm layer, beneath the concrete

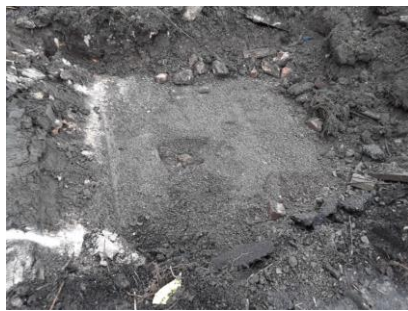
| Item No. | Sample No. | Location | Description | Asbestos type | Recommendation |
|---|---|---|---|---|---|
| 8 | FK001160 | Soils, 10.03.20 Excavation Site - External - Trial pit 8 - Soil sample taken from the top 200mm layer | The soil makeup consists of soil, crush and rubble. | NAD | None |

Item 8 - Trial pit 8 - Soil sample taken from the top 200mm layer

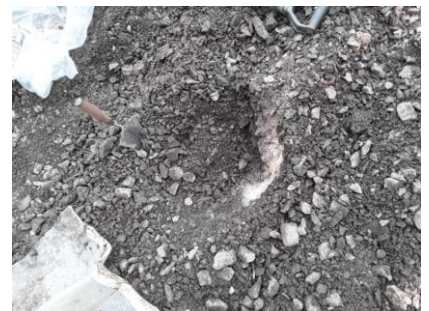
| Item No. | Sample No. | Location | Description | Asbestos type | Recommendation |
|---|---|---|---|---|---|
| 9 | FK001169 | Soils, 10.03.20 Excavation Site - External - Trial pit 9 - Soil sample taken from the top 200mm layer | The soil makeup consists of soil, crush and rubble. | NAD | None |

Item 9 - Trial pit 9 - Soil sample taken from the top 200mm layer

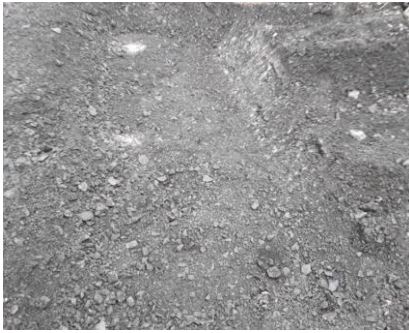
| Item No. | Sample No. | Location | Description | Asbestos type | Recommendation |
|---|---|---|---|---|---|
| 10 | FK001170 | Soils, 10.03.20 Excavation Site - External - Trial pit 10 - Soil sample taken from the top 200mm layer | The soil makeup consists of soil, crush and rubble. | NAD | None |

Item 10 - Trial pit 10 - Soil sample taken from the top 200mm layer

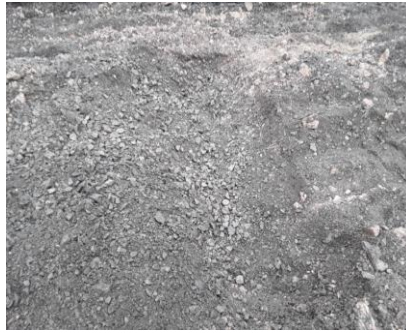
| Item No. | Sample No. | Location | Description | Asbestos type | Recommendation |
|---|---|---|---|---|---|
| 011 | FK001171 | Soils, 10.03.20 Excavation Site - External - Trial pit 11 - Soil sample taken from the top 200mm layer | The soil makeup consists of soil, crush and rubble. | NAD | None |

Item 11 - Trial pit 11 - Soil sample taken from the top 200mm layer

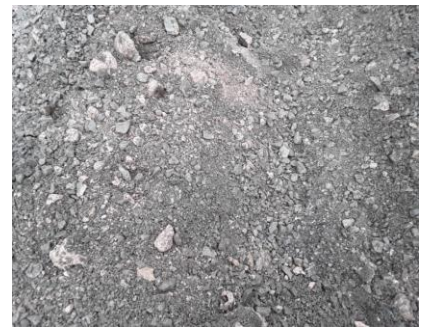
| Item No. | Sample No. | Location | Description | Asbestos type | Recommendation |
|---|---|---|---|---|---|
| 012 | FK001172 | Soils, 10.03.20 Excavation Site - External - Trial pit 12 - Soil sample taken from the top 200mm layer | The soil makeup consists of soil, crush and rubble. | NAD | None |

Item 12 - Trial pit 12 - Soil sample taken from the top 200mm layer

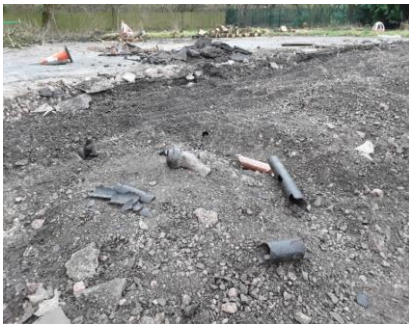
| Item No. | Sample No. | Location | Description | Asbestos type | Recommendation |
|---|---|---|---|---|---|
| 013 | FK001173 | Soils, 10.03.20 Excavation Site - External - Trial pit 13 - Bitumen pipe buried beneath soil and associated debris to the ground | The soil makeup consists of soil, crush and rubble.<br>Please note the pipe is buried beneath the soil and appears to be running down to the fence line. | Chrysotile | Remove |

Item 13 - Trial pit 13 - Bitumen pipe buried beneath soil and associated debris to the ground

Items 13, 15, 17, 18, 19 and 20. Installations and fragments of non-licensed products should be removed by 'litter picking' from surface / soil.

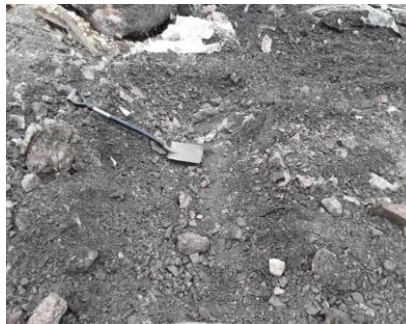
| Item No. | Sample No. | Location | Description | Asbestos type | Recommendation |
|---|---|---|---|---|---|
| 014 | FK001174 | Soils, 10.03.20 Excavation Site - External - Trial pit 14 - Soil sample taken from the top 200mm layer | The soil makeup consists of soil, crush and rubble. | NAD | None |

Item 14 - Trial pit 14 - Soil sample taken from the top 200mm layer

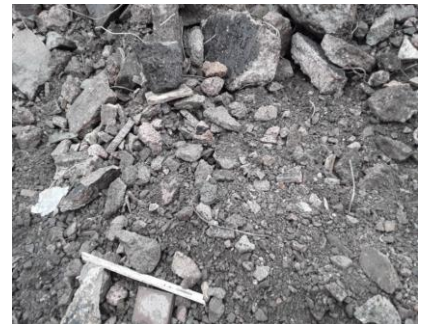
| Item No. | Sample No. | Location | Description | Asbestos type | Recommendation |
|---|---|---|---|---|---|
| 015 | FK001176 | Soils, 10.03.20 Excavation Site - External - Spoil stack adjacent trial pit 13 - Bitumen pipe debris on and mixed in the spoil stack | The spoil stack is made up from soil, concrete, crush and rubble. | Chrysotile | Remove |

Item 15 - Spoil stack adjacent trial pit 13 - Bitumen pipe debris on and mixed in the spoil stack

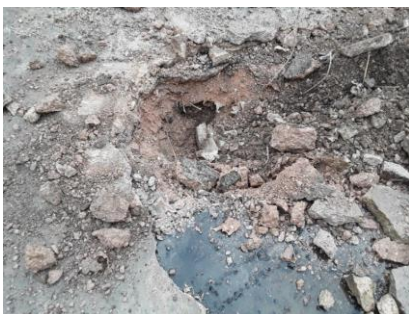
| Item No. | Sample No. | Location | Description | Asbestos type | Recommendation |
|---|---|---|---|---|---|
| 016 | FK001177 | Soils, 10.03.20 Excavation Site - External - Trial pit 15 - Soil sample taken from the top 200mm layer | The soil makeup consists of soil, concrete, crush and rubble. | NAD | None |

Item 16 - Trial pit 15 - Soil sample taken from the top 200mm layer

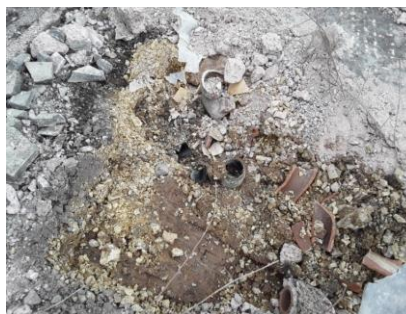
| Item No. | Sample No. | Location | Description | Asbestos type | Recommendation |
|---|---|---|---|---|---|
| 017 | FK001178 | Soils, 10.03.20 Excavation Site - External - Trial pit 16 - Bitumen pipe buried beneath soil and associated debris to the ground | The soil makeup consists of soil, crush and rubble.<br>Please note the pipe is buried beneath the soil and appears to be running down to the nearest foul water duct. | Chrysotile | Remove |

Item 17 - Trial pit 16 - Bitumen pipe buried beneath soil and associated debris to the ground

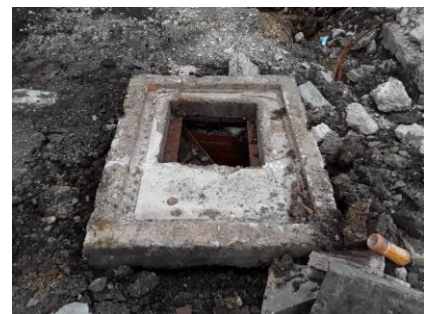
| Item No. | Sample No. | Location | Description | Asbestos type | Recommendation |
|---|---|---|---|---|---|
| 018 | FK001179 | Soils, 10.03.20 Excavation Site - External - Foul drain, north corner - Cement used as shuttering to the underside of the foul drain entrance | Brick and concrete built sewage duct containing a clay waste pipe beneath the removed access point. | Chrysotile | Remove |

Item 18 - Foul drain, north corner - Cement used as shuttering to the underside of the foul drain entrance

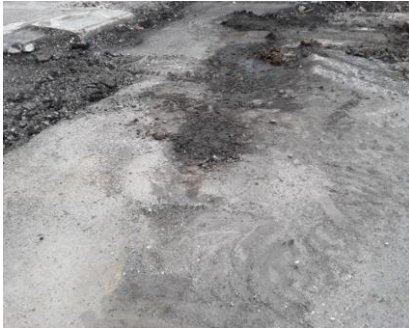
| Item No. | Sample No. | Location | Description | Asbestos type | Recommendation |
|---|---|---|---|---|---|
| 019 | FK001180 | Soils, 10.03.20 Excavation Site - External - Area adjacent trial pit 16 - Bitumen debris to the ground | The soil makeup consists of soil, crush and rubble. | Chrysotile | Remove |

Item 19 - Area adjacent trial pit 16 -  
Bitumen debris to the ground

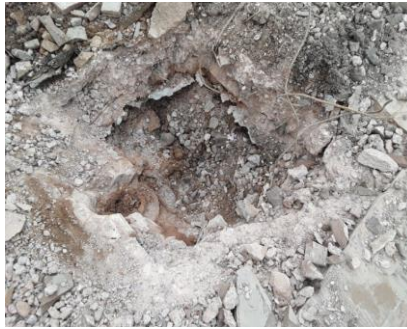
| Item No. | Sample No. | Location | Description | Asbestos type | Recommendation |
|---|---|---|---|---|---|
| 020 | SP FK001178 | Soils, 10.03.20 Excavation Site - External - Trial pit 17 - Bitumen pipe buried beneath soil and concrete slab | Please note the debris is scattered throughout the area. | Chrysotile | Remove |

Item 20 - Trial pit 17 - Bitumen pipe  
buried beneath soil and concrete slab

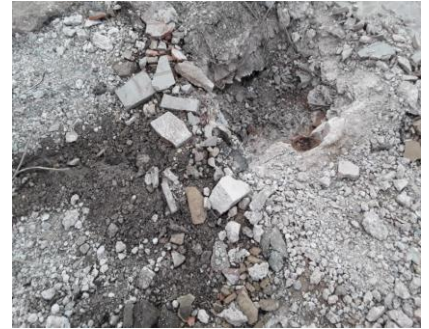
| Item No. | Sample No. | Location | Description | Asbestos type | Recommendation |
|---|---|---|---|---|---|
| 021 | FK001181 | Soils, 10.03.20 Excavation Site - External - Concrete slab - Felt used as a damp proof course beneath the former walls throughout the site | Please note the pipe is buried beneath the soil and appears to be running down to the nearest foul water duct. | NAD | None |

Item 21 - Concrete slab - Felt used as a  
damp proof course beneath the former  
walls throughout the site
