## Report - 78470/K

### REPORT ON THE PETROGRAPHIC EXAMINATION OF THREE MORTAR SAMPLES (Site: Sunlight House, Manchester; Project Ref. Project Ref 002579WJ476)

WJ Structures Ltd  
132-134 Chapel Street  
Leigh  
Lancashire  
WN7 2DB

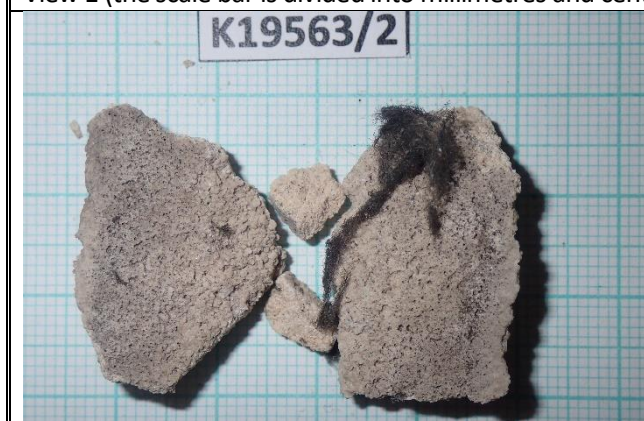
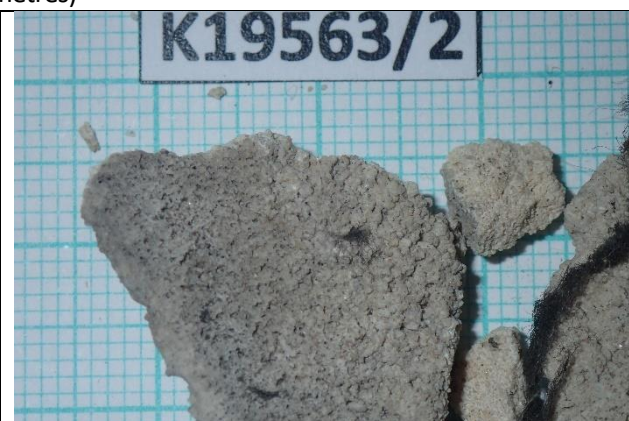
Figure B2

| <b>Condition of sample</b> | Broken mortar fragments with a maximum dimension of about 30mm |

Sample K19563/2

Little Quay Street - Sample 2

View 1 (the scale bar is divided into millimetres and centimetres)

View 2 (the scale bar is divided into millimetres and centimetres)

View 3 (the scale bar is divided into millimetres and centimetres)
