# Oldham Road, Newton Heath

## Ground Investigation

Curtins Ref: 074031-CUR-00-XX-RP-GE-002

Client Name: One Manchester

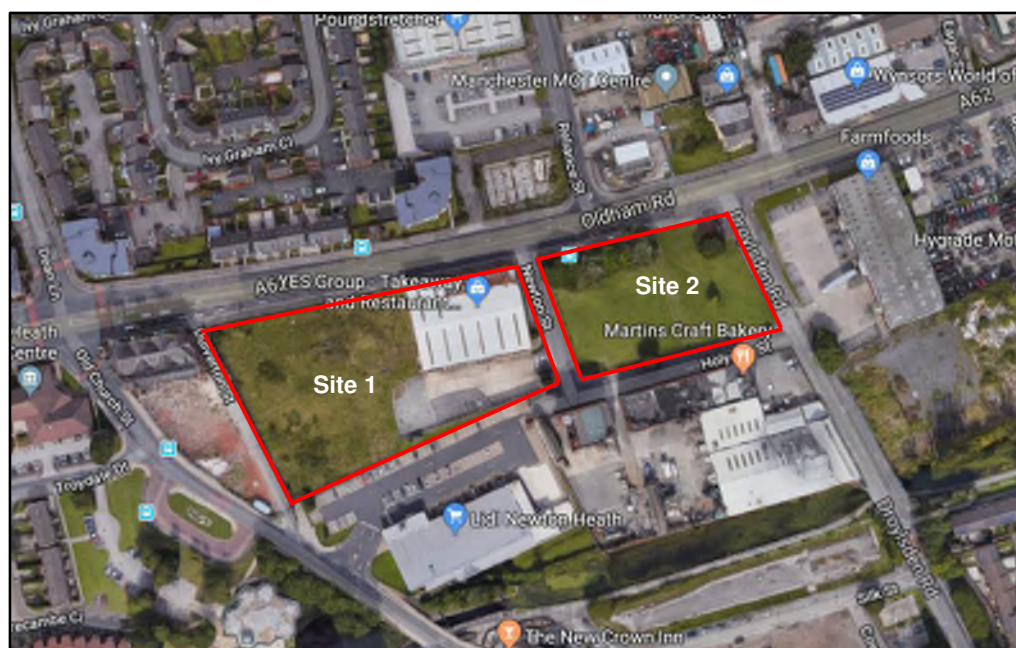
Figure 2.1a – Site Location Plan (Site 1 and 2)

To the west of Newton Street, referred to as Site 1 in this report and seen in Figure 2.1a, the site is currently occupied by a warehouse present in the north with hardstanding forming carparking for the warehouse in the south. To the west of the warehouse is grassed with denser vegetation. The whole of the western area is fenced off to the public. The site east of Newton Street, referred to as Site 2 in this report and seen in Figure 2.1a, is grassed with a few trees present in the north and is open to the public.

The site is relatively flat topographically to the west of Newton Street and to the east is slightly raised in the west of the grassed area and flat to the east.

The site is divided into two plots separated by Newton Street, Site 1 to the west and Site 2 to the east. The site location plan and sub-division is presented in *Figure 2.1a*. A Due Diligence Investigation of Site 1 and Site 2 was undertaken in October 2019 comprising window sample boreholes; environmental testing of soils; in-situ and laboratory geotechnical testing of soils; and 4no ground gas monitoring visits.

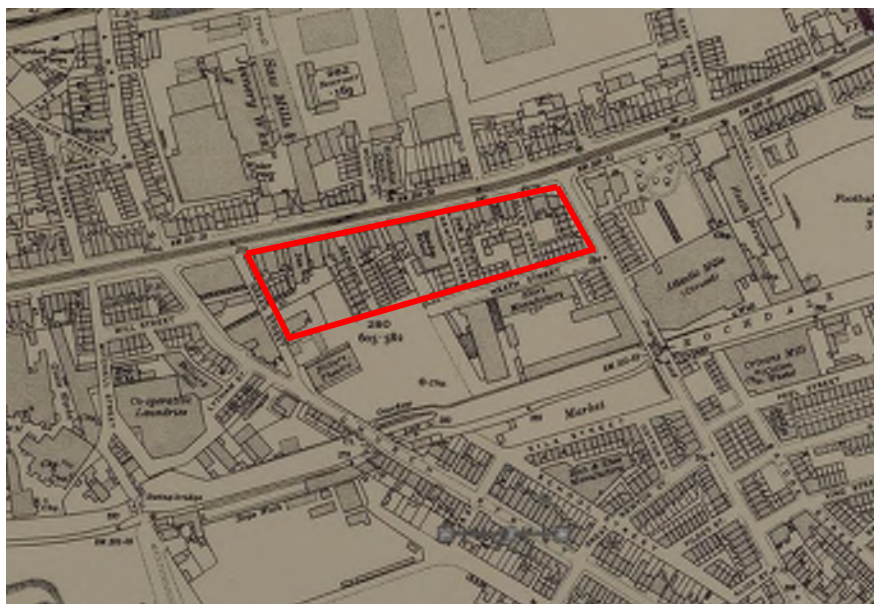
However, analysis of historical bomb mapping from the University of Manchester (*Figure 2.6*) shows the area surrounding the site has no recorded bombs, targets or damaged buildings. No fire bombs (red circles) hit the site or the surrounding area according to the Manchester WWII bomb damage maps.

*Figure 2.6: Site boundary shown in red dated 1931.*

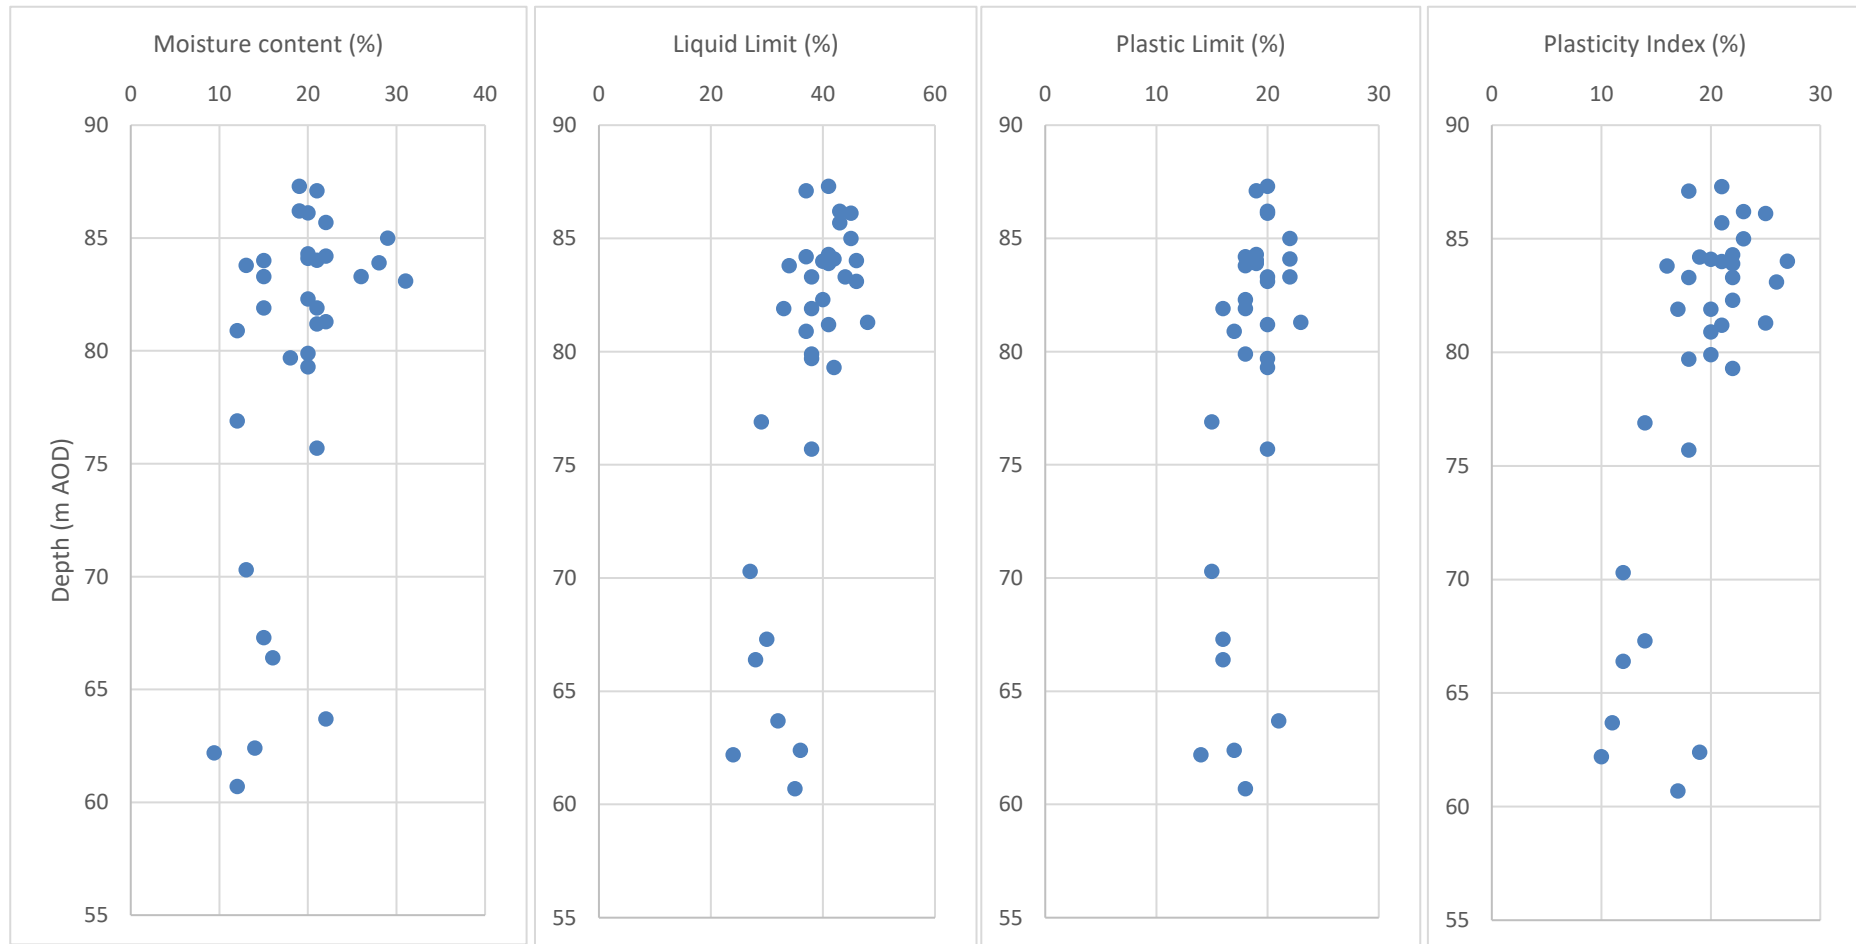
The Atterberg Test results indicate a clayey soil with low to intermediate plasticity. The Plasticity Indices were generally between 10% and 27% with a decrease in plasticity index from 80.00m AOD. A high moisture content, liquid limit and plasticity index were recorded in WS05 at 2.50m bgl. The results of Atterberg Limits are presented on *Figure 6.2.1a* and *Casagrande graphs* are presented in *Appendix D*.

**Figure 6.2.1a – Summary of Atterberg Test Results**

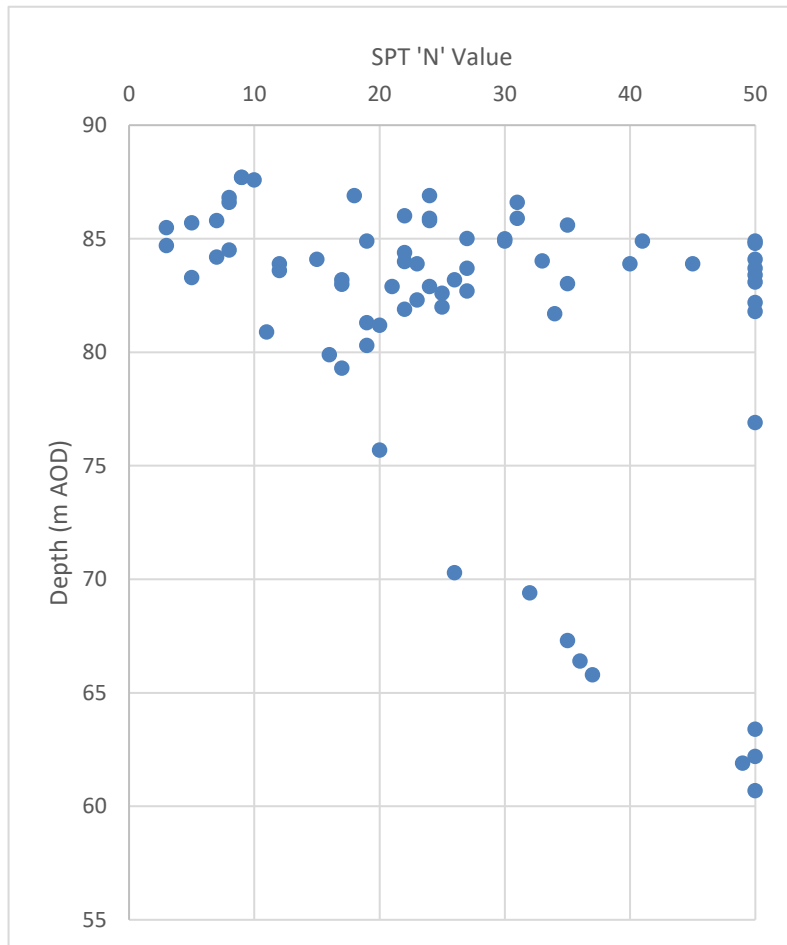
The SPT 'N' results indicates variable stratum comprising soft to very stiff deposits. A typical increase in stiffness is observed with depth, *Figure 6.2.1b*.

**Figure 6.2.1b** – Standard Penetration Test vs. Depth

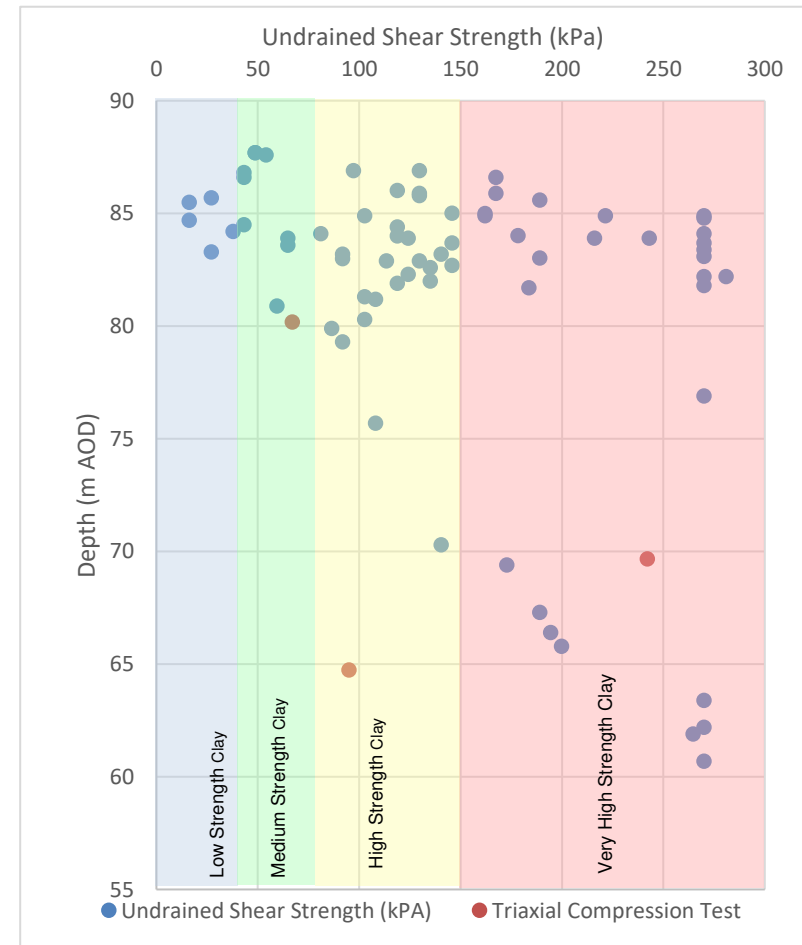
**Figure 6.2.1c** – Estimated Undrained Shear Strength vs Depth

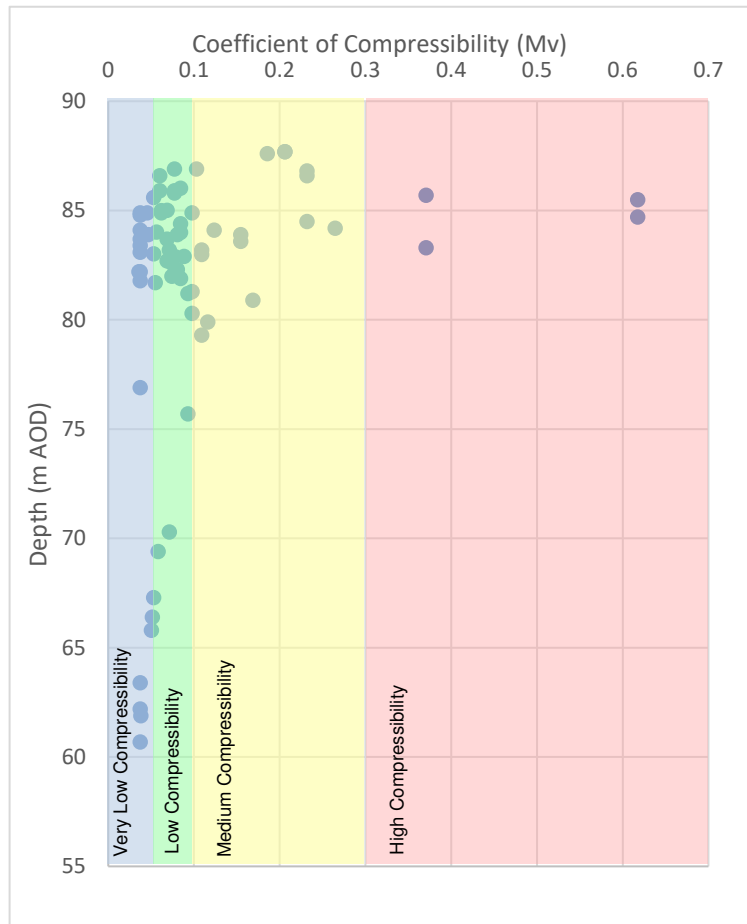
Using an  $f_2$  factor of 0.54 for an average plasticity index of 19%,  $M_v$  values typically range between 0.036 and 0.61  $\text{m}^2/\text{MN}$  indicating very low to high compressibility. The high compressibility material are recorded in shallow soils. Most results indicate a low to medium compressibility clay, *Figure 6.2.1d*.

**Figure 6.2.1d** – Estimated Volume Compressibility Coefficients ( $M_v$ ) vs Depth

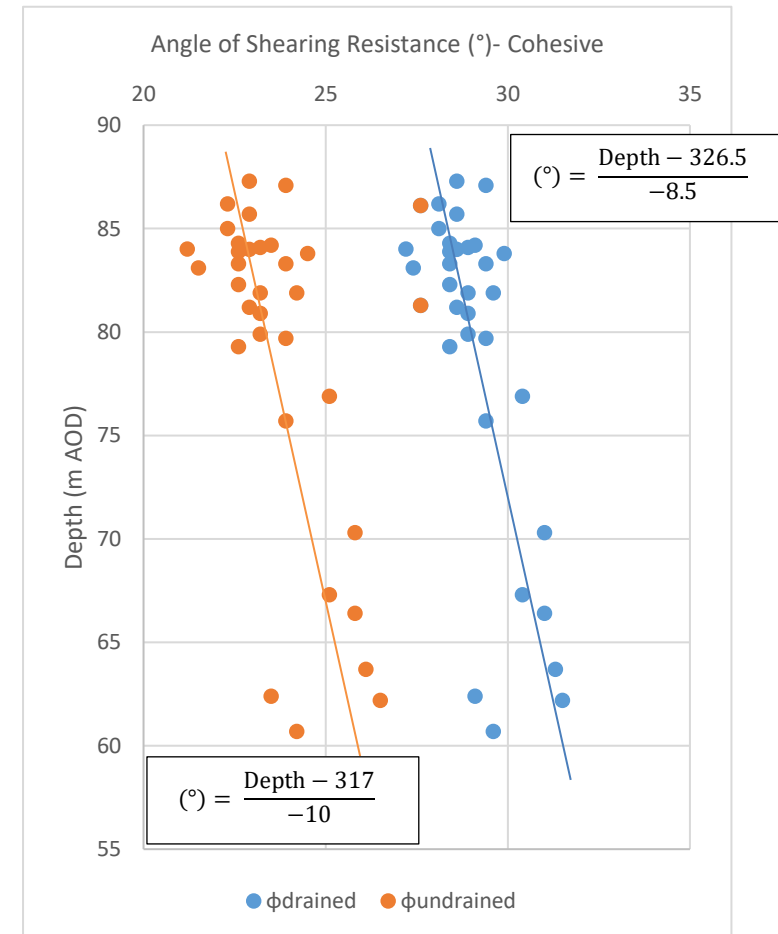
The Angle of Shearing Resistance,  $\phi'$ , for the cohesive Glacial Till has been derived from the correlation with Plasticity Indices (Ref. 10). The values are shown in *Figure 6.2.1e*.

**Figure 6.2.1e** – Angle Shearing Resistance (Cohesive) vs Depth

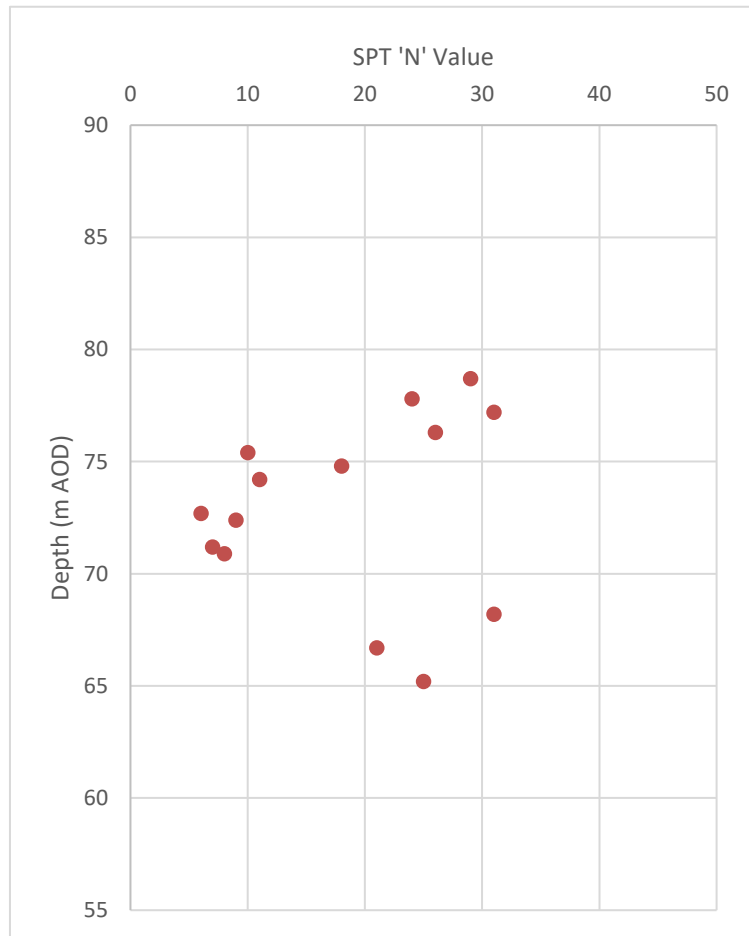
Fourteen SPT 'N' values were recorded in the granular strata, ranging between 6 and 31. The SPT 'N' values indicate loose to dense deposits identifying variable ground conditions across the site. The results are shown in *Figure 6.2.2a*.

**Figure 6.2.2a** – Standard Penetration Test vs. Depth

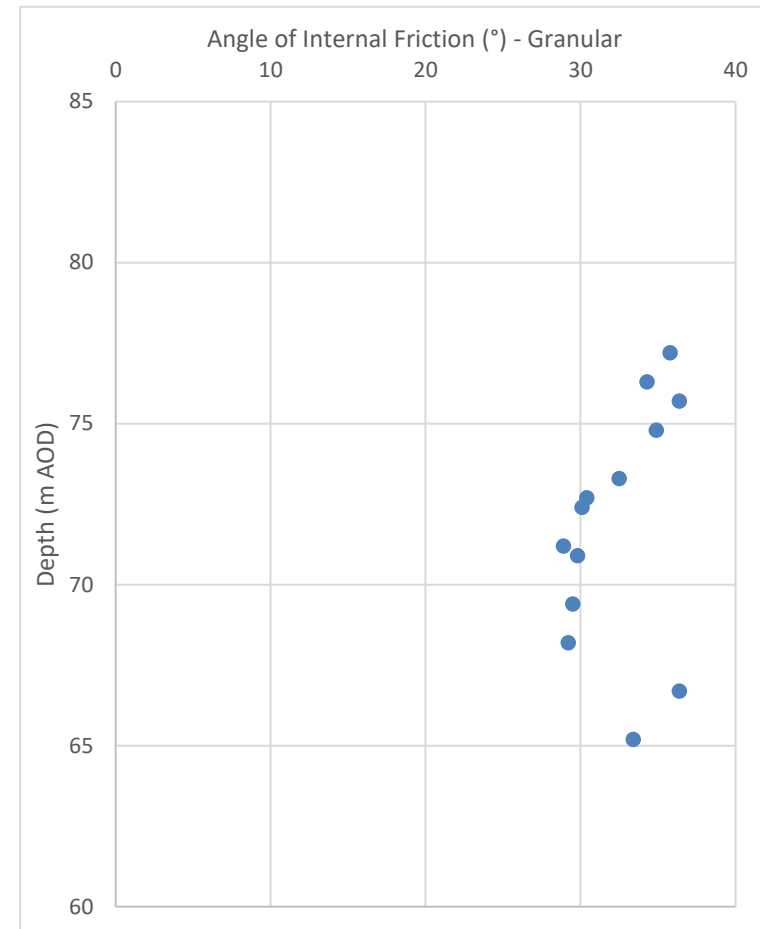
A moderately conservative characteristic Angle of Shearing Resistance ( $\phi'$ ) has been derived from correlation with SPT N values (Peck et al, 1967, Ref 11) and a review of published values. The results are shown in *Figure 6.2.2b*.

**Figure 6.2.2b** – Angle of Internal Friction (Granular) vs Depth

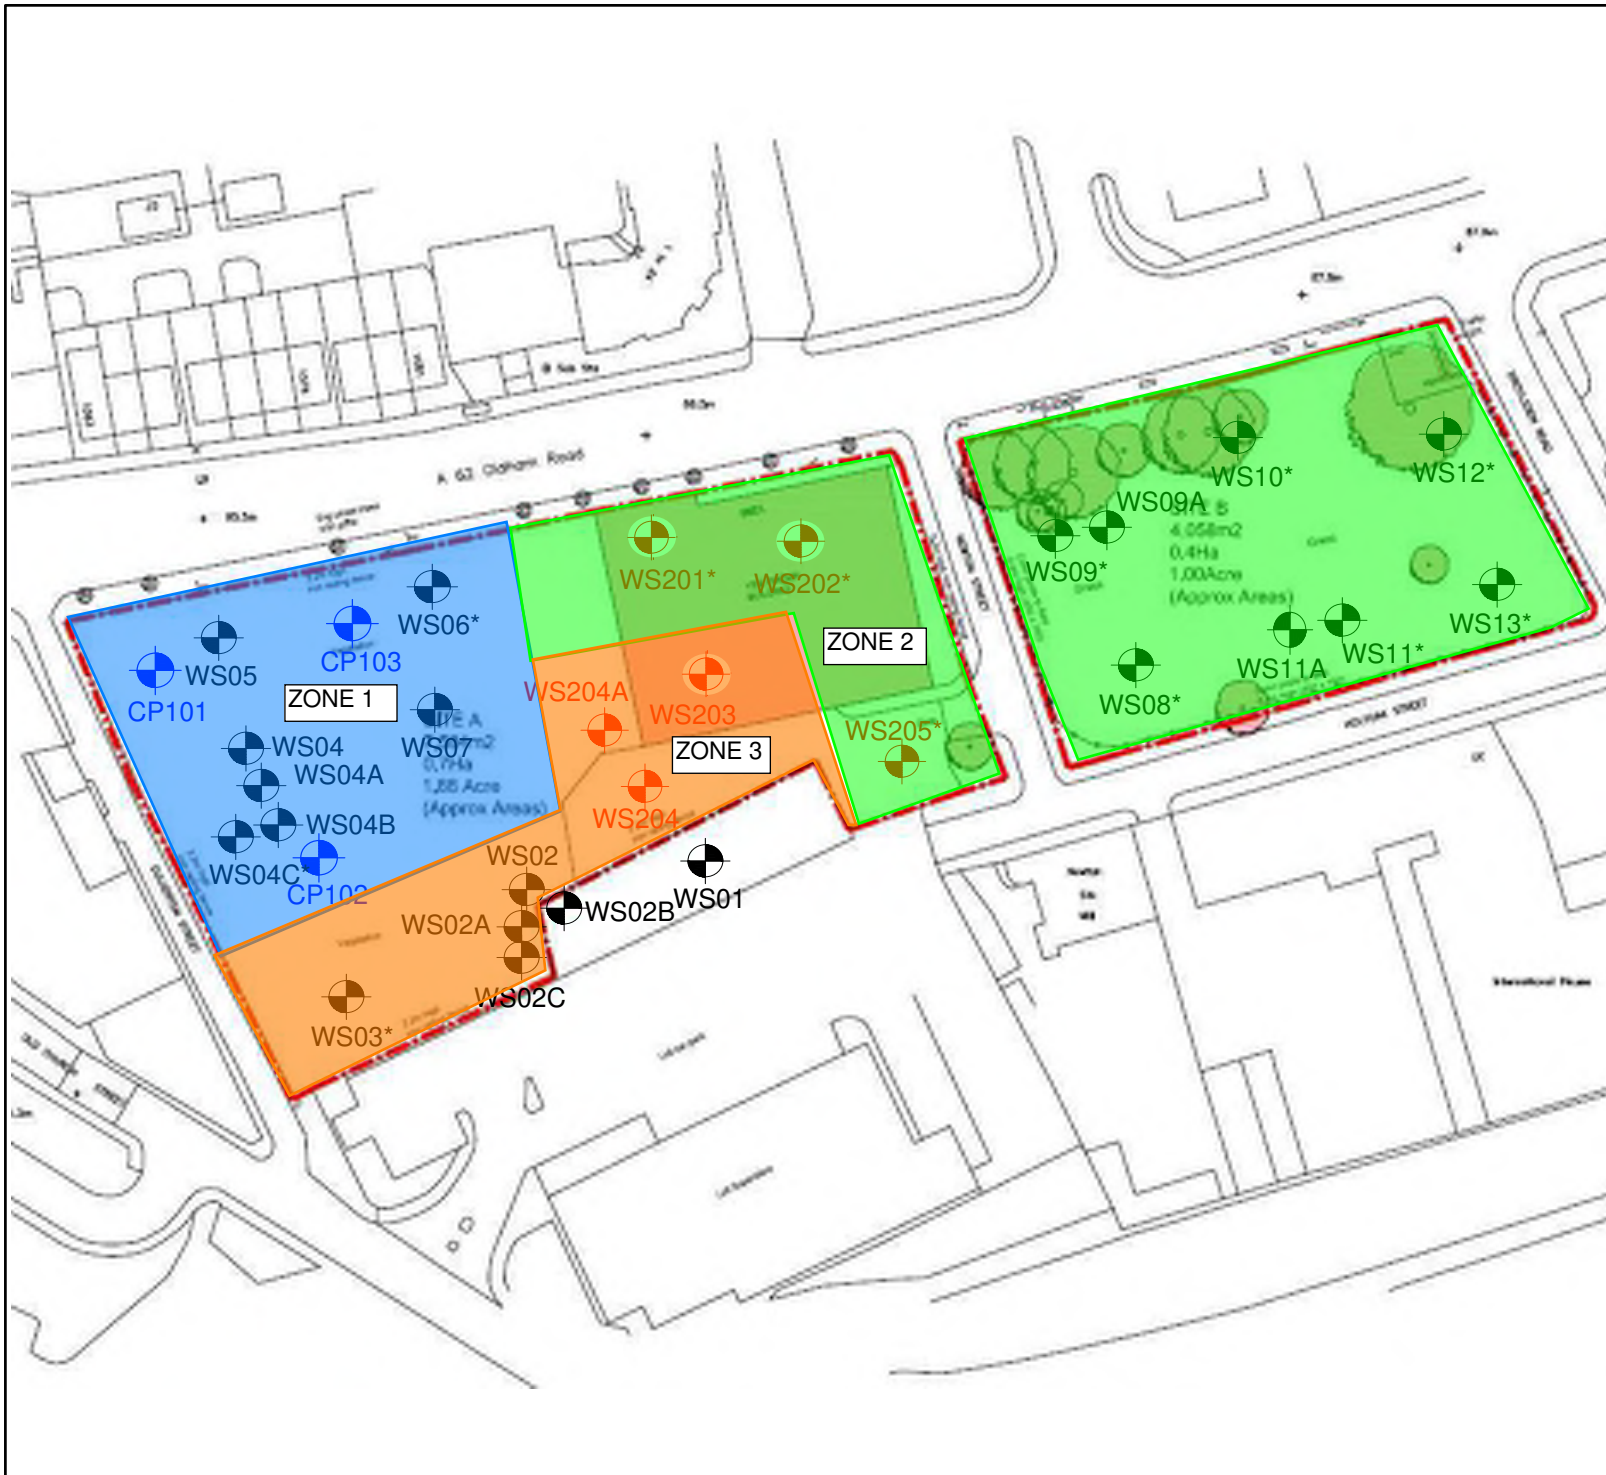
### PROPOSED LOCATIONS FOR SITE INVESTIGATION

2019 WINDOW SAMPLE BOREHOLE LOCATIONS

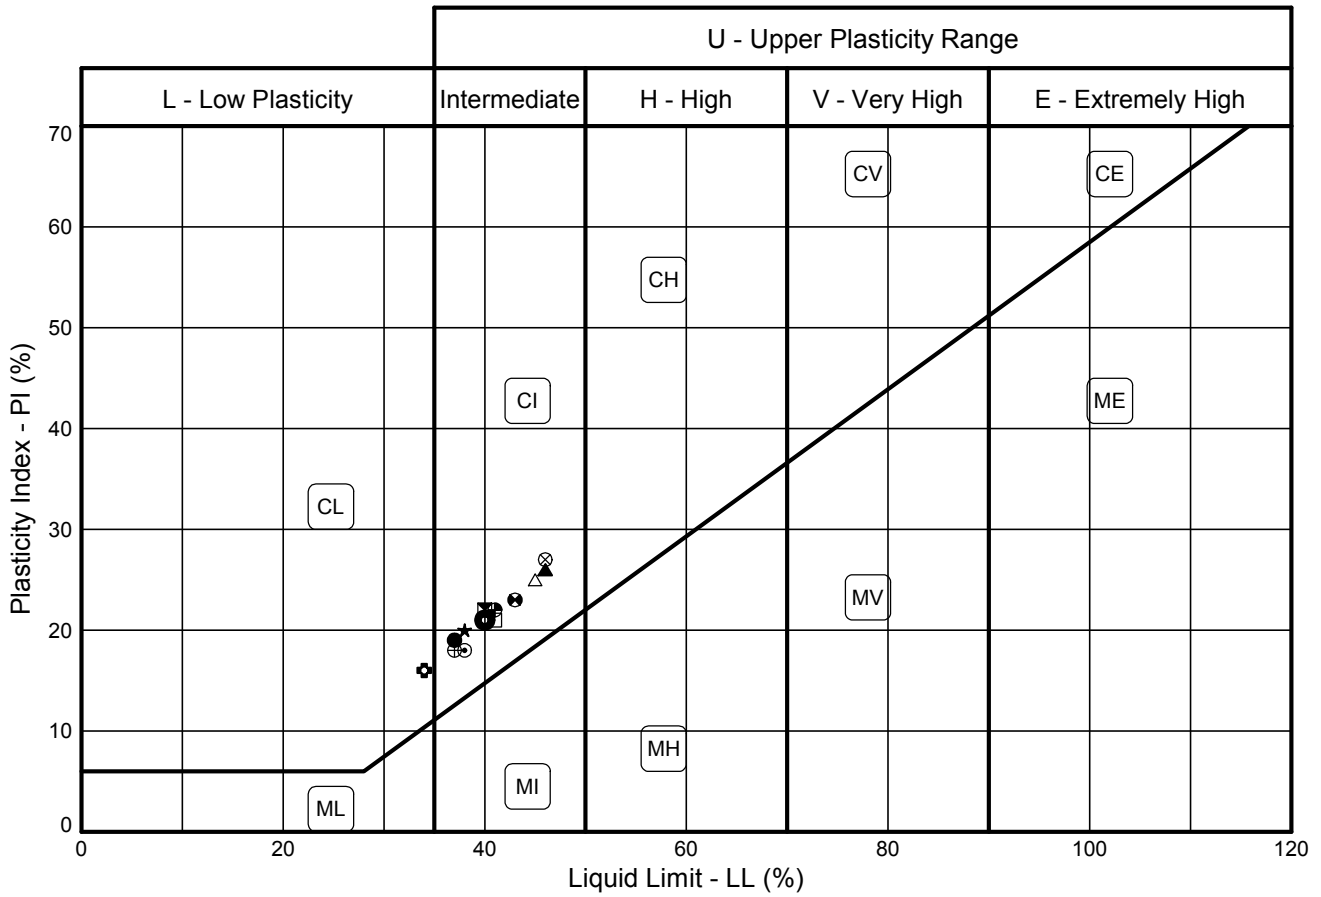
# PLASTICITY CHART - PI Vs LL

In accordance with BS5930:2015  
Testing in accordance with BS1377-2:1990

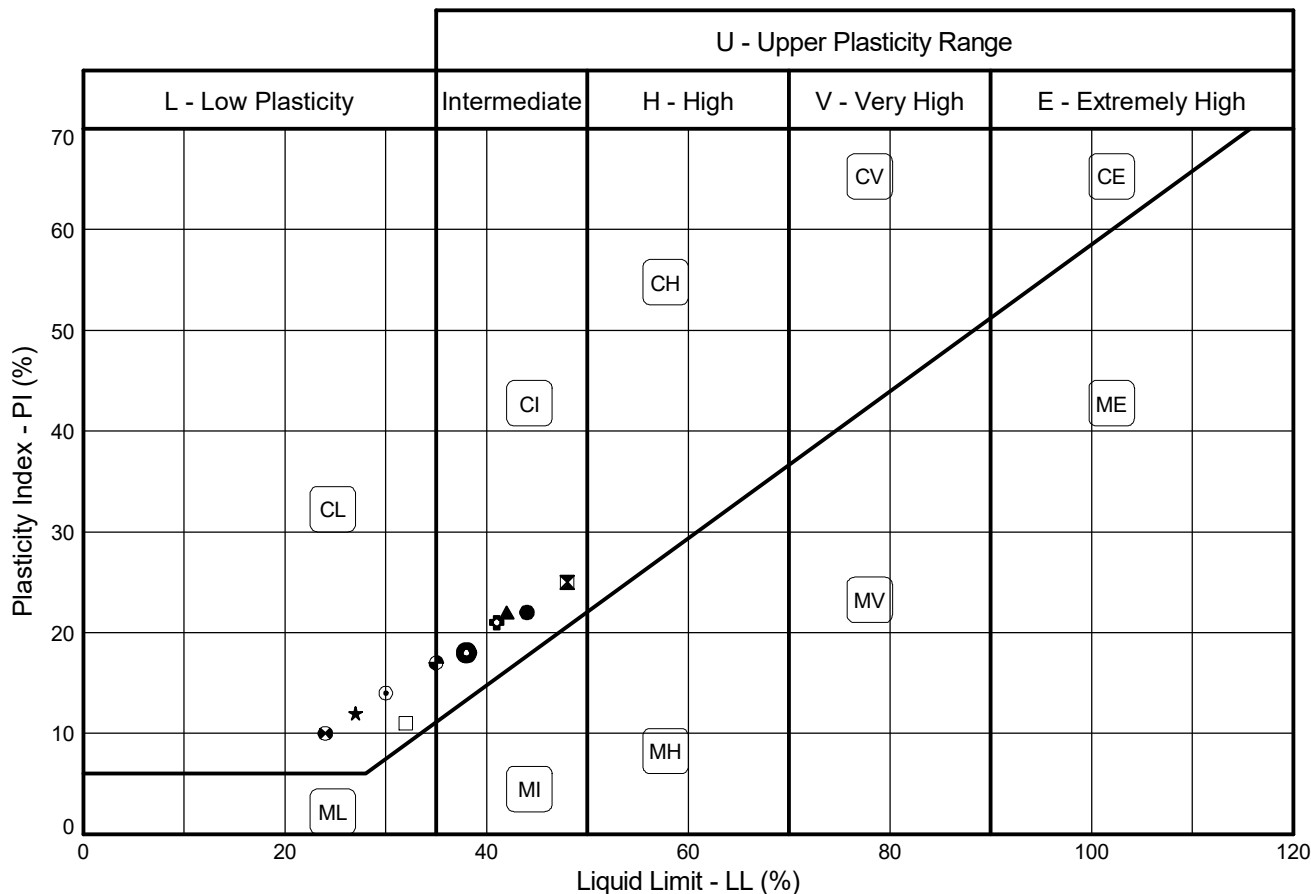
# PLASTICITY CHART - PI Vs LL

In accordance with BS5930:2015  
Testing in accordance with BS1377-2:1990

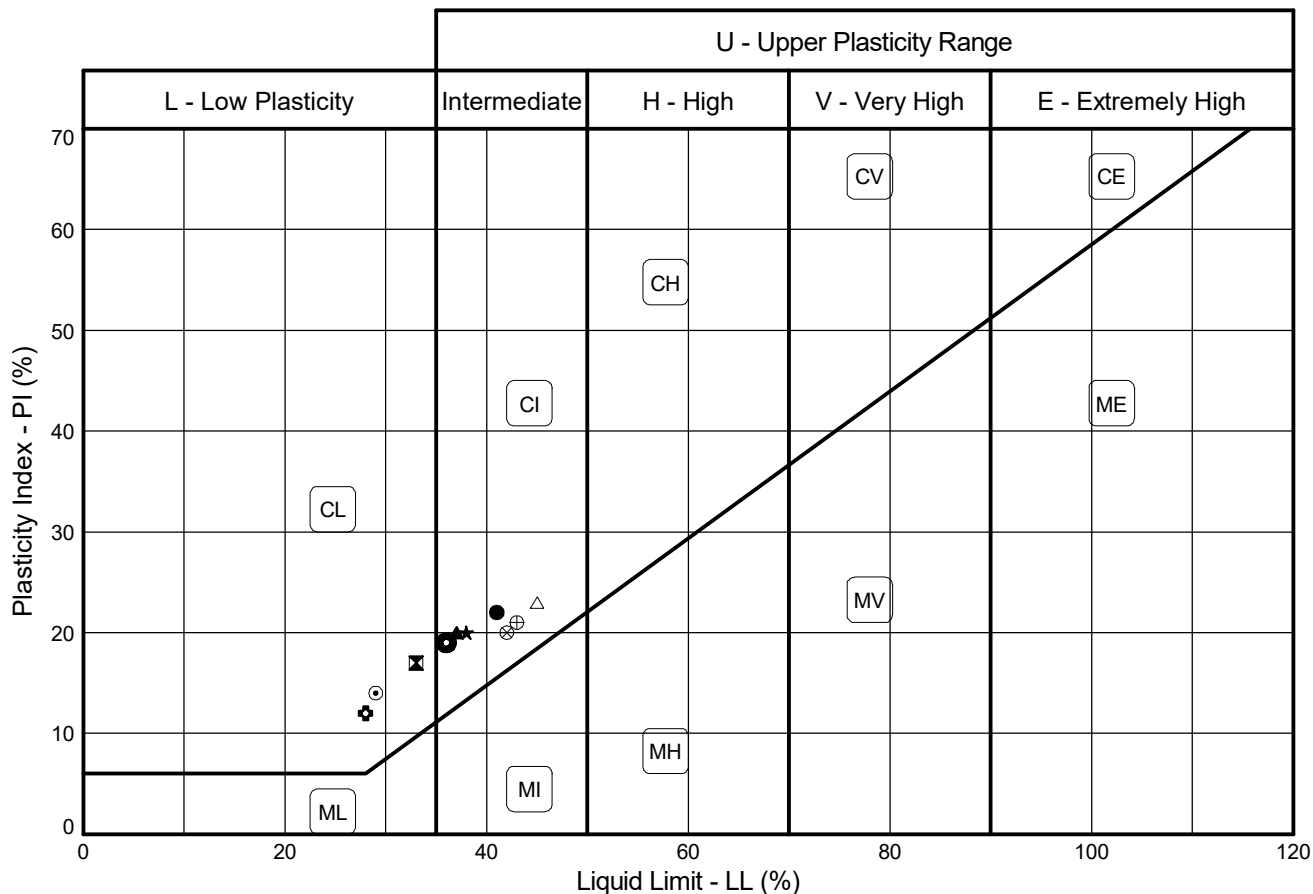
# PLASTICITY CHART - PI Vs LL

In accordance with BS5930:2015  
Testing in accordance with BS1377-2:1990

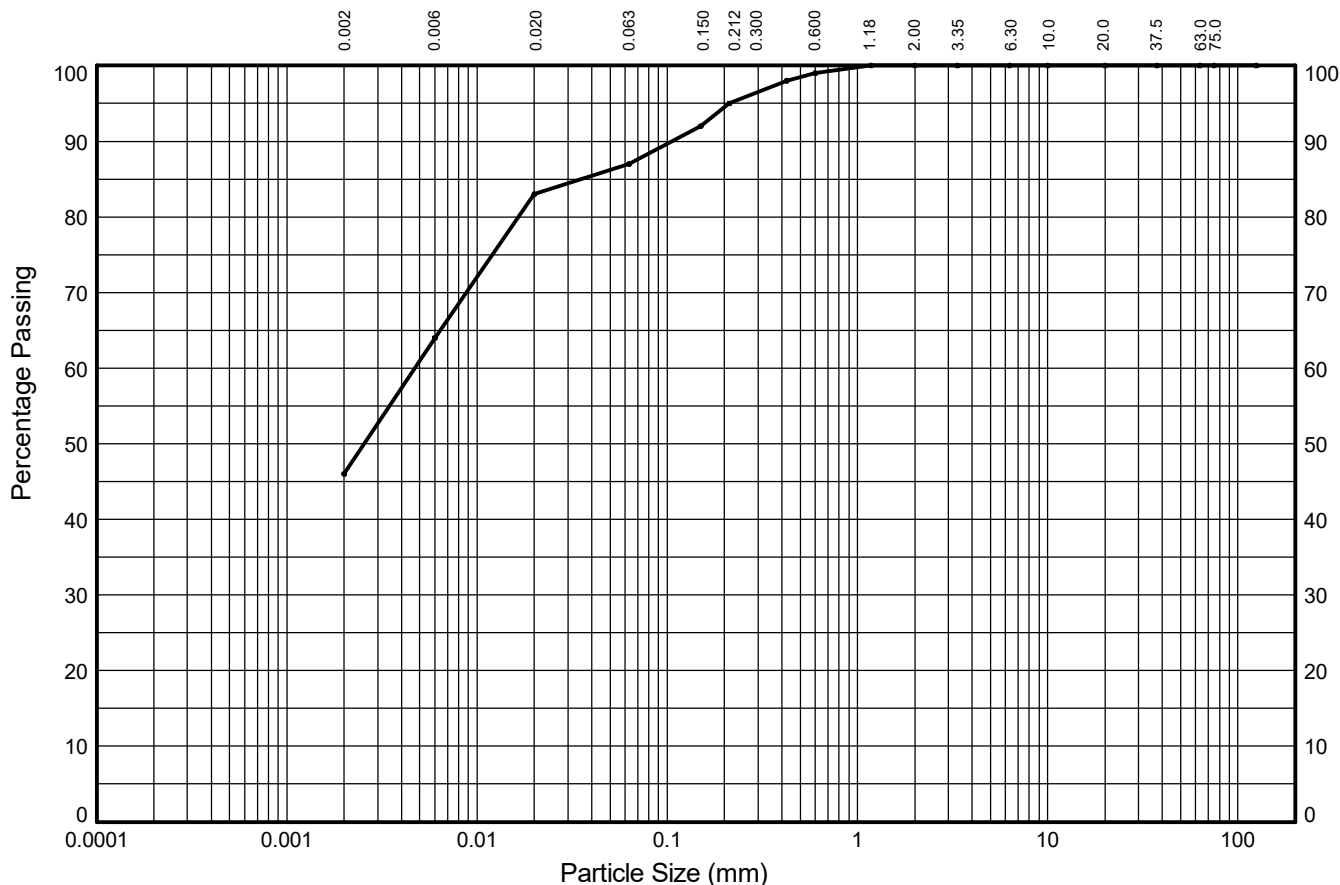
In accordance with clauses 9.2, 9.4 of BS1377:Part 2:1990

Position ID: **CP101** Sample Ref: **20/09769/3** Sample Type: **D** Depth (m): **6.00**

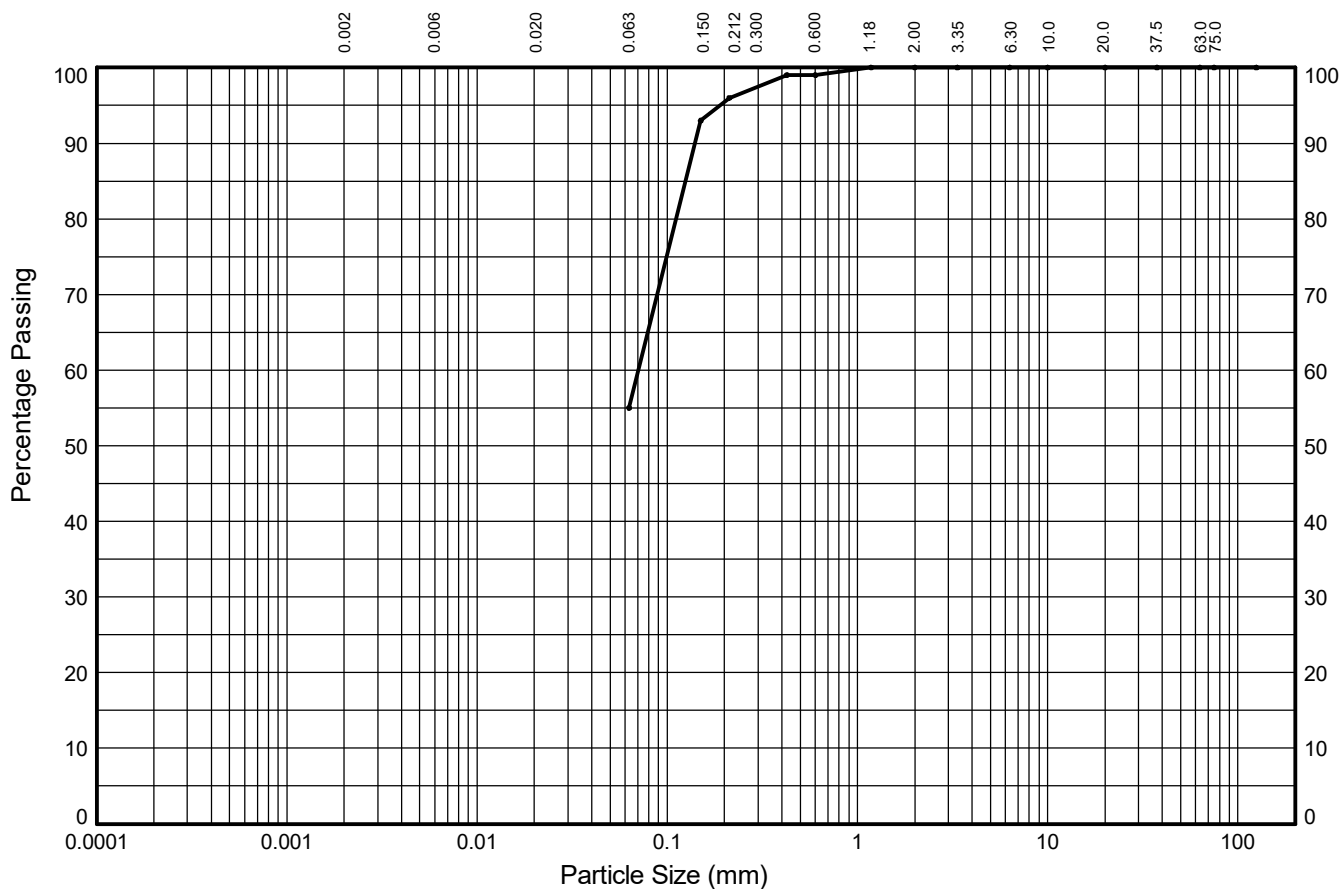
Depth (m): **12.00**

In accordance with clauses 9.2 of BS1377:Part 2:1990

| | - | - | - | 40% | 4% | 1% | 0% | 0% | 0% | |

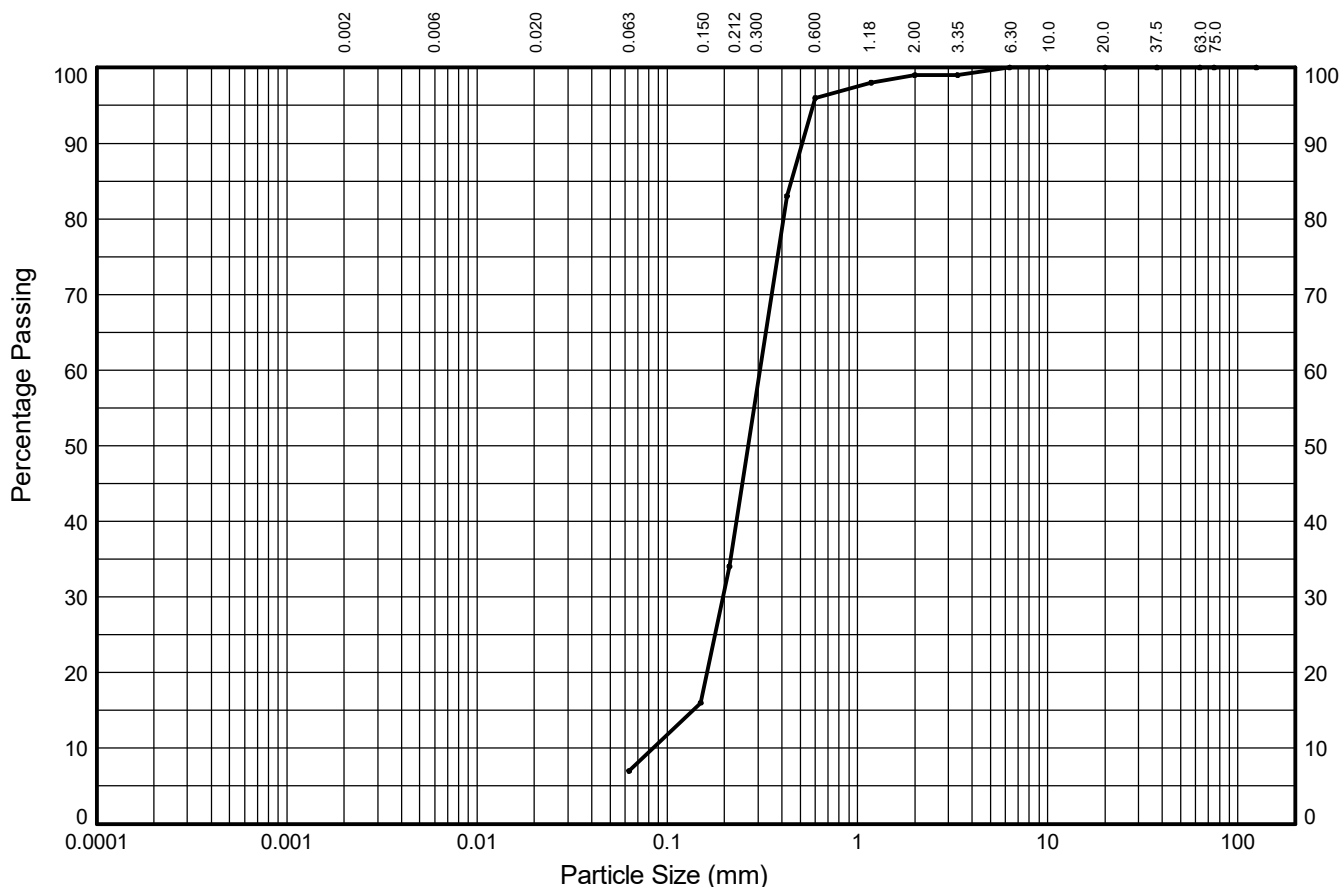
Depth (m): **7.50**

In accordance with clauses 9.2 of BS1377:Part 2:1990

| | - | - | - | 24% | 66% | 3% | 1% | 0% | 0% | |

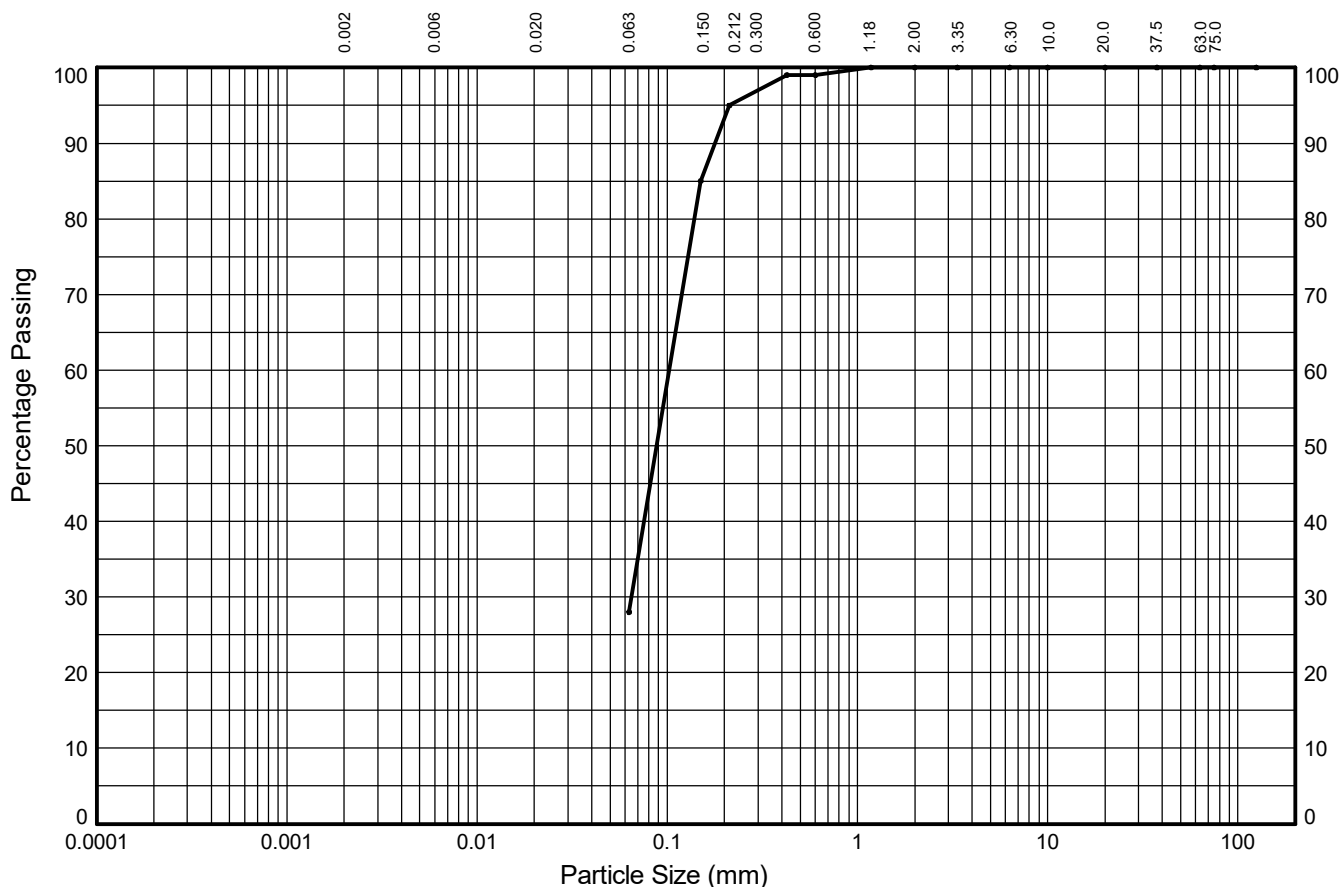
Depth (m): **18.00**

In accordance with clauses 9.2 of BS1377:Part 2:1990

| | - | - | - | 65% | 6% | 1% | 0% | 0% | 0% | |

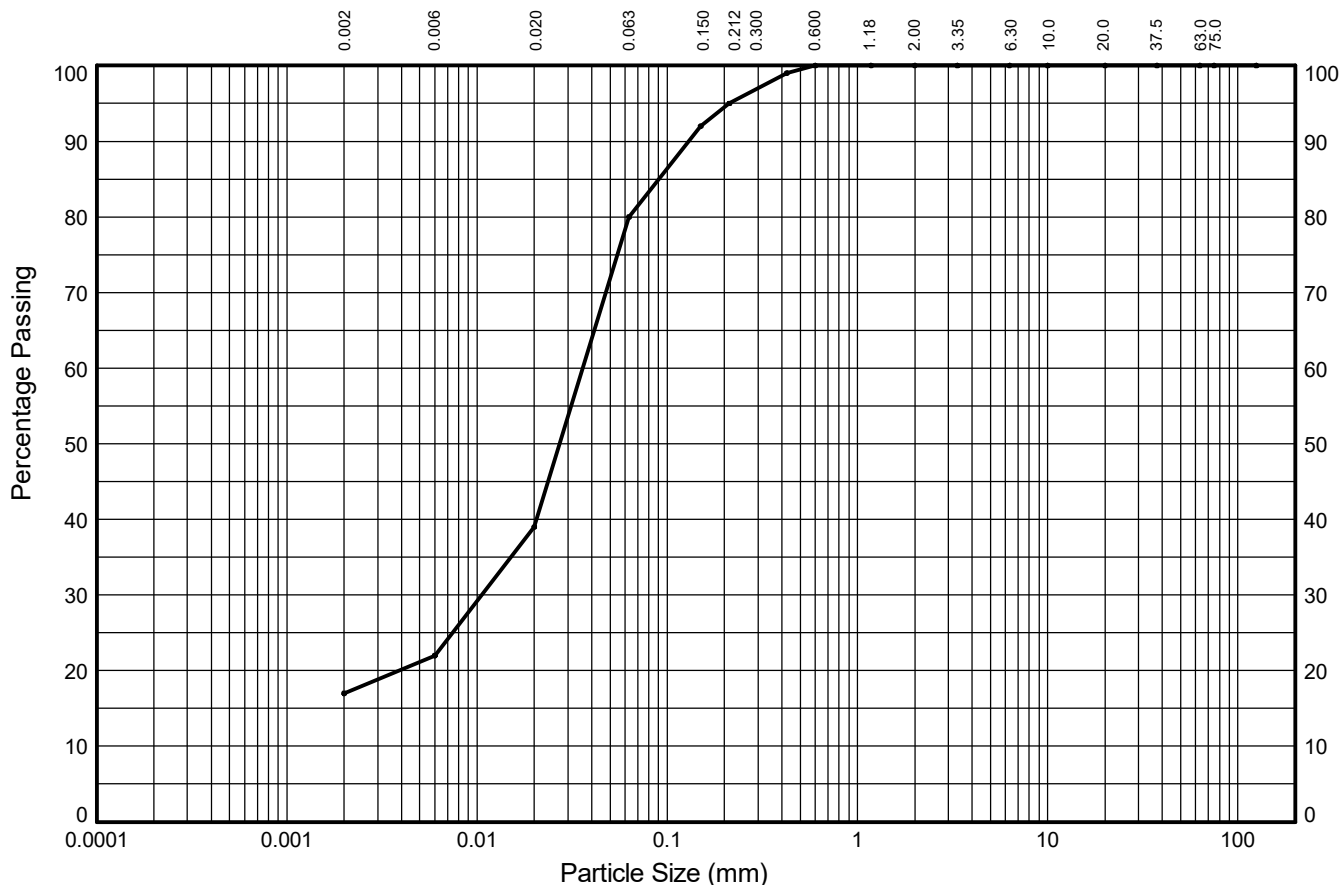
Depth (m): **10.00**

| CLAY | fine | medium | coarse | fine | medium | coarse | fine | medium | coarse | COBBLES |
|---|---|---|---|---|---|---|---|---|---|---|
| | 5% | 17% | 41% | 14% | 6% | 0% | 0% | 0% | 0% | |

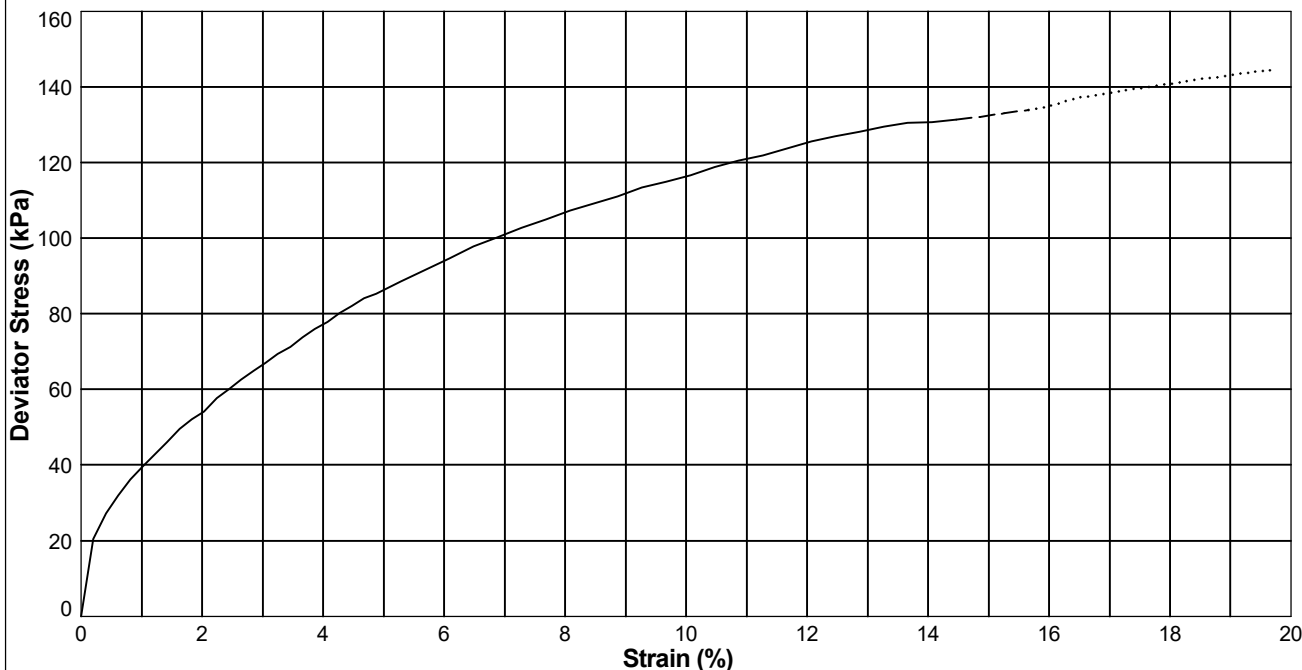
| STAGE NUMBER | | 1 | 2 | 3 |
|---|---|---|---|---|
| | Plastic (Barrelling) | | | |

Key: ————— Stage 1      - - - - - Stage 2      ..... Stage 3

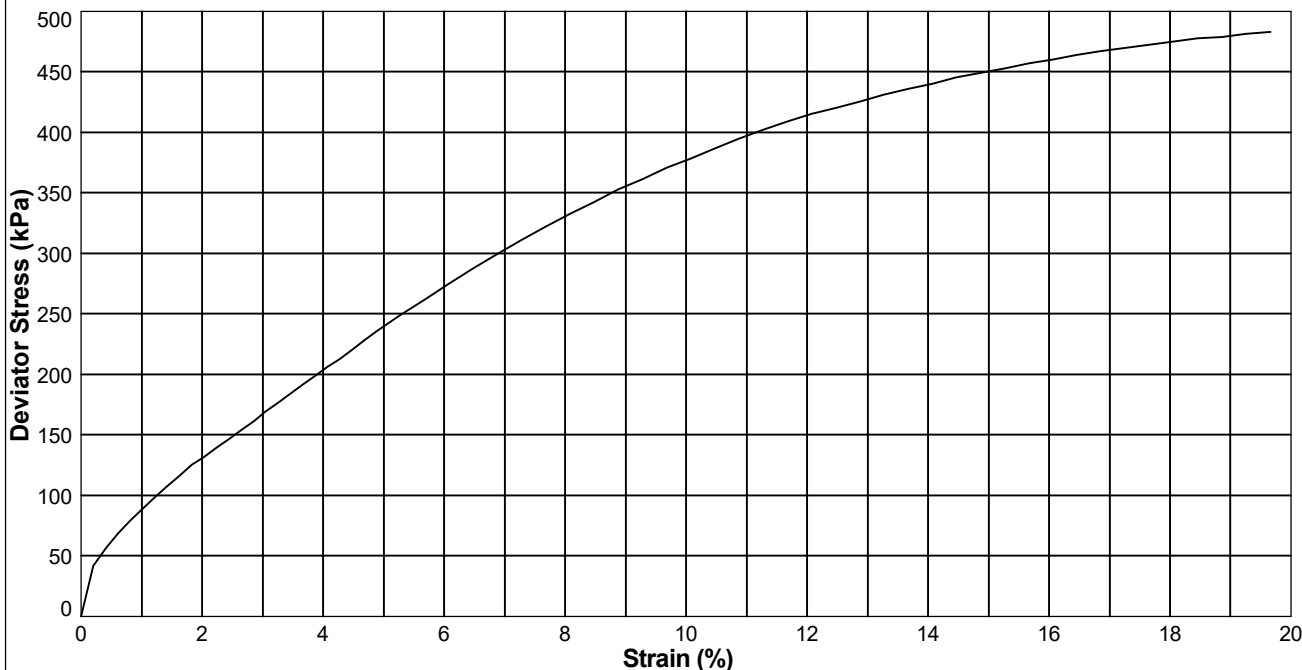
| STAGE NUMBER | | 1 | 2 | 3 |
|---|---|---|---|---|
| FAILURE DETAILS | Strain at Failure (%) | 19.7 | | |
| | Mode of Failure<br><br>1 : Plastic (Barrelling) | | | |

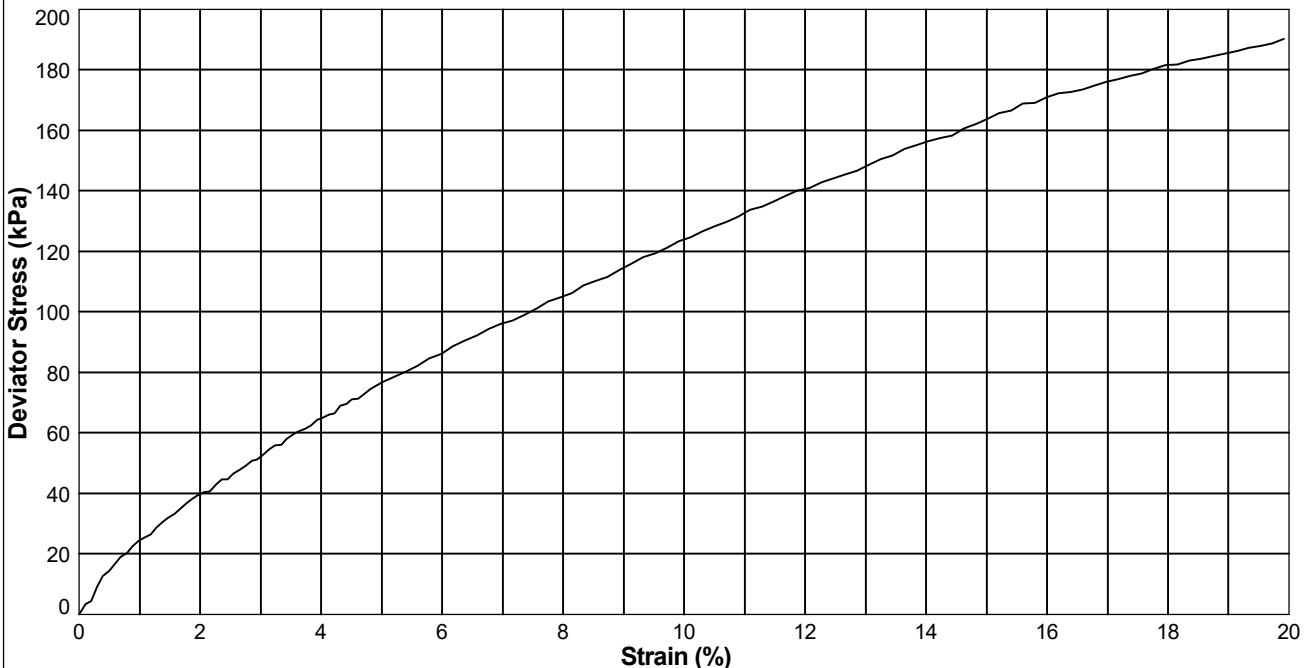
| STAGE NUMBER | | 1 | 2 | 3 |
|---|---|---|---|---|
| FAILURE DETAILS | Strain at Failure (%) | 19.9 | | |
| | Mode of Failure | <p>1 : Semi-plastic (bulging, shear &amp; axial splitting)</p> | | |
