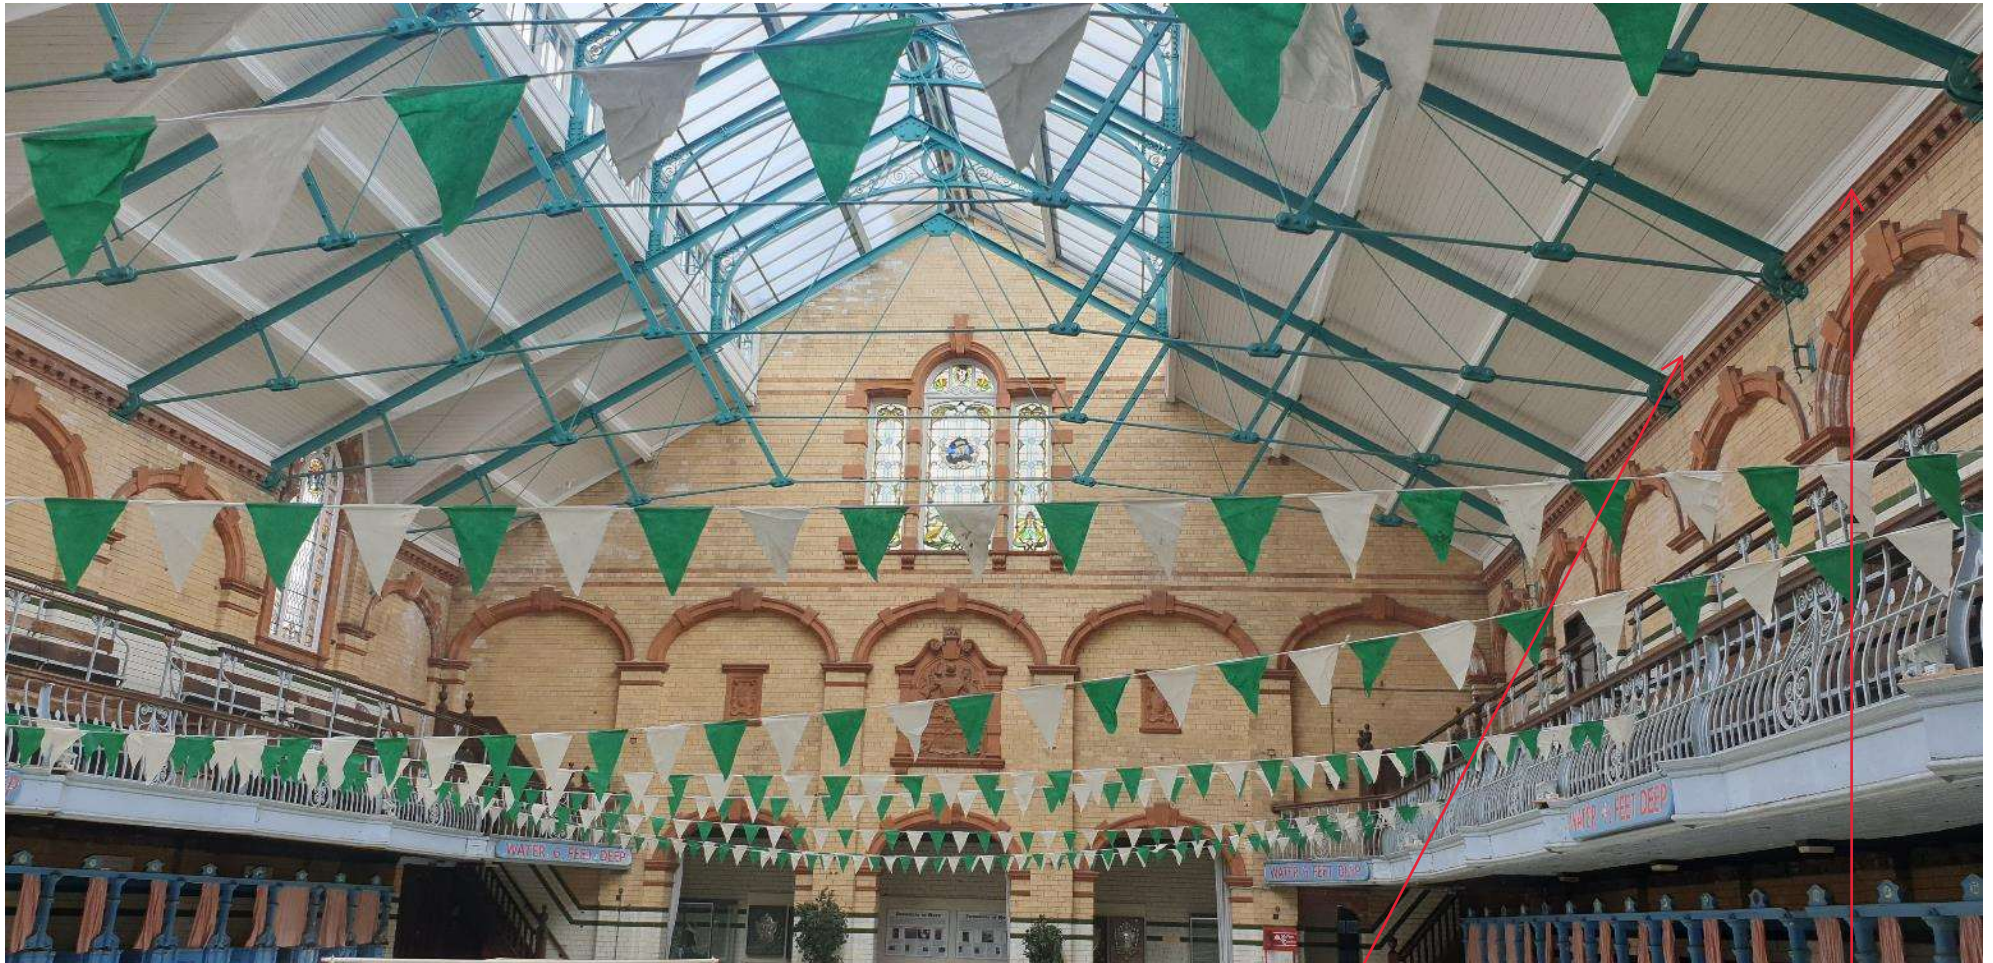
Beam detector units to be fixed to timber above cornice with reflectors mounted on opposite wall.  
5 units in each pool evenly spaced.  
See revised layout drawing.

New fire alarm cable to run above cornice

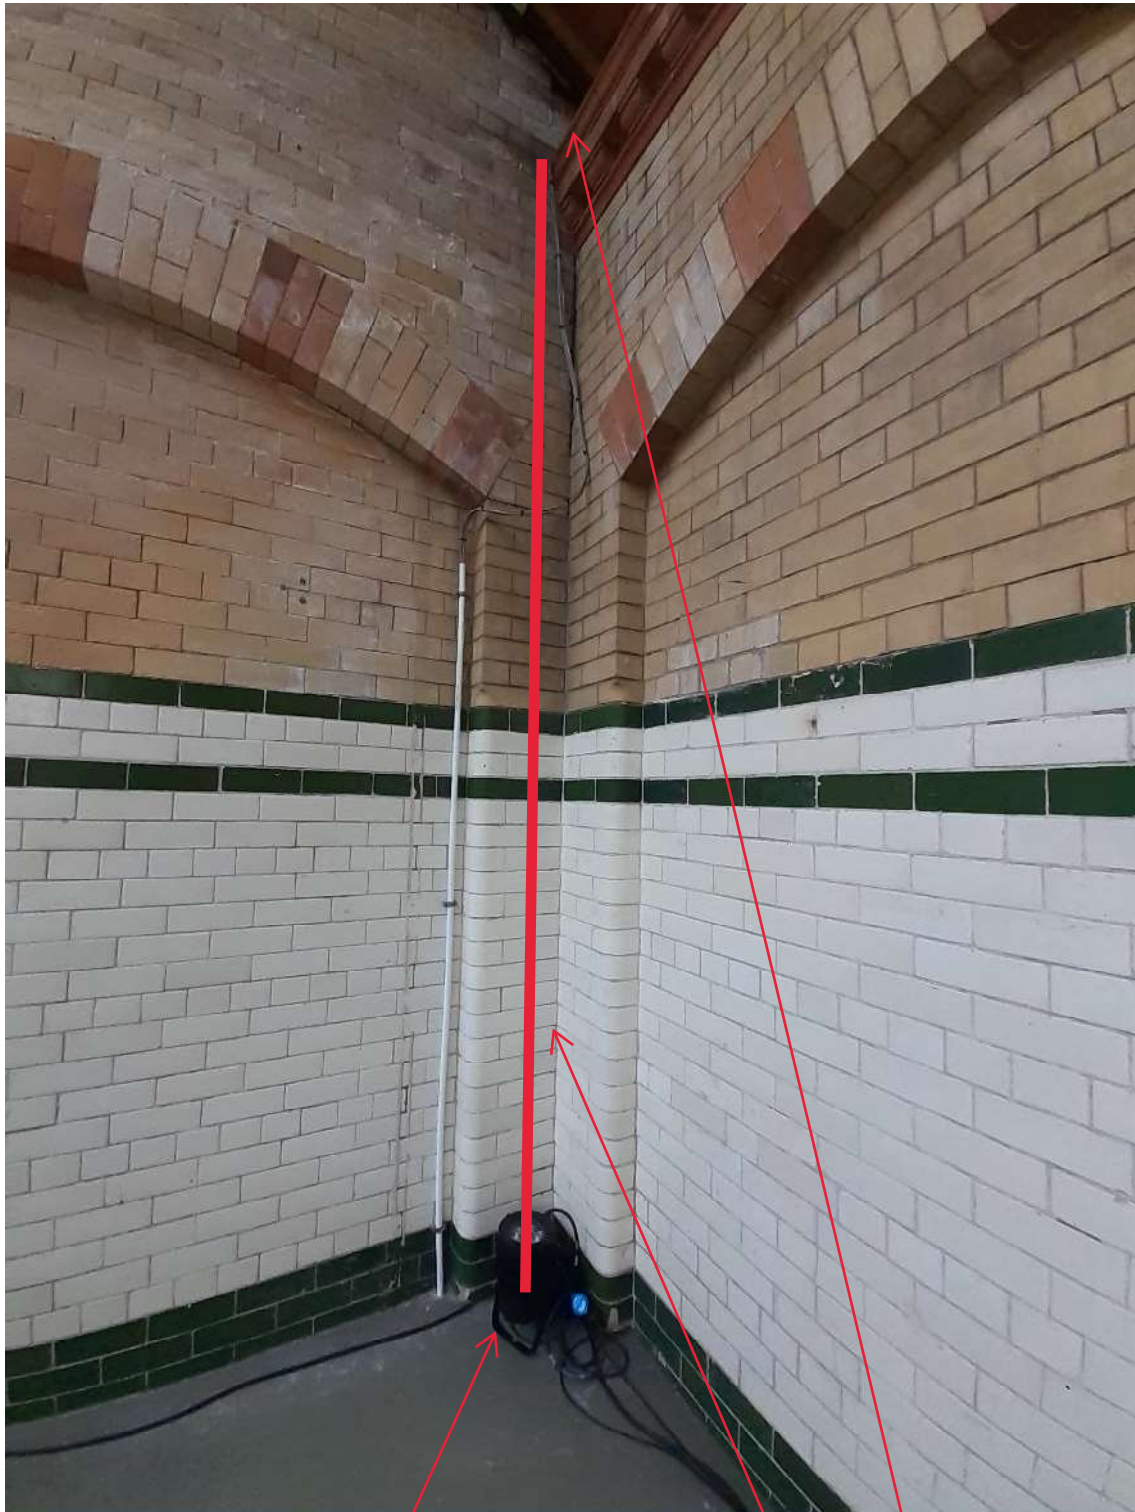
New penetration  
from below.

Cables to exit  
conduit and run  
above cornice

Fire alarm  
cabling to run in  
new steel  
conduit. Installed  
close to corner.

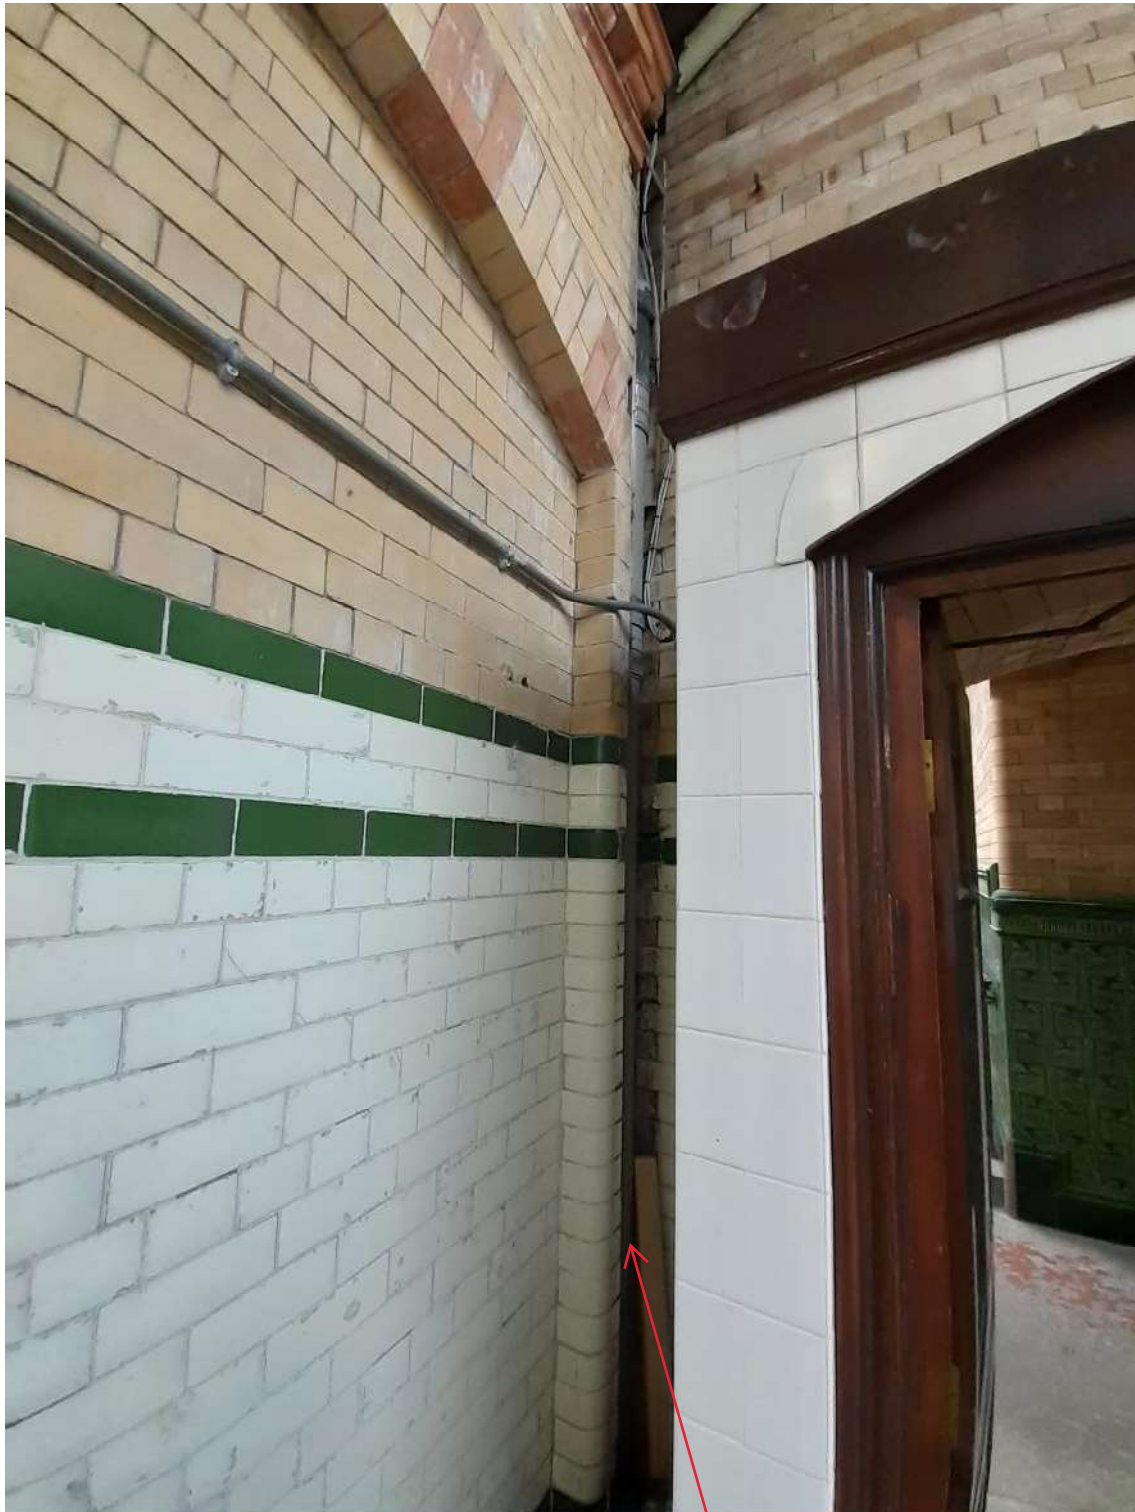
New fire alarm cable to run within this concealed space from below to high level and entre new room via existing penetration

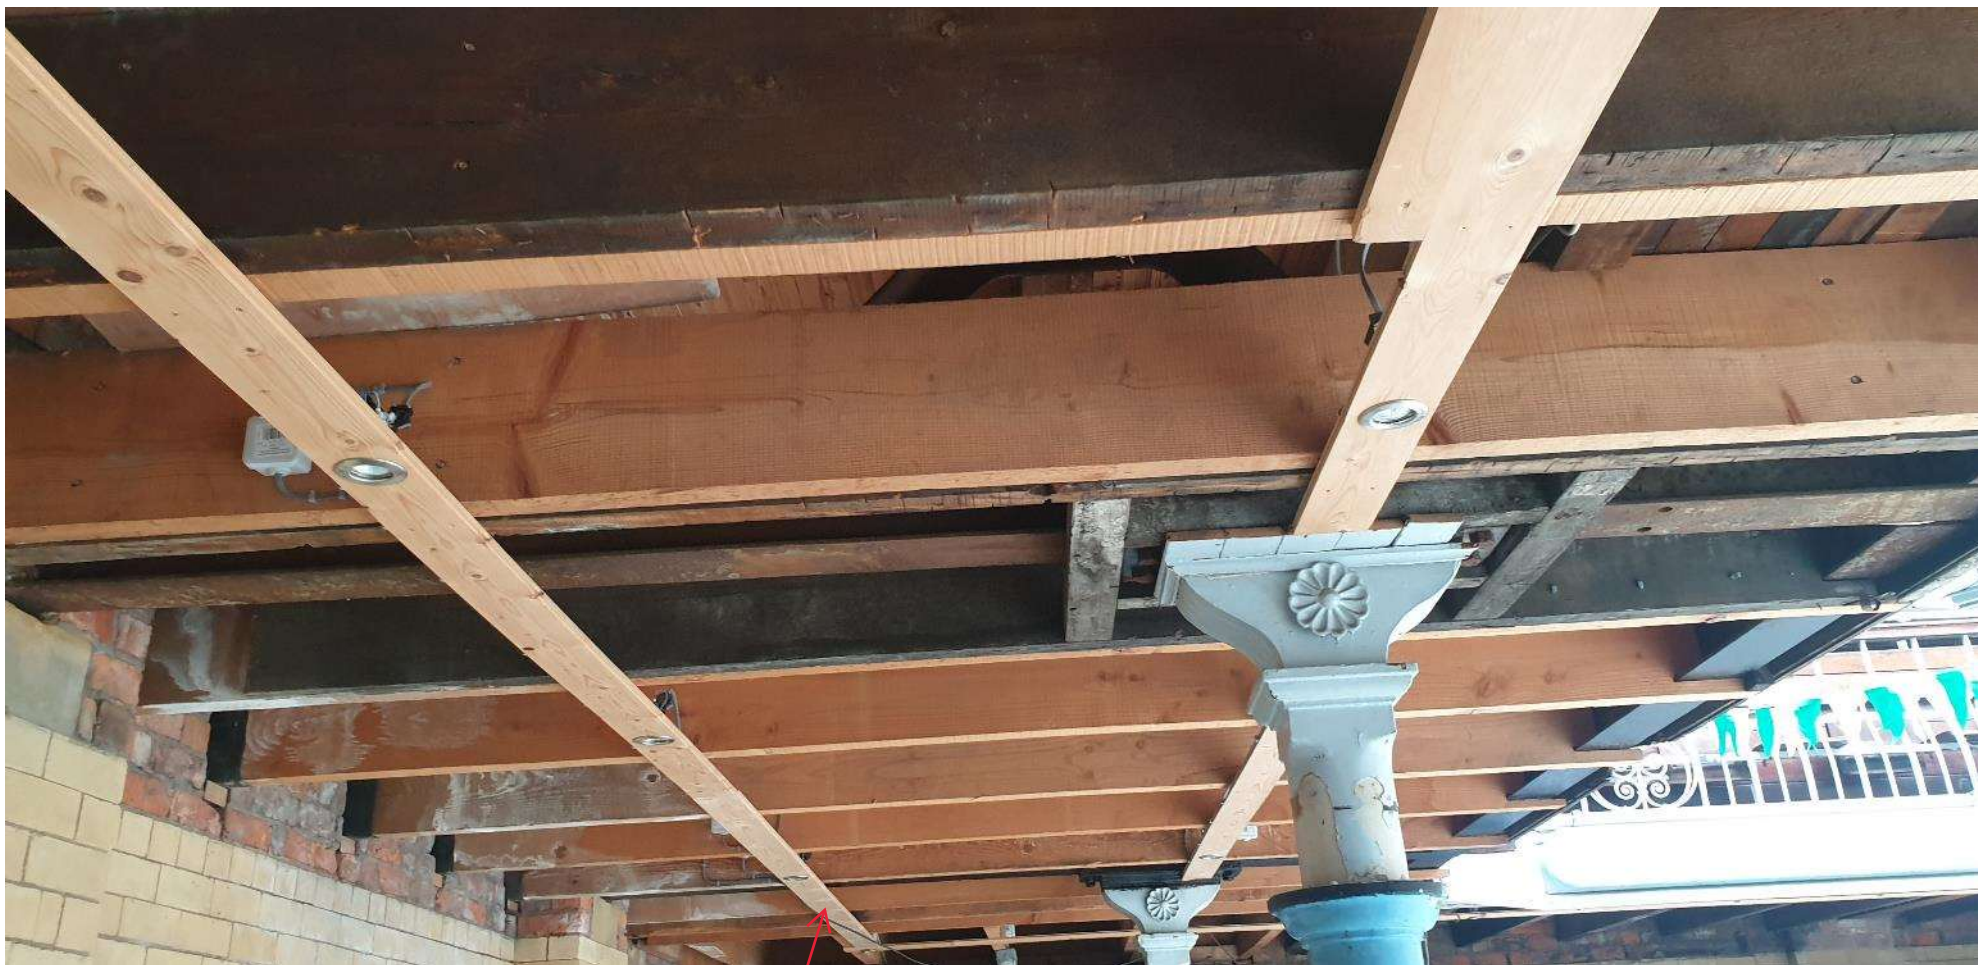
Example of  
space below  
balconies for  
cable routes to  
reach above

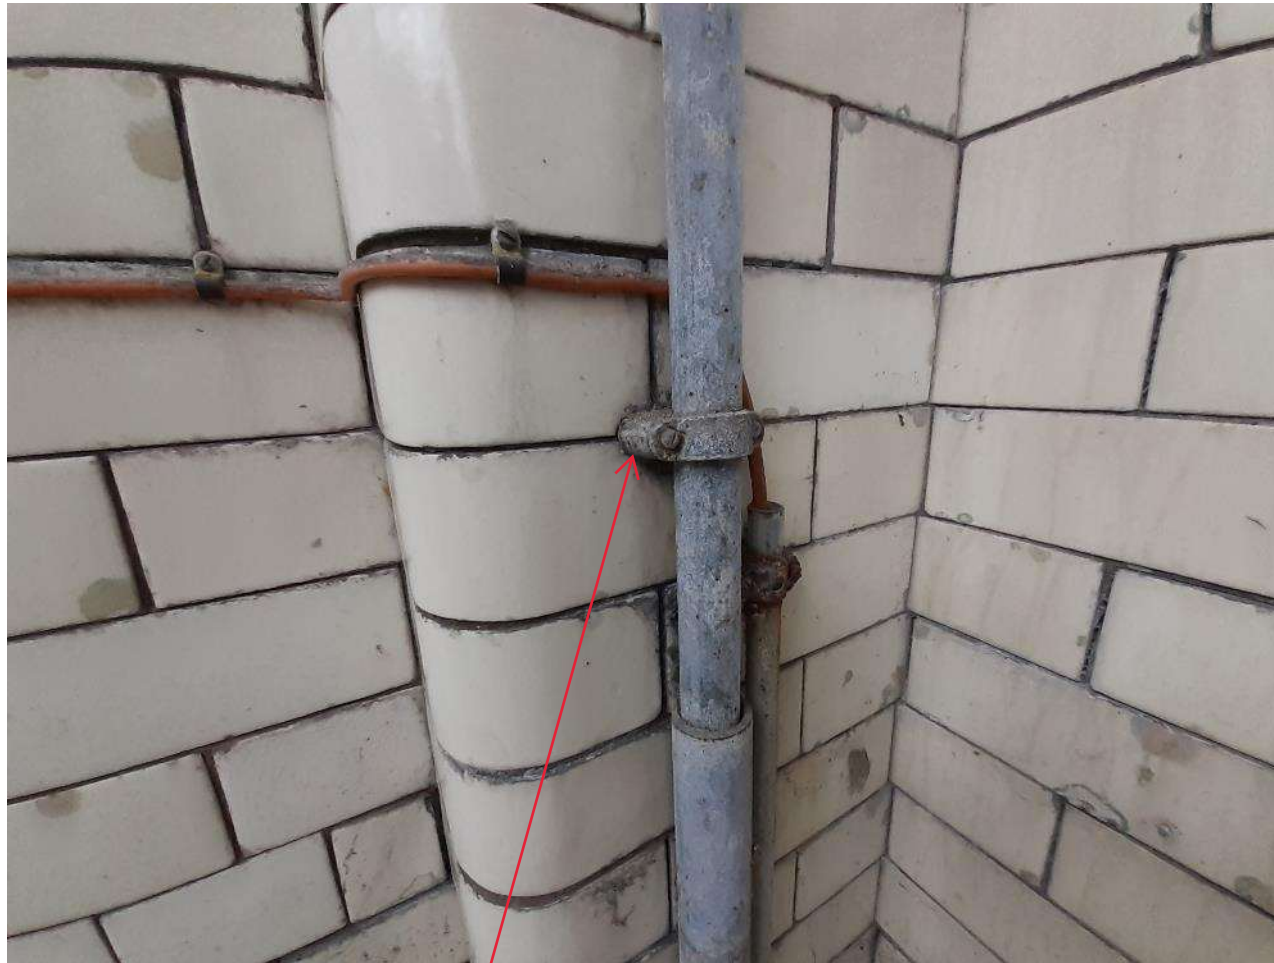
Existing conduit.  
Contractor to install new  
conduit in a similar  
manner. Drilling and  
clipping to mortar and  
not brick/tiles
