ARBORICULTURAL SURVEY  
(BS 5837:2012)

232, 234 & 236 PALATINE ROAD  
DIDSBURY  
MANCHESTER  
M20 2WF

December 2024

Job Number 5592

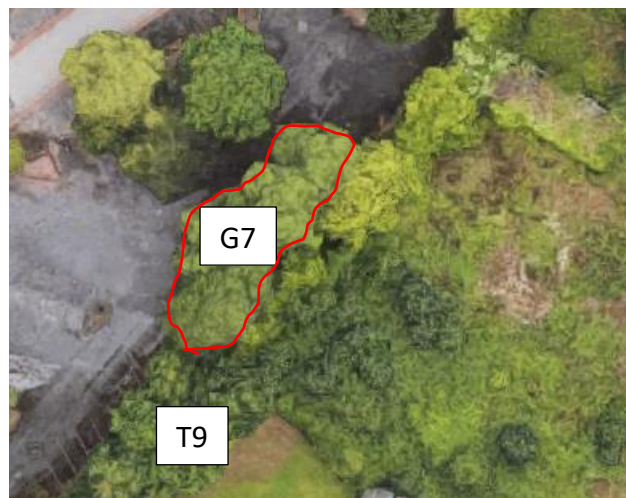
- 5.2.6 G7 is located within the adjacent site on lower ground and the RPA of this group is barely affected. The crown spreads have been plotted the same for all trees within the Tree Constraints Plan due to the rough site terrain but in reality they don't really overhang the site as shown below:

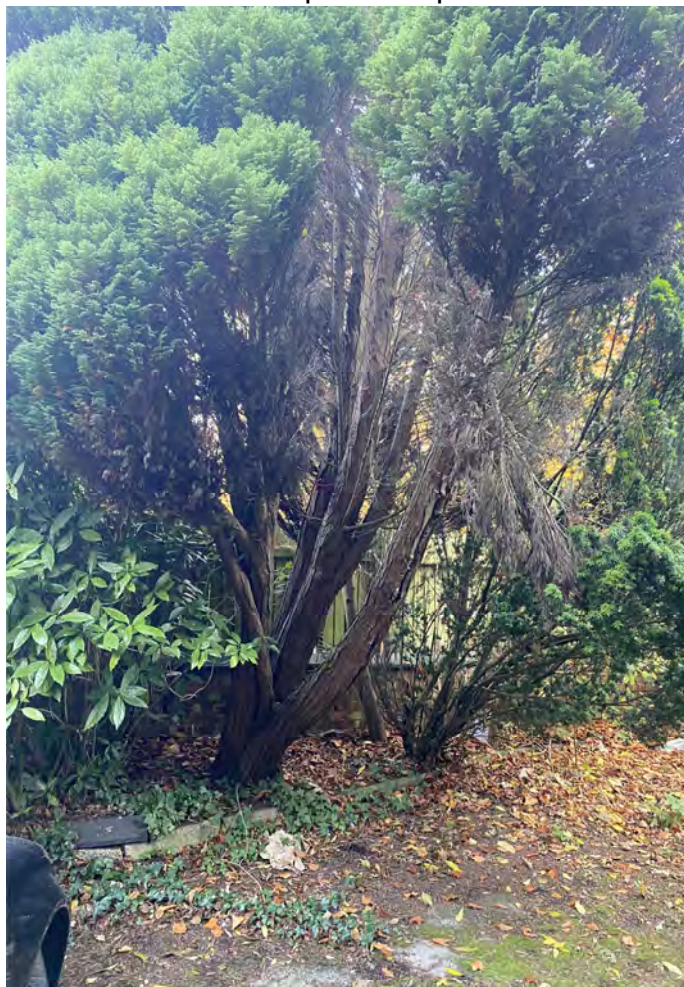
G1 poor Juniper

| Tree No. | Species | Root Protection Area (m <sup>2</sup> ) | Circle Radius (m) | Distance to any proposed construction or surfacing (m) | Can the Tree be Successfully Retained |
|---|---|---|---|---|---|
| G1 | Mixed | 18.10 | 2.40 | Remove for condition | |

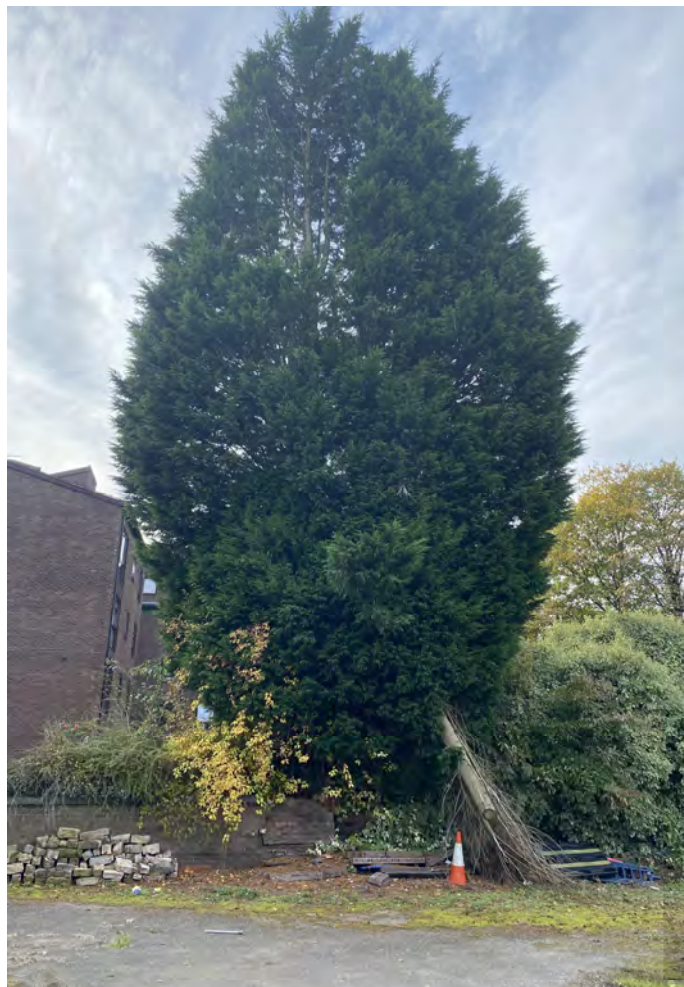
- 5.2.7 T10 (Leyland Cypress) is a large tree located within the adjacent site and has damaged the existing boundary wall as well as shed quite a few limbs. There is existing hard surfacing within the site with no obvious signs of root activity. It has been recommended that some negotiation may take place between the owners for the removal of the tree.
- 5.2.8 G6 (Ash) is a very poor group and also would warrant removal but they are third party trees and again some negotiation between the two site owners would be useful at some point for their removal due to Ash Dieback.
- 5.2.9 A clear tree works specification and details of all tree protective measures can be found in the following Arboricultural Method Statement.

| Arboricultural Data Sheet: 232, 234 & 236 Palatine Road, Didsbury, Manchester, M20 2WF | | | | | | | | | | Date of Survey: 25/10/24 | | Weather: Dry | | Surveyor: PM | | |
|---|---|---|---|---|---|---|---|---|---|---|---|---|---|---|---|---|
| T10 | Leyland Cypress | 1000 | 15 | M | 4 | 4 | 4 | 4 | 2 | F/P | A large specimen located within adjacent property seriously affected boundary wall. Previous limb failure, partially cleared. | Remove fallen limb. | 10+ | C1 | 452.39 | 12.00 |

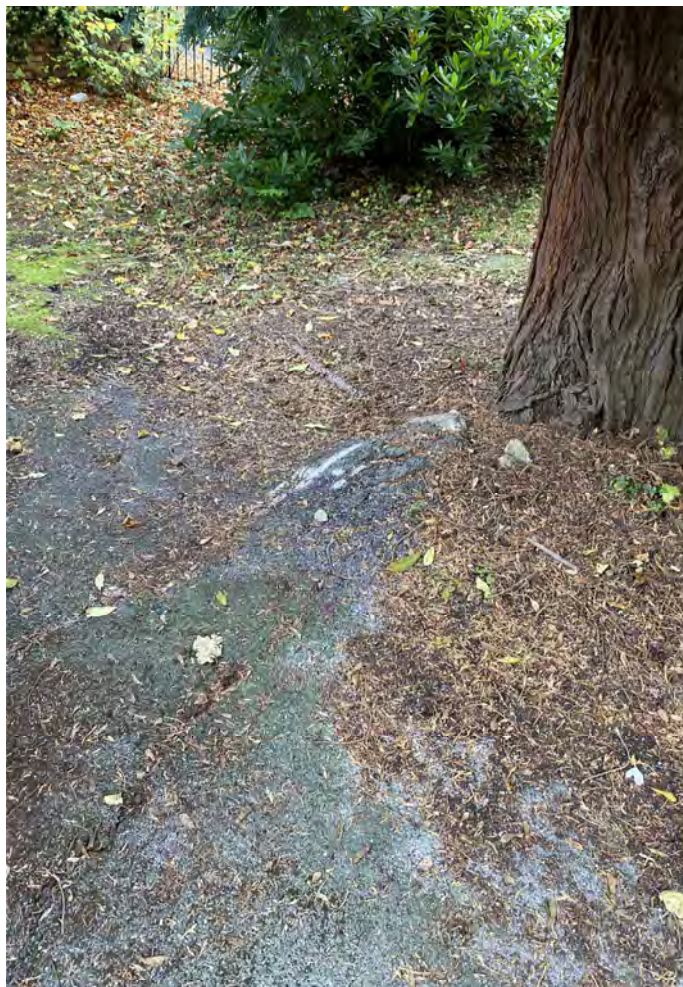
G3 fallen Juniper

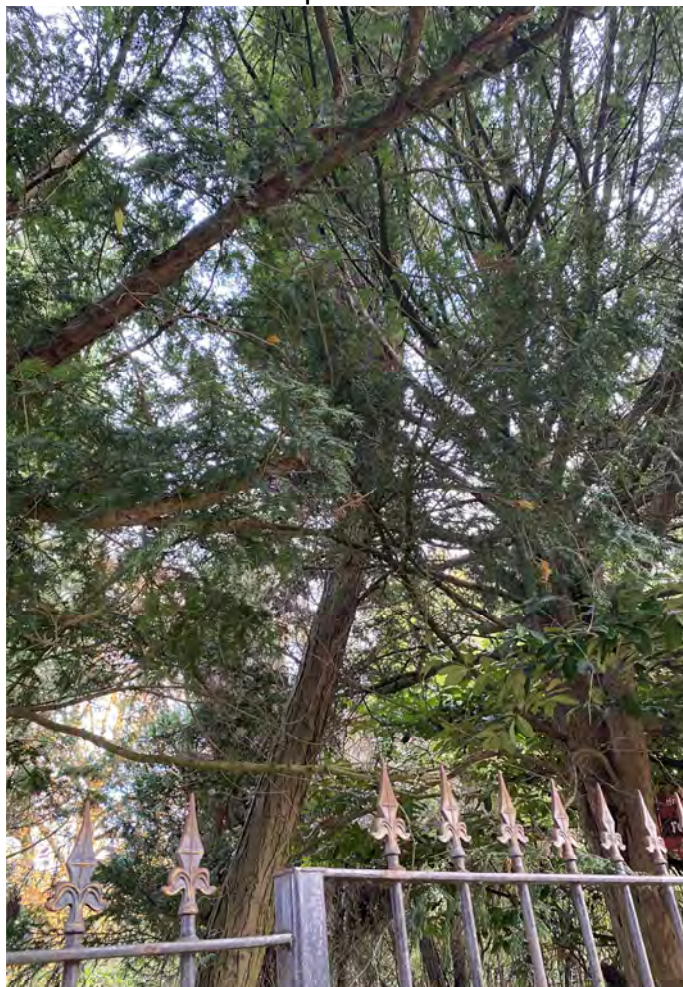
G4 poor Juniper

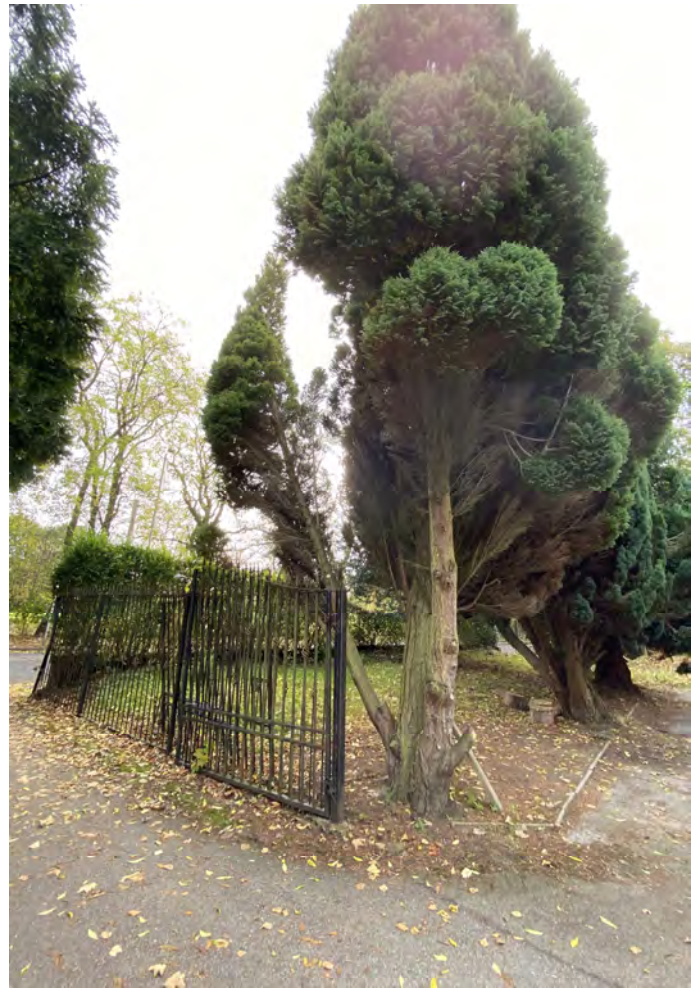
G4 poor Juniper

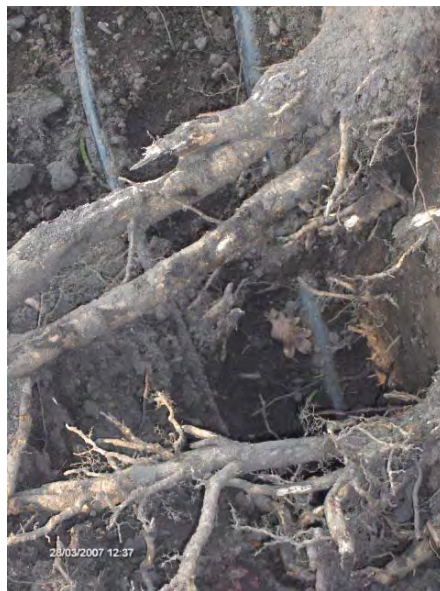
- the severance of a root, for example by trenching will destroy all parts of the root beyond that point. Even roots less than 10mm in diameter may be serving the fine roots over a wide area. The larger the root severed, the greater the impact on the tree.

**Typical root damage caused by excavation works**
