# Chorlton Baths, Manchester

## Final Phase 2 Geo-Environmental Investigation Risk Assessment & Remediation Strategy

**Job Number:** LKC241317

**Date:** December 2024

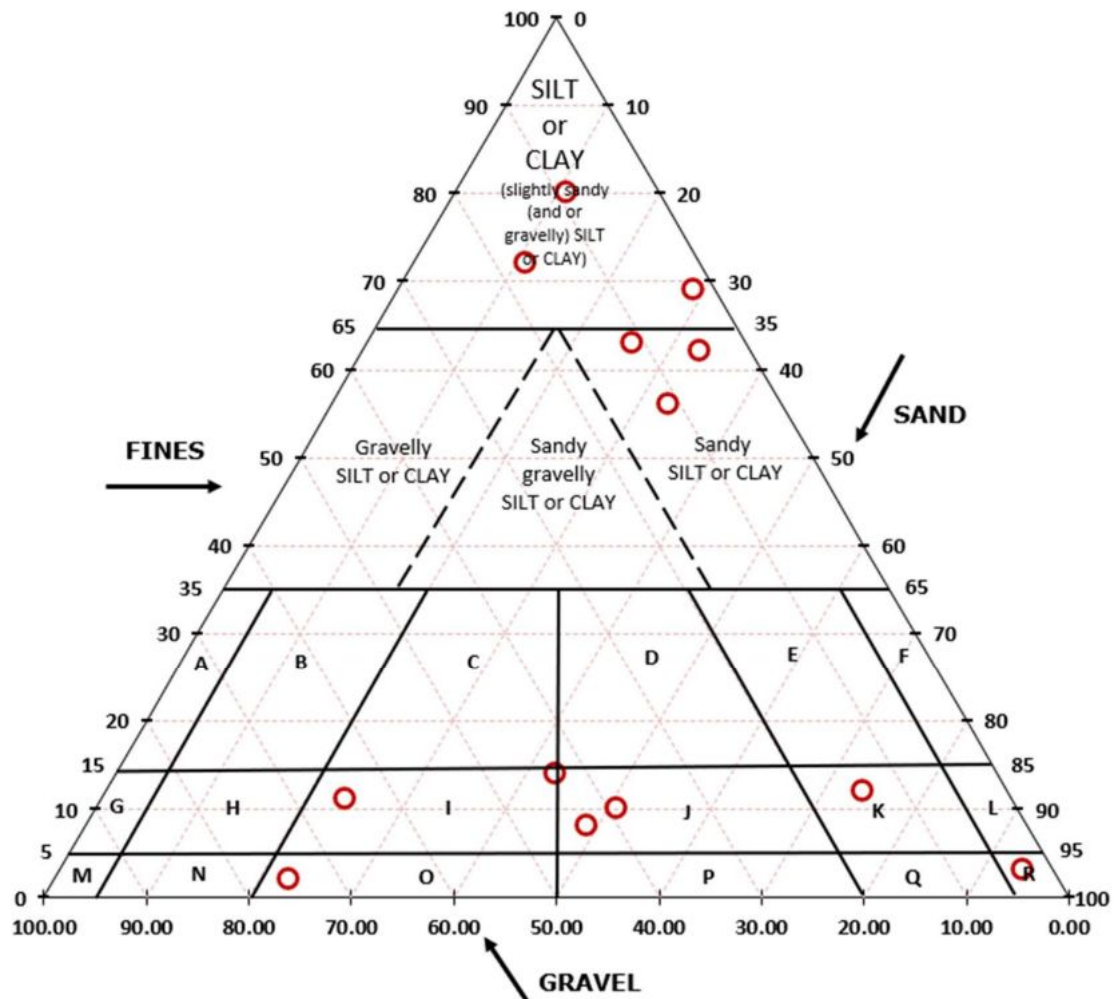
Graph 5-1: Ternary plot of the PSD results.

Cohesive samples from the site works, logged as soft to very stiff slightly gravelly sandy clay, returned a clay fraction of 56-80%. The plots of the PSD tests are shown on the ternary plot reproduced in Graph 5-1.

Clay samples were subjected to Atterberg Limits (plasticity) and Moisture Content testing. Results are provided in Appendix D. The clay ranged from low to high plasticity.

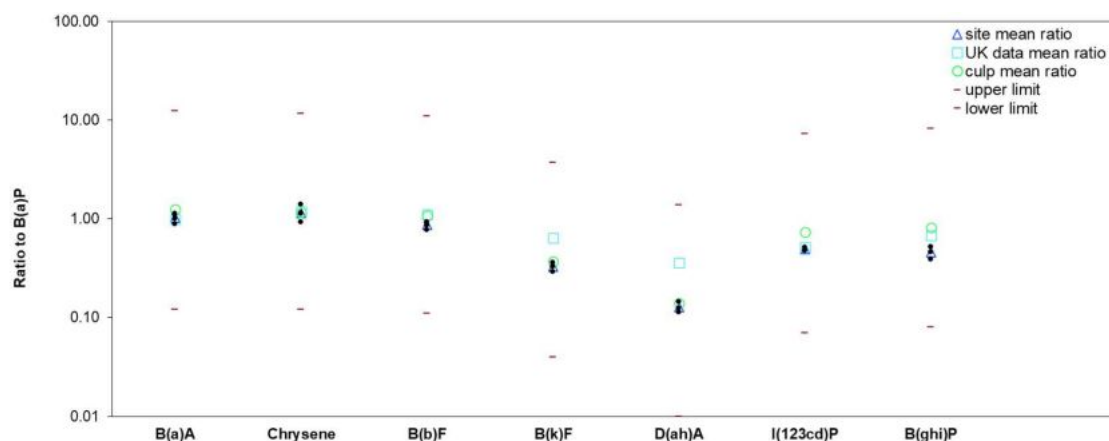
Graph 6-1: The ratio of PAH to B(a)P in soil for all available data at the site based on 4 samples (where values were >LOD to allow the calculation of a ratio).

Graph 6-1 summarises the study site data with respect to how the ratios of carcinogenic PAHs relate to B(a)P, within the confidence limits provided in the HPA document.

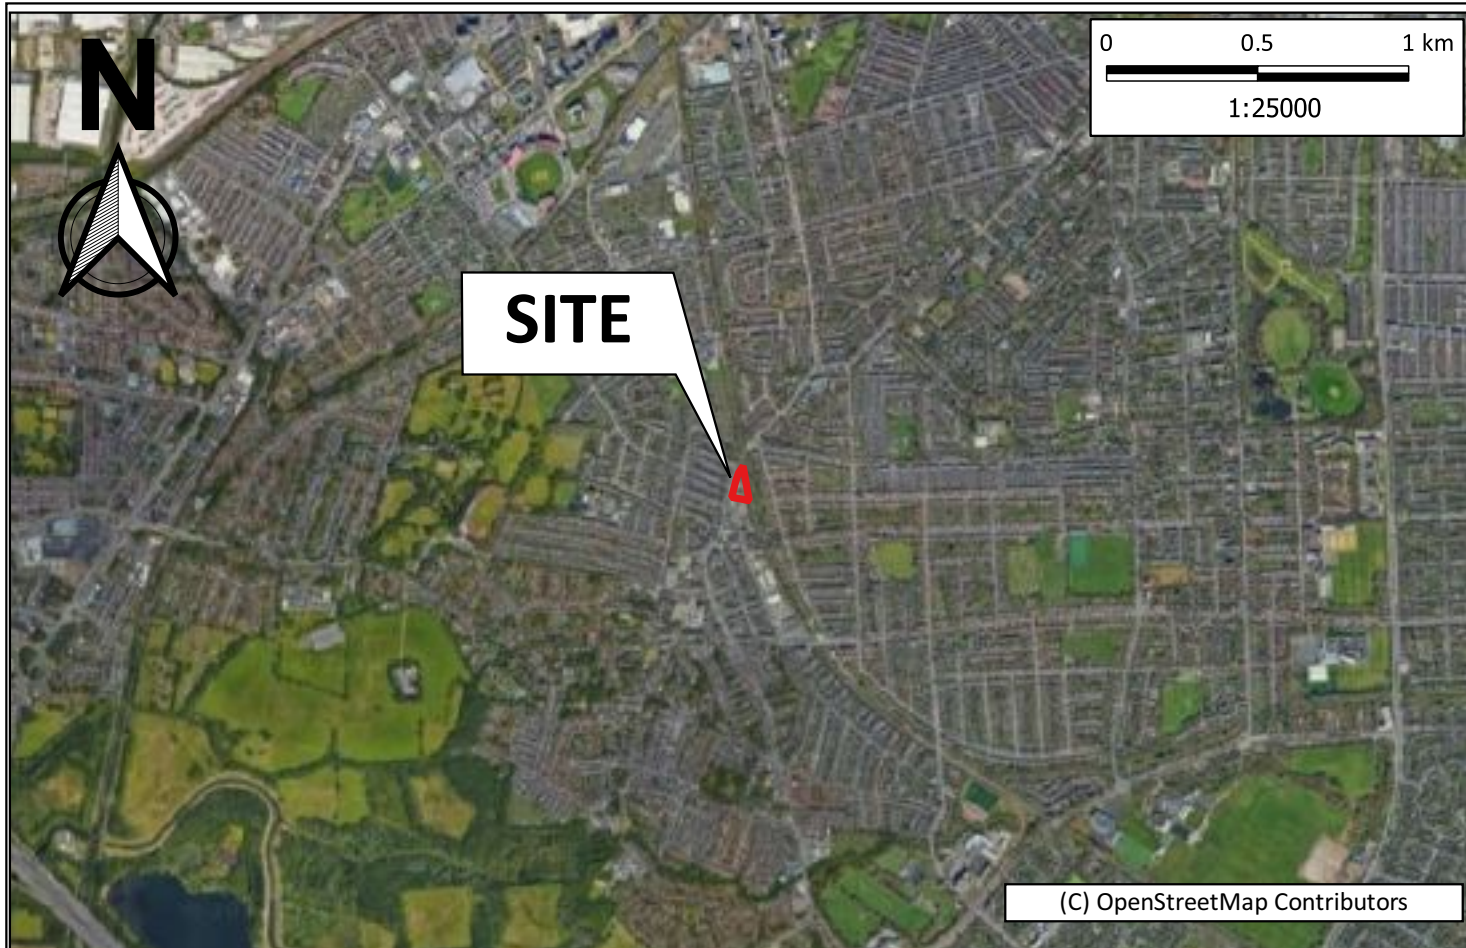
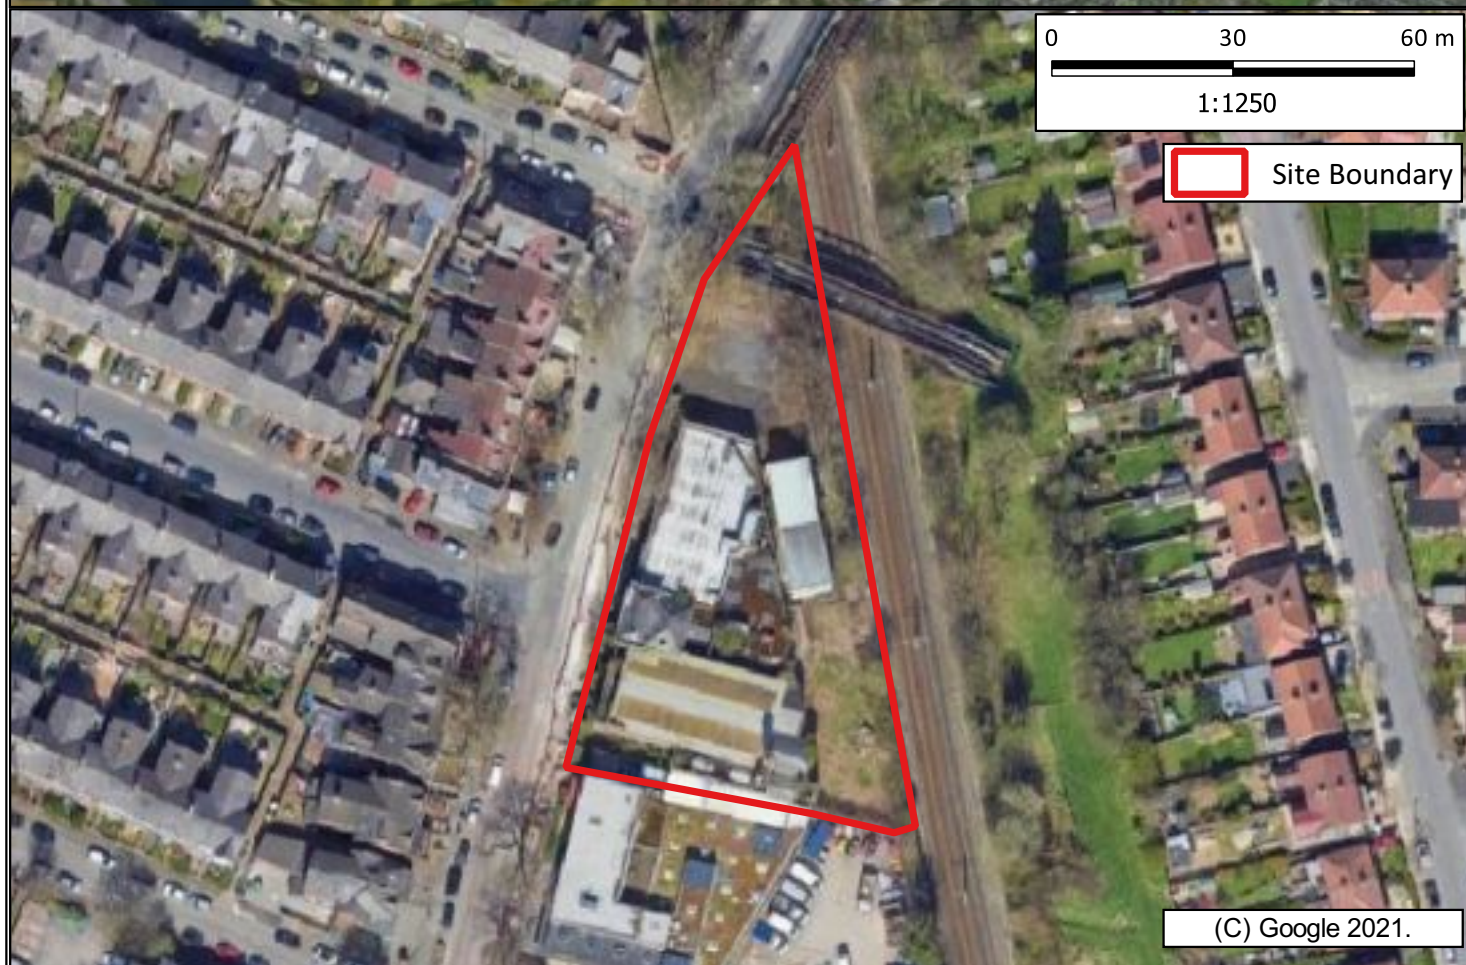
| Job No.:<br>LKC241317 | Drawn By:<br>MB | Checked By:<br>PD | Drawn:<br>Nov 2024 | Figure:<br><br>1 | Revision: | | |

| Client:<br><br>Caddick Construction Ltd | | | | Title:<br><br>Site Location &<br>Boundary Plan | | | |

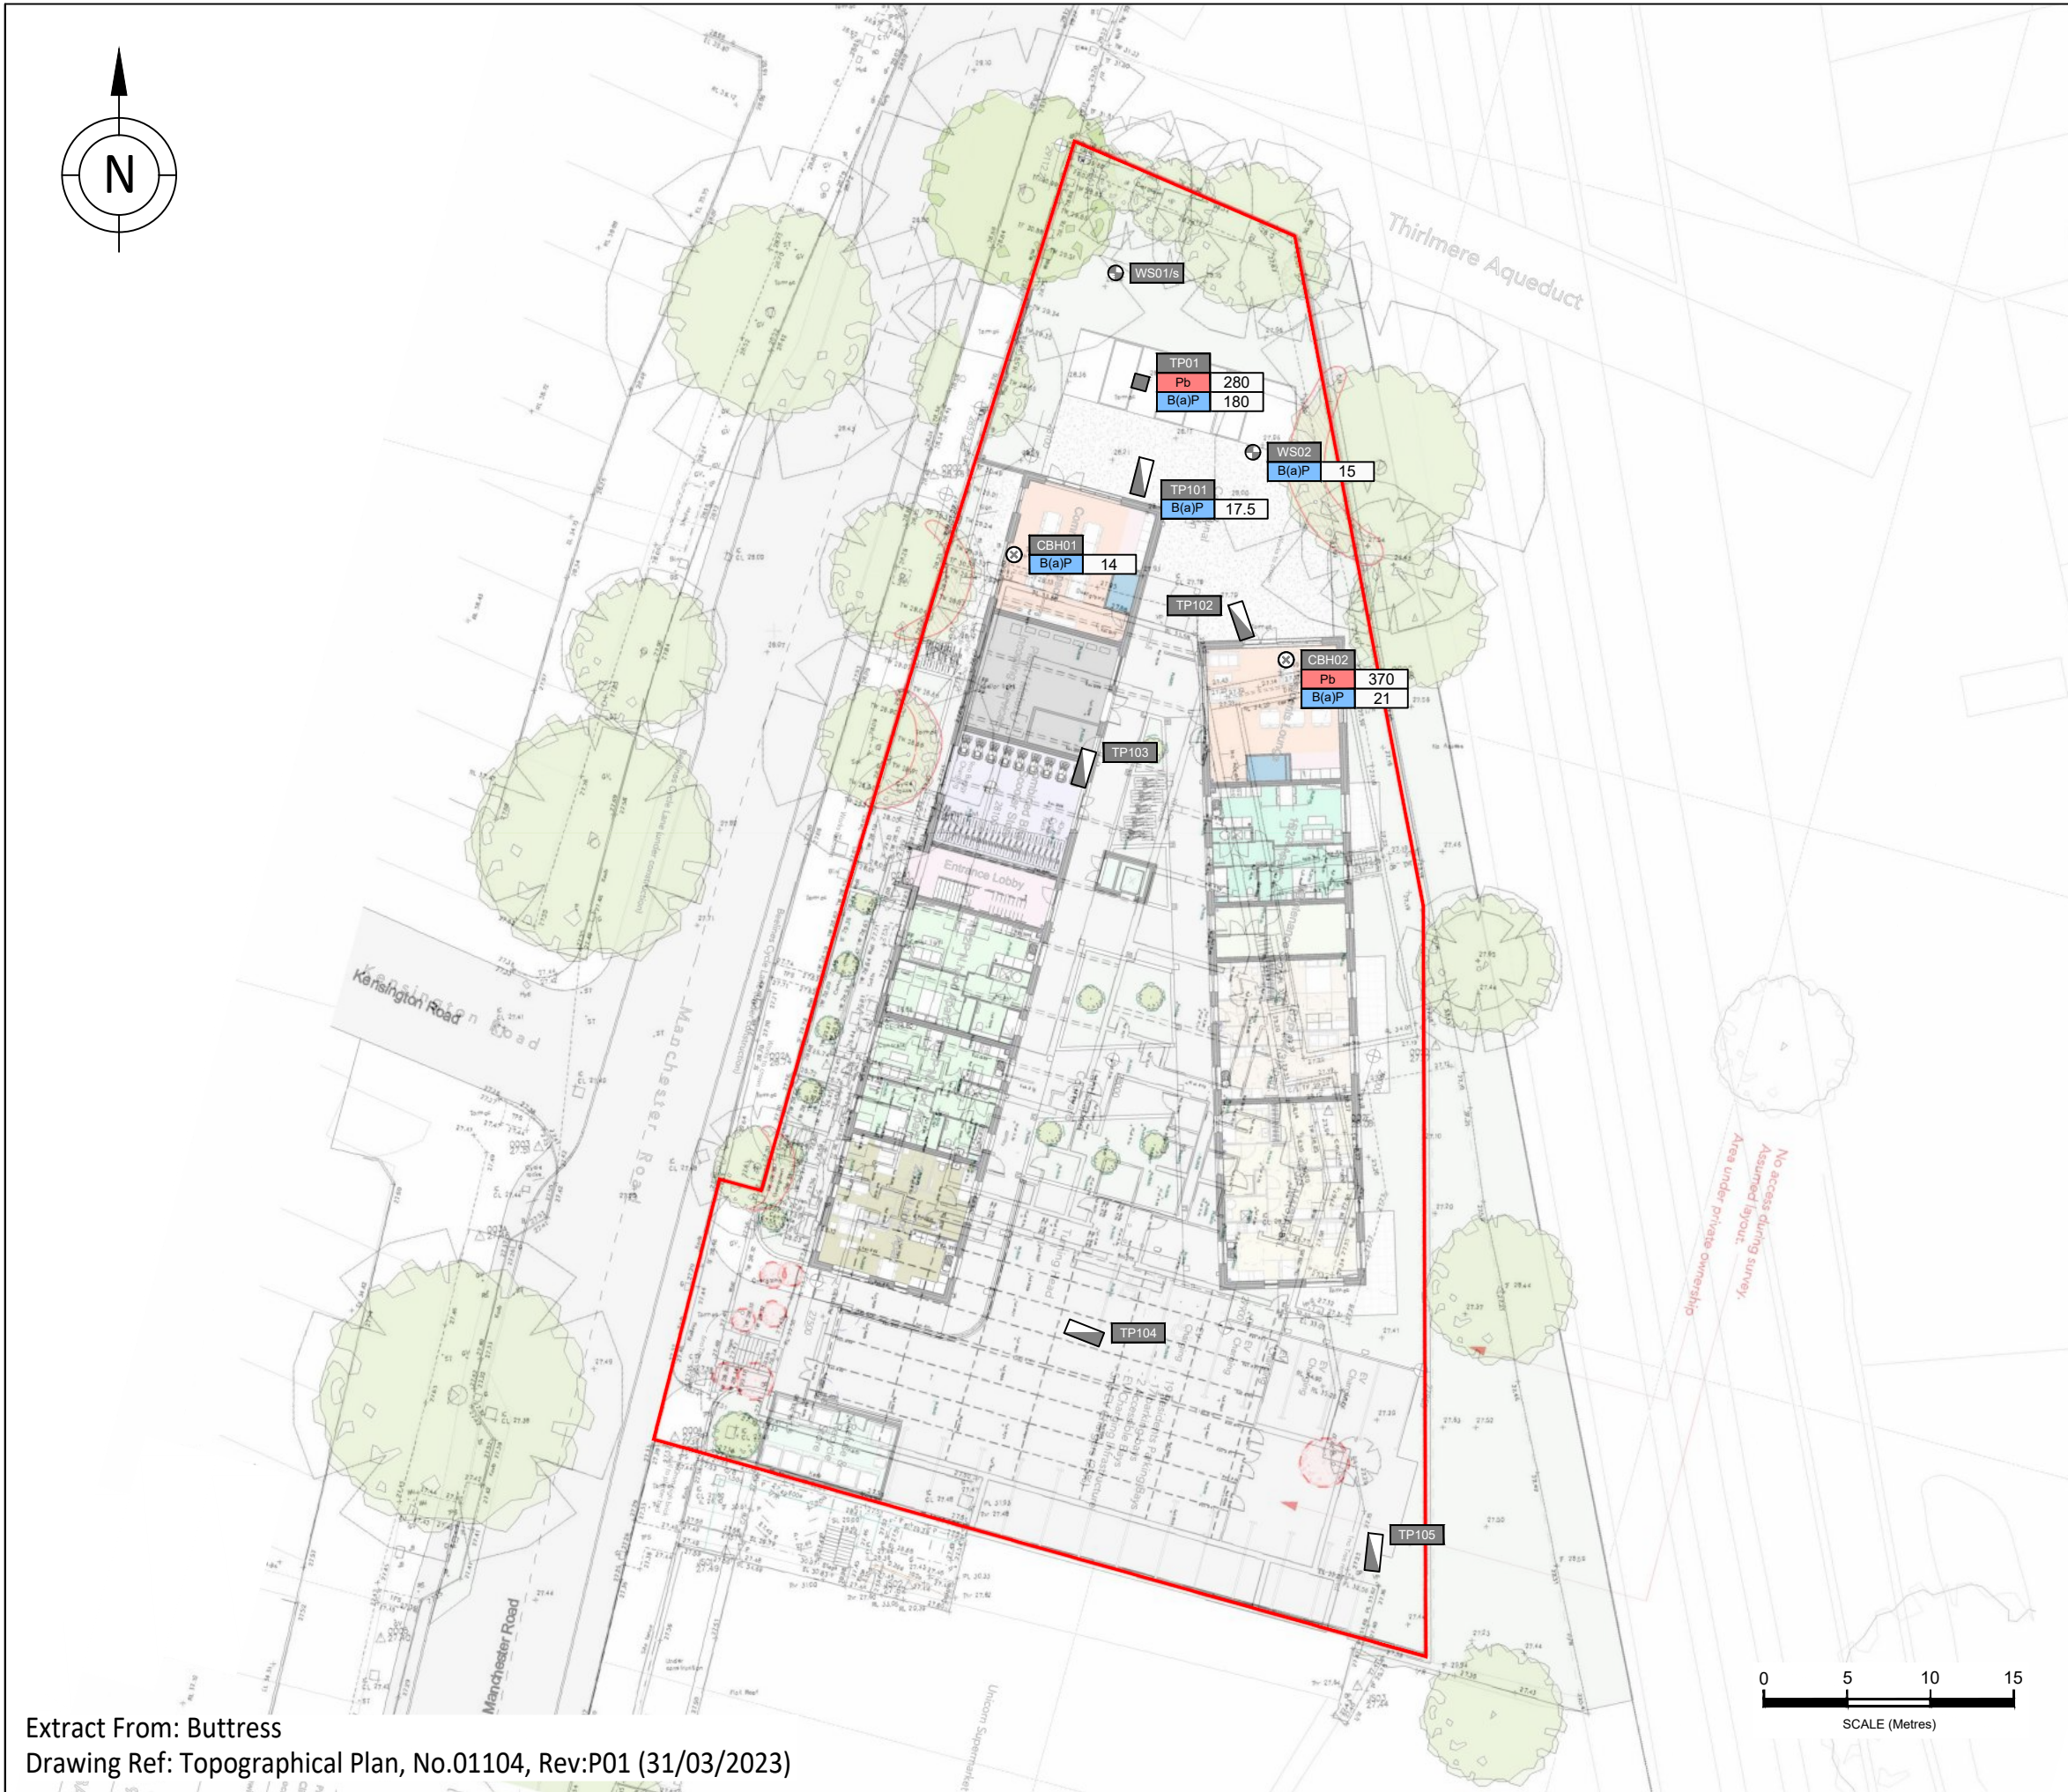
| Job No.: LKC241317 | Scale (See Scale Bar): See Scale Bar | Figure: 3 | Revision: A |

- Site Boundary
- Trial Pit (TP)

Extract From: Buttress  
Drawing Ref: Proposed Site Plan, No.04100,  
Rev:P04 (07/08/2023)

All site investigation locations are shown in Figure 3.

The locations were chosen to allow adequate assessment of ground conditions across the site. Table 3-1 details the site investigation locations.

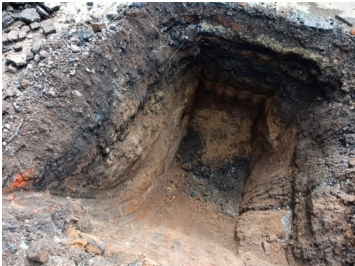
| | | | Pit Dimensions | | | Pit Stability | |
| | | | Length (m) | Width (m) | Depth (m) | Unstable | |
| | | | 2.10 | 2.10 | 2.30 | | |

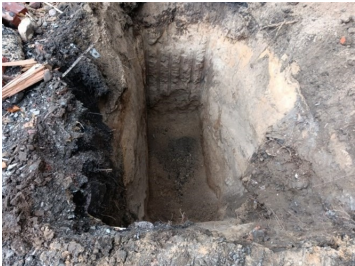
| | | | Pit Dimensions | | | Pit Stability | |
| | | | Length (m) | Width (m) | Depth (m) | Unstable | |
| | | | 3.10 | 2.10 | 2.70 | | |

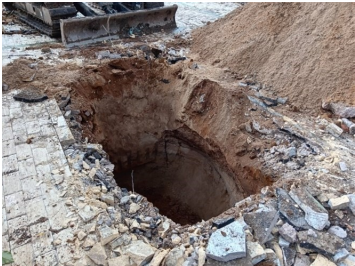
| | | | Pit Dimensions | | | | | Pit Stability | | |
| | | | Length (m) | | Width (m) | | Depth (m) | | Unstable | |
| | | | 2.60 | | 2.00 | | 2.50 | | | |

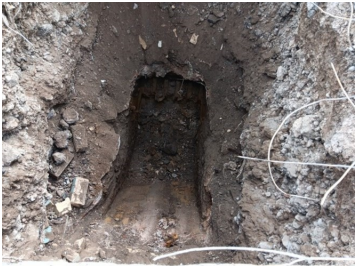
| Pit Dimensions | | | Pit Stability |
| Length (m) | Width (m) | Depth (m) | Unstable in made ground |

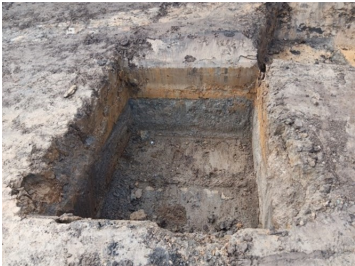
| | | Pit Dimensions | | | Pit Stability | | | |
| | | Length (m) | Width (m) | Depth (m) | Stable | | | |
| | | 1.50 | 1.00 | 1.10 | | | | |

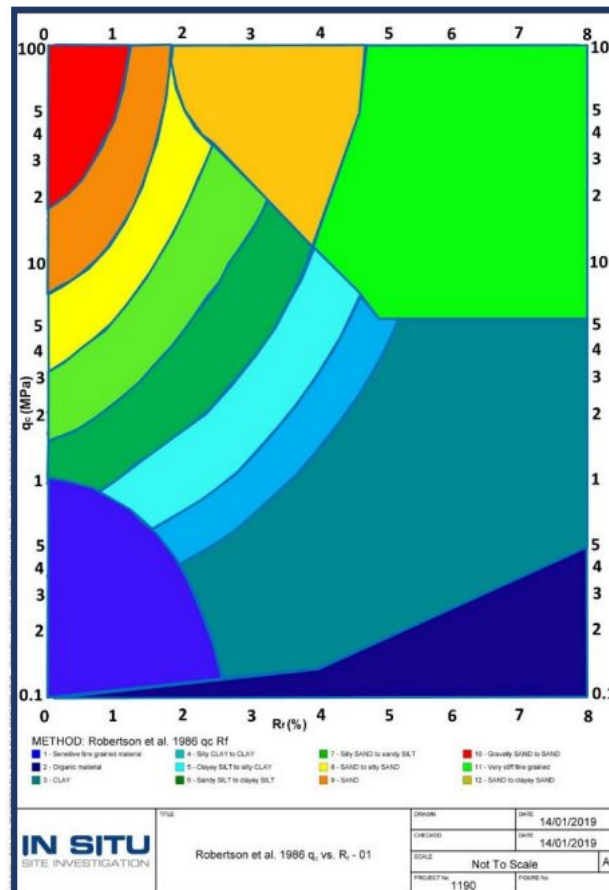
**Figure 3.2:** *Robertson et al., 1986 soil behaviour type chart.*

The interpretation used in this report is *Robertson et al. (1986)*, which is shown in Figure 3.2. The results are presented on *CPT Log 01*, in *Appendix B*.

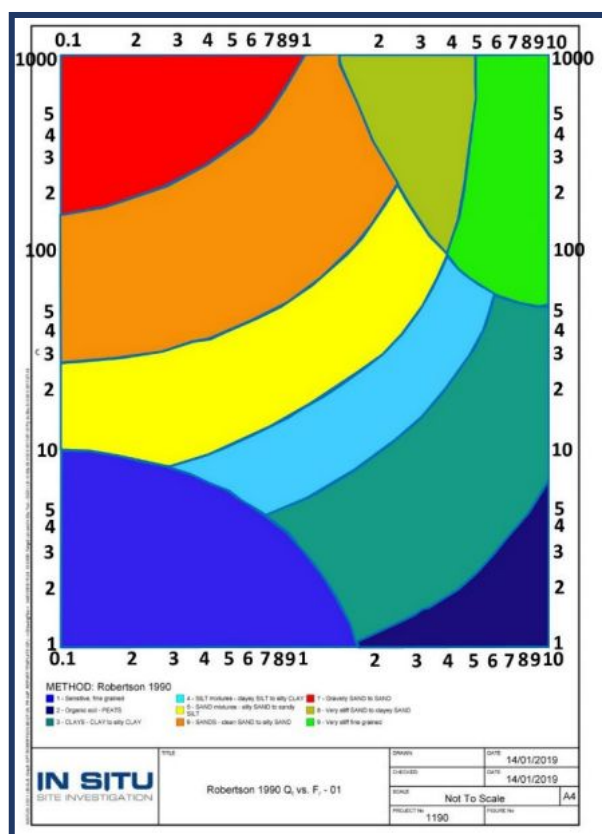
**Figure 4.1:** Robertson 1990 soil behaviour type chart.

The soil behaviour type index,  $I_c$ , was derived by *Jefferies and Davies (1991)*, and was created to simplify the application of CPTU SBT chart shown in *Chapter 3, Figure 3.2*. This approach has been modified for use with the *Robertson (1990)* normalised CPT soil classification chart, *Figure 4.1*. The normalised cone parameters  $Q_t$  and  $F_r$  (for definitions see *Appendix A5 Symbol List*) can be combined into one Soil Behaviour Type Index,  $I_c$ , (*Lunne et al., 1997*).

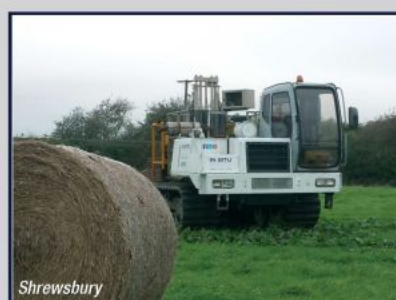
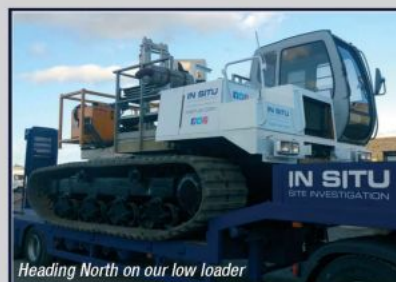
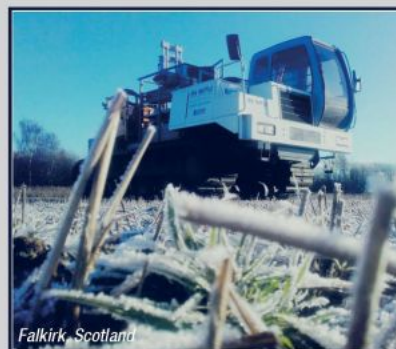
##### CPT RIG DIMENSIONS

| TYPICAL SITES FOR THIS RIG | SOFT, BOGGY SITES.<br>THE RIG HAS LOW GROUND BEARING PRESSURE. |
