## Domett Street, Manchester

### Remedial Strategy Report

For: John Southworth Builders Ltd.

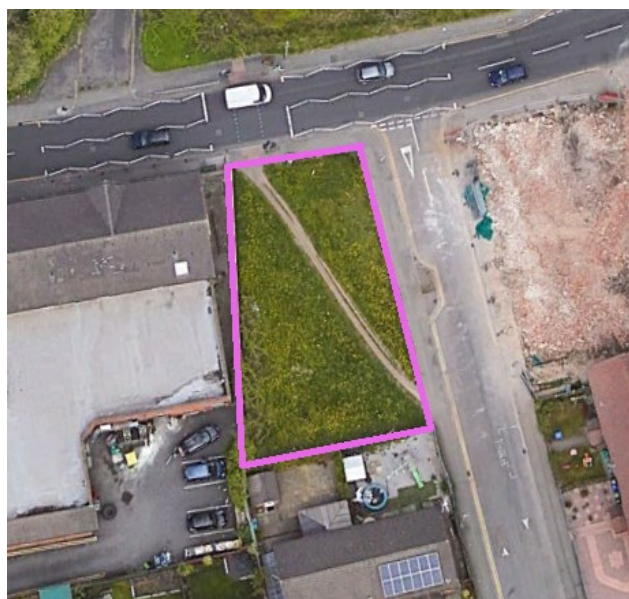
Figure 1: Aerial image of the site dated April 2022.

The site currently comprises a vacant area of previously used as a construction storage area for a nearby construction site. The site is accessed via Old Market Street off the northern boundary. The site is bound by Domett Street to the east, residential dwellings to the south, mixed use retail and residential premises to the west and Old Market Street to the north. An aerial photo of the site is below:

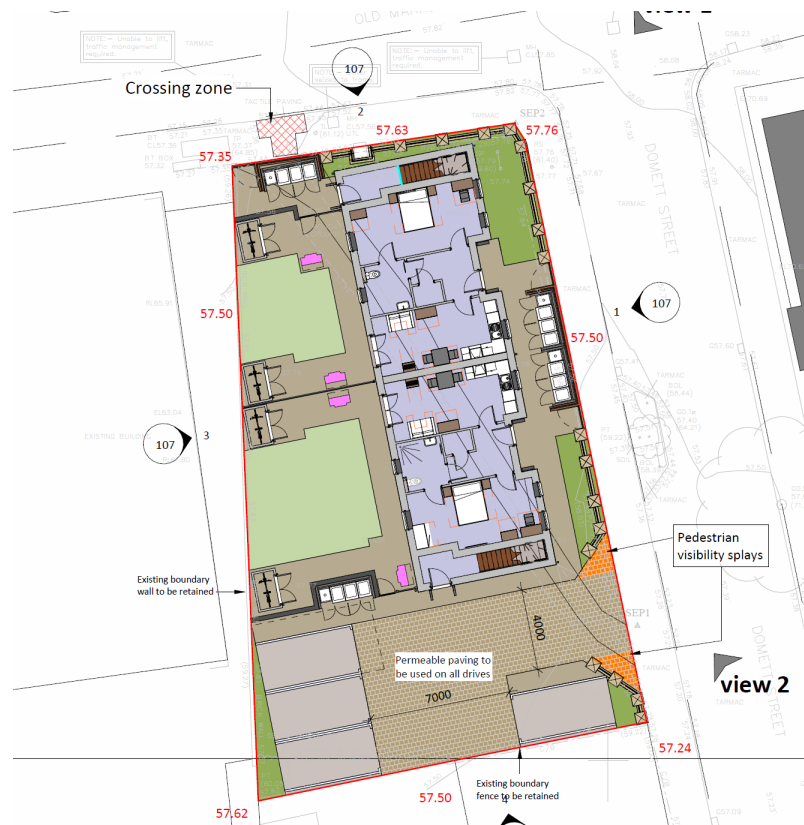
Figure 2: Extract of the proposed development plan

This Remedial Strategy Report has been undertaken to determine the remedial requirements of the site based upon the previous site investigation works. It is the client's intention to develop the site into a low-rise residential development comprising 4 No. apartments with associated areas of soft landscaping and hardstanding. The proposed development plan is contained in Appendix 2. An extract is shown below:

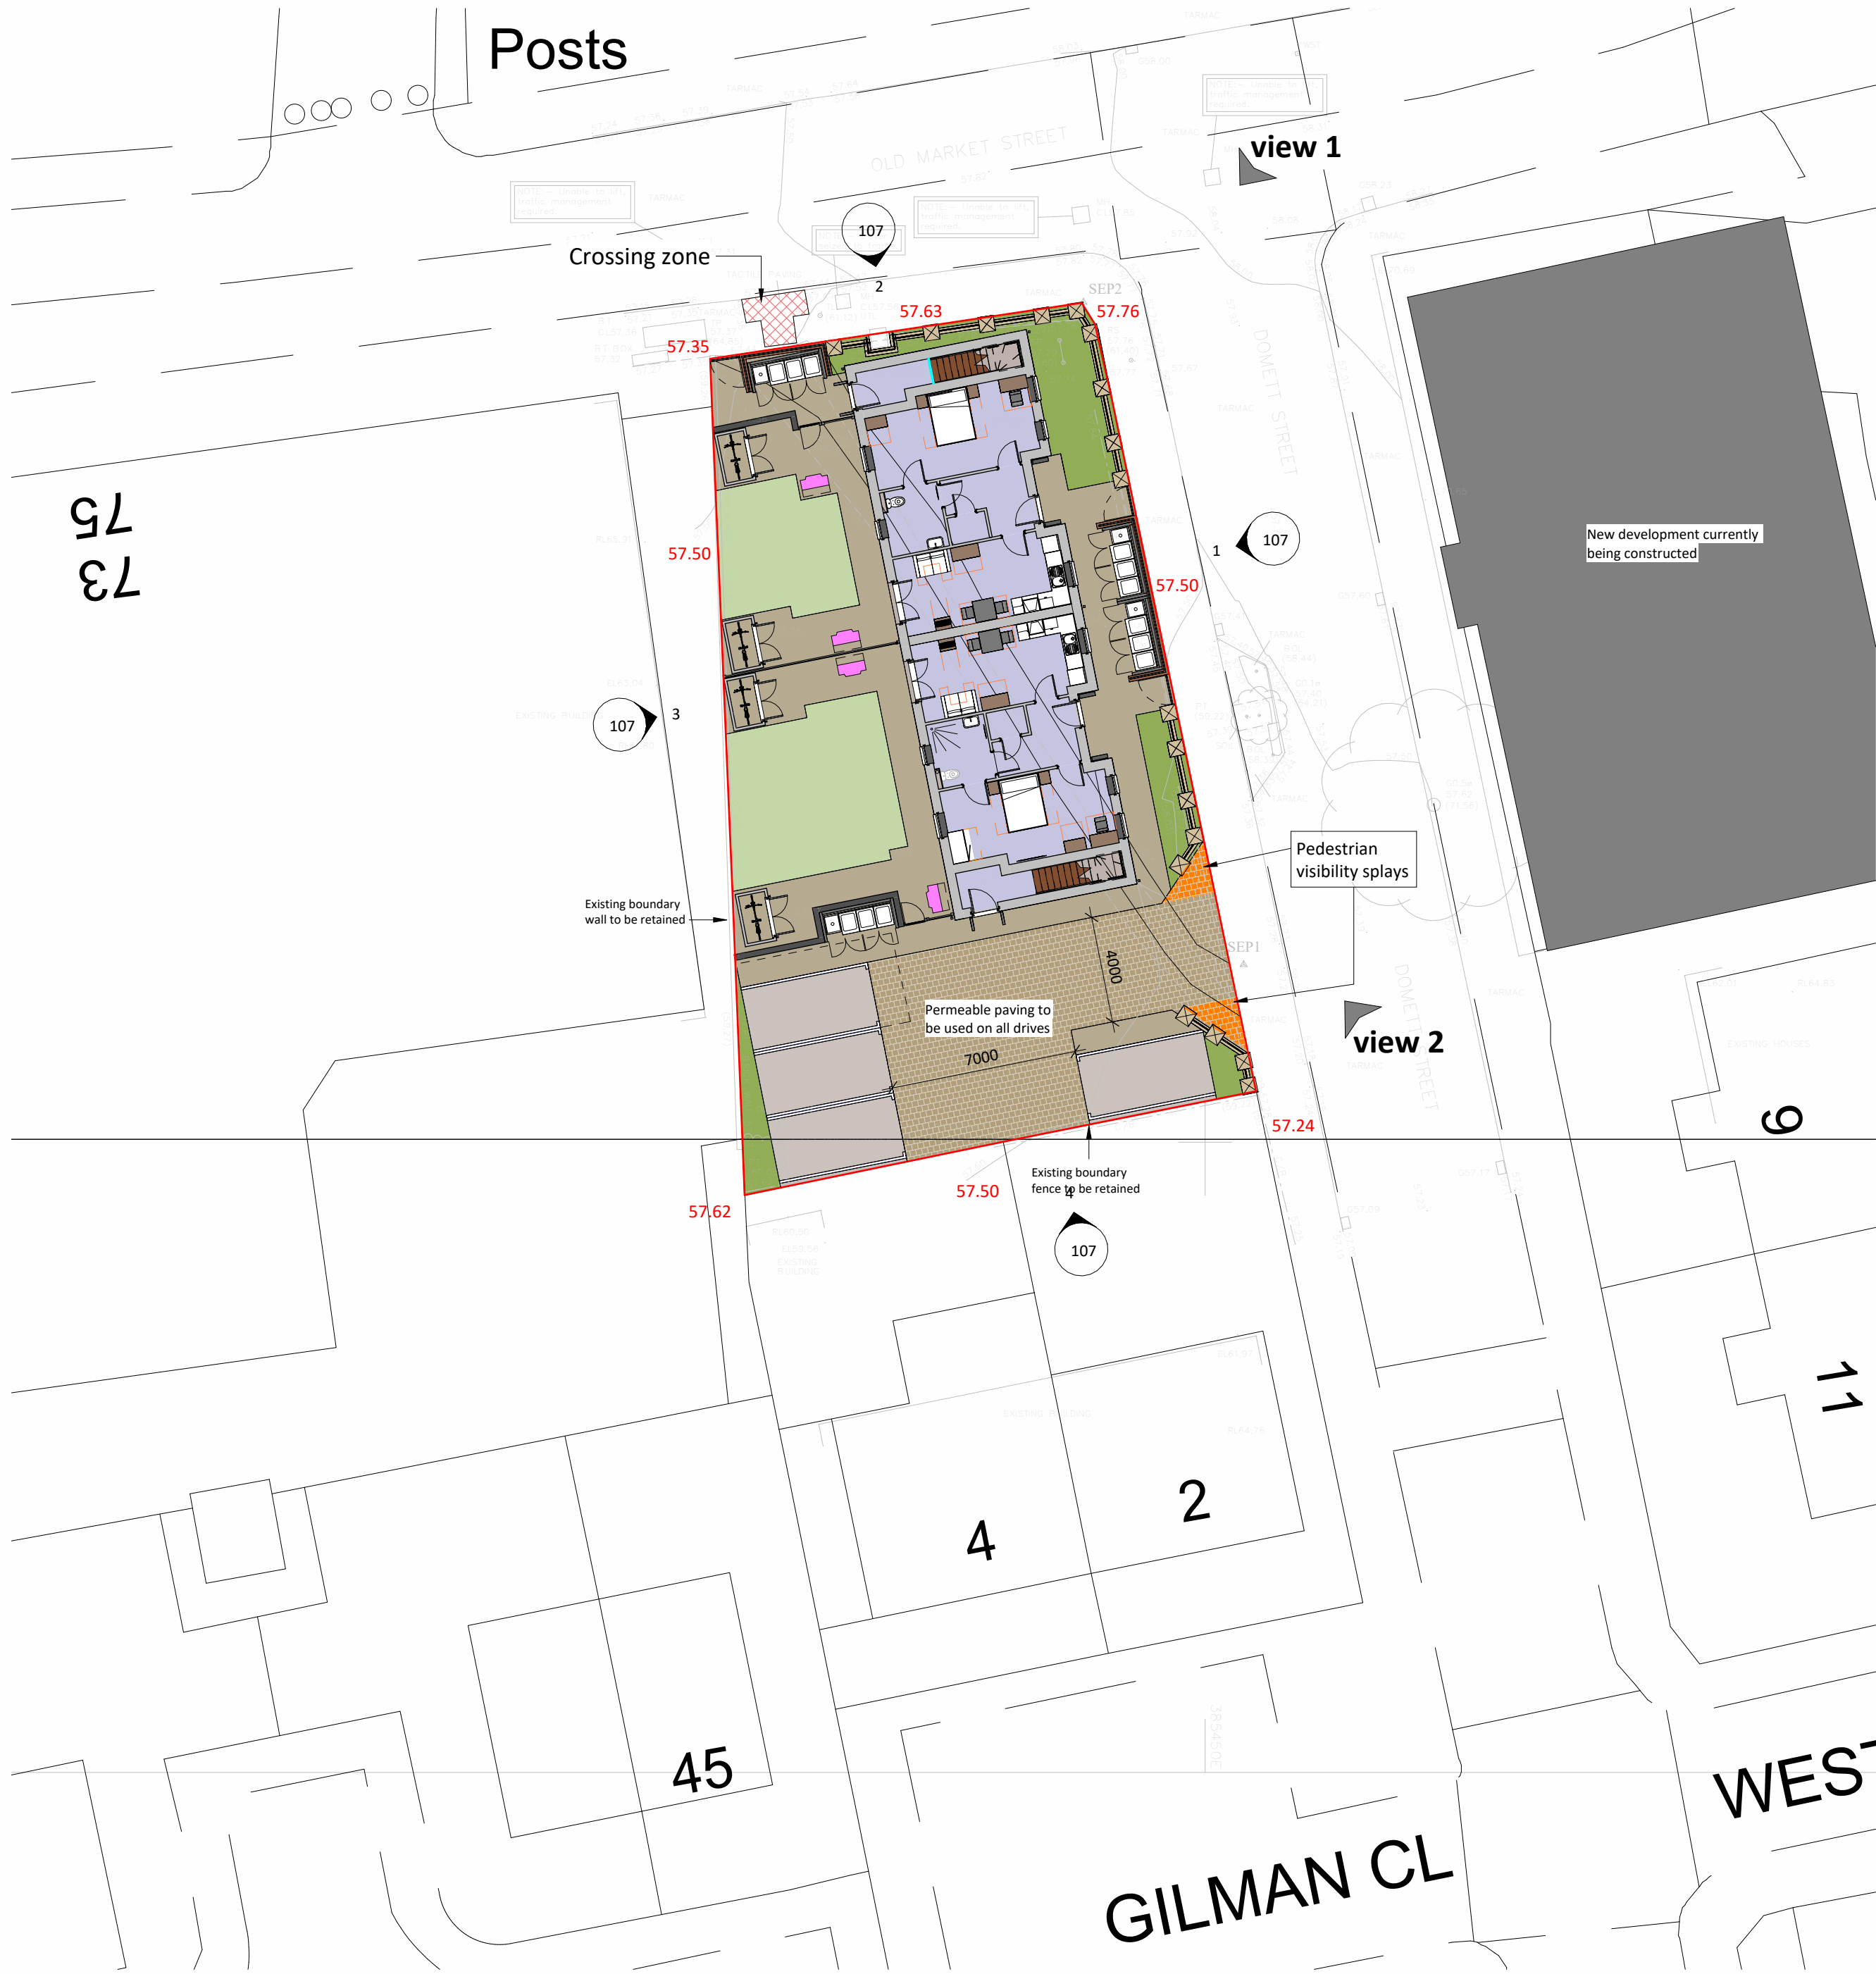
00 Proposed Site Plan  
1 : 200

Indicates approximate location of ASHP to be confirmed and detailed by contractor

Note:  
> Make allowance for Brick piers to front boundary wall at max. 2000mm centers  
> Timber walls refer to timber sheds in rear gardens  
> Make allowance for metal gates to entrance footpaths and carparks if required
