# Drainage Report

Address: Dalton Avenue, Fallowfield

### Drain Survey of Sewer Line:

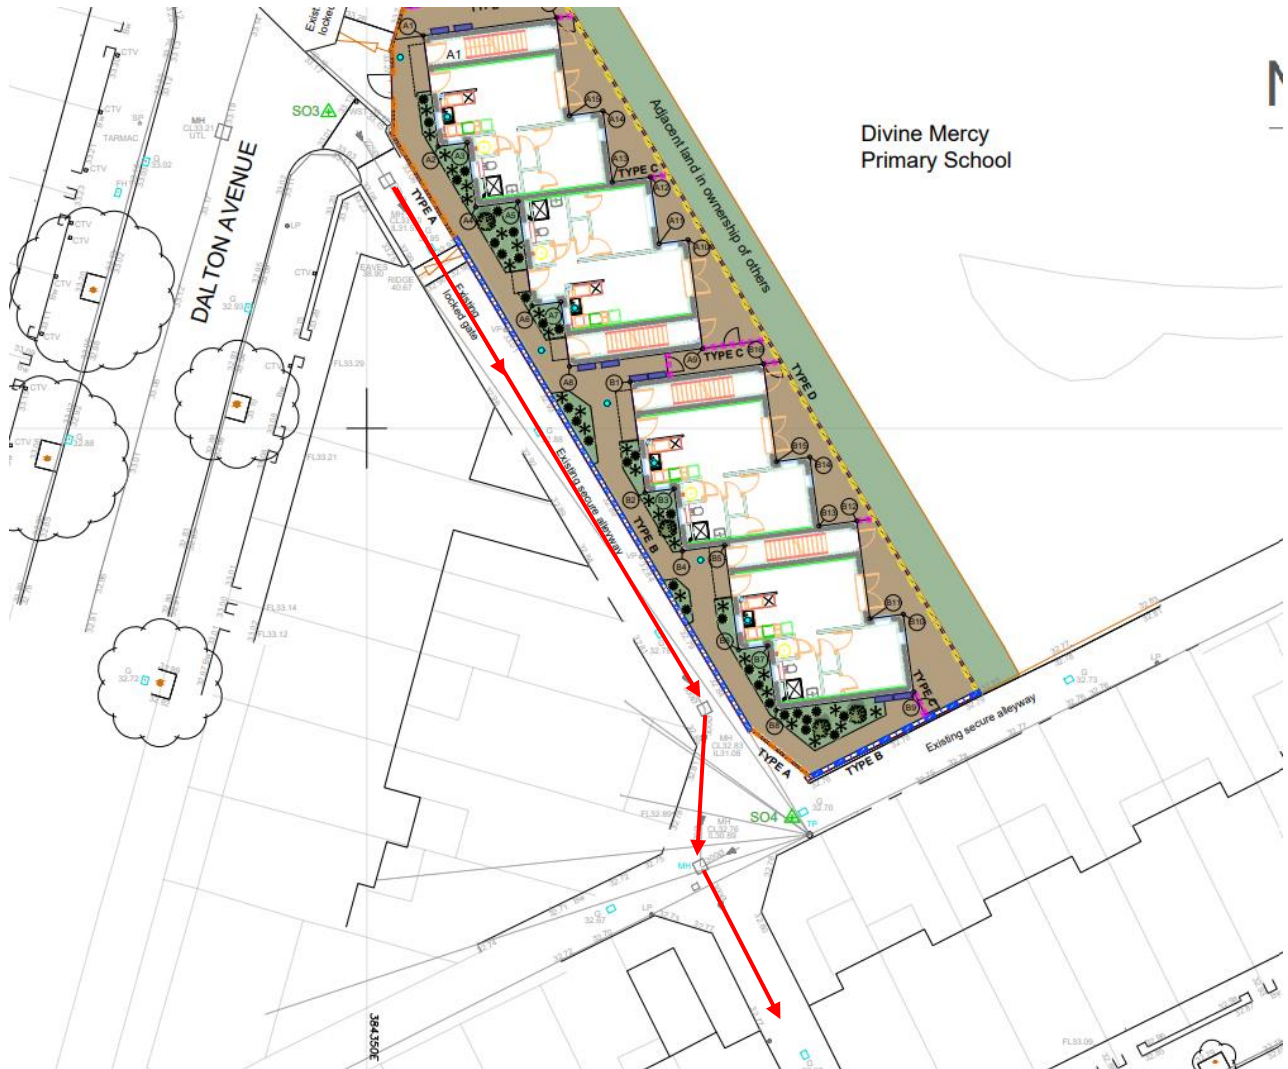
The drains ran from the direction of Dalton Avenue, down a rear alleyway past the proposed site and connected into a shared manhole in the alleyway behind the properties on Thornton Road. The sewer then travelled between two blocks of houses and discharged to another sewer on Thornton Road (Red arrows on layout below).
