# MANCHESTER COMMUNICATIONS ACADEMY

## Arboricultural Impact Assessment

JSL5177\_770

Manchester Communications  
Academy  
V1

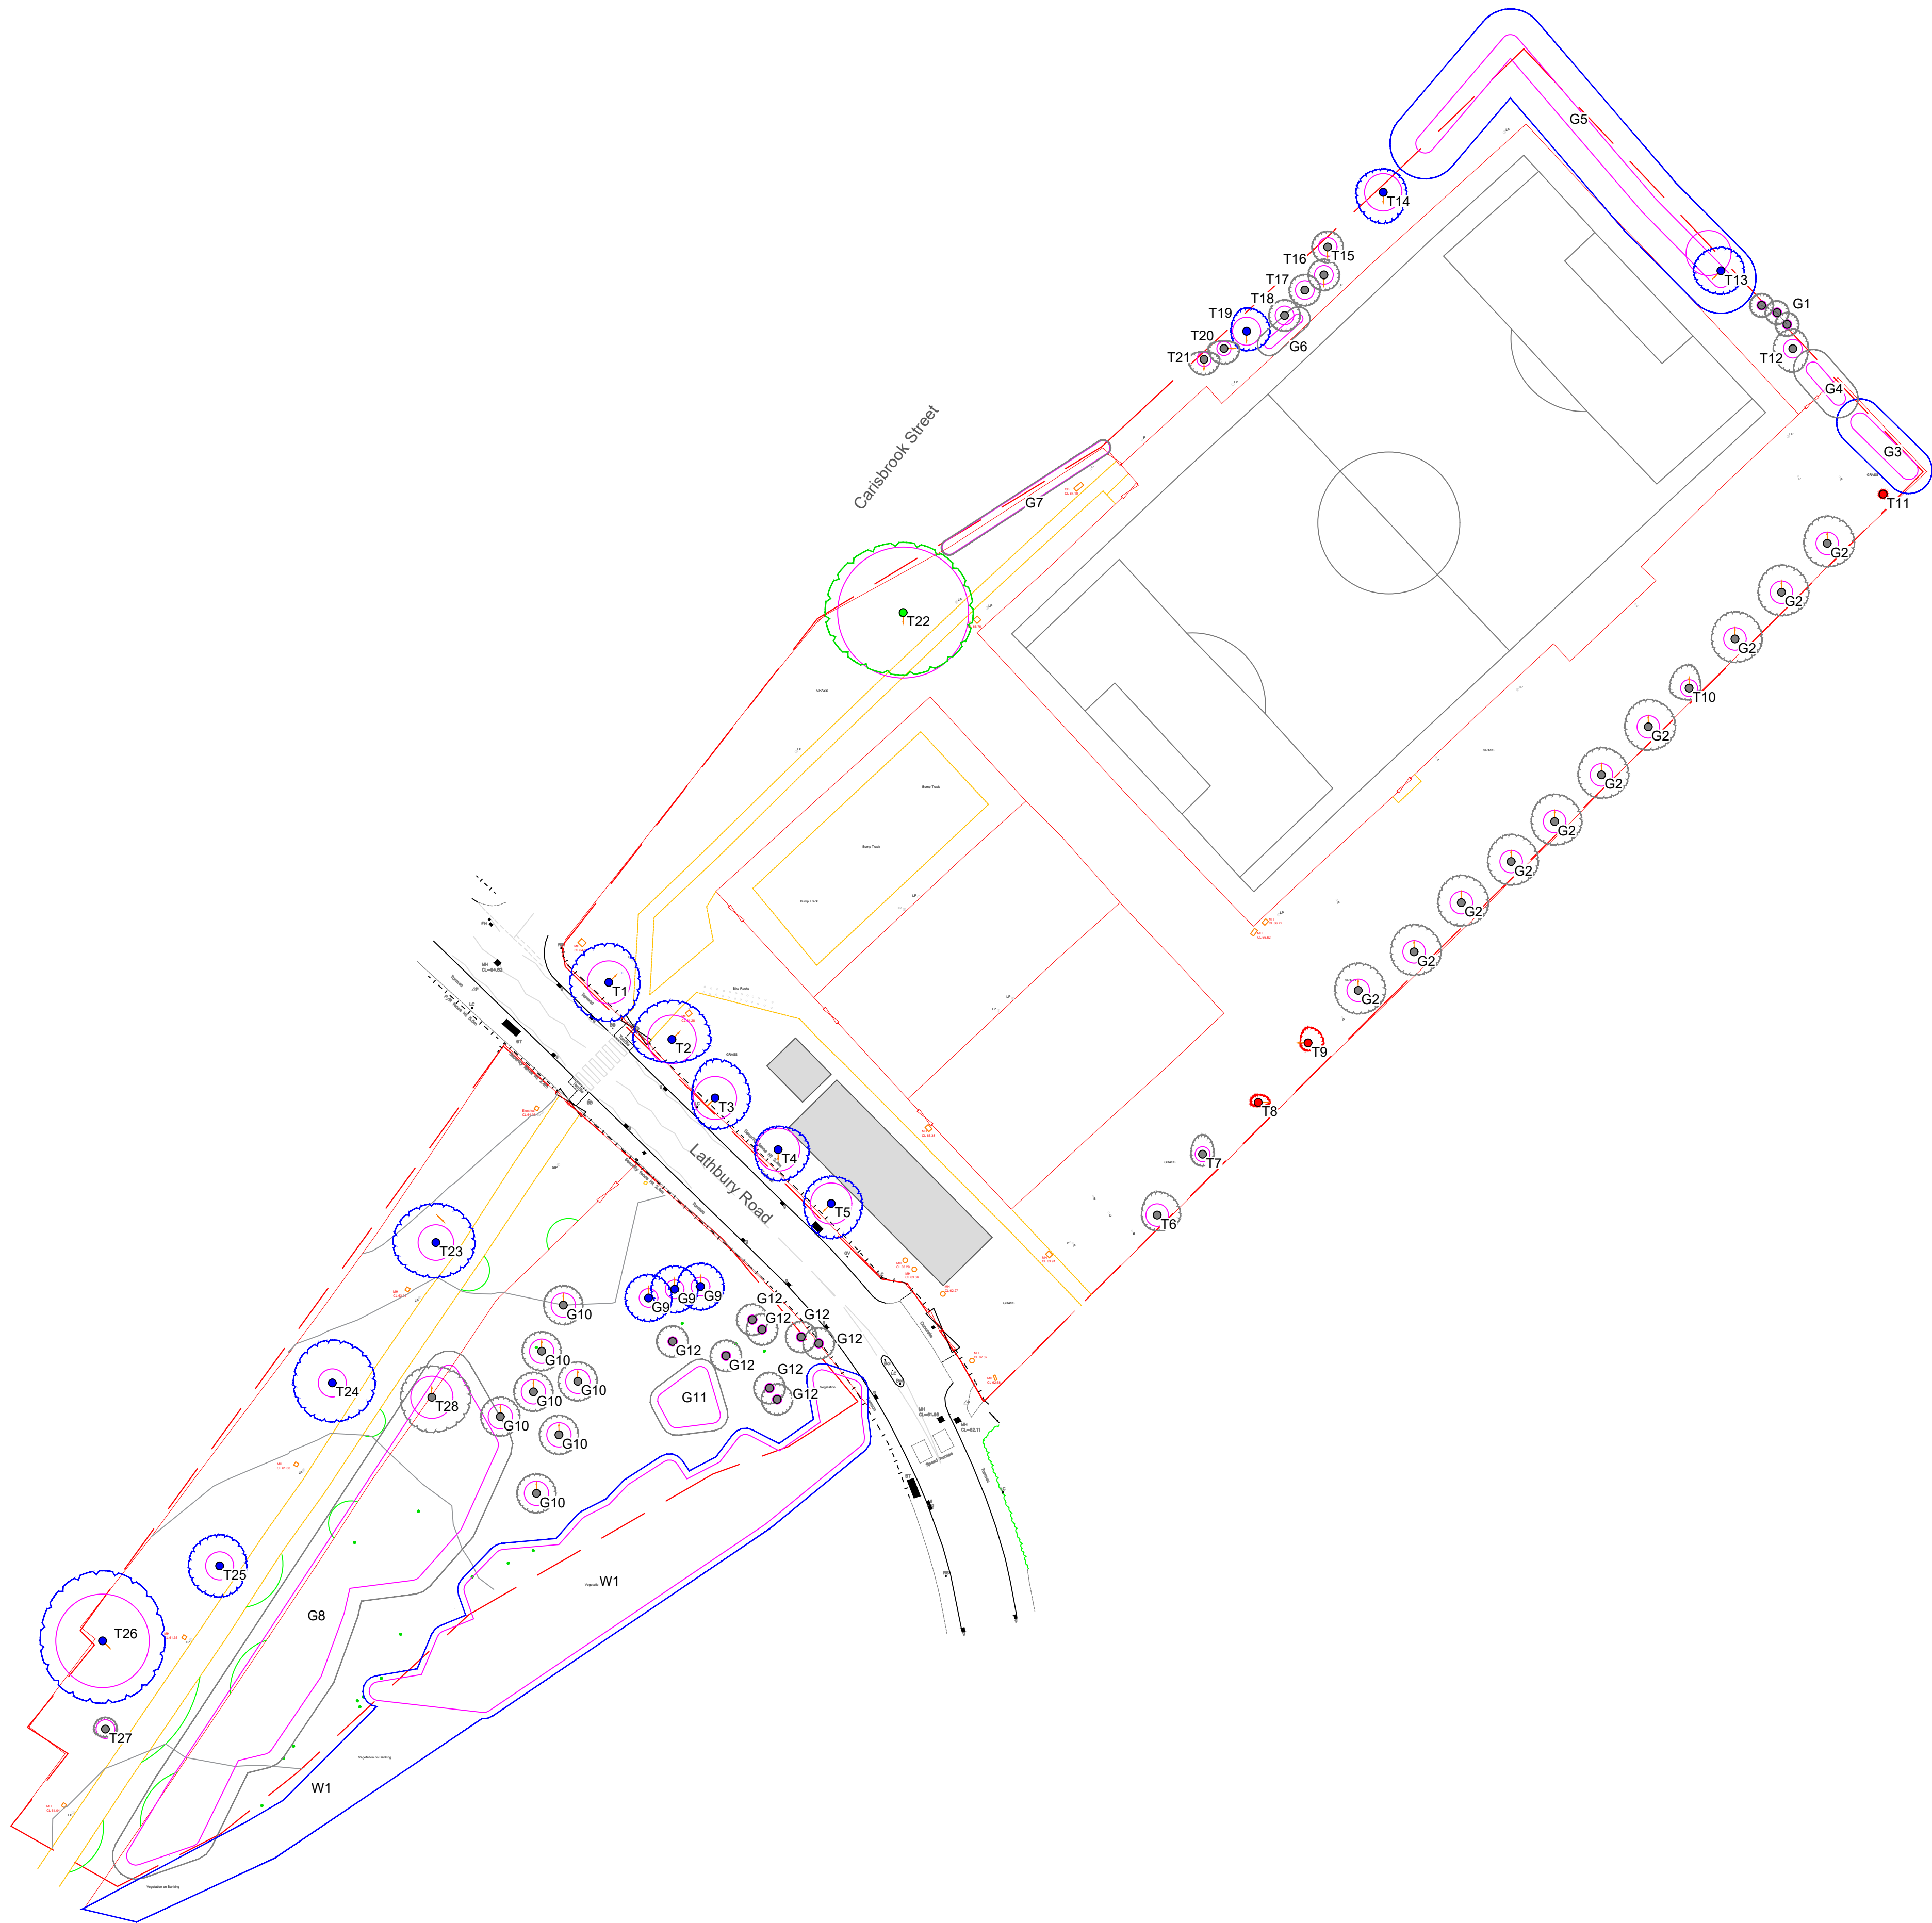
**JSL5177\_700: TREE CONSTRAINTS PLAN**

- NOTES:
- Refer to RPS Tree Survey Report & Schedule for further details.
  - Survey based on a visual inspection from the ground and is not intended as a full arboricultural inspection.
  - Plan produced in accordance with recommendations set out in BS 5837:2012 - 'Trees in Relation to design, demolition and construction'.
  - Due to the legal protection afforded to breeding birds vegetation removal should not take place during the bird nesting period; generally, although not restricted to, March - August inclusive.
  - Survey based upon topographic survey ref. MUK3213 produced by JPP UK in May 2024 and satellite imagery.

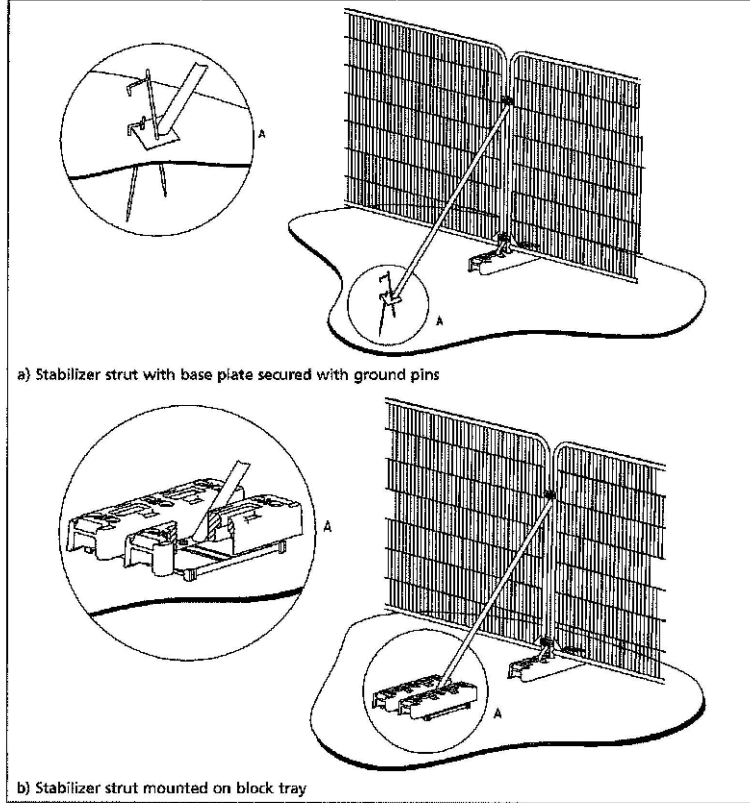
Figure 3 Examples of above-ground stabilising systems

Tree Protection should be form of braced Heras fencing panels secured with anti tamper clips and with supports fixed into the ground to prevent movement once installed. Manufacturers' recommendations should be provided to assure correct installation.

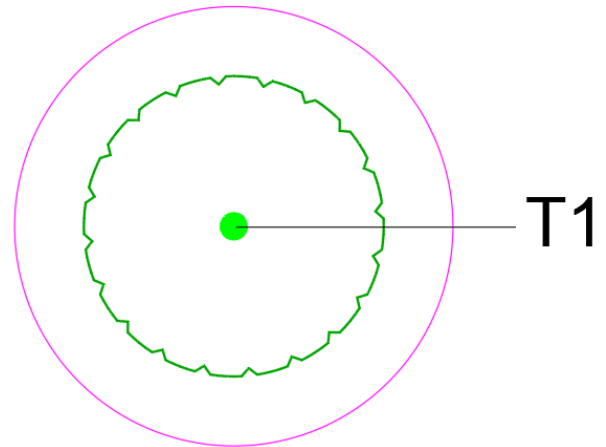
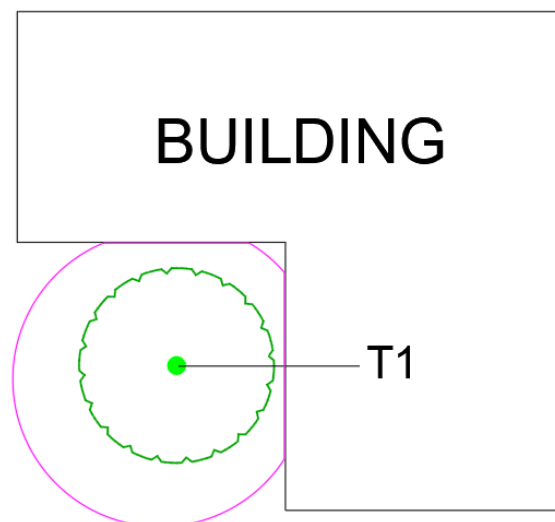
Where tree root spread is considered to have been influenced by site conditions the trees RPA's have been plotted to the Tree Constraints Plan as a polygon. The plotted polygon is of the **same area** as it would be as a circle and its shape reflects an arboricultural assessment of likely root distribution.

An example of a polygonal RPA, considered appropriate due to the presence of a building in close proximity to a tree, is shown to the right.

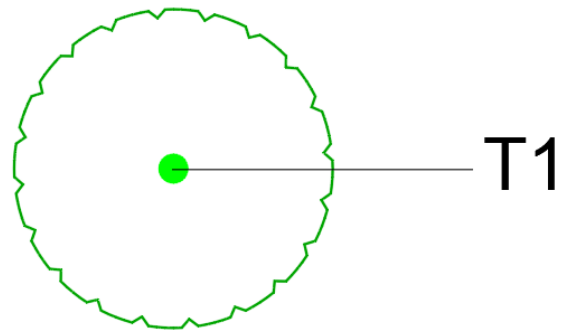
It will typically be unacceptable to design any built development within the current spread of a tree.

Where built development is proposed in close proximity to existing trees consideration should be given to the amount of working space required to allow its construction.

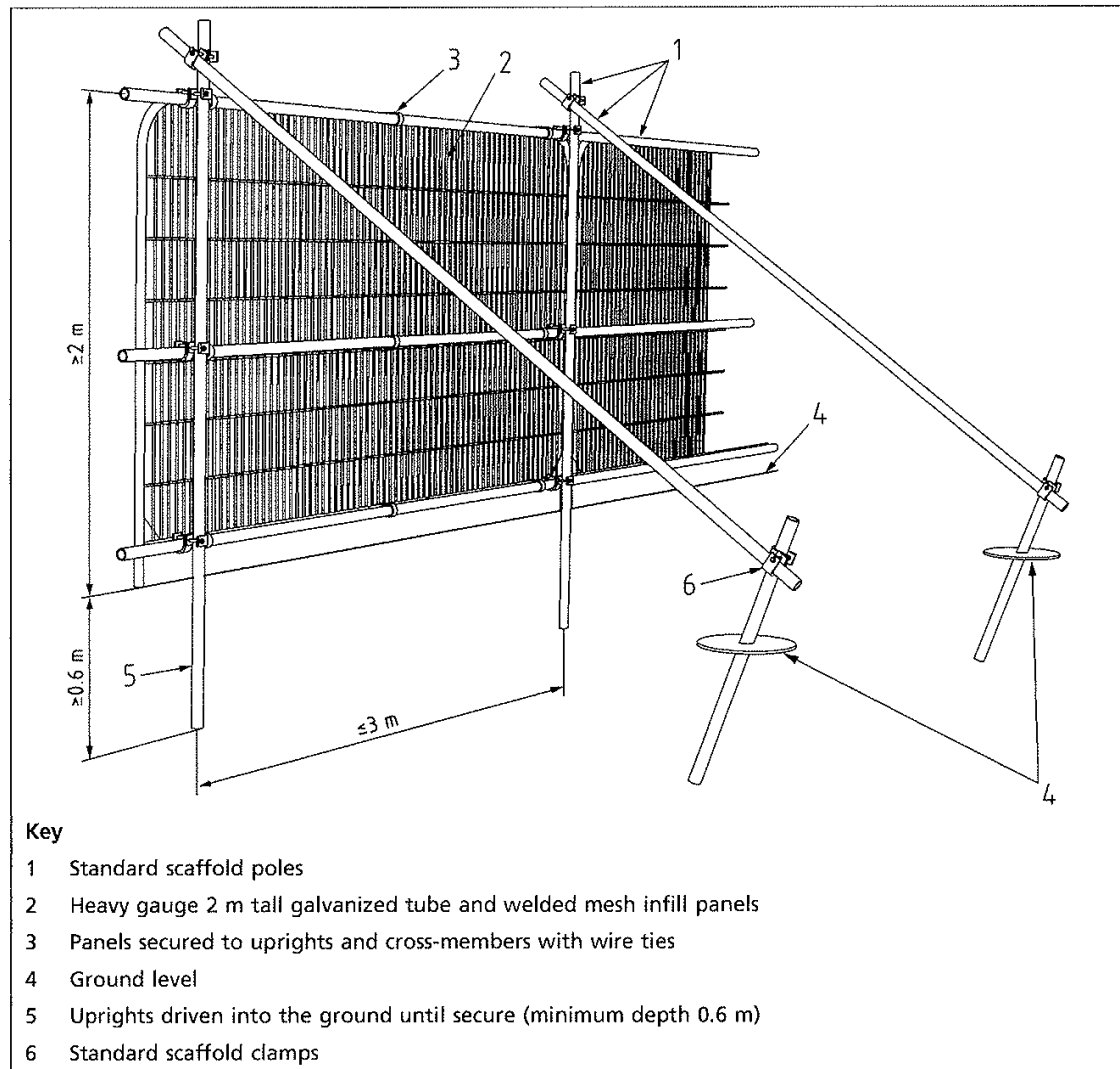
Figure 2 Default specification for protective barrier

Suggested Barrier Specification (as per BS5837: 2012)
