## Tootal Building, Manchester Paint Analysis

### **Report on Findings** Report No HPM48MS01

ISSUE 01– 14/10/2024

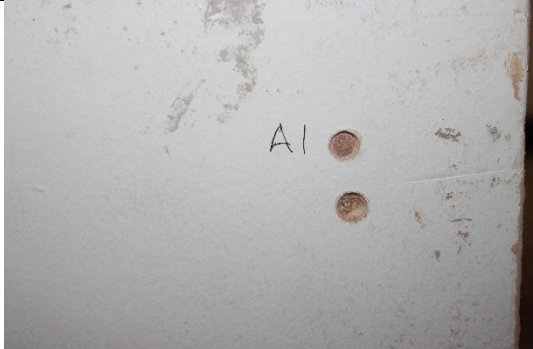
| Sample Ref: 01 | Location: Tootal Building |
|---|---|
| <p>Paint sample removed from:</p> <p>Location: 01 – Canalside Suite, Column No 1</p> <p>A total of 8 separate paint layers were found.</p> | |

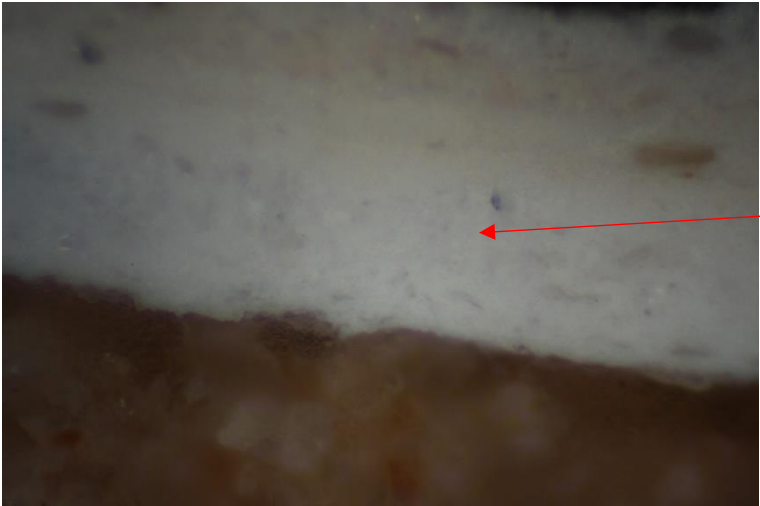
| Sample Ref: 01 | Location: Tootal Building |
|---|---|
| <br> | <p><b>X50 Magnification –</b></p> <p>Current visible paint coating – Titanium white.</p> <p>Single pink paint coating</p> <p>2No Titanium white paint layers.</p> <p>Single light grey paint coating</p> <p>3No Titanium white paint layers.</p> <p>Gypsum plaster</p><br><p><b>X400 Magnification -</b></p> <p>Earliest paint layers.</p> <p>Modern Titanium white paint layer over gypsum plaster.</p> <p>Note: The gypsum plaster is a later plaster material and likely post WW2.</p> |

The samples taken from the two columns (samples 1 and 2) had only 8 separate paint layers present with all of these being based on modern Titanium white pigments. The plaster substrate of these samples was also pink gypsum indicating that the plaster and paint layers were post WW2. It is likely that the columns have been replastered in their current square configuration at some time. All of the paint layers were light in colour with the majority being white although there was also a very light pink and light grey paint scheme being used at some time.

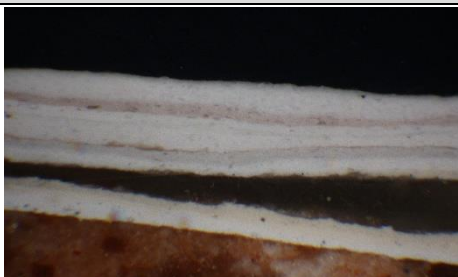
| Sample Ref: 01 | Location: Tootal Building |
|---|---|
| <p>Early schemes tested for lead</p> <p>Yes – no evidence of lead based paints.</p> | |

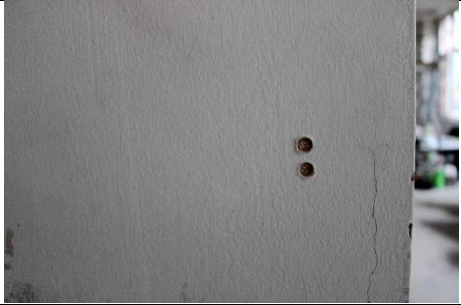
| Sample Ref: 02 | Location: Tootal Building |
|---|---|
| <p>Paint sample removed from:</p> <p>Location: 02 – Canalside Suite, Column No 2</p> <p>A total of 8 separate paint layers were found.</p> | |

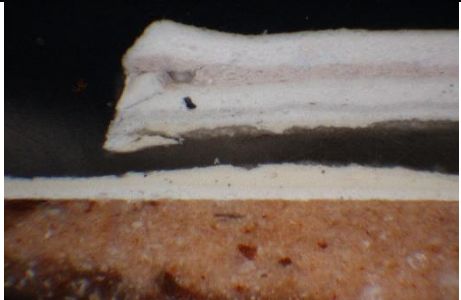
| Sample Ref: 02 | Location: Tootal Building |
|---|---|
| <p>Early schemes tested for lead</p> <p>Yes – no evidence of lead based paints.</p> | |

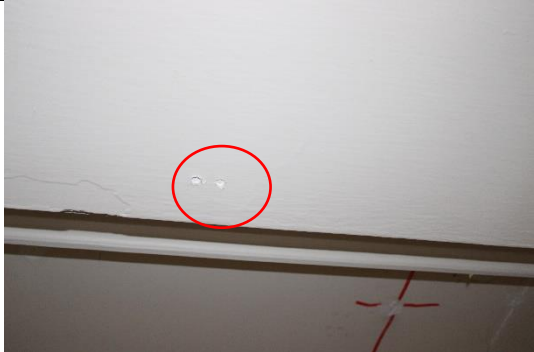
| Sample Ref: 03 | Location: Tootal Building |
|---|---|
| <p>Paint sample removed from:</p> <p>Location: 03 – Canalside Suite, Beam cornice No 1</p> <p>A total of 14 separate paint layers were found.</p> | |

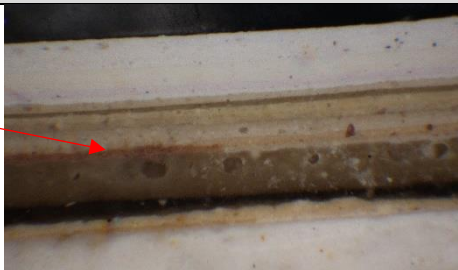
| Sample Ref: 03 | Location: Tootal Building |
|---|---|
| <p>Early schemes tested for lead</p> <p>Yes –Some evidence of lead carbonate pigments within paint layer #4.</p> | |

There was very little evidence of lead-based paints in the samples taken with only the cornice (samples 3 and 4) testing positively for lead in a single paint layer. However, lead carbonates and oxides were used in small quantities as driers in paint until they were finally banned in 1992. Even at these small concentrations the total lead content may exceed the 1% threshold noted within the CLAW (Control of Lead at Work) Regulations and all necessary control measures should be implemented whilst working with these materials.

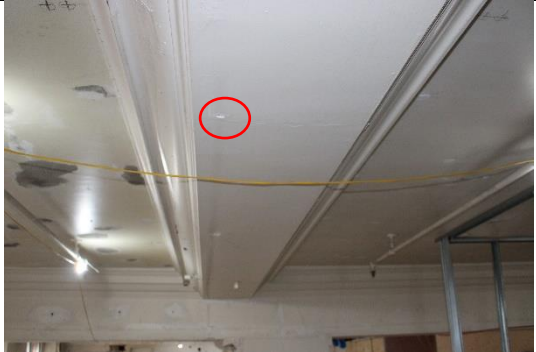
| Sample Ref: 04 | Location: Tootal Building |
|---|---|
| <p>Paint sample removed from:</p> <p>Location: 04 – Canalside Suite, Beam cornice No 2</p> <p>A total of 14 separate paint layers were found.</p> | |

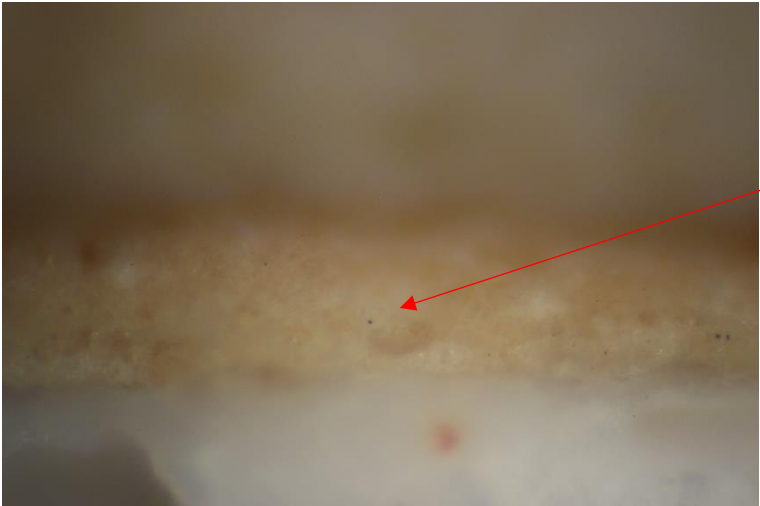
| Sample Ref: 04 | Location: Tootal Building |
|---|---|
| <br> | <p><b>X50 Magnification –</b></p> <ul style="list-style-type: none"> <li>Current visible paint coating – Titanium white</li> <li>Earlier Titanium white paint coating</li> <li>Light pink (off-white) paint coating</li> <li>Titanium white paint coating</li> <li>7No stone / off white paint coatings based on zinc oxide.</li> <li>Single thick layer of stone coloured paint based on zinc oxide.</li> <li>Single layer of off-white paint coating based on zinc oxide.</li> </ul> <p>Lime plaster</p><br><p><b>X400 Magnification -</b></p> <ul style="list-style-type: none"> <li>Earliest paint layers.</li> <li>Off-white oil paint based on zinc oxide.</li> </ul> <p>Lime plaster</p> |

Both of the samples taken from the corncicing indicated that 14 separate paint layers were present. The earliest decorative scheme was an off-white coloured oil paint that was based on zinc oxide pigments. This was followed by a further 8 off-white or light stone decorative schemes. None of these early scheme were true lead-based paints although lead carbonate was present in one of the off-white paint schemes (layer #4).

The later paint schemes applied to the cornices are based on Titanium white pigments which were much lighter in colour. Four separate Titanium white paint schemes are present with one of them having a slight pink hue.

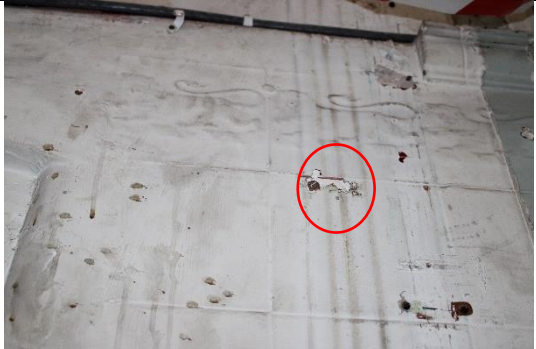
| Sample Ref: 05 | Location: Tootal Building |
|---|---|
| <p>Paint sample removed from:</p> <p>Location: 05 – Canalside Suite, Glazed Tiles</p> <p>A total of 6 separate paint layers were found.</p> | |

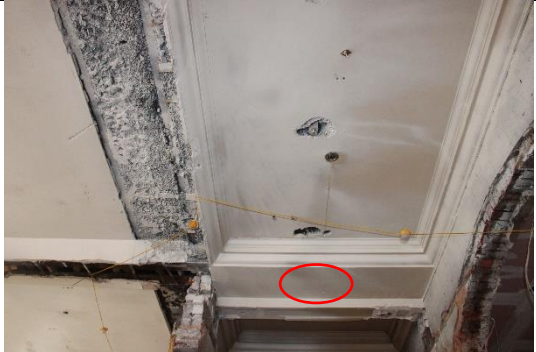
| Sample Ref: 06 | Location: Tootal Building |
|---|---|
| <p>Paint sample removed from:</p> <p>Location: 06 – GBS Suite, Cornice</p> <p>A total of 10 separate paint layers were found.</p> | |

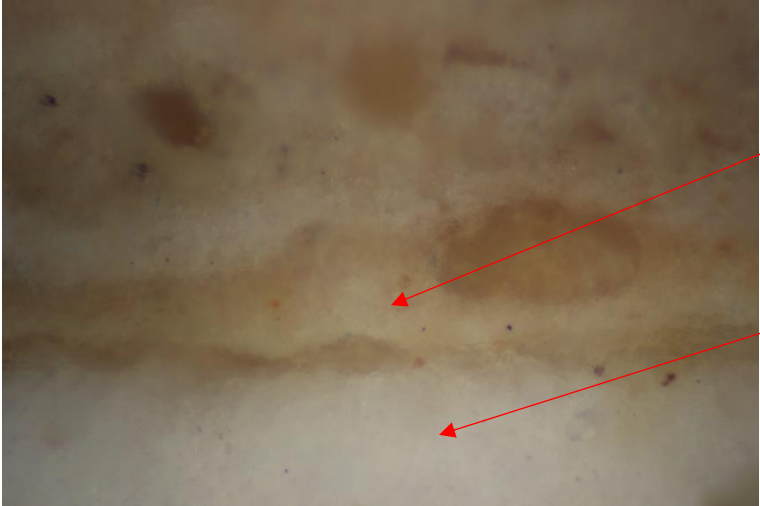
| Sample Ref: 06 | Location: Tootal Building |
|---|---|
| | <p><b>X50 Magnification –</b></p> <p>Current visible paint layer – modern Titanium white.</p> <p>9No layers of off-white paint coatings.</p> <p>Lime plaster</p><br><p><b>X400 Magnification -</b></p> <p>Earliest paint layer.</p> <p>Off-white oil paint based on zinc oxide.</p> <p>Lime plaster.</p> <p>Note: The sample is missing the later Titanium white paint layers that were present in the other samples. It is possible that this particular area has been covered or not painted in recent times.</p> |

A single sample was taken from the cornice above the entrance doors into this room area from the lobby (sample 6). The sample indicated that 10 separate paint layers were present with all of these being white / off-white in colour.

Only the most recent paint layer was based on Titanium white with all the earlier layers being based primarily on zinc oxide pigments. Given the lack of modern pigments it is likely that this ceiling area was covered sometime after WW2. No lead carbonate paints were present in the sample.

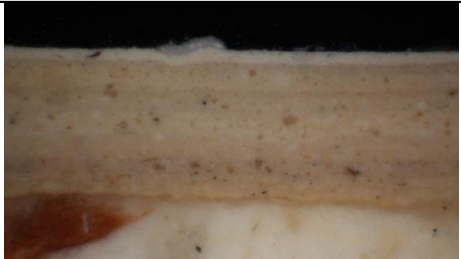
| Sample Ref: 06 | Location: Tootal Building |
|---|---|
| <p>Early schemes tested for lead</p> <p>Yes – no evidence of lead based paints.</p> | |

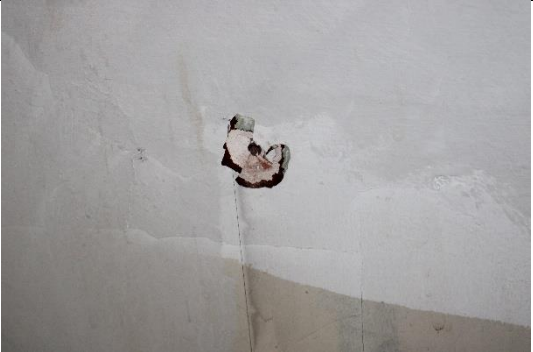
| Sample Ref: 07 | Location: Tootal Building |
|---|---|
| <p>Paint sample removed from:</p> <p>Location: 07 – Canalside Suite, wall area.</p> <p>A total of 19 separate paint layers were found.</p> | |

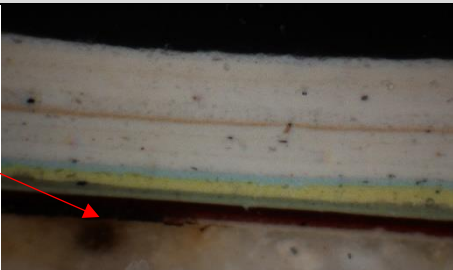
| Sample Ref: 07 | Location: Tootal Building |
|---|---|
| <p>Early schemes tested for lead</p> <p>Yes – Layer #1 tested positive for lead carbonate.</p> | |
