Report no 12517/24

Sunlight House

Sunlight House, Quay Street, Manchester, M3 3HP

Paint Sample Report and Analysis

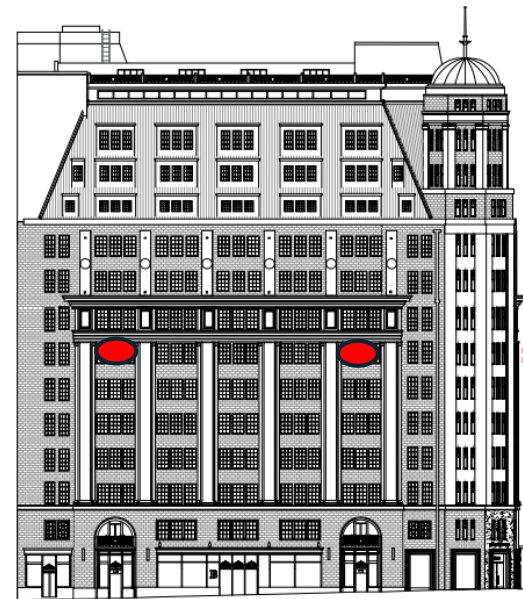
Paint sample location Quay St Level 6

Paint sample location

Sunlight House was built in 1932 in Art Deco style. The samples show some pink mastic on the base which has been coated with a zinc rich primer, the base coat is similar in colour to Ochre White from the Dulux Heritage Range then there are in excess of 8 layers of white paint.

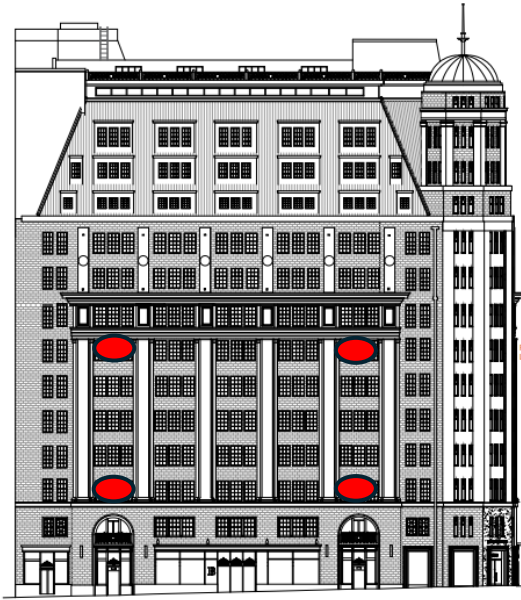
Paint sample location Quay St Level 2

● Paint sample location
