## Bat Emergence and Re-Entry Surveys (BERS)

114 Chain Road, Manchester, Manchester, M9 6GN

5<sup>th</sup> June 2024

“The demolition of B1:B4 and B6, erection of a chapel, with associated landscaping works and parking areas”

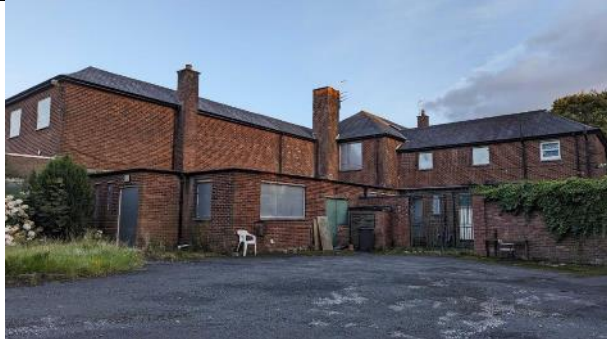
| <i>Surveyor 1 [position 1]</i> | | <p><b>No roosting activity was recorded for this position (<i>Figure 1</i>), during the survey.</b></p> <p>The first activity of the survey for this position was a common pipistrelle at 20:13, this pass was heard and not seen.</p> <p>Constant activity by common pipistrelles was recorded between 20:16 and 21:30. The majority were heard and not seen, with two seen passes, one common pipistrelle travelling northeast around B1 and the other travelling southeast over B1.</p> | | | | <p><b>Figure 1.</b> Observing the north and west (B1).</p> | |

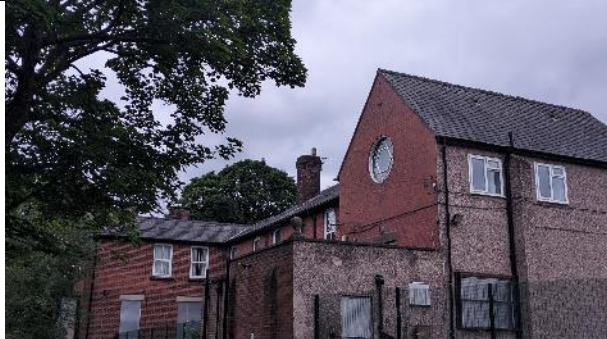
| <i>Surveyor 2 [position 2]</i> | | <p><b>No roosting activity was recorded for this position (<i>Figure 2</i>), during the survey.</b></p> <p>The first activity of the survey for this position was a common pipistrelle passing east to west around the survey building at 20:21.</p> <p>A common pipistrelle was recorded making a low pass at 20:26 travelling south to north, around the survey building.</p> | | | | <p><b>Figure 2.</b> Observing the north and east (B1).</p> | |

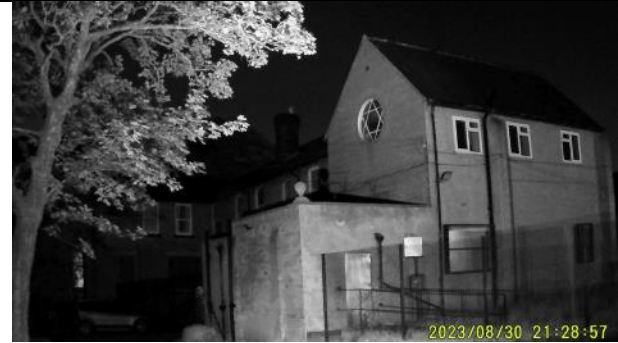
| <i>IR [position 2]</i> | <p><b>No roosting activity was recorded for this position, during the survey.</b></p> <p><b>IR at the darkest point of the survey (<i>Figure 3</i>).</b></p> | <p><b>Figure 3.</b> IR at the darkest point of the survey.</p> |

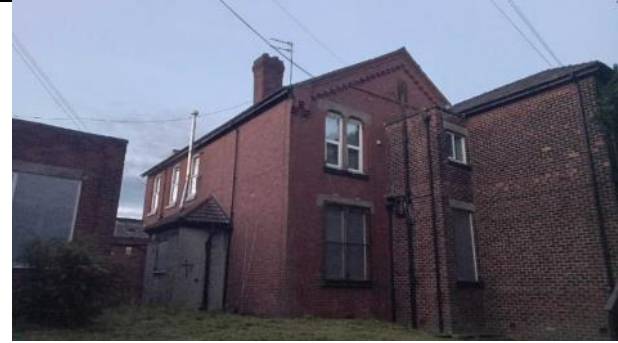
| <i>Surveyor 3 [position 3]</i> | <p><b>Roosting activity was recorded for this position (<i>Figure 4</i>), during the survey.</b></p> <p>The first activity of the survey for this position was a distant pass by two common pipistrelles at 20:07 and 20:11, these passes were heard and not seen.</p> <p><b>At 20:13 a common pipistrelle displayed light sampling activity and emerged from a lifted tile near the apex of one of the southern gables from B1. This was not captured by the IR, which was facing a different feature initially, during the survey.</b></p> <p>Two passes by common pipistrelle were recorded at 20:23 and 20:29. The first pass was from the north to the south of the survey building, over the survey building. The second pass was from west of the site to east of the site (behind the surveyor position), within the on-site trees.</p> | <p><b>Figure 4.</b> Observing the south (B1).</p> |

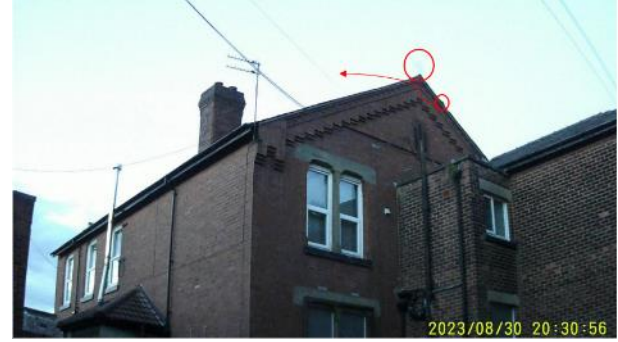
| | <p><b>At 20:30 a common pipistrelle emerged from a lifted tile near the apex of the southern gable. The bat then travelled southwest of the survey building (Figure 5).</b></p> <p>Feeding and commuting activity were recorded for the remainder of the survey near this position between 20:35 and 21:26, the majority associated with behind the surveyor position (i.e., on-site trees).</p> | <p><b>Figure 5.</b> Common pipistrelle emergence from lifted roof tile.</p> |
| IR [position 3] | <p><b>One emergence by common pipistrelle from a lifted tile near the apex of one of the southern gables (20:30), was recorded by the IR for this position, during the survey (Figure 5). This was the same as was observed by the surveyor.</b></p> <p><b>IR at the darkest point of the survey (Figure 6).</b></p> | <p><b>Figure 6.</b> IR at the darkest point of the survey.</p> |

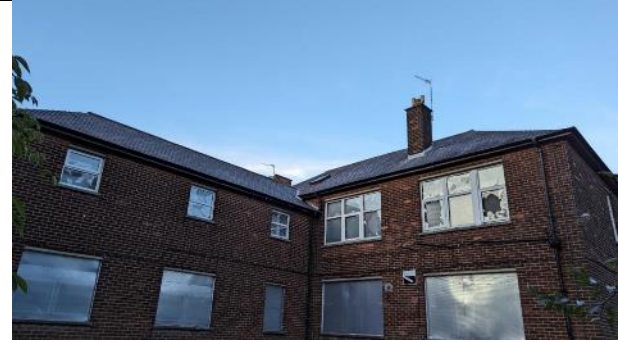
| Surveyor 4 [position 4] | <p><b>No roosting activity was recorded for this position (Figure 7), during the survey.</b></p> <p>The first activity of the survey for this position was a common pipistrelle pass from south to north, around the survey building at 20:10.</p> <p>Constant common pipistrelle activity was recorded throughout the survey with feeding activity associated with the on-site trees between 20:13 and 21:30.</p> | <p><b>Figure 7.</b> Observing the south and west (B1).</p> |

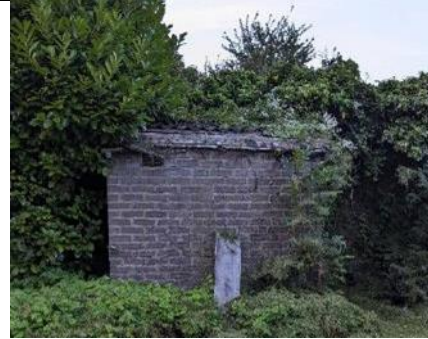
| <p><i>Surveyor 5 [position 5]</i></p> | <p><b>No roosting activity was recorded associated with B3 for this position, during the survey.</b></p> <p>The first activity of the survey for this position was constant feeding and circling overhead by a common pipistrelle associated with the surrounding trees between 20:30 and 20:45.</p> <p>From 20:51 two common pipistrelles were recorded feeding and circling above the surveyor's position and within the surrounding trees until 21:30.</p> | <p><b>Figure 8.</b> Observing B3.</p> |

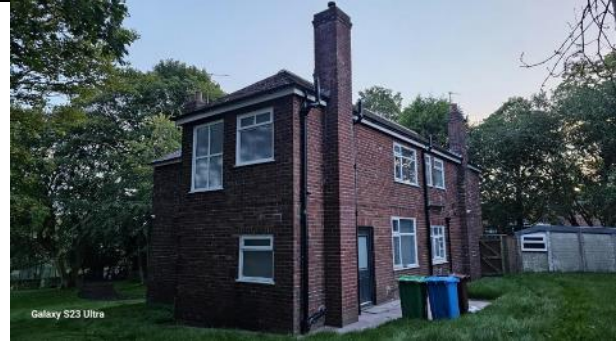
| <p><i>Surveyor 6 [position 6]</i></p> | <p><b>No roosting activity was recorded for this position (Figure 9), during the survey.</b></p> <p>The first activity of the survey for this position was a pass by a common pipistrelle at 20:20, this was heard and not seen.</p> <p>Constant common pipistrelle feeding activity was recorded between 20:28 and 20:44, associated with the nearby trees.</p> <p>Brown long-eared activity was recorded between 21:07 and 21:22, this was heard and not seen.</p> | <p><b>Figure 9.</b> Observing north and east (B5).</p> |

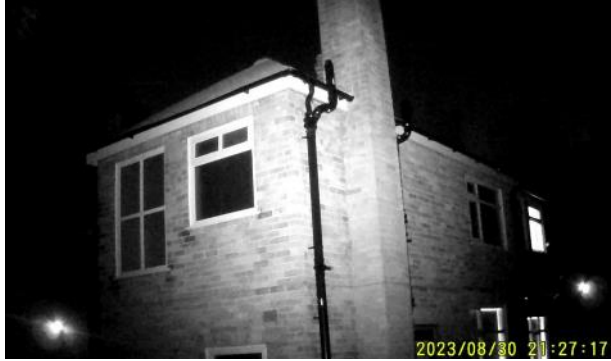
| <i>IR [position 6]</i> | <p><b>No roosting activity was recorded for this position, during the survey.</b></p> <p><b>IR at the darkest point of the survey (<i>Figure 10</i>).</b></p> | <p><b>Figure 10.</b> IR at the darkest point of the survey.</p> |

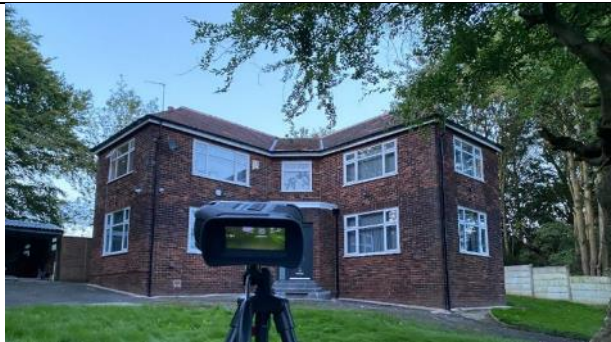
| <i>Surveyor 7 [position 7]</i> | <p><b>No roosting activity was recorded for this position (<i>Figure 11</i>), during the survey.</b></p> <p>Constant activity around the survey building was recorded during the survey, for this position. This included three passes by noctules, eight passes by brown long-eared bats, and numerous counts of common pipistrelle passes/feeding activity.</p> <p>Of the passes that could be seen, one common pipistrelle was recorded passing the building at 20:19, travelling north to south, west of the survey building.</p> <p>Another common pipistrelle was recorded feeding over the garden, travelling north to south, west of the survey building.</p> <p>Two common pipistrelle passes were recorded at 20:45, travelling in opposite directions. One travelling south to north, west of the survey building, and one travelling north to south, west of the survey building.</p> | <p><b>Figure 11.</b> Observing the south and west (B5).</p> |

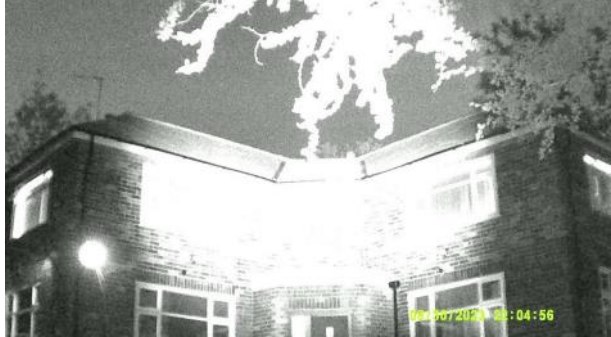
| <i>IR [position 7]</i> | <p><b>No roosting activity was recorded for this position, during the survey.</b></p> <p><b>IR at the darkest point of the survey (<i>Figure 12</i>).</b></p> | <p><b>Figure 12.</b> IR at the darkest point of the survey.</p> |

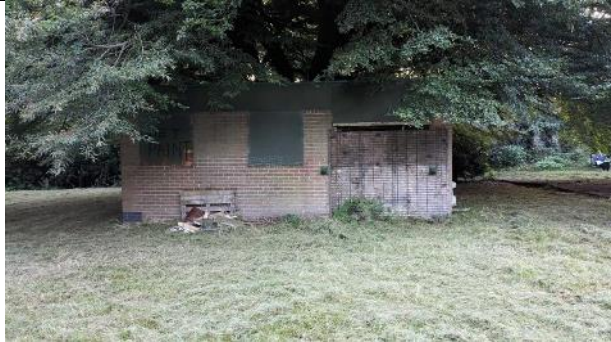
| <i>Surveyor 8 [position 8]</i> | <p><b>No roosting activity was recorded for this position during the survey.</b></p> <p>The first activity of the survey recorded for this position was constant common pipistrelle feeding activity above the surveyor position between 20:30 and 20:45.</p> <p>From 20:51, two common pipistrelles were recorded feeding above the surveyor position and around the surrounding trees. This activity was recorded until 21:30.</p> | <p><b>Figure 13.</b> Observing B6.</p> |

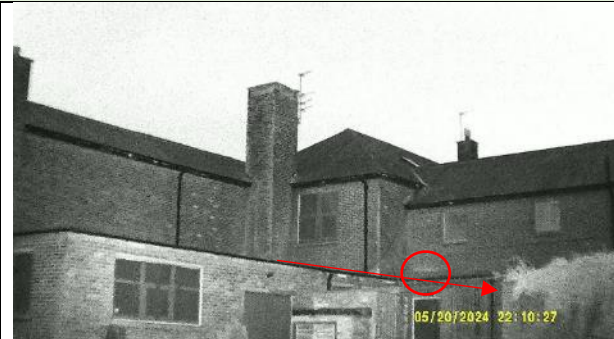
| Surveyor 1 [position 1] | <b>Roosting activity was recorded for this position during the survey.</b><br><br>An emergence by a common pipistrelle was recorded at 22:10 from beneath some flat roof bitumen (Figure 14).<br><br>Other bat activity recorded for this position included common pipistrelle passes and feeding activity between 21:24 and 22:32, associated with the adjacent trees, north to south, west of the survey building. | | | | | | |

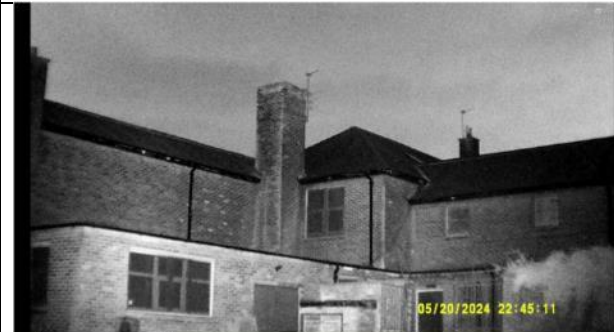
| IR [position 1] | <b>A common pipistrelle emergence from beneath some roof bitumen was recorded for this position (Figure 14), during the survey. This was the same as was observed by the surveyor.</b><br><br>IR at the darkest point of the survey (Figure 15). | | | | | | |

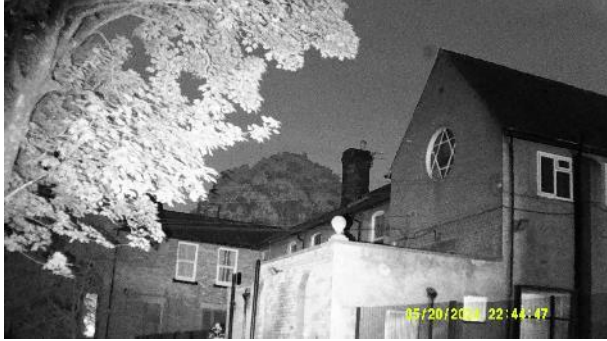
| <i>IR [position 2]</i> | <p><b>No roosting activity was recorded for this position during the survey.</b></p> <p><b>IR at the darkest point of the survey (<i>Figure 16</i>).</b></p> | <p><b>Figure 16.</b> IR at the darkest point of the survey.</p> |

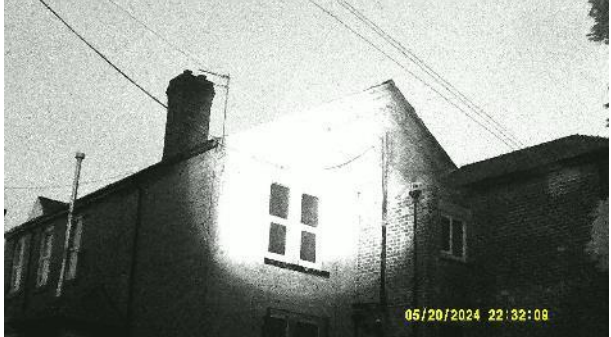
| <p><i>IR [position 3]</i></p> | <p><b>A common pipistrelle emergence from a lifted roof tile was recorded for this position (Figure 17), during the survey.</b></p> <p><b>IR at the darkest point of the survey (Figure 19).</b></p> | <p><b>Figure 19.</b> IR at the darkest point of the survey.</p> |

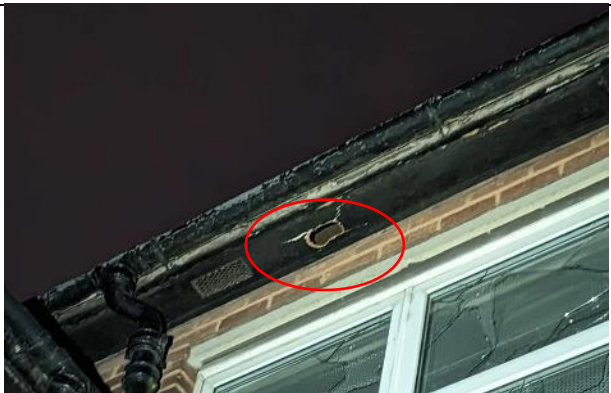
| <p><i>Surveyor 4 [position 4]</i></p> | <p><b>Roosting activity was recorded for this position during the survey.</b></p> <p>The first bat activity of the survey was a noctule pass at 21:04, over B1 north to south.</p> <p><b>Three common pipistrelle emergences were recorded from a small gap in the soffit (Figure 20) at 21:26, 21:29, and 21:34.</b> These were not captured by the IR which was positioned slightly away from the surveyor for fuller coverage.</p> <p>Common pipistrelles were also constantly active (i.e., feeding and commuting), between 21:26 and 22:23.</p> <p>Feeding activity by common pipistrelles was also recorded between 21:49 until 22:05, in overhead trees southwest of the survey building.</p> | <p><b>Figure 20.</b> Gap in soffit.</p> |

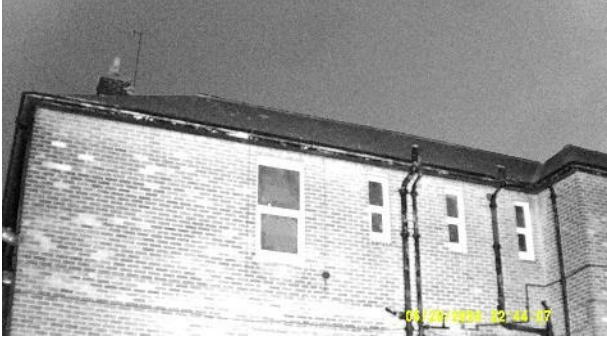
| IR [position 4] | <p><b>No roosting activity was recorded for this position during the survey.</b></p> <p><b>IR at the darkest point of the survey (Figure 21).</b></p> | <p><b>Figure 21.</b> IR at the darkest point of the survey.</p> |

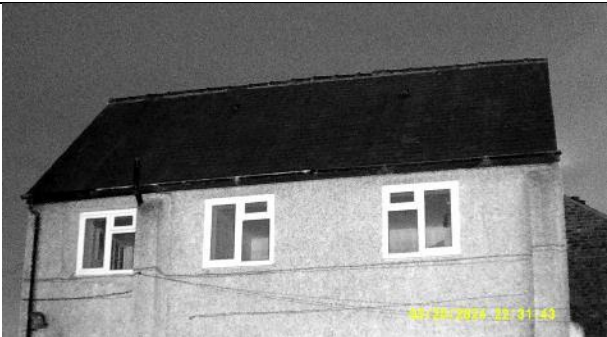
| IR [position 9] | <p><b>No roosting activity was recorded for this position during the survey.</b></p> <p><b>IR at the darkest point of the survey (Figure 22).</b></p> | <p><b>Figure 22.</b> IR at the darkest point of the survey.</p> |

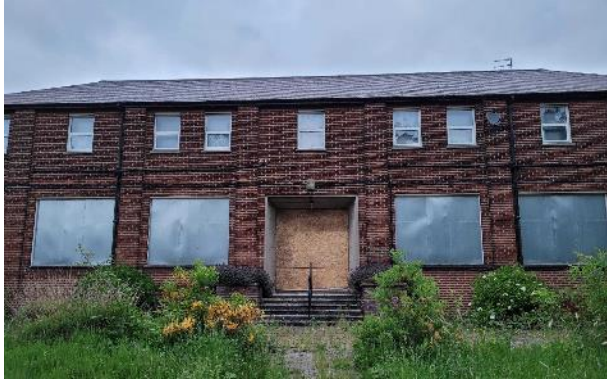
| <i>Surveyor 6 [position 10]</i> | <p><b>No roosting activity was recorded for this position (<i>Figure 23</i>) during the survey.</b></p> <p>The first bat activity recorded was a noctule pass at 21:04, which was heard but not seen.</p> <p>Common pipistrelle activity was constant throughout the survey for this position (feeding and commuting), until the last activity recorded at 22:37.</p> | <p><b>Figure 23.</b> Observing the south (B1).</p> |

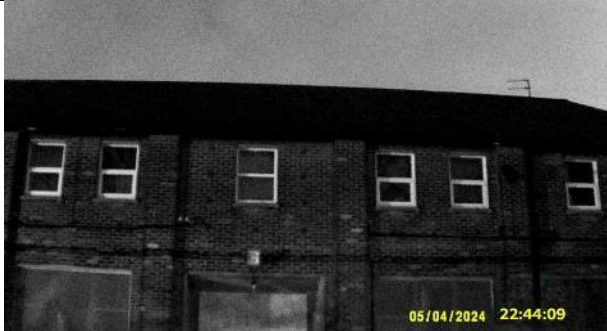
| <i>IR [position 10]</i> | <p><b>No roosting activity was recorded for this position during the survey.</b></p> <p><b>IR at the darkest point of the survey (<i>Figure 24</i>).</b></p> | <p><b>Figure 24.</b> IR at the darkest point of the survey.</p> |
