# Manchester Art Gallery

Heritage Assessment  
November 2024

Project name: Manchester Art Gallery  
Project number: 9604  
Document number: MAG-BUT-08-B2-RP-A-00-0001

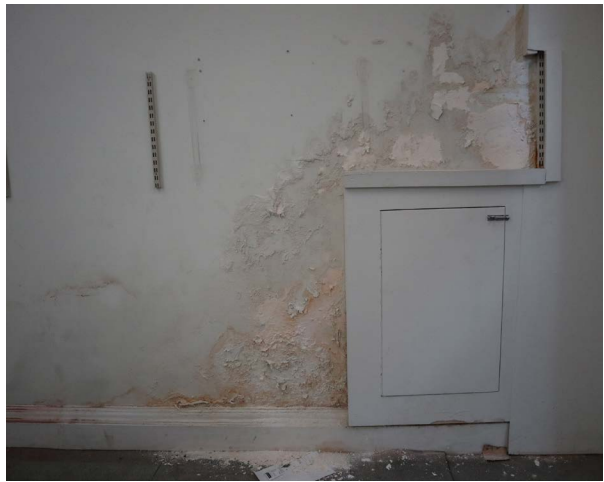
Figure 19 Photograph showing damaged plaster to east corner

Saturated moisture content readings were taken along the east corner of this wall at 1m from floor level (ref. Hutton and Rostron masonry moisture profile survey), and resultant damage to the lime plaster is visually apparent. Removal of the modern plasterboard finishes are proposed to a further section of the east wall where finishes have been historically water stained (but with no ongoing water ingress detected). There is no adverse change to the existing condition and removal is considered beneficial as removal allows continued safe use of the space.

Remove damp affected plaster from north east wall.

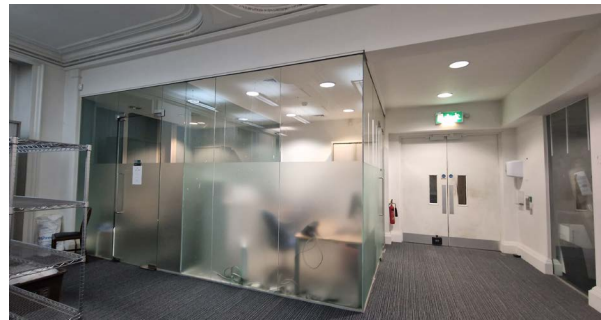
Figure 20 Photograph showing modern glazed partitions and screens to be removed

Remove existing modern glazed partitions and screens to allow for construction of new concrete floor slab and space for new roller racking.

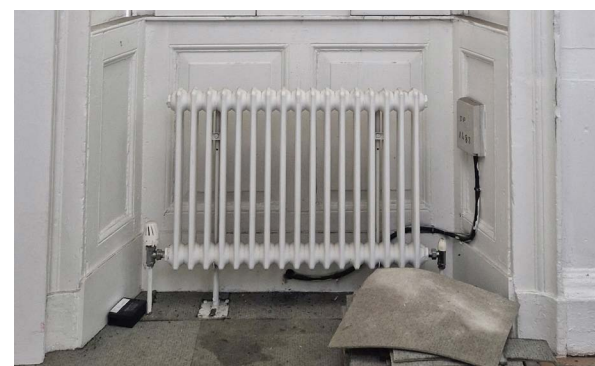
Figure 21 Photograph showing existing modern radiators

The existing radiators are required to be removed as part of the proposals to upgrade heating provision and improve environmental control in the space. New radiators are to be installed to replace the existing (albeit in a new position) therefore there will be no perceptible change to the existing condition.

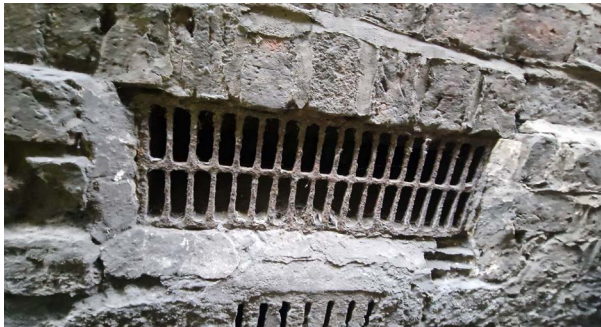
The report also found that the subfloor was generally dry, and identified that the existing subfloor vents under each window to the east / south side of the space are providing some airflow. Further investigation is required to these vents once they have been cleared/ cleaned to establish remedial works required, it is also proposed to install new cast iron vent covers as the existing are either missing, heavily corroded or deformed (see figure 22). The method of ventilation to the west side of the subfloor requires further investigation - there are no low level vents visible in the lightwell along Back George Street, the subfloor is mostly dry so it is believed ventilation is achieved through alternative means.

Figure 22 Photograph of existing historic corroded cast iron vent cover (photo shows the only remaining intact cover)

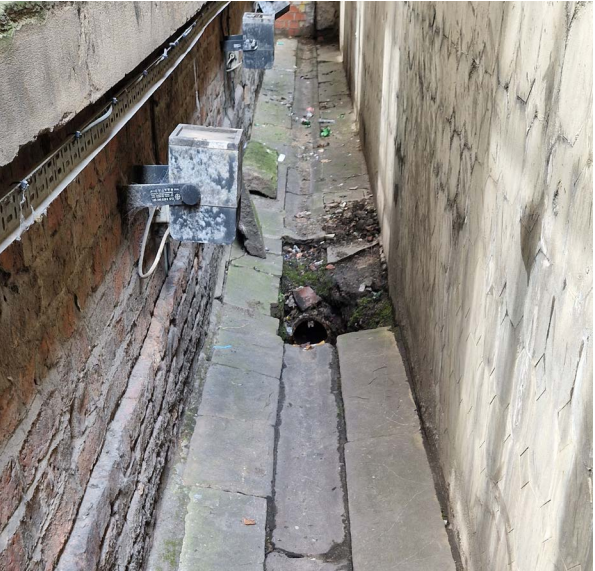
Remediate failed lightwell drainage including capping off a collapsed pipe, the rebuilding of a buried manhole adjacent to Princess Street, reinstatement of a yard gully where the existing has been removed adjacent to George Steet, and a corner inspection chamber to connect the two (reference Booth King drawing MAG-BKP-18-ZZ-DR-C-90-0515). Damaged paving slabs will be replaced to match existing as part of the works, and a new DPM installed at the interface with the building. External walls to be core drilled in 1no. location below floor level to allow for connection of sump pump drainage into existing lightwell drainage.

Figure 24 Photograph showing cracked paving slabs and broken out gully

Works to remediate failed drainage in the lightwell will address a primary cause of water ingress to the building, particularly in the east corner. There is no adverse change to the existing condition and removal is considered beneficial as it prevents continued deterioration of the fabric.

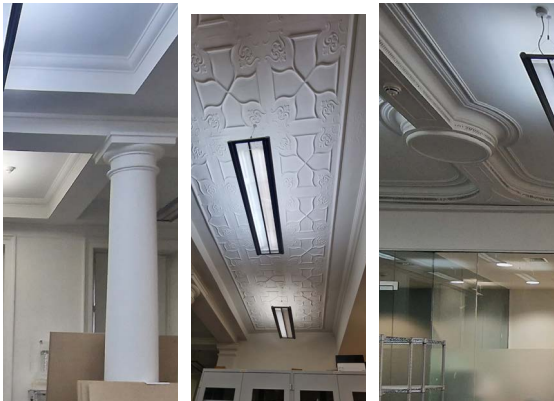
localised areas have failed they are proposed to be repaired like-for-like with traditional materials to suit the ceiling construction (refer to MAG-BUT-08-B2-DR-A-35-4002 and section RS8 of the restoration specification MAG-BUT-XX-XX-SP-A-00-0001).

Figure 25 Photographs showing historic ceiling types (Left: Lath and plaster, Middle: Lath and Plaster decorative panels, Right: Fibrous Plaster)

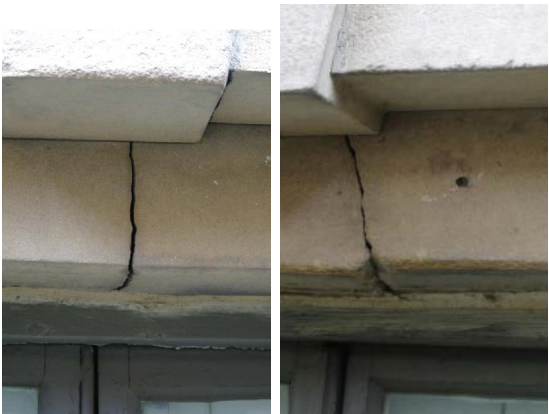
Booth King undertook a ground level structural survey of the building in April 2024 as part of a wider assessment of external fabric repairs (please note these works do not form part of this application). The survey revealed 2no. failed lintels to the Athenaeum basement windows, the remediation of which is considered urgent and has therefore been included in this work package to prevent further deterioration, and to facilitate the proposed window repairs and security upgrades (refer to 14794-BKP-14-ZZ-TN-S-0003).

Figure 26 Photographs showing failed lintels to WIN-004 on George Street (left) and WIN-010 on Princess Street (right)

- Redecoration of walls, ceilings and woodwork in breathable paint.
- Repairs to 2no. failed window lintels.

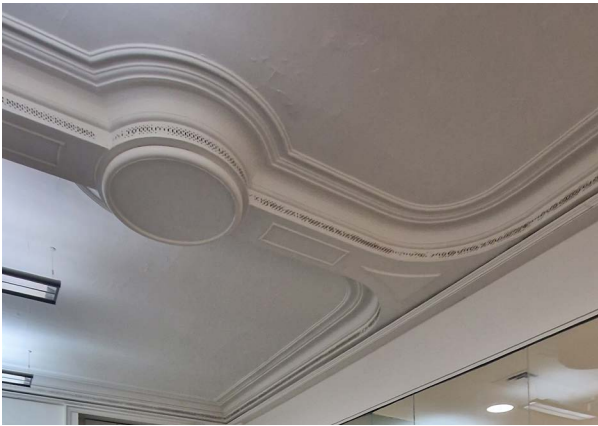
Infilling metal grilles to downstand beams to reduce uncontrolled air infiltration (please refer to MAG-BUT-08-B2-DR-A-06-6002 and section RS8 in MAG-BUT-XX-XX-SP-A-00-0001 for further details). The metal grilles are present to the downstand beams in B02-B2-003 as part of the old redundant heating system and no longer serve a functional purpose. The apertures in the grilles are proposed to have a **cover adhered over**.

Figure 28 Photograph showing high level metal grilles in B02-B2-003

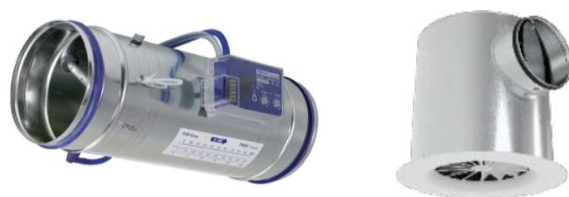
Extend and amend existing ventilation ductwork from existing plantroom with new VAV and CAV units and extend ductwork runs into space, to be suspended from modern suspended and original ceilings.

Figure 30 Images of proposed duct fittings (Left: Variable air volume unit, Right: Variable air volume diffuser)

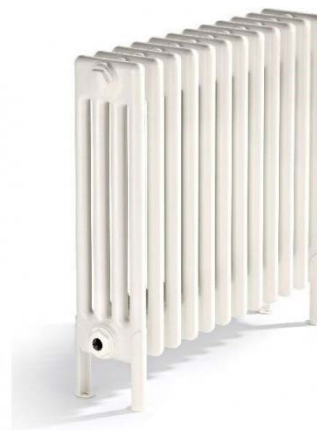
Pipework is proposed to be run above the timber floor as opposed to within the subfloor to allow for easy maintenance access to the pipes, to avoid future disruption to the floor.

Figure 31 Image of proposed column radiator with welded feet

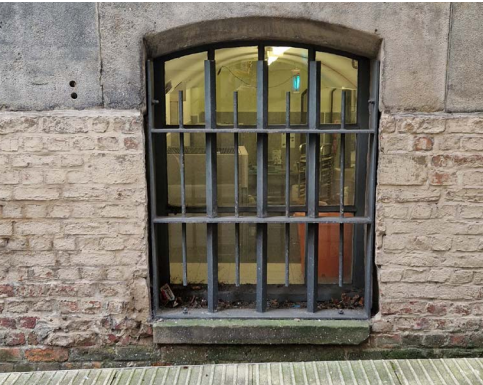
Figure 33 Existing security bars installed on the Grade I listed Art Gallery building

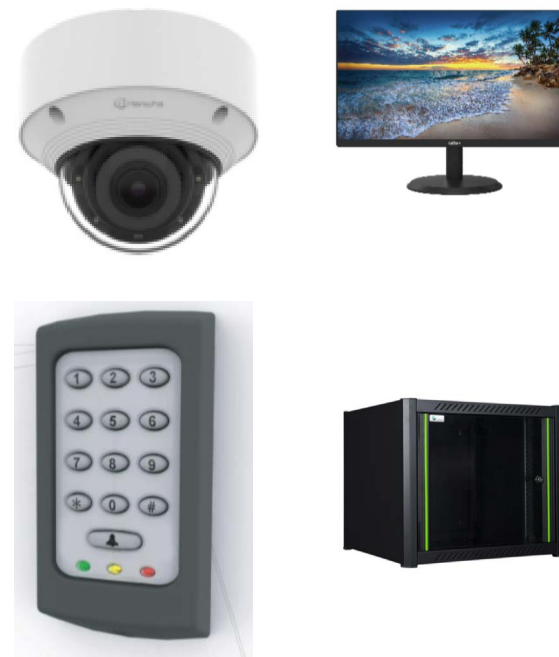
Figure 35 Proposed security fittings (from left to right: Wall mounted CCTV camera, CCTV monitor, keypad card reader, wall mounted data cabinet rack)

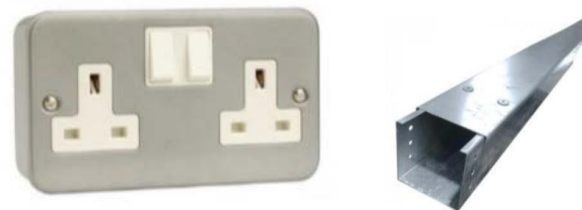
New wall mounted small power requirements and data outlets

Figure 36 Image showing proposed wall mounted socket box and high level containment trunking

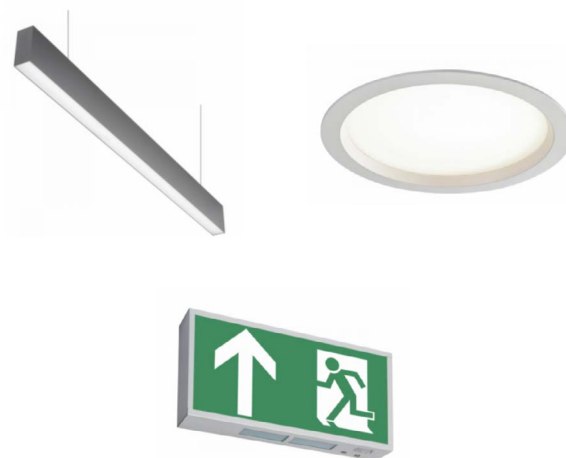
New lighting throughout with local switching, including new high quality suspended light fittings and recessed spots to the existing suspended plasterboard ceilings in the paper store.

Figure 37 Images showing proposed light fittings
