**Land at Welcomb Street: Lost Watercourse Assessment**  
**Planning Ref: 139997/FO/2024**

**Overview:**

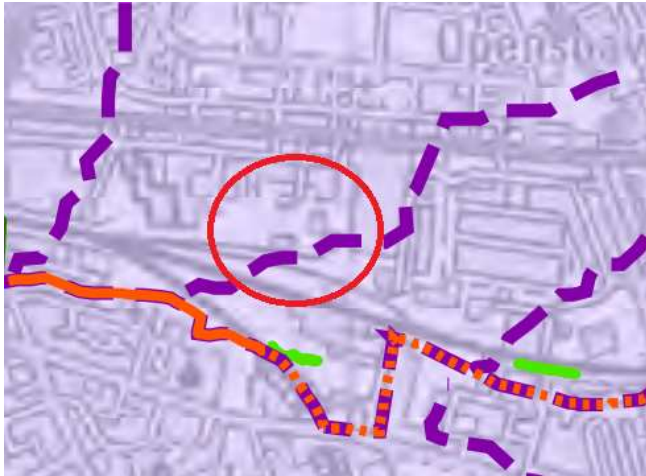
**Critical Drainage Area Plan**

6. The MCC Critical Area Drainage Plan (MCC SFRA 2011) indicates a 'lost watercourse' within or close to the development site and adjacent industrial plot. The accuracy and level of detail on this plan is unreliable, furthermore this does not reflect the 1845 OS map which shows the watercourse beyond (or intersecting) the SE boundary.

Purple dashed line = Lost Watercourse

Orange solid line = Corn Brook Open Watercourse

Orange dashed line = Corn Brook Culverted Watercourse

Green line = Other Waterbodies

17. The MCC Critical Drainage Area plan extracted from the SFRA and latest plan issued by MCC (11/10/24) indicates a 'lost watercourse' routed through the SE corner of the site. The accuracy and level of detail on this plan is unreliable, furthermore, this does not reflect the 1845 OS map. Additionally, the information does not take account of the UU trunk sewer which is on a similar alignment and bisects the 'lost watercourse' line.
