# Television Baseline Survey Report

NOMA GP Ltd

2&3 Angel Square

July 2024

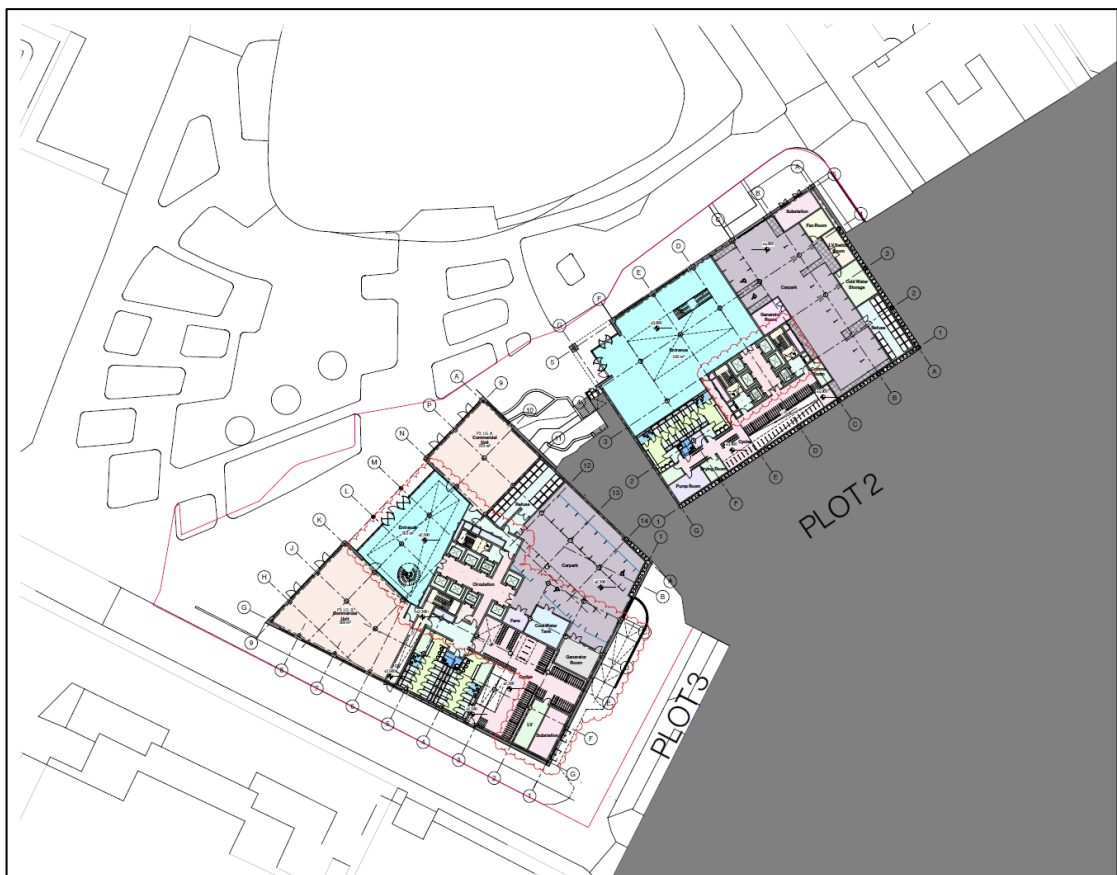
Figure 1 Proposed development site plan

The proposed development site plan is shown in Figure 1<sup>3</sup> below.

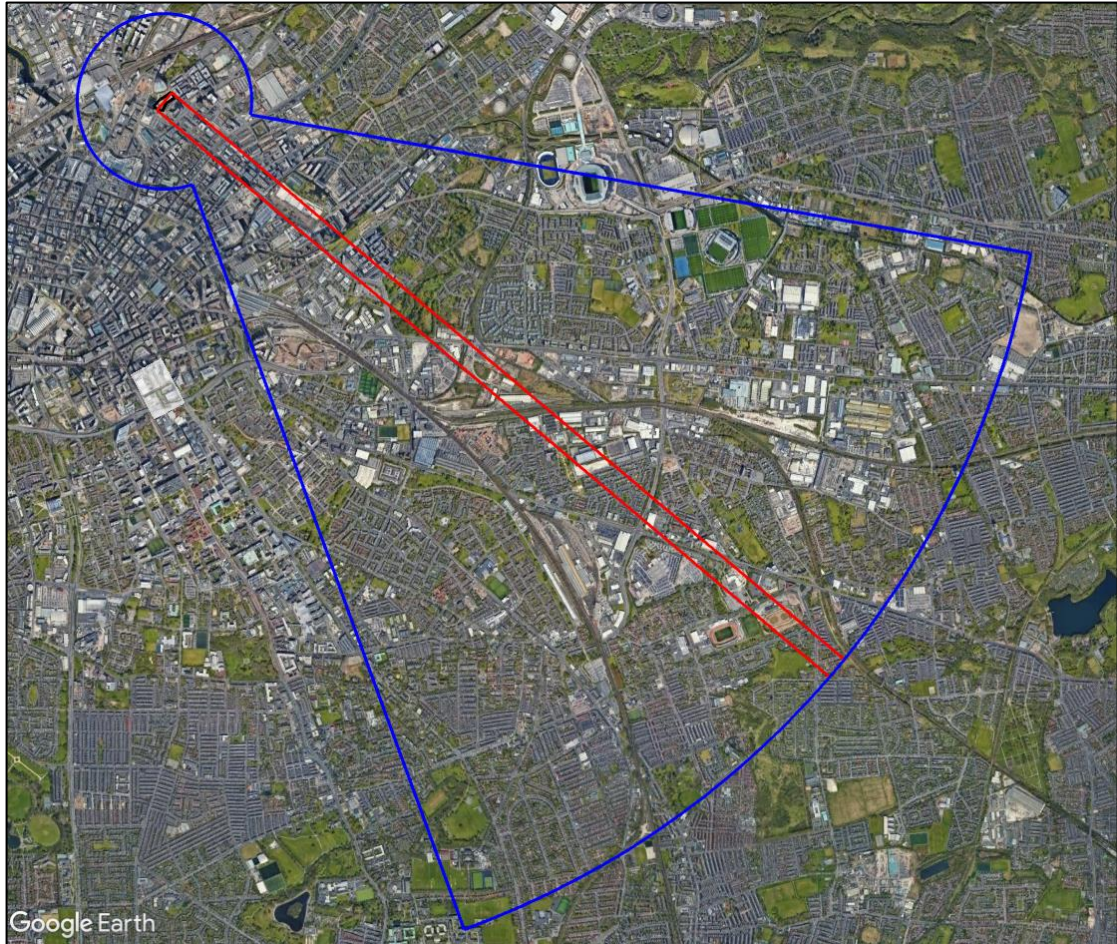
Figure 6 Interference zones map

Figure 6 below shows the interference zones overlaid onto an aerial image of the area.

The shadow zone passes over urban areas that contain multi-storey flats, commercial buildings, and/or typical 2-storey residential dwellings. Areas closest to the proposed development are at the highest risk of experiencing television interference. This is typically limited to 1km based on Pager Power's assessment experience. Multi-storey flats and/or commercial buildings are mostly located within 1km of the proposed development shadow zone. Beyond this distance 2-storey dwellings are present.

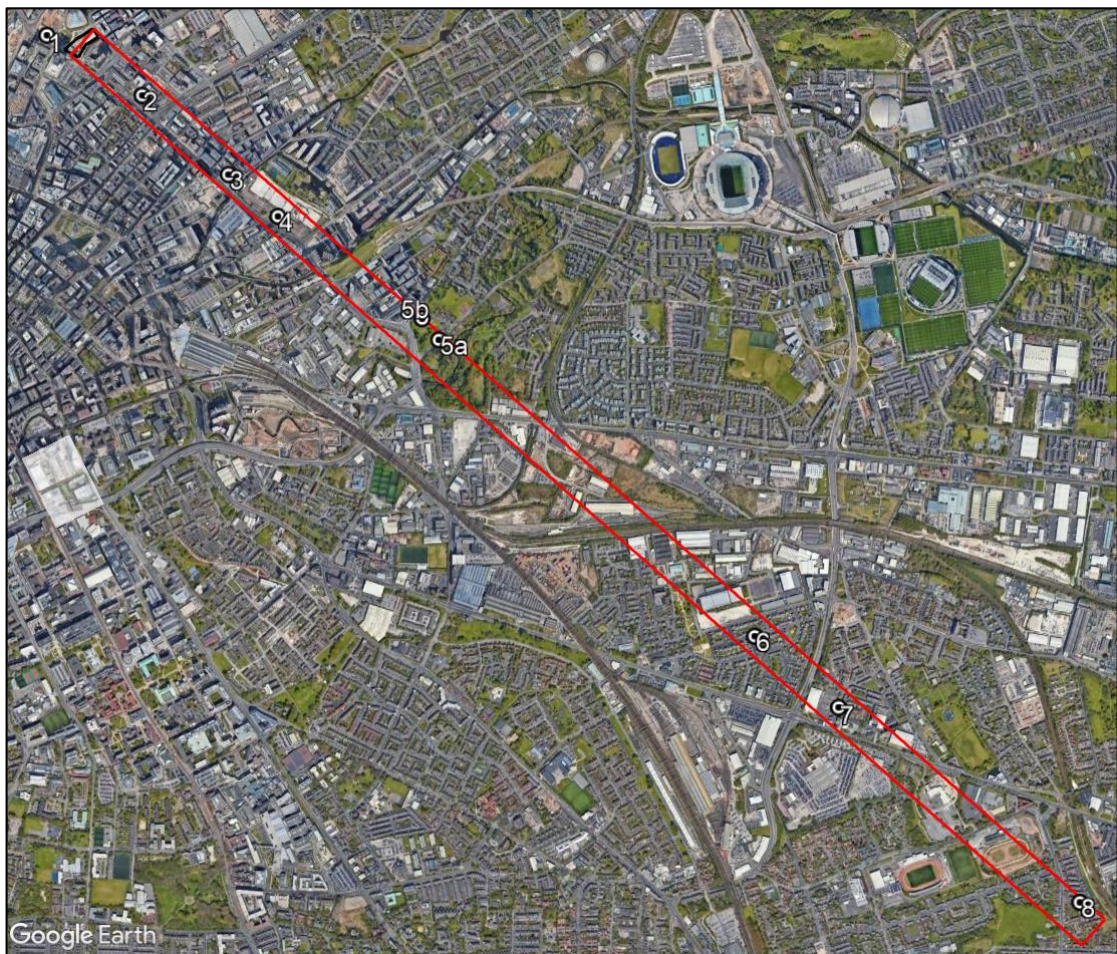
Figure 7 Survey locations

Figure 7 below shows the survey locations overlaid onto aerial photography. The proposed development location and the shadow zone are also shown. Survey locations were chosen pre-survey (within the shadow zone) however safe and available access influenced the specific position on the day. Survey location 1 was chosen in front of the proposed development to consider the signal strength which may be affected by existing obstructions and not that of the proposed development. Furthermore, it provides a good a like for like comparison for a post-construction survey (if appropriate) to determine if effects are attributable to the proposed development.

No access was available at or near to this survey location 4 and therefore no recording was undertaken at this location. For survey location 5a, no services were available (discussed further in the following section); however, they were available at the nearby survey location 5b. Survey locations are more closely grouped nearer the proposed development because interference is generally more likely the closer the location is to the obstruction. Radial white icons represent television survey locations.

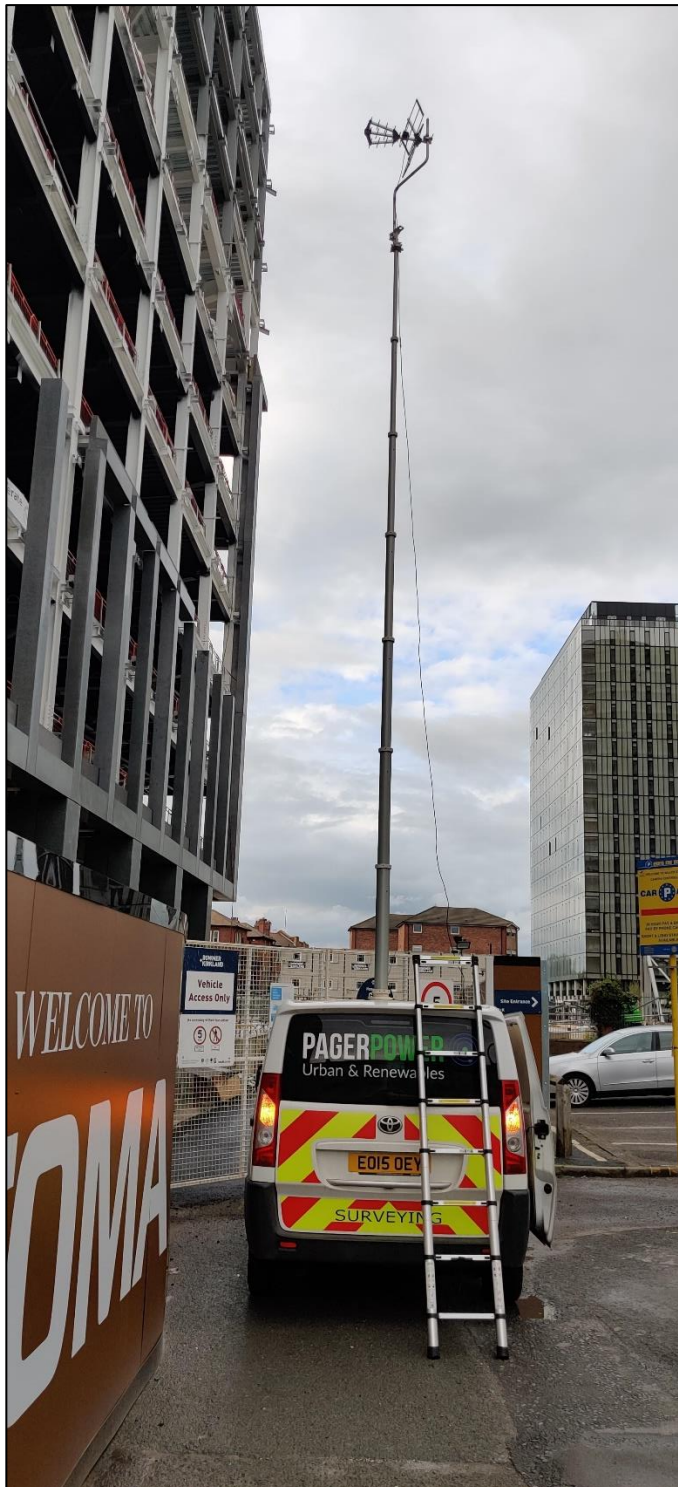
### Location 1

Notes: No UHF aerial or satellite dishes were observed.

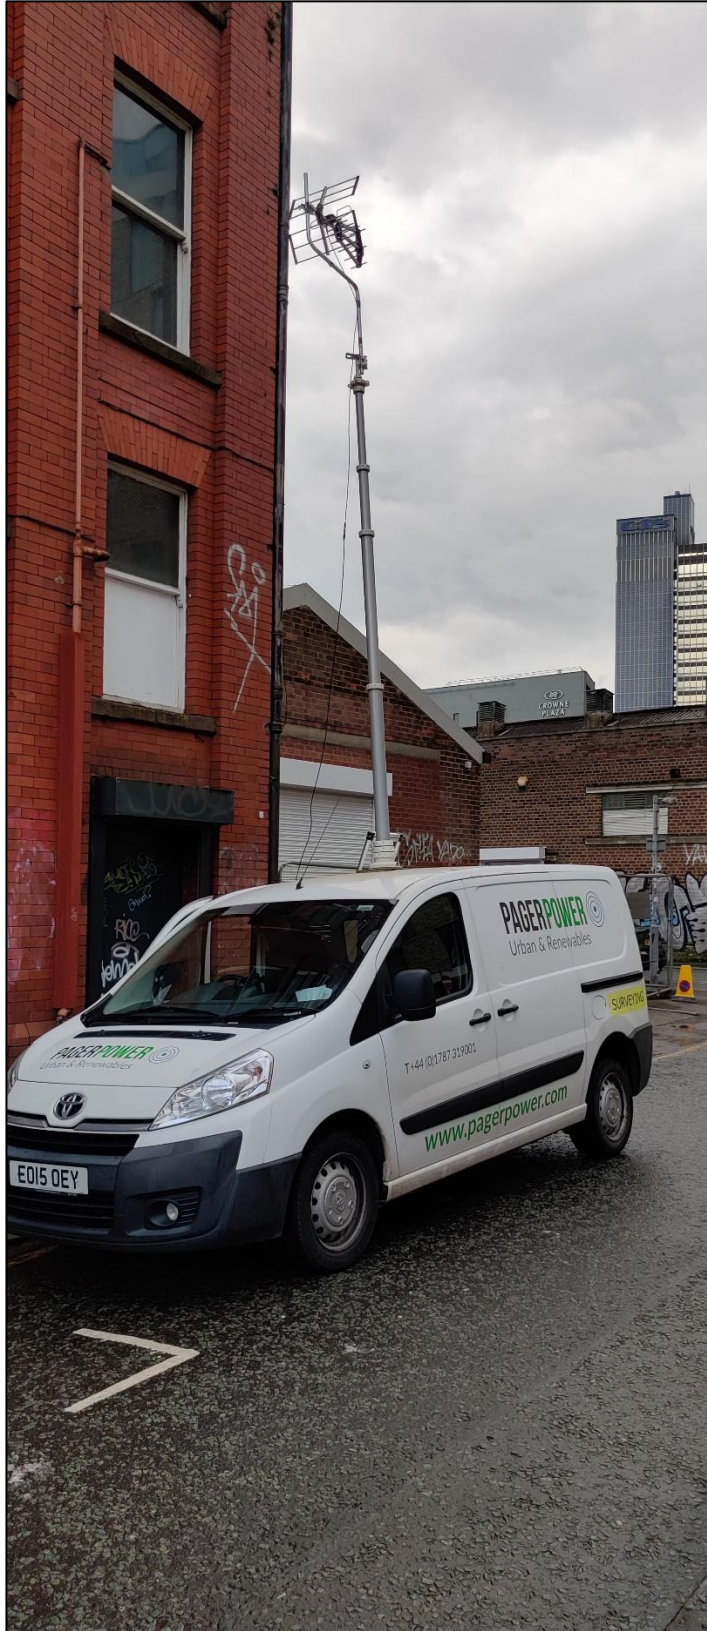
Location 2

Notes: No UHF aerial or satellite dishes were observed.

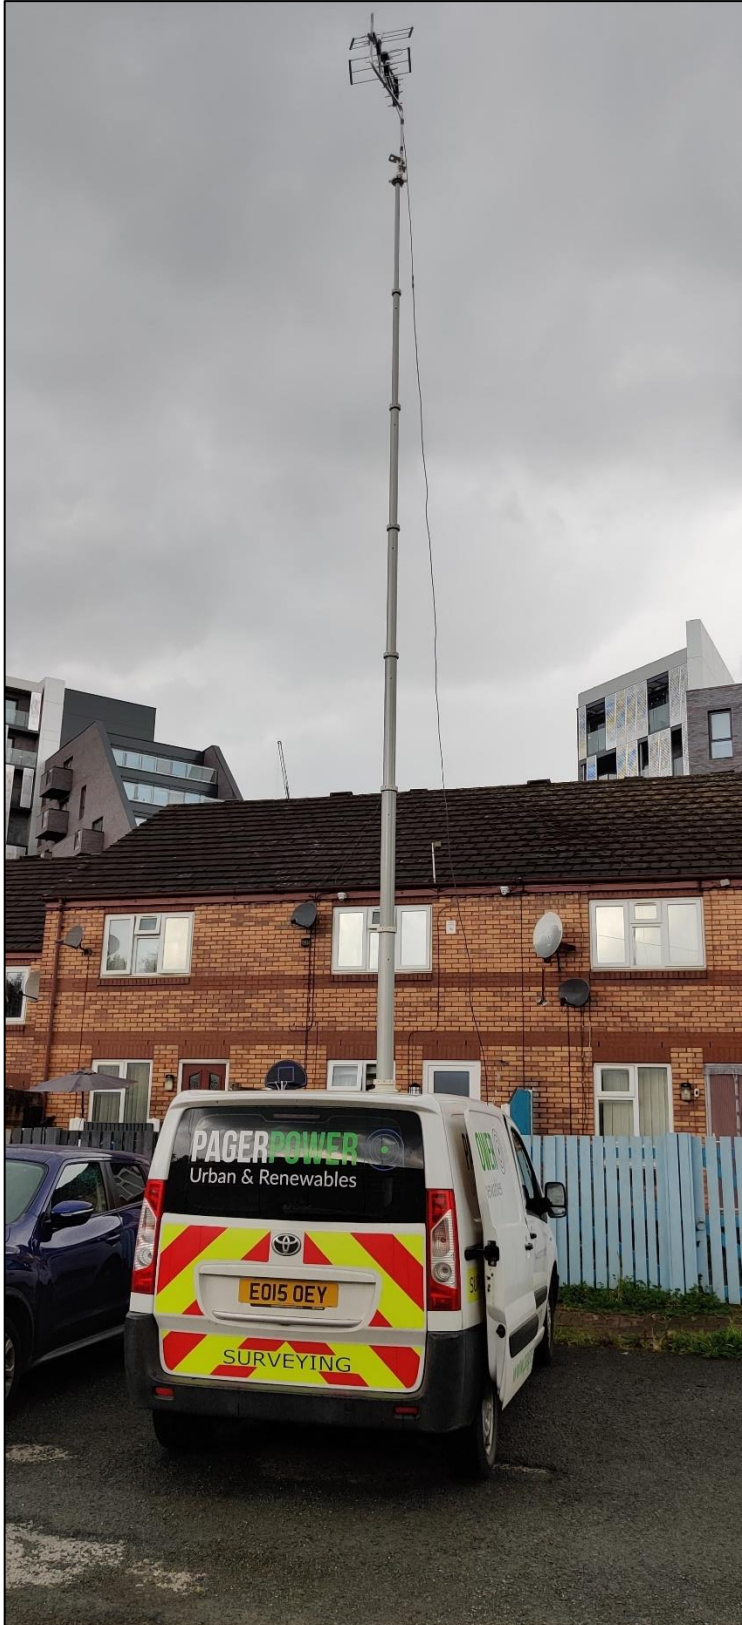
Location 5b

Notes: Multiple HP UHF aerial directed towards the Winter Hill transmitter was observed.  
Multiple satellite dishes were observed.

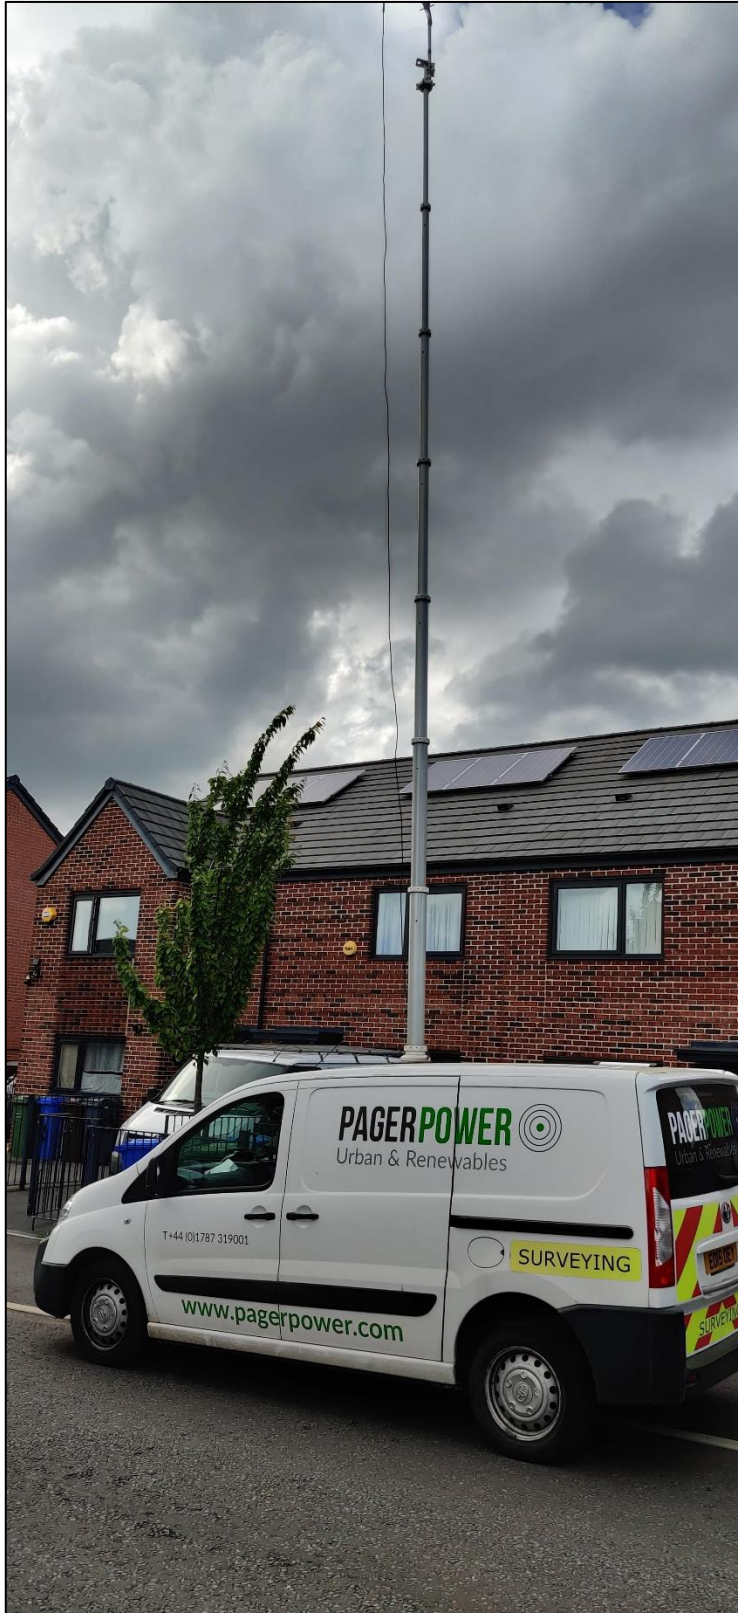
Location 6

Notes: One HP UHF aerial directed towards the Winter Hill transmitter was observed. Multiple satellite dishes were observed.

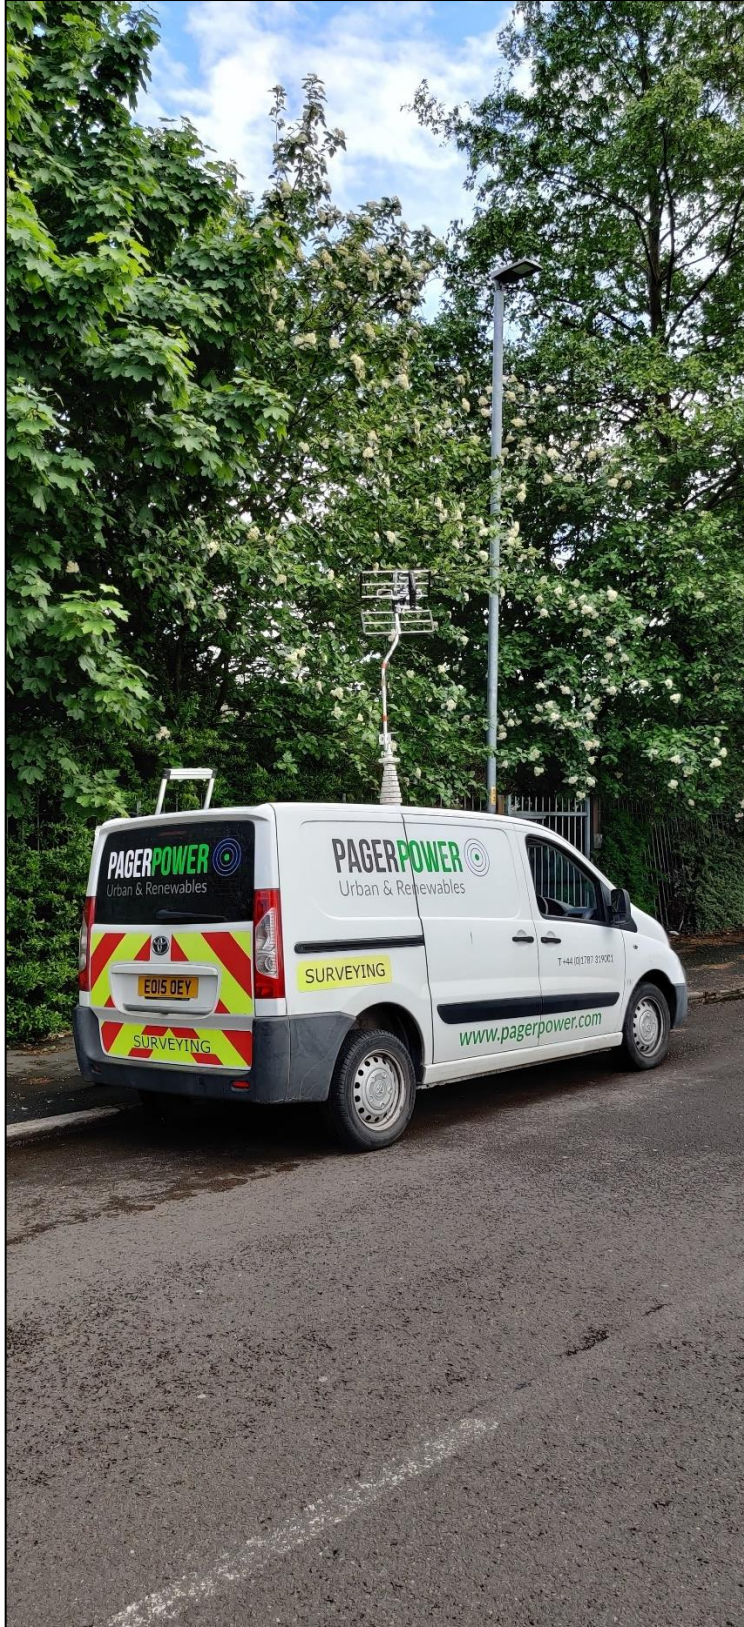
Location 7

Notes: Multiple HP UHF aerial directed towards the Winter Hill transmitter was observed.  
Multiple satellite dishes were observed.

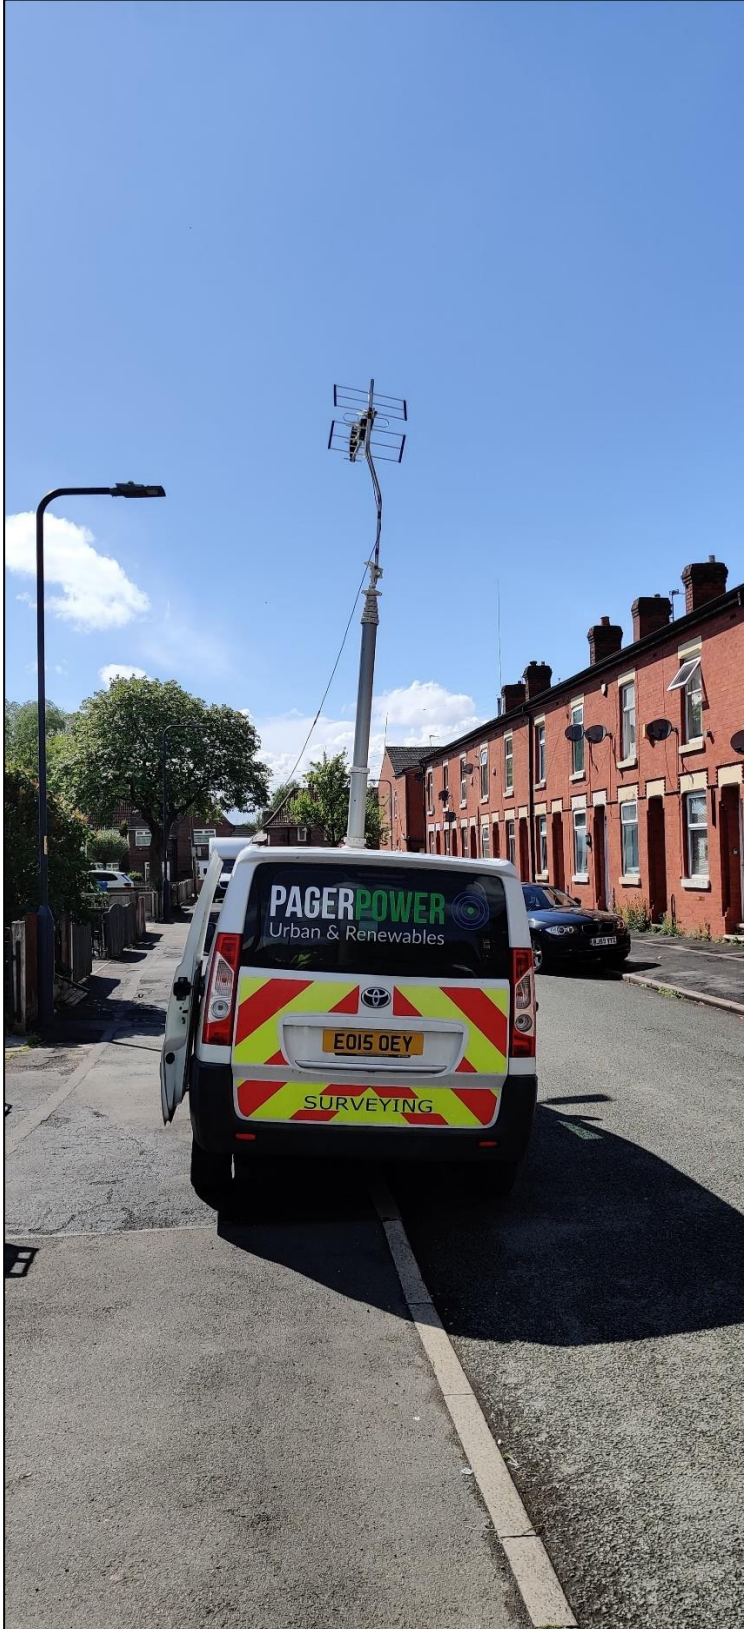
Location 8

Notes: Multiple HP UHF aerial directed towards the Winter Hill transmitter was observed.  
Multiple satellite dishes were observed.
