## PHASE 4 VALIDATION REPORT

## Phase 4: Validation Report Of Remediation

Location: Manchester Metropolitan University  
Lower Ormond Road, Manchester, M15 6BX.

Report No. C3757/24/E/7070

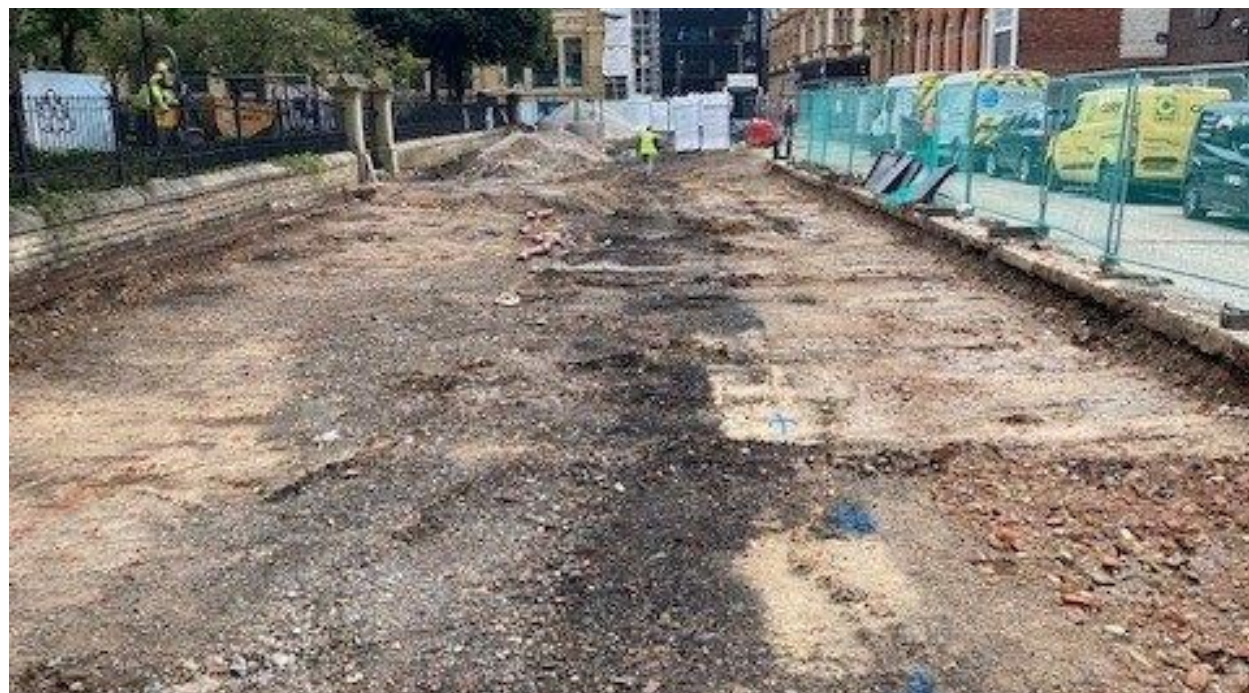
The site was observed reduced to formation level, in Photograph 1 some of the relict contaminated made ground can be observed as a dark grey to black material.

Photograph 1: Photograph of footpath reduced to formation level. Dark grey and black colouration of gravel denotes area of observed contamination to be remediated.

It is considered that the site has been suitably remediated to remove the pathway of contaminated material which was proven beneath the site. Photograph 1 shows that the material had been removed to a suitable depth and photographs 2, 3, and 4 indicate that this material has been suitably encapsulated beneath a permanent hardstanding. In addition to this a concrete screed reinforcement has been placed to support the road which will permanently fully sever any pathways from the surface and no further action is required.

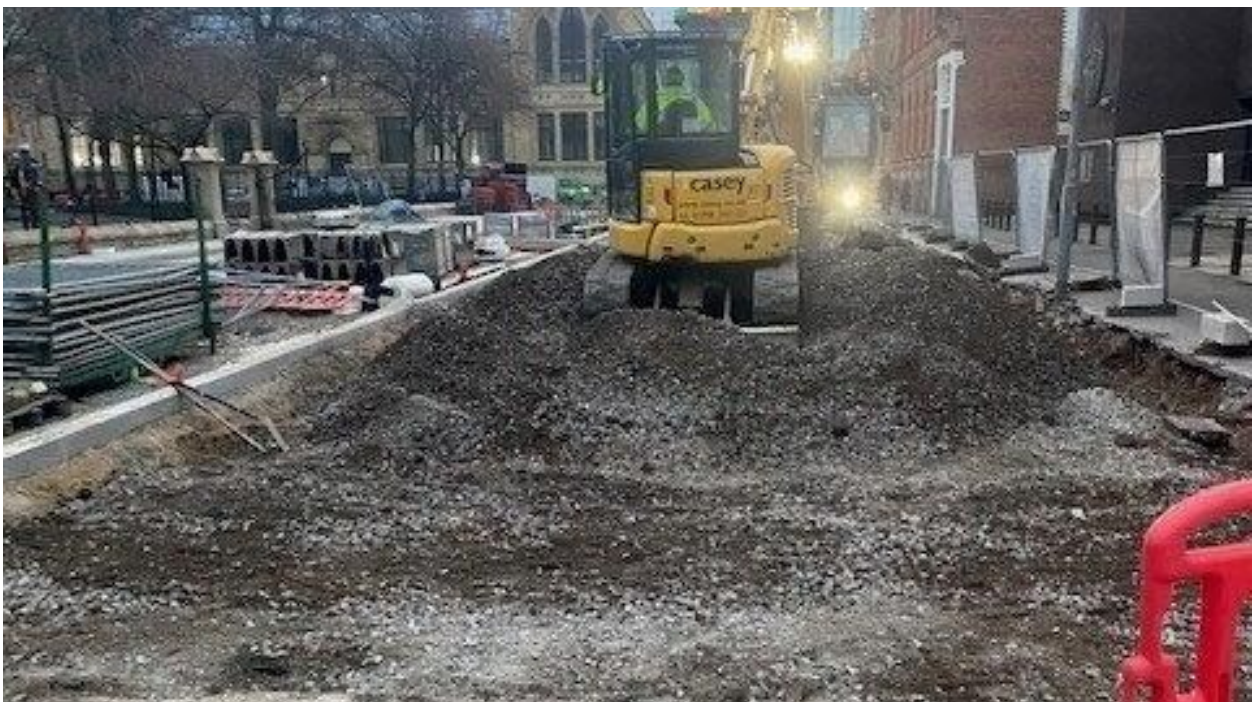
Photograph 2 shows the placement of the Type 1 material to act as sub-base, placed in two separate layers. This material was imported direct from Marchington Stone Quarry and placed in line with the specification of works. This was inspected to prior to placement and no obvious visual or olfactory contamination was observed in addition no readings were recorded on samples selected for headspace testing using a PID monitor.

Photograph 2: Photograph of stone being delivered to site and laid in accordance with series 800.

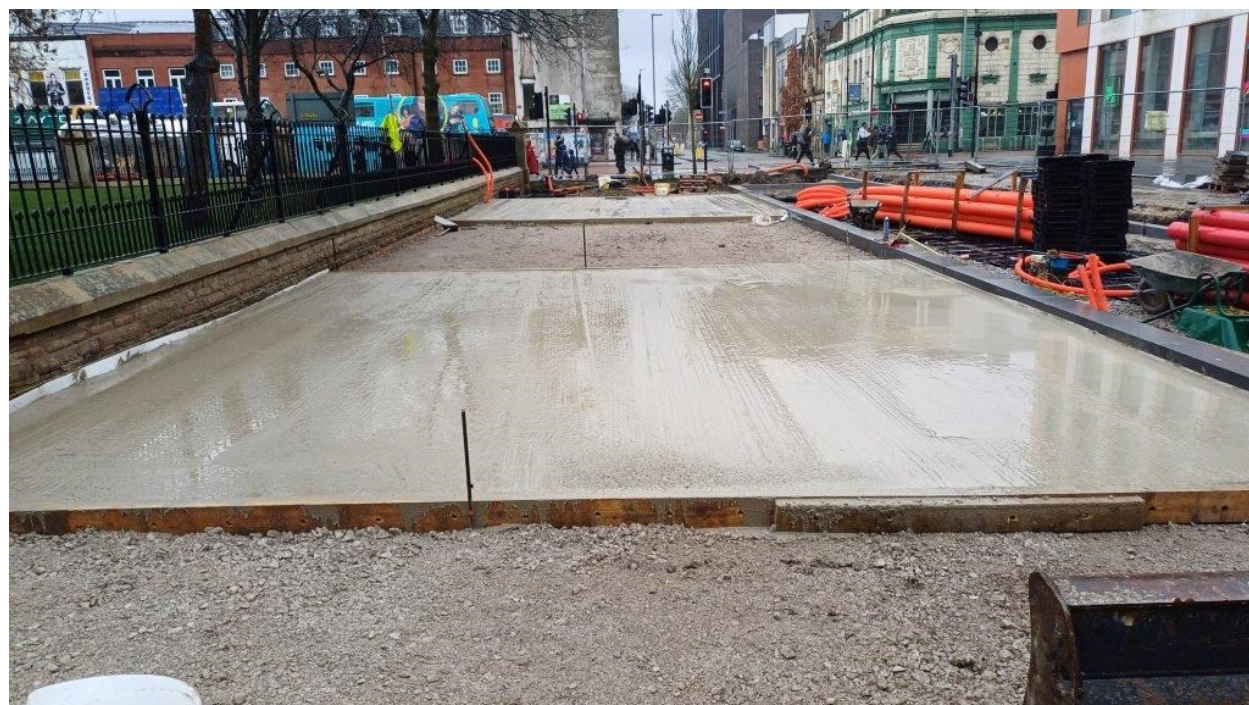
Photograph 3 shows the placement of the concrete base to act as a reinforcement course to the paving surface, and Photograph 4 shows the final construction of the footpath.

Photograph 3: Construction of concrete base course place on top of type 1 and residual contamination fully encapsulated
