## ONE VICTORIA, Great Ducie Street Snagging Timeline and Final Sample Panel Photographs

6th August 2024

## 28<sup>th</sup> August 2024

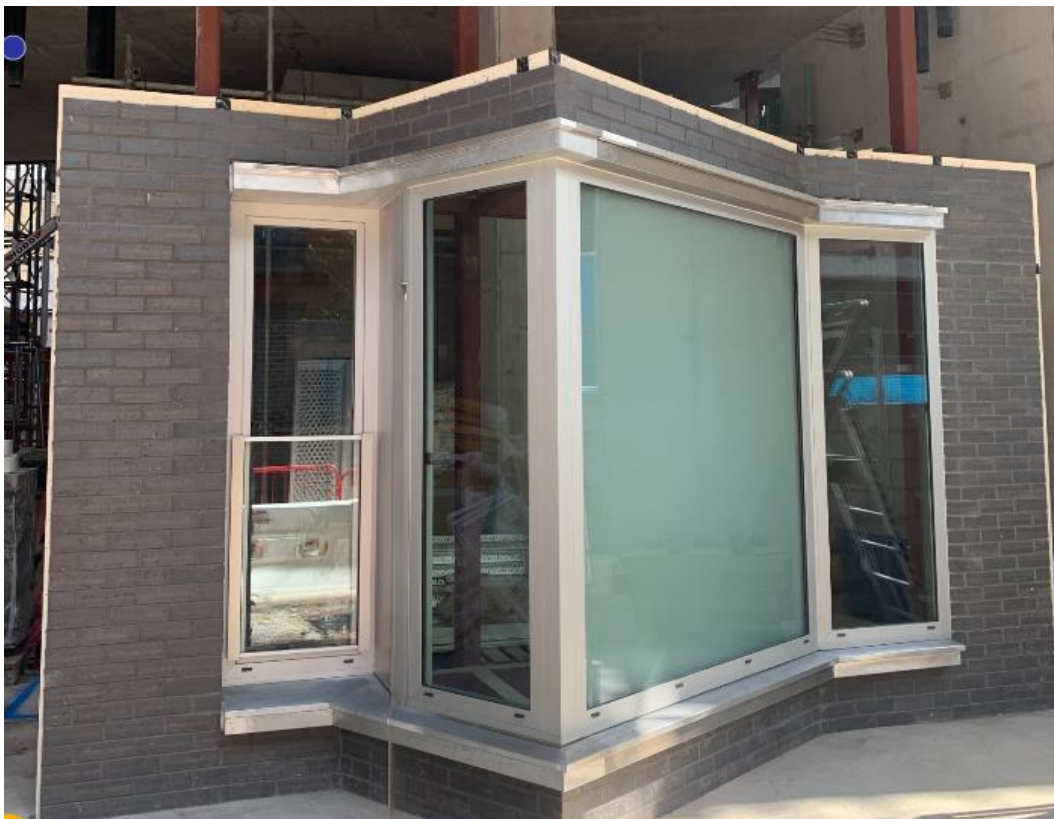
Sample panel 02: Sawtooth bay details

Sample panel 02 was presented to MCC with window sill and head flashings formed in mill finished aluminium as previously agreed with MCC. DAY confirmed that the main facades are to be installed in anodised aluminium 100A to match the surrounding windows and approved materials palette.

MCC visual inspection highlighted the following observations which require further works to bring the sample panel in line with the case officers expectations.

- Better control of joint alignment is required to all joints with particular attention drawn to the window head external corner and the window sill internal corner. Please refer to photo 1 and 02 below highlighting the details in question.
- Better control of joint alignment is required to the right-hand window jamb to eliminate wide mastic joints. Please refer to photo 1 and 02 below highlighting the details in question.
- Mastic joints, to be finished in black at interface with the surrounding brickwork. Mastic pointing to be controlled to prevent bleeding into the masonry and mortar joints (see photo 03)
- Mastic joints between aluminium panels to be finished in grey as presented. Mastic pointing to be controlled to prevent bleeding into other surrounding finishes.

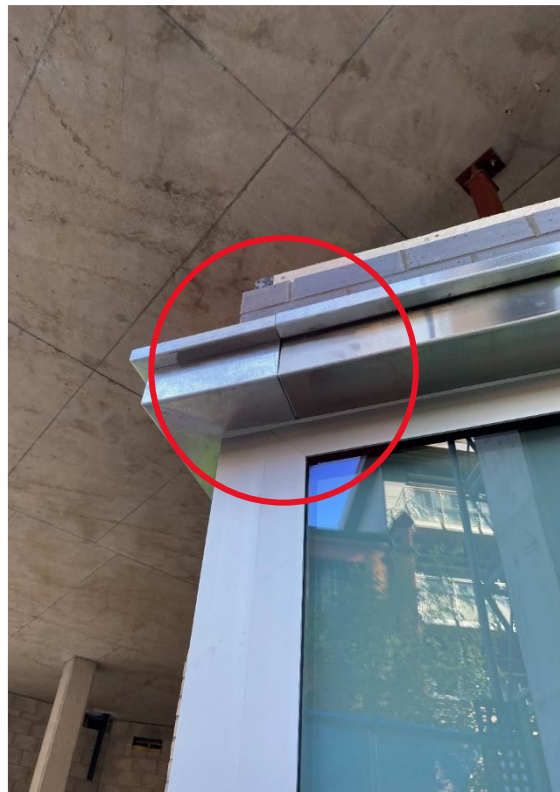
#### Sample panel 02: Image 01

Head flashing out of alignment. Capping detail to be brought into alignment with adjacent panel and drip interface.

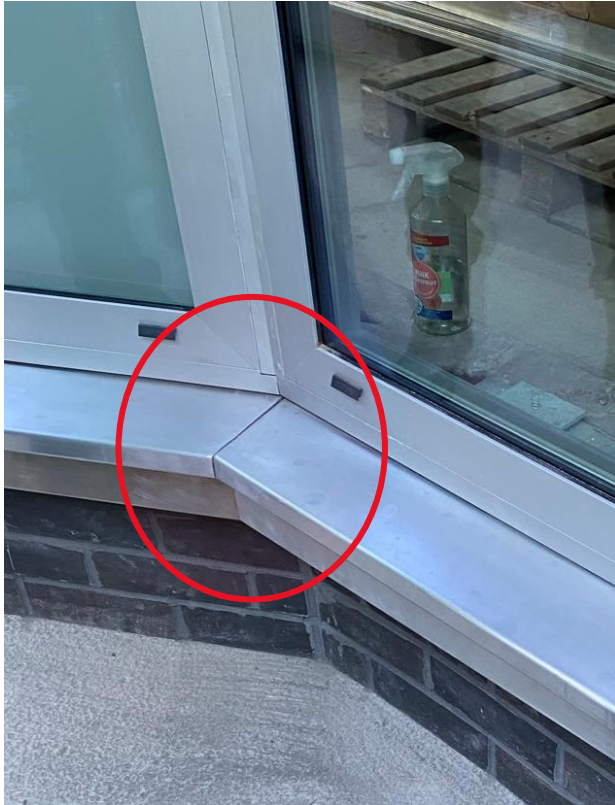
Sample panel 02: Image 02

Cut joint in sill flashing to be "clean" and within alignment with adjacent panel.

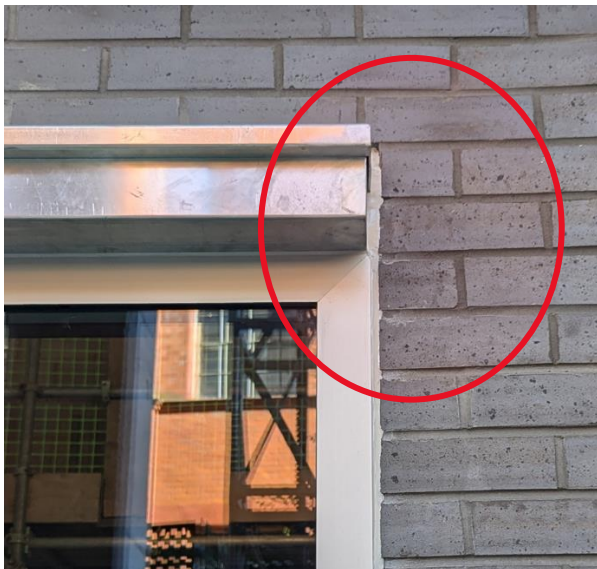
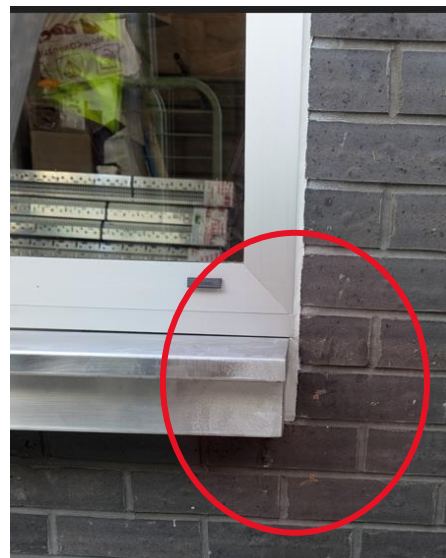
Sample panel 02: Image 03 and 04

Alignment of sill flashing to window jamb to be brought into alignment.

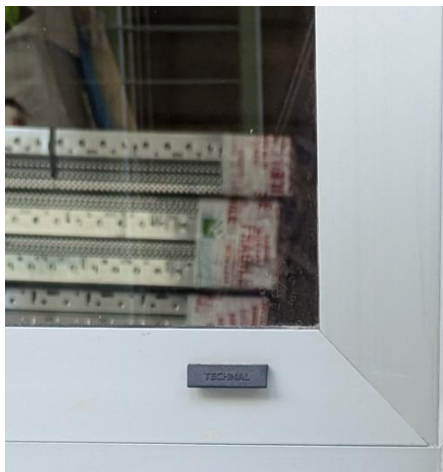
Photo 05

An additional request was made for DAY to review alternate colour options for the window drain hole cover caps. Discussions with the supplier has identified the following options:

- I. Remove black drain hole cover caps and leave drainage weep vent open (see photo 05 and 06 below for comparison)
- II. Provide a bespoke painted finish to the drain hole cover caps to closely match the finish of the windows. DAY are seeking clarification on the longevity and warranty surrounding the applied paint finish when applied over the plastic drain caps. If the drainage caps can not be warranted by the supplier an alternate solution will need to be discussed with all parties.

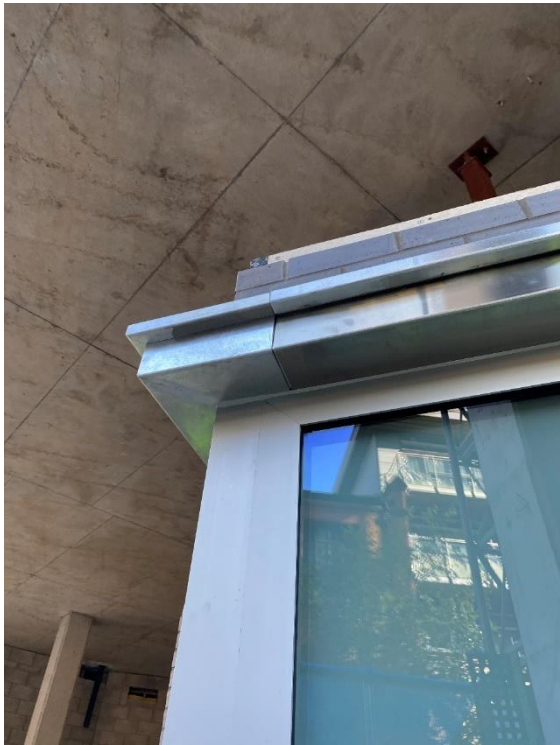
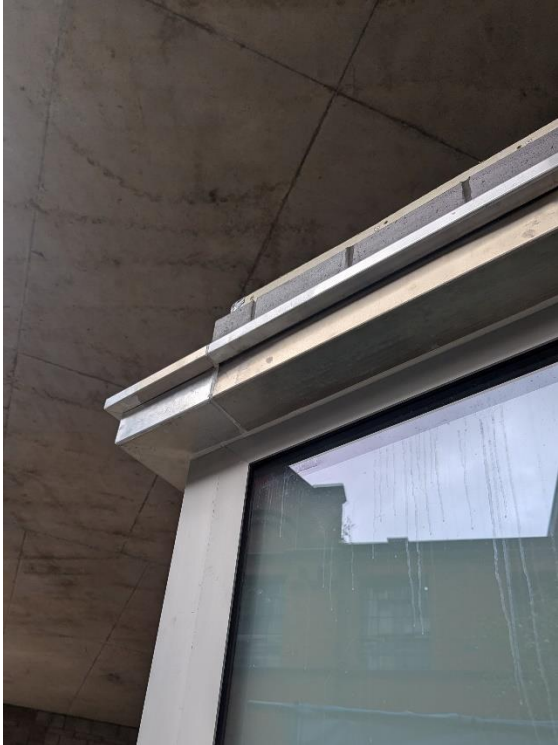
### REMEDIATION 1

Head flashing out of alignment. Capping detail to be brought into alignment with adjacent panel and drip interface.

| Inspection of works 08.08.24 | Inspection of works 21.08.24 |
|---|---|
| | <p data-bbox="890 1599 1420 1760">Panel has been realigned and joint between panels has been infilled with grey mastic to match mastic used around frame.</p> |

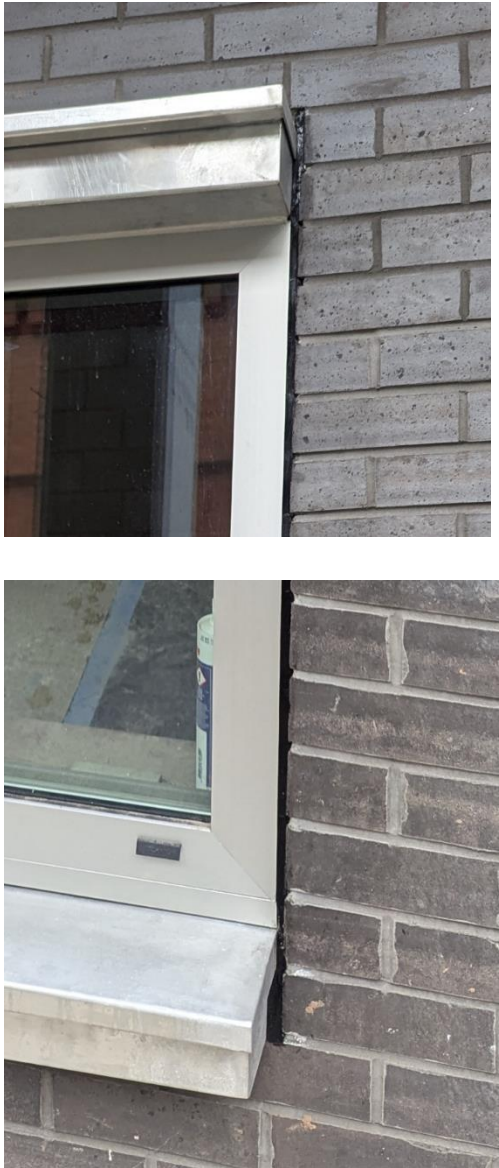
## REMEDIATION 2

Better control of joint alignment is required to the window jamb to eliminate wide mastic joints.

| Inspection of works 08.08.24 | Inspection of works 21.08.24 |
|---|---|
| | <p data-bbox="831 1765 1390 1843">Panels now aligned with mastic replaced in black as requested by MCC.</p> |

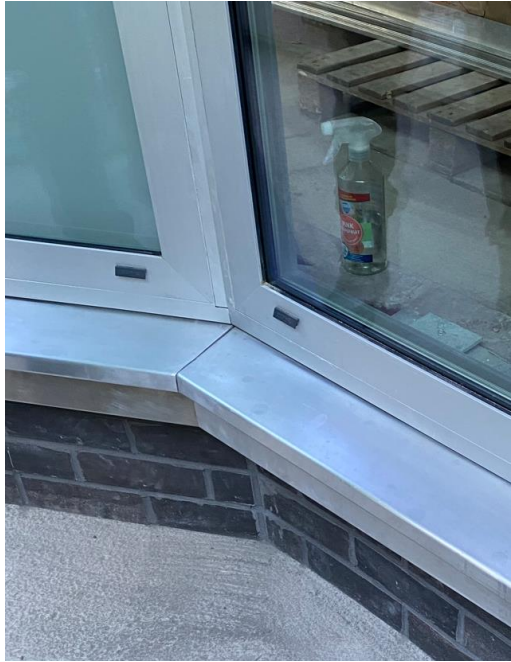
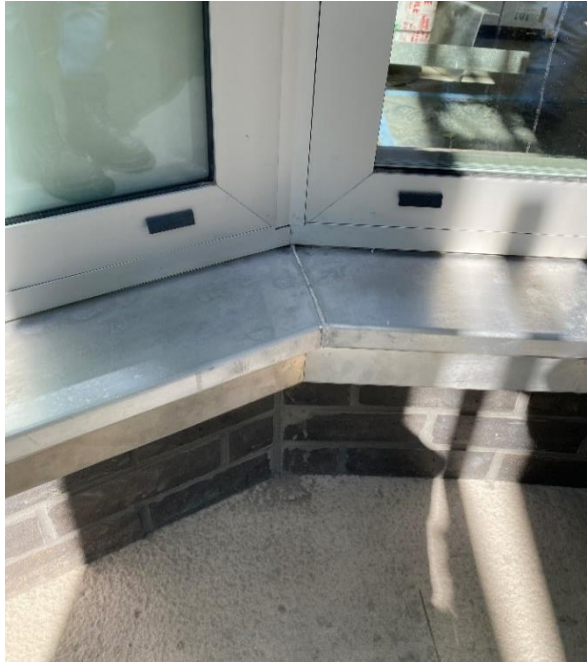
### REMEDIATION 3

Cut joint in sill flashing to be “clean” and within alignment with adjacent panel.

| Inspection of works 08.08.24 | Inspection of works 21.08.24 |
|---|---|
| | <p data-bbox="849 1218 1426 1294">Tolerance between joints better aligned and treated with colour matched mastic.</p> |

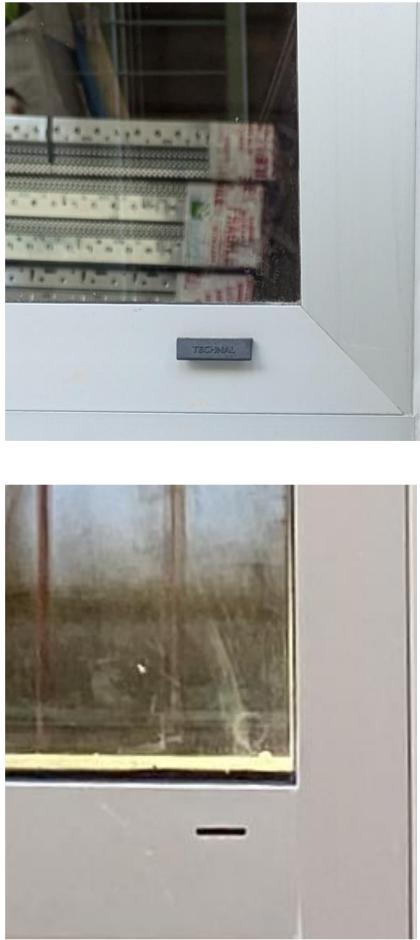
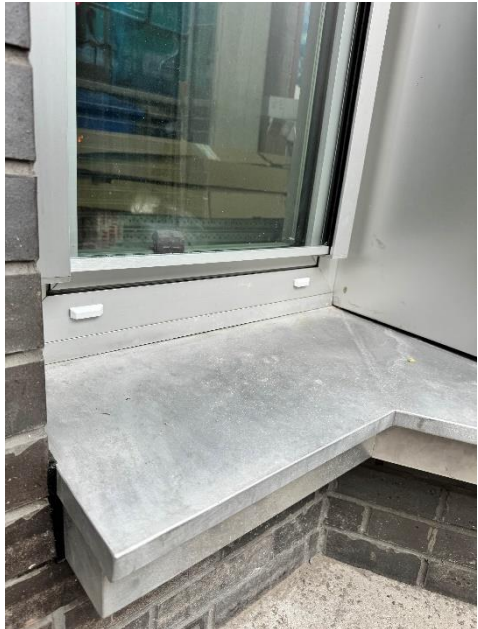
## REMEDICATION 4

Additional request for grey window drain hole cover caps.

For context, the windows at One Victoria are an 'FZ' system, the windows at Fairfax are an 'FY' system. Technal are the window manufacturer for both schemes. Technal only supply white or black cover caps for the 'FZ' system (used at One Victoria).

Unable to source the caps from the manufacturer, our window supplier have sourced a plastic injection company that have created a drainage cap to match our natural silver anodised window. 5 sample caps have been installed onto the sample panel as shown in the photograph below.

| Inspection of works 08.08.24 | Inspection of works 22.08.24 |
|---|---|
| | <p data-bbox="858 1518 1315 1599">Drainage caps matching natural silver anodised window.</p> |
