# Coal Mining Site Investigation & Risk Assessment

Site: Pitsford Road, Manchester

Reference: 17-302-R3-1

Date: August 24

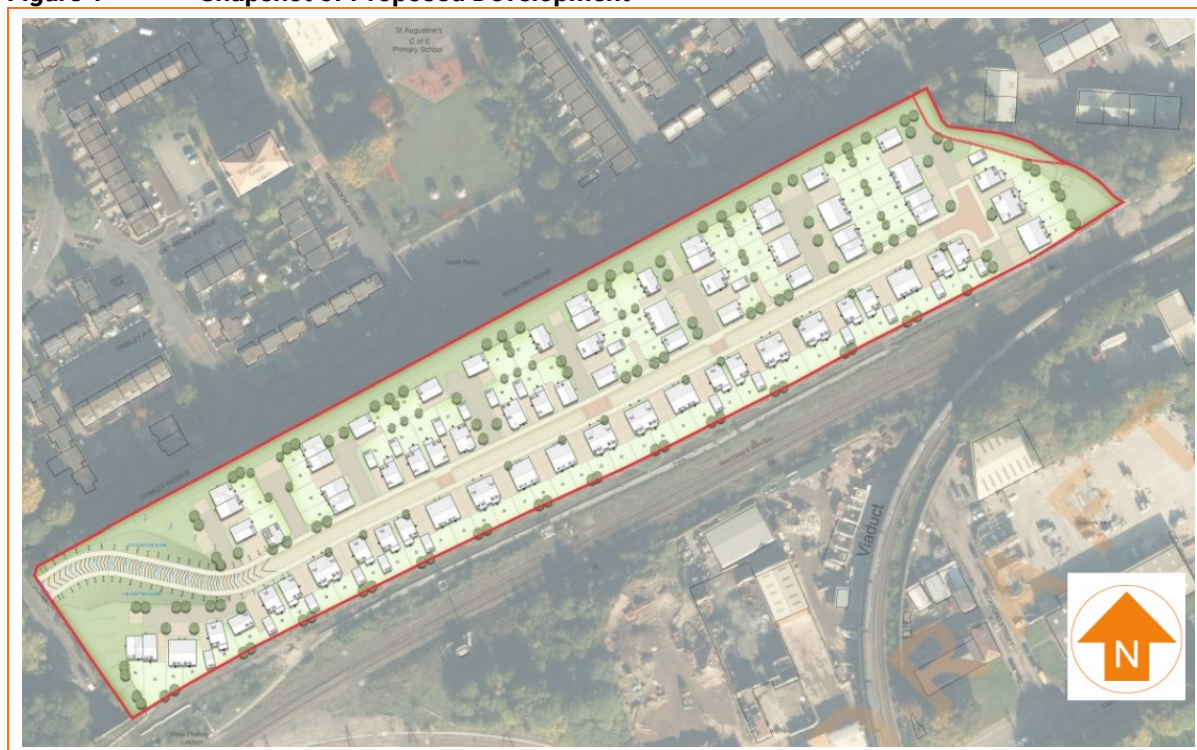
**Figure 1** Snapshot of Proposed Development

A snapshot of the Proposed Development Layout is indicated in Figure 1.

Bellway Homes intends to construct a low-rise residential development with associated gardens, estate roads and infrastructure. Drawing 17-302-002 (Appendix IV) identifies the proposed development layout.

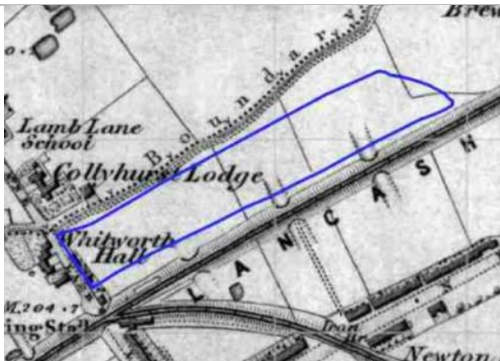
| MAP EDITION | HISTORICAL LAND USE | HISTORICAL MAP EXCERPT |
|---|---|---|
| <b>1848</b><br><b>1:10,560</b> | The site consists of agricultural land adjacent to the Lancashire and Yorkshire Railway Line. | |

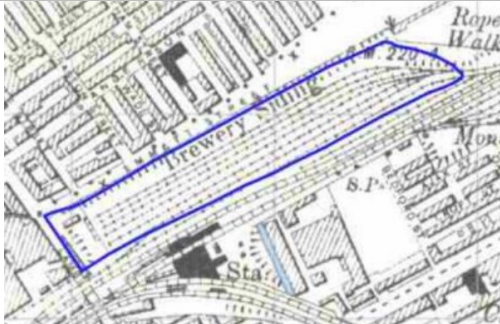
| MAP EDITION | HISTORICAL LAND USE | HISTORICAL MAP EXCERPT |
|---|---|---|
| <b>1891</b><br><b>1:10,560</b> | The site has been developed into Brewery Sidings with associated buildings in the southwest.<br><br>Markings also suggest the presence of embankments to the north and west of the sidings.<br><br>A structure is present in the west of the site. | |

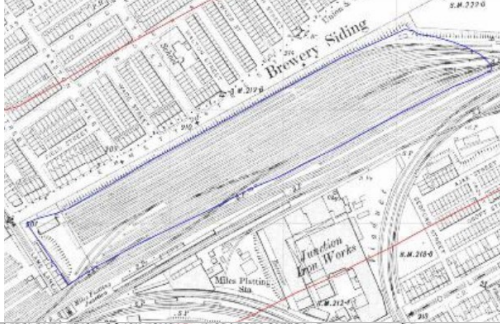
| MAP EDITION | HISTORICAL LAND USE | HISTORICAL MAP EXCERPT |
|---|---|---|
| <b>1908</b><br><b>1:2,500</b> | Further sidings have been added to the north with associated ground levelling.<br><br>A small structure has been added in the north, along with redevelopment of lines in the south of the site. | |

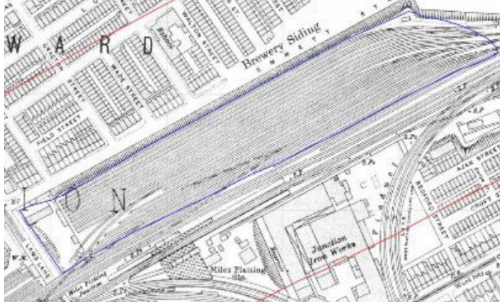
| MAP EDITION | HISTORICAL LAND USE | HISTORICAL MAP EXCERPT |
|---|---|---|
| <b>1922</b><br><b>1:2,500</b> | A structure has been added in the southwest of the site. | |

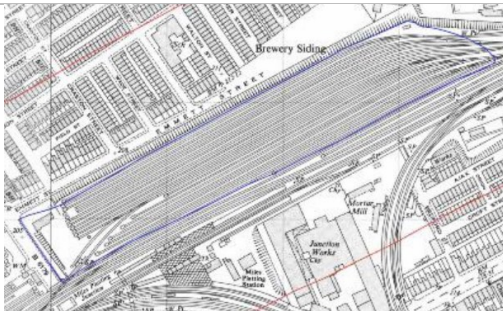
| MAP EDITION | HISTORICAL LAND USE | HISTORICAL MAP EXCERPT |
|---|---|---|
| <b>1949-1950</b><br><b>1:2,500</b> | Small structures in the southwest of the site have been removed. | |

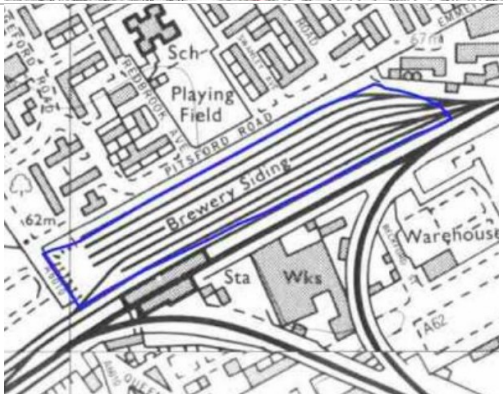
| MAP EDITION | HISTORICAL LAND USE | HISTORICAL MAP EXCERPT |
|---|---|---|
| <b>1980-1985</b><br><b>1:10,000</b> | No changes recorded. | |

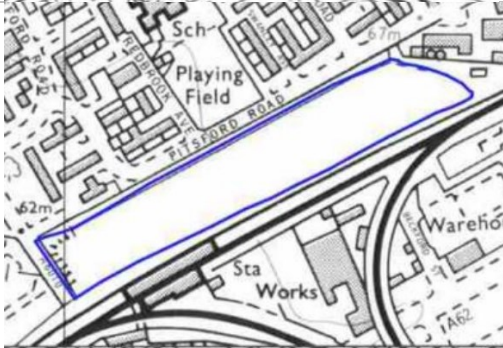
| MAP EDITION | HISTORICAL LAND USE | HISTORICAL MAP EXCERPT |
|---|---|---|
| <b>1985-1988</b><br><b>1:10,000</b> | Railway sidings and associated small structures have been removed.<br><br>An embankment is still noted to the west. | |

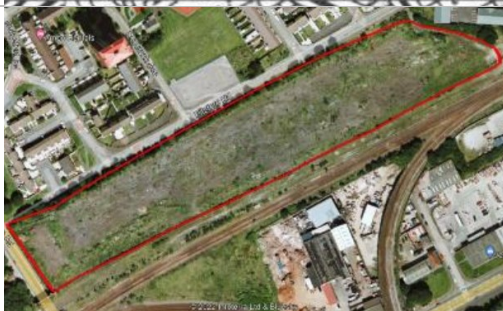
| MAP EDITION | HISTORICAL LAND USE | HISTORICAL MAP EXCERPT |
|---|---|---|
| <b>2003</b><br><b>Aerial</b><br><b>Imagery</b> | Aerial imagery indicates that the land has become partially overgrown with self-seeding vegetation. | |

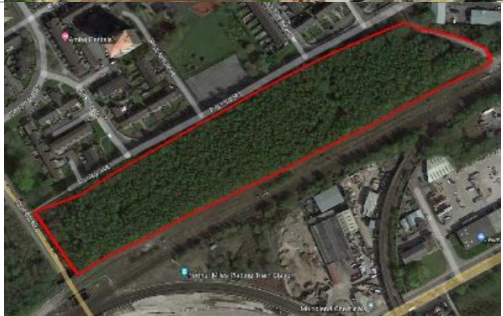
| MAP EDITION | HISTORICAL LAND USE | HISTORICAL MAP EXCERPT |
|---|---|---|
| <b>2021</b><br><b>Aerial</b><br><b>Imagery</b> | Vegetation is shown to be dense across the site. | |

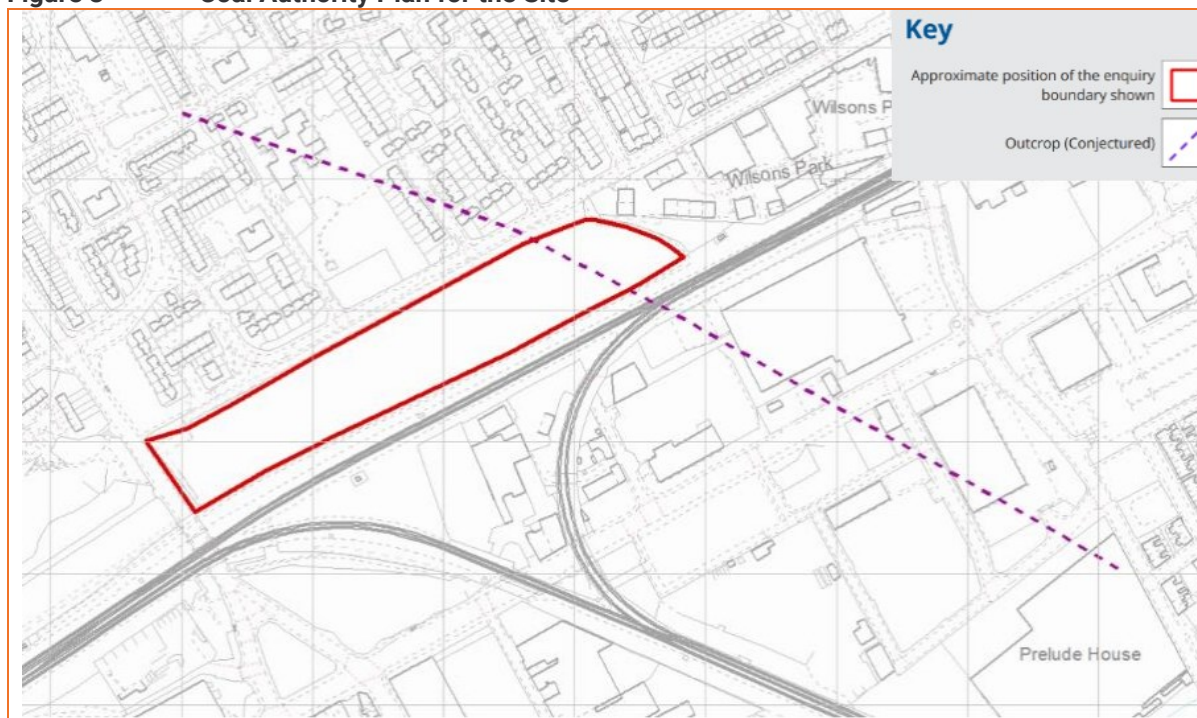
**Figure 3** Coal Authority Plan for the Site

The Coal Authority plan referenced: shows the conjectured coal seam beneath the site and this is presented in Figure 3.

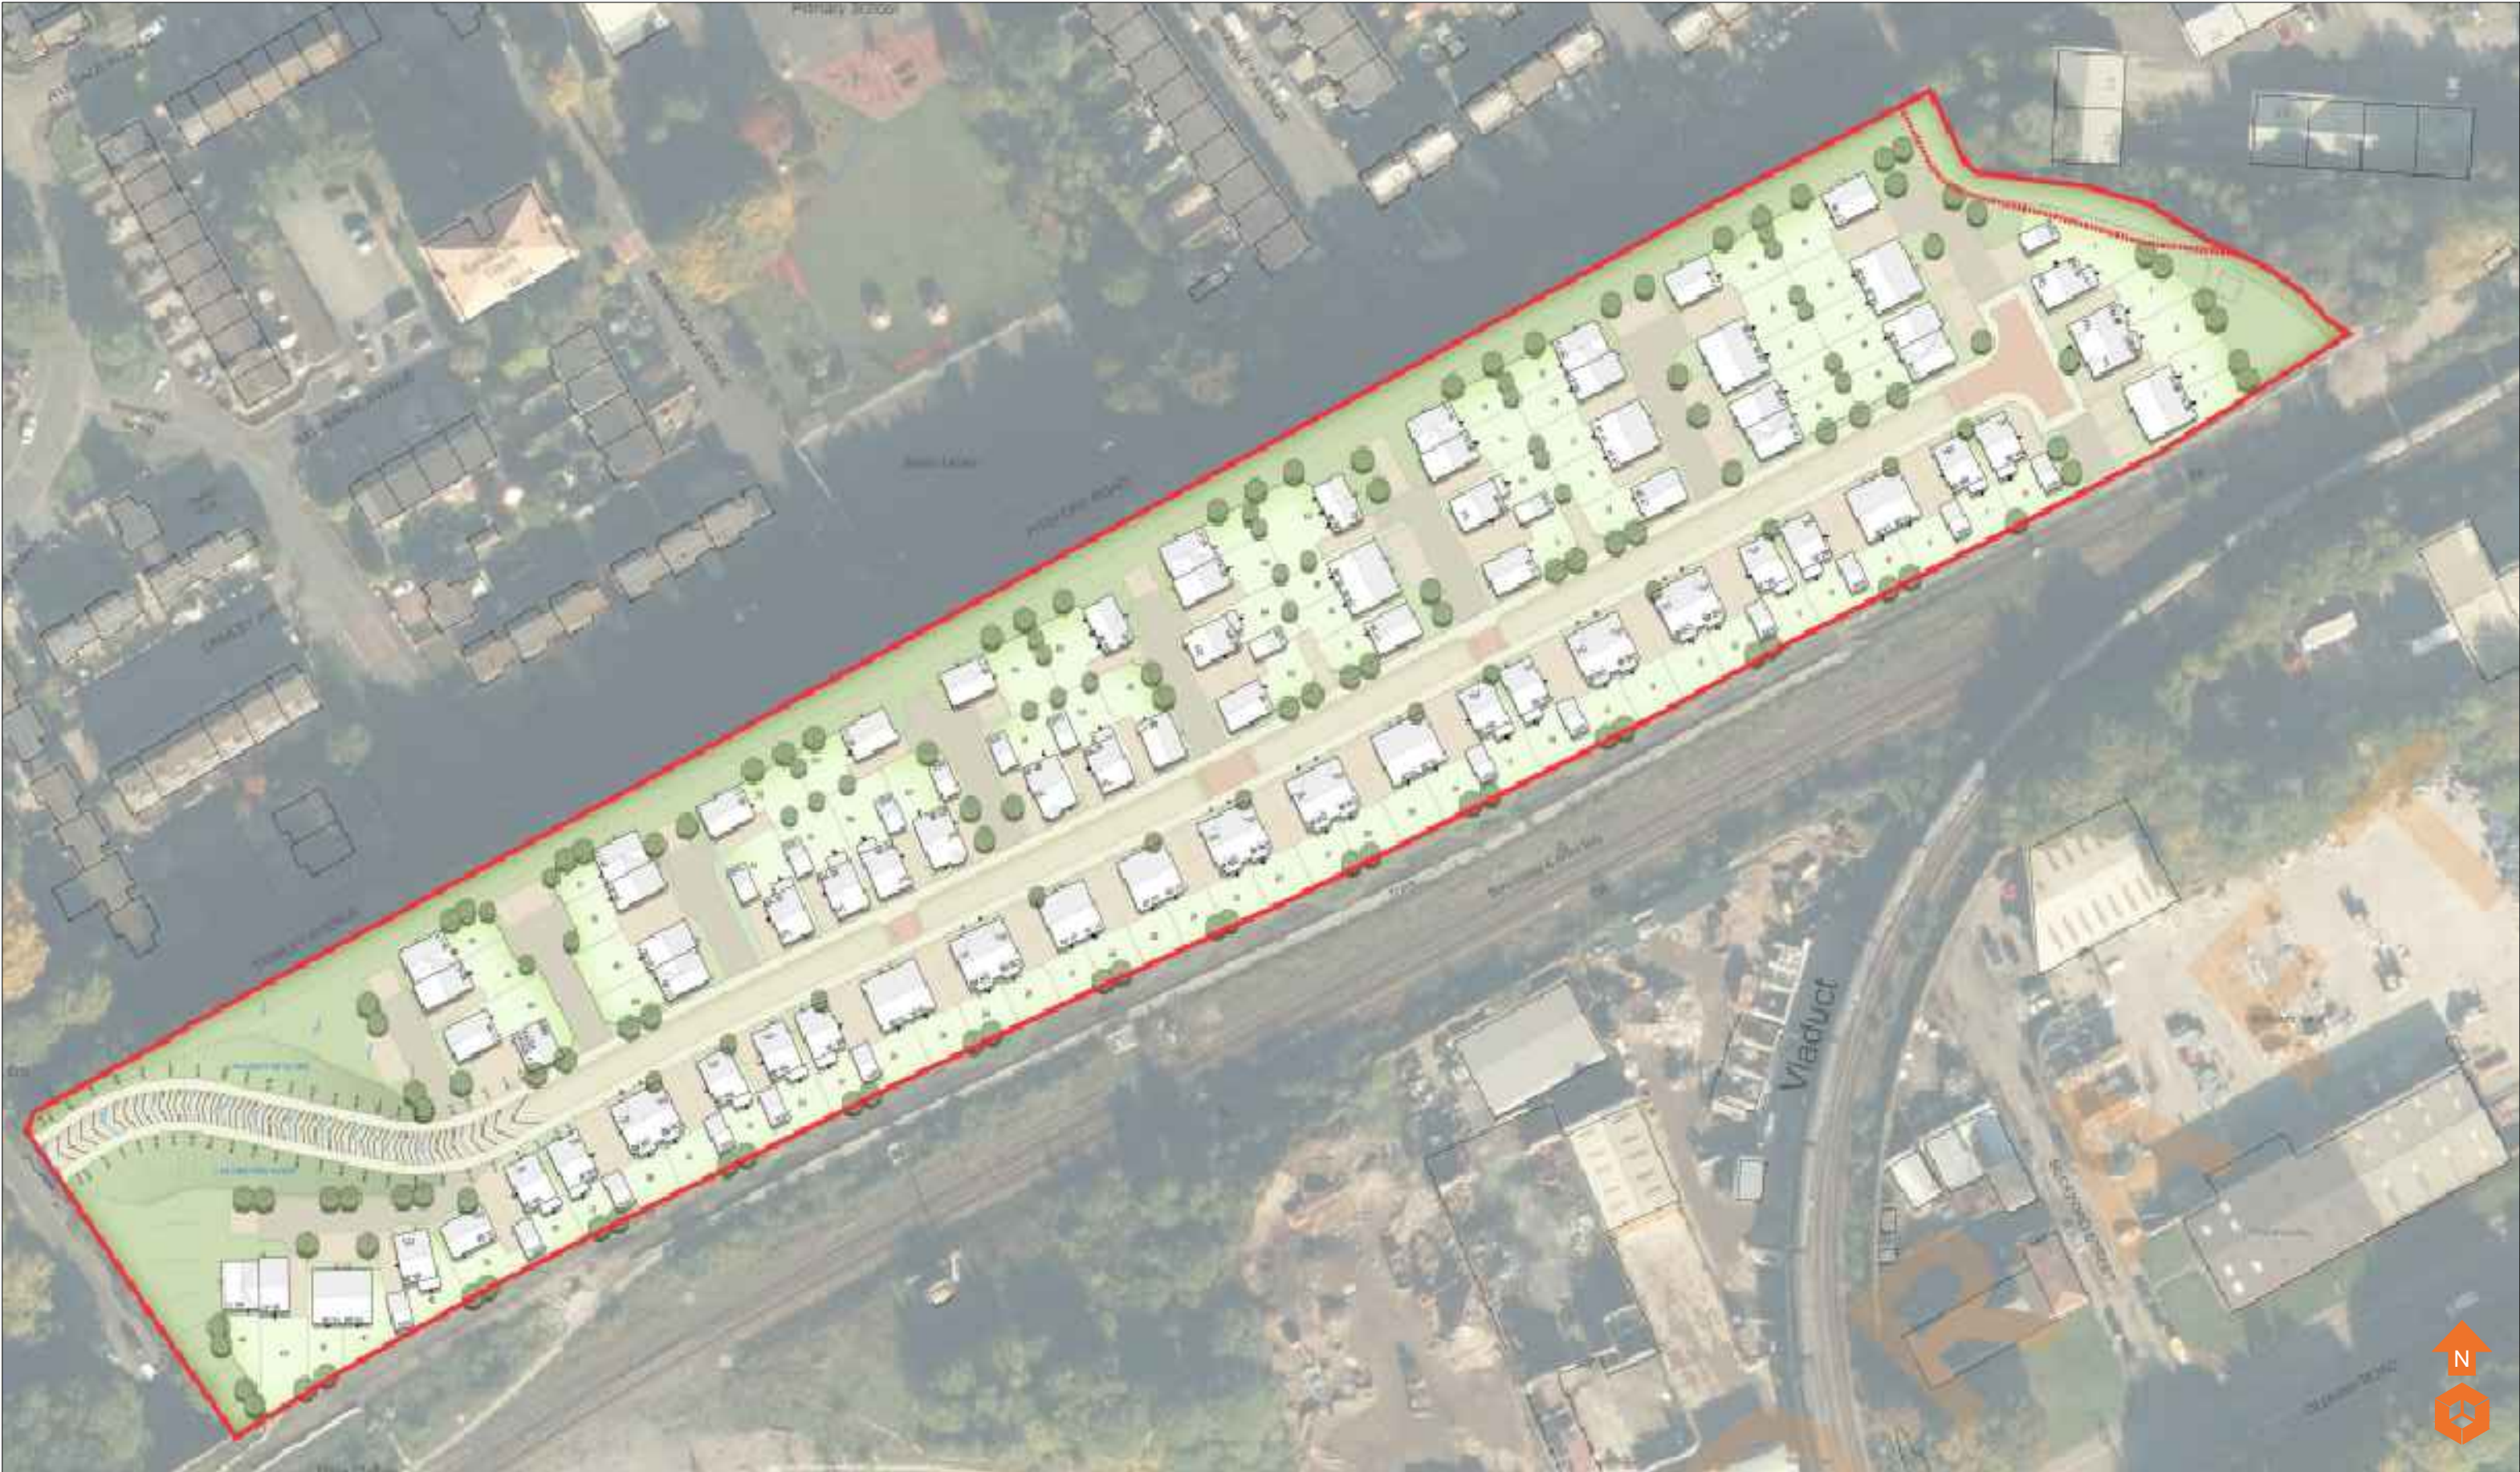
| P1 | REVA | 11.04.2024 | OW | HM | ND | Job Title: | Pitsford Road, Manchester | Drawing Title: | Proposed Development Plan | The client must not amend any drawing, design or other intellectual property produced by E3P Ltd without permission in writing from E3P Ltd in advance of any amendments being made. In the event that such written permission is not obtained in advance of the amendments being made, E3P Ltd shall not be liable for any damage and/or losses occurring as a result of the amended drawing, design or intellectual property. |

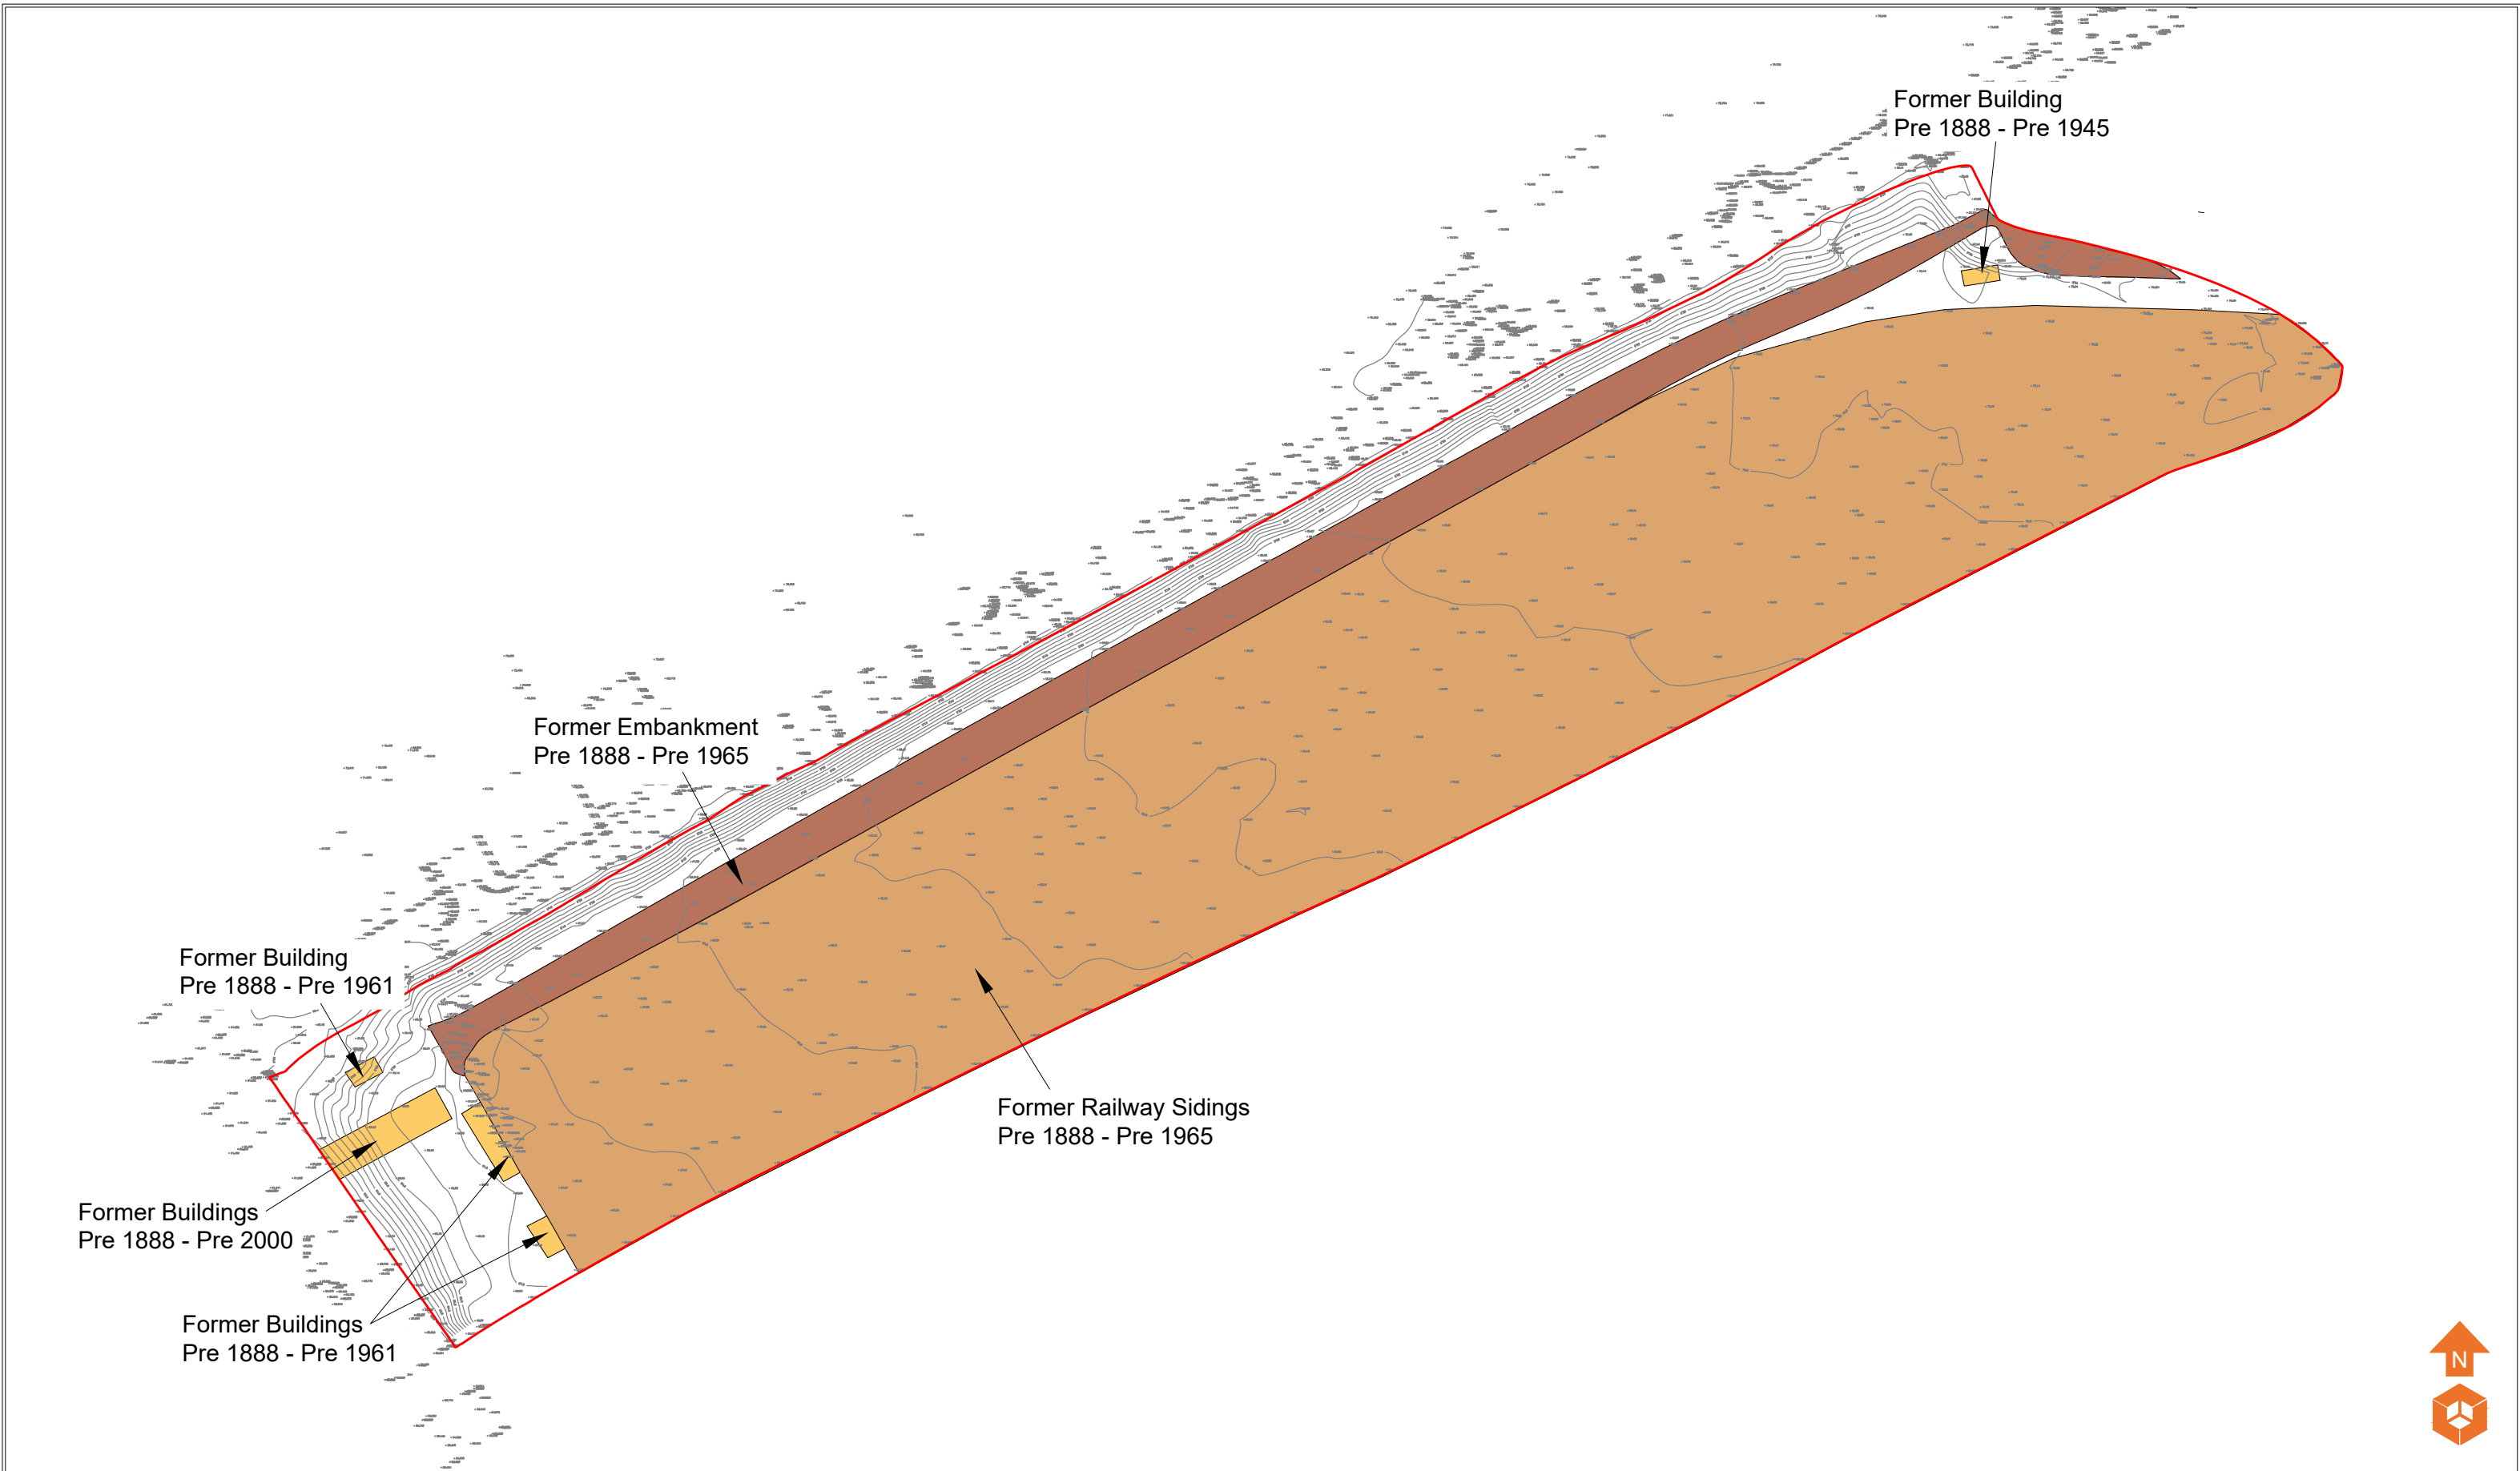
Historical Features

- Former Buildings
- Former Railway Sidings
- Former Embankment

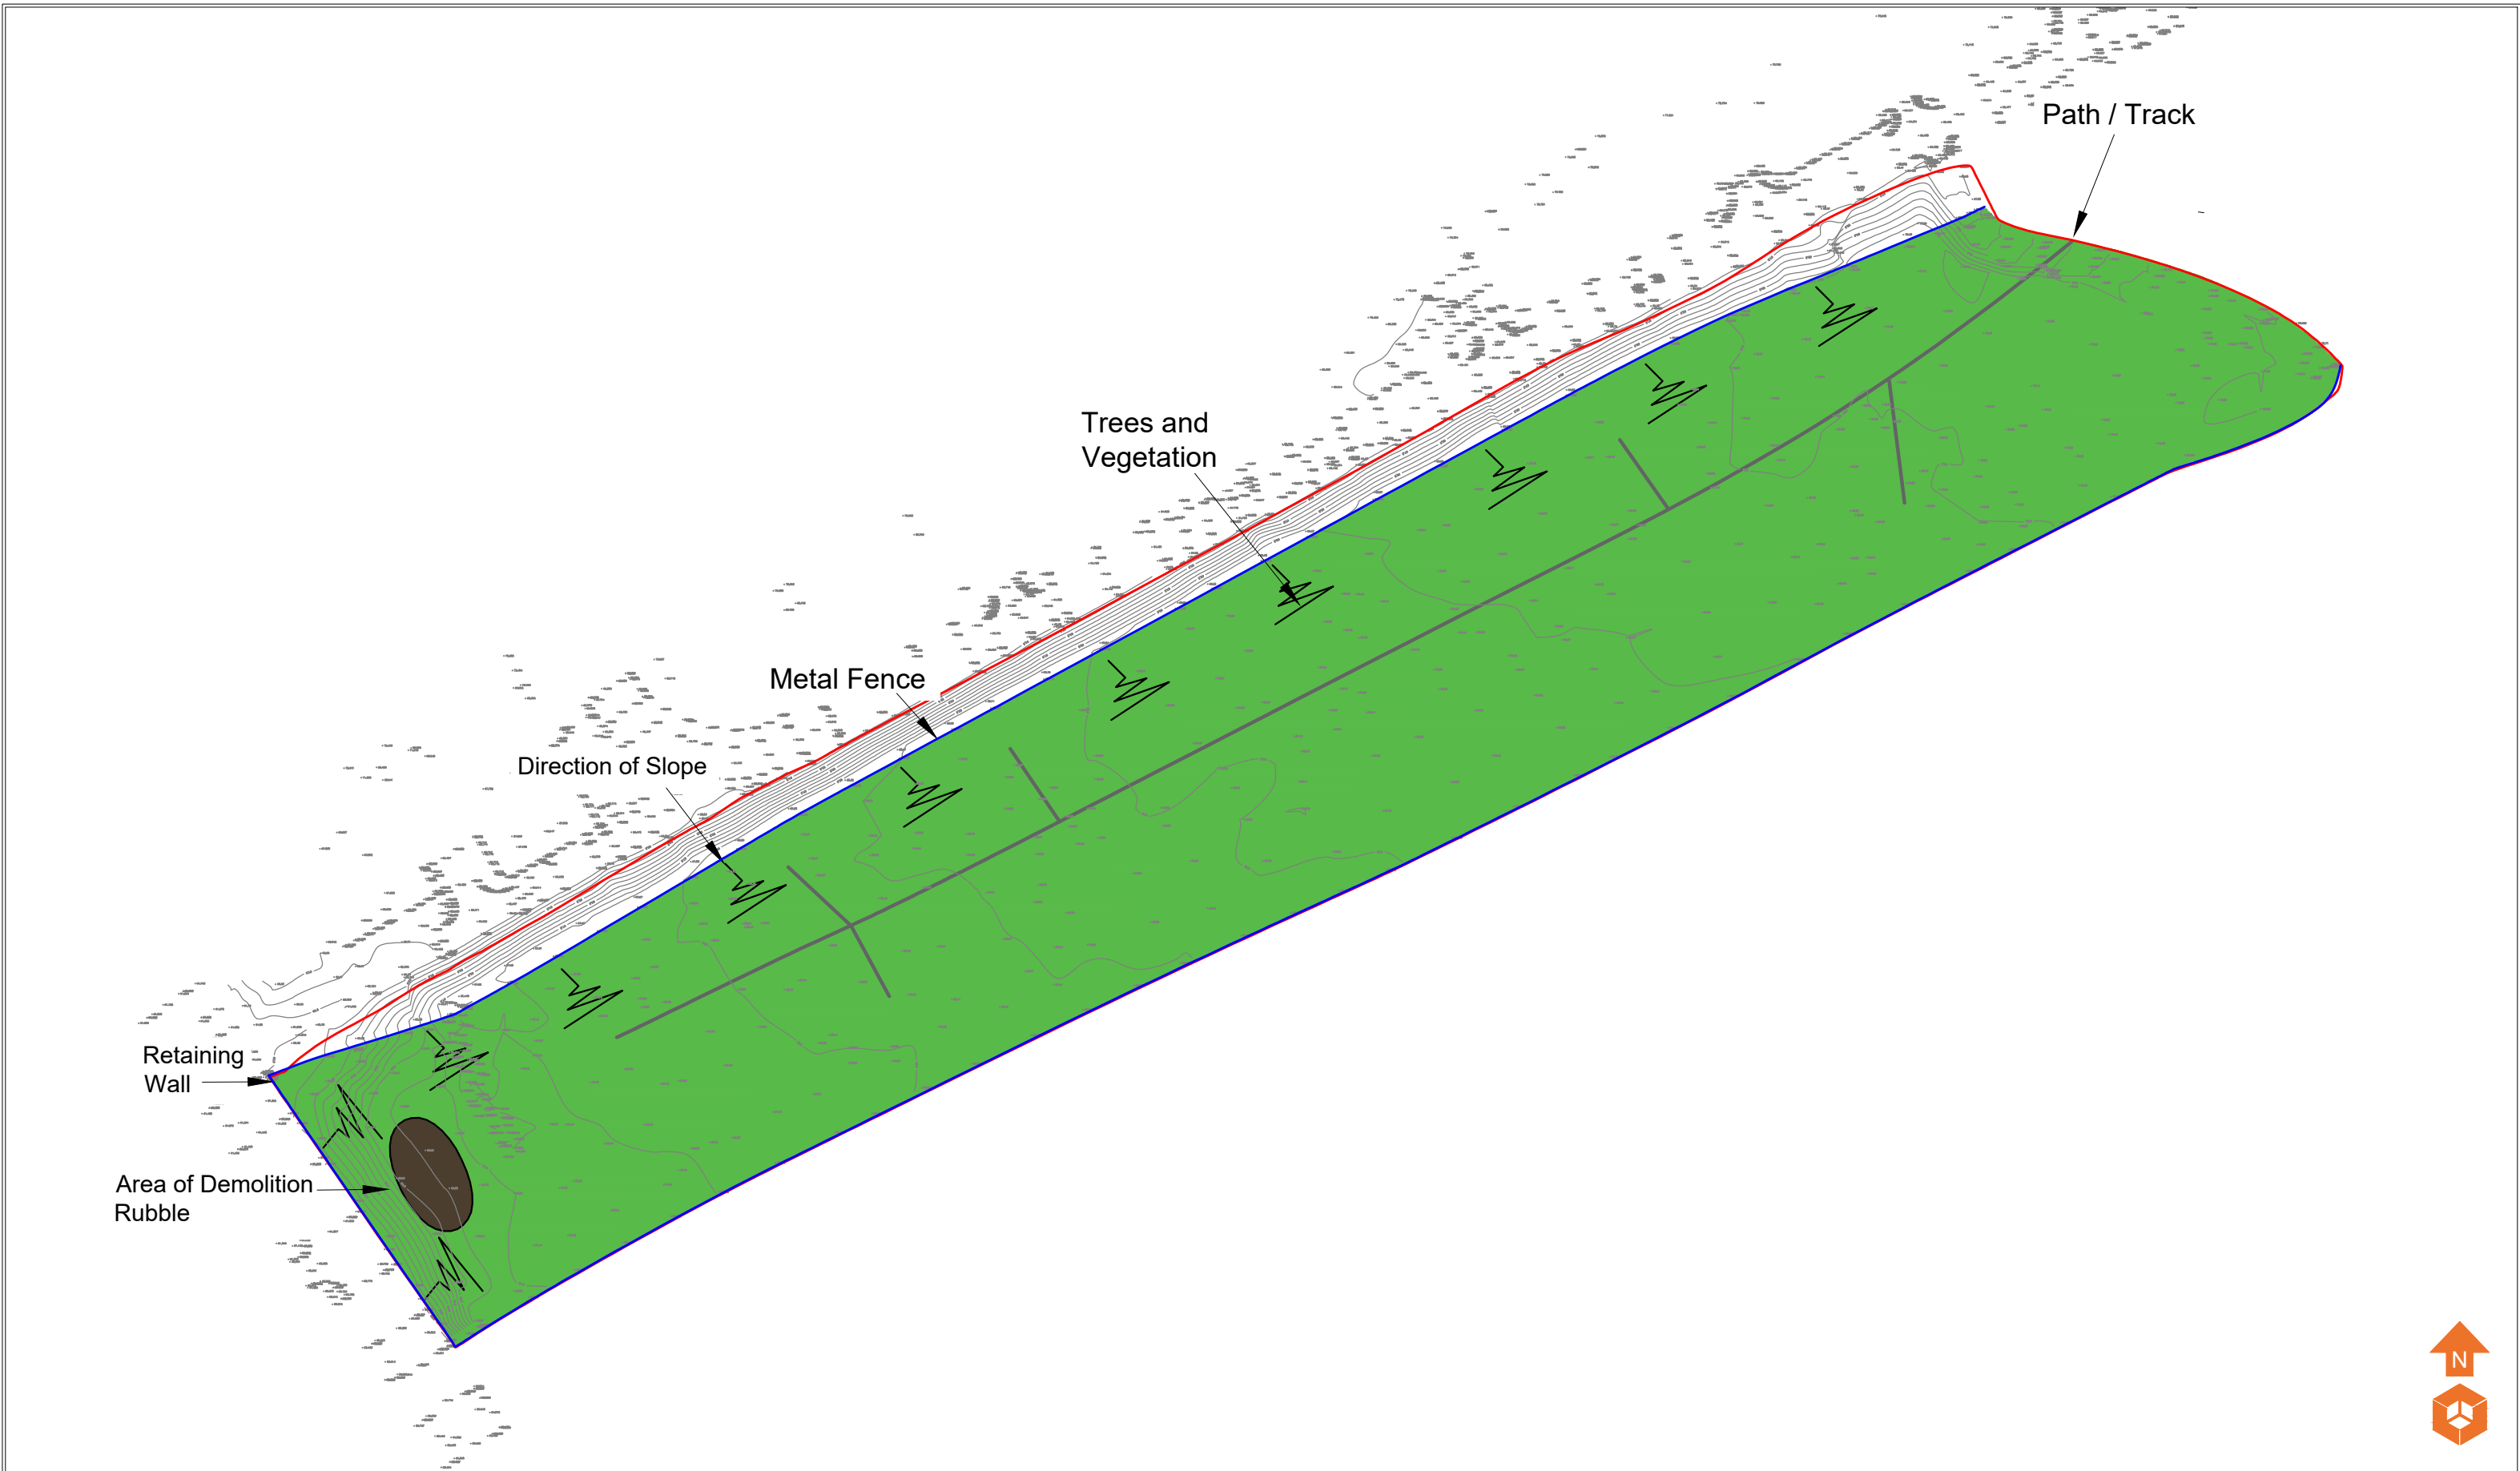
Site Features

- Trees and Vegetation
- Path and Track
- Metal Fence
- Retaining Wall
- Knotweed
- Demolition Rubble
- Slope Direction

| <b>Retaining Structures</b> | There is an approximately 3.00m brick wall forming the western boundary of the subject site that acts as a retaining wall for the site and Queens Road. The wall is showing some evidence of cracking. | |

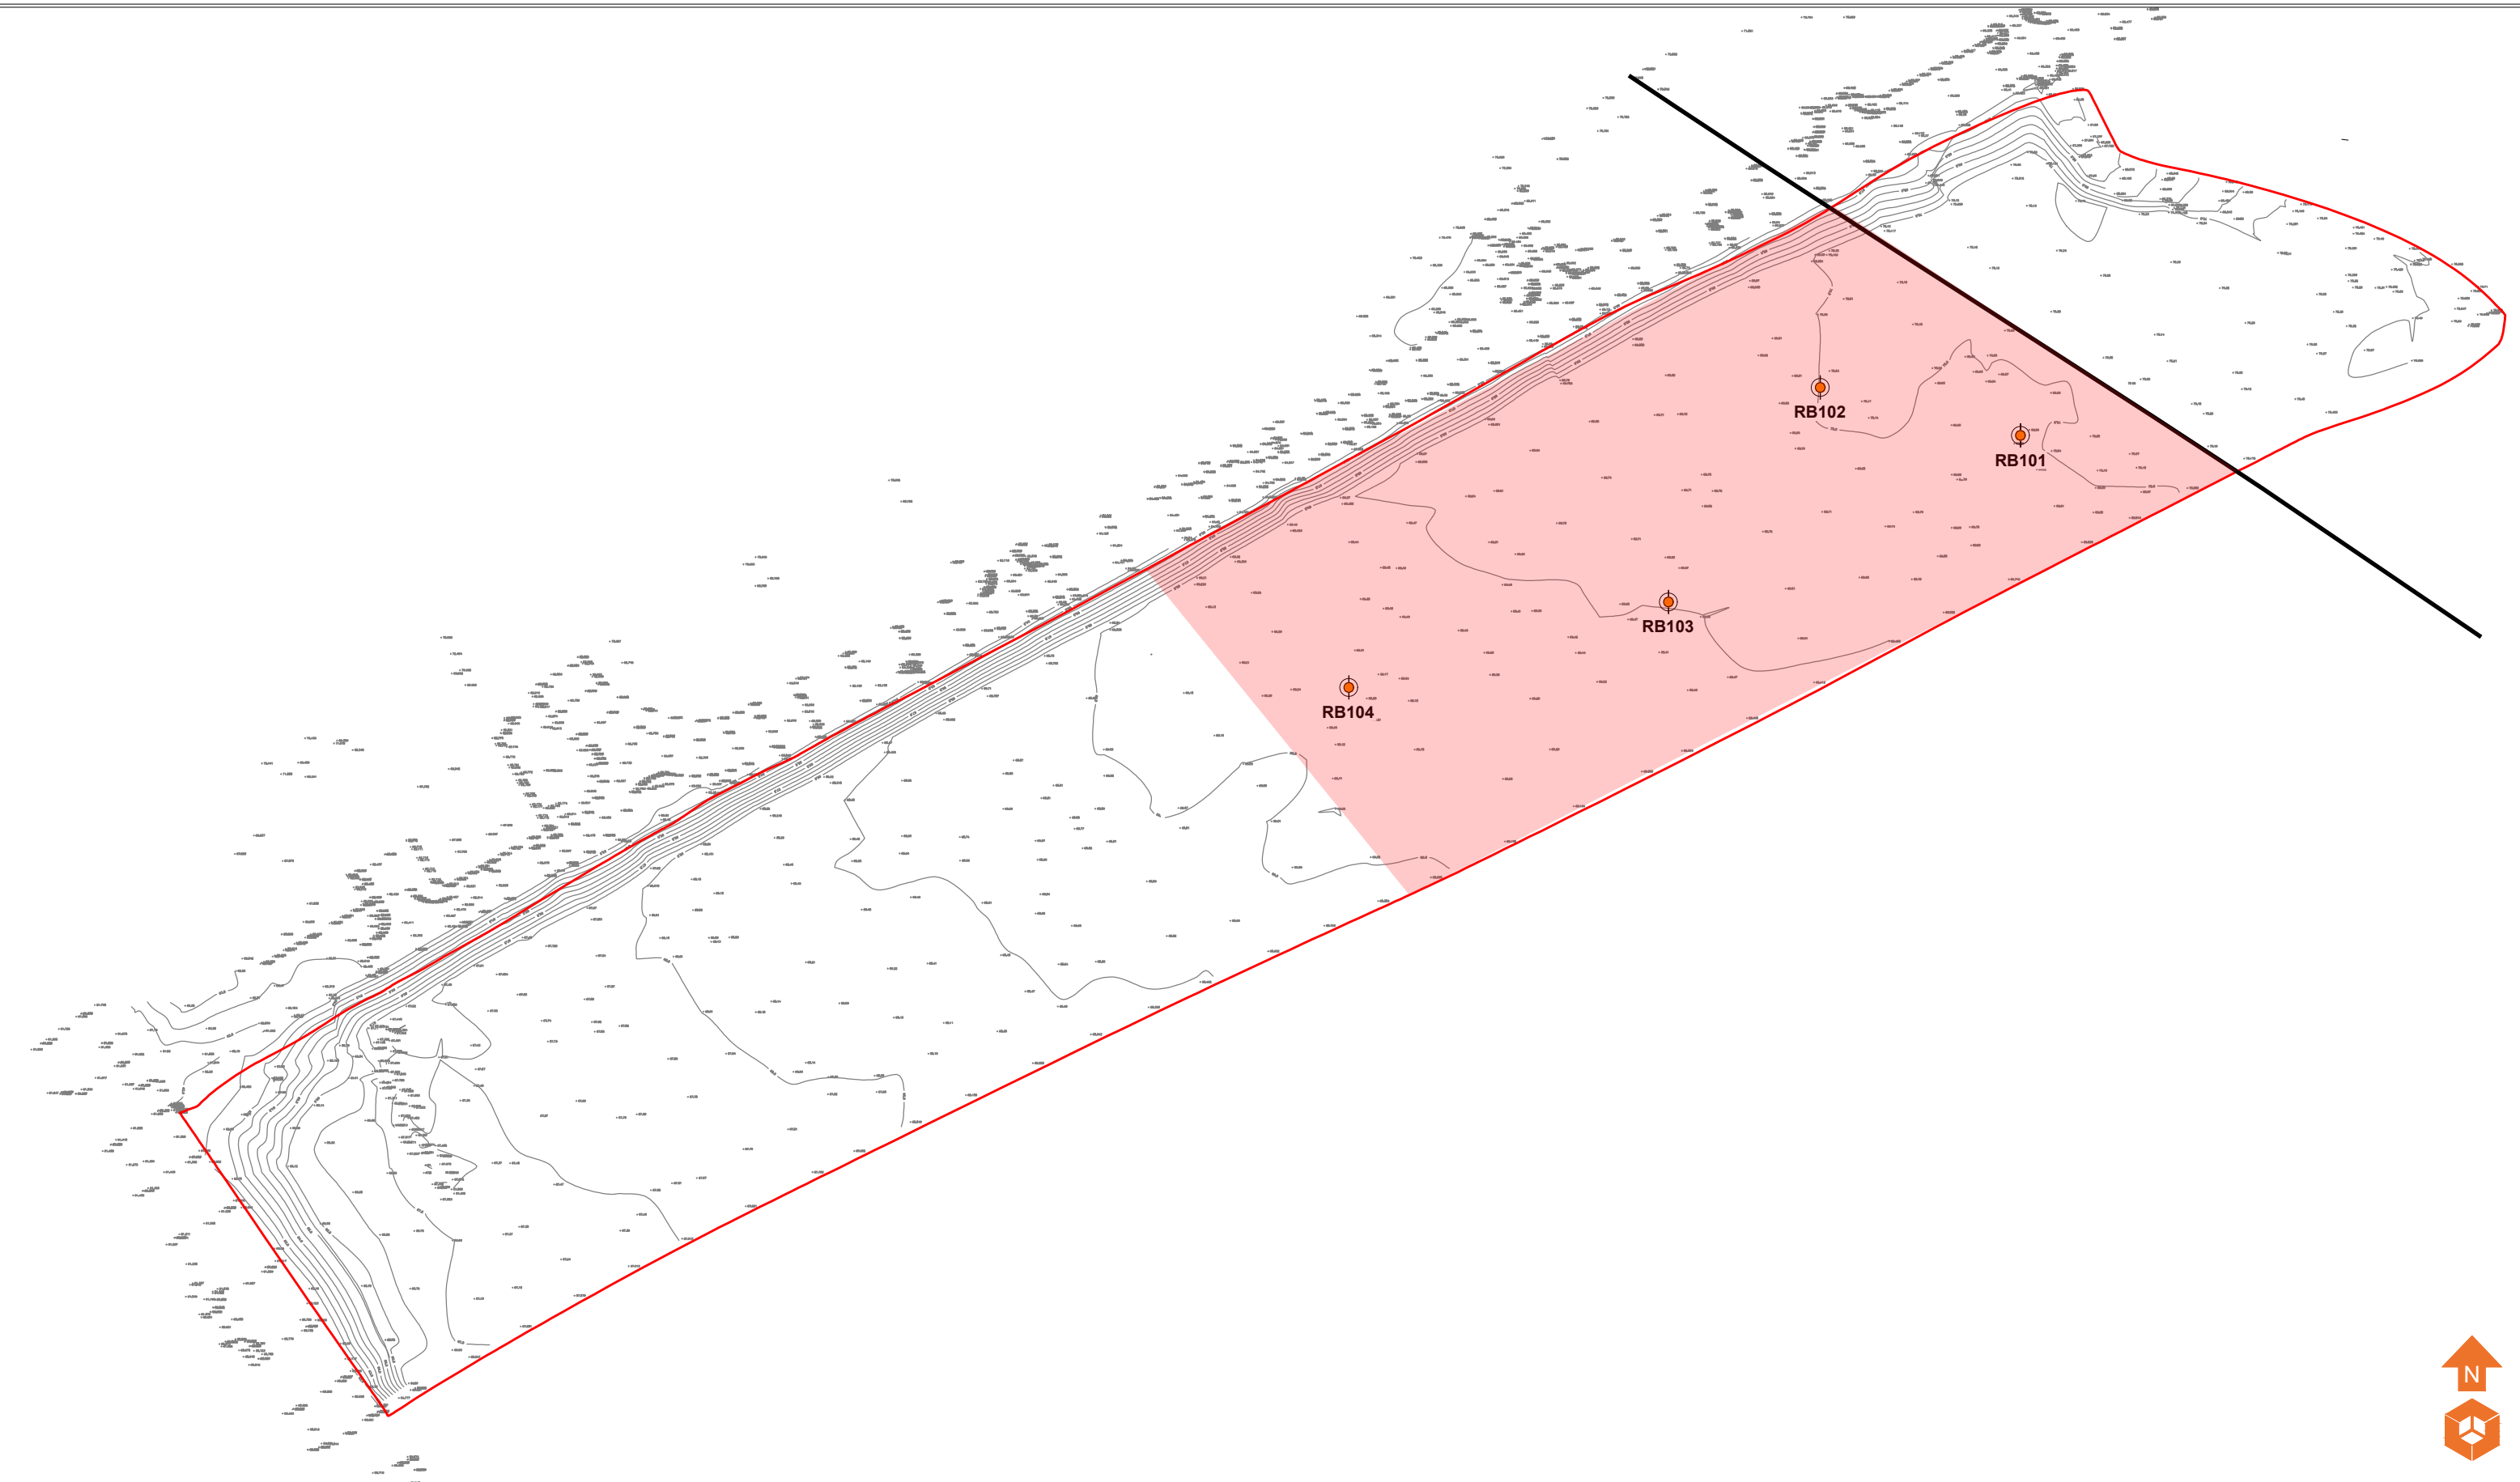
**Location Symbols**

- Approximate Rotary Borehole Location
- Approximate Location of Coal Seam
- Approximate Area of Potential Workings

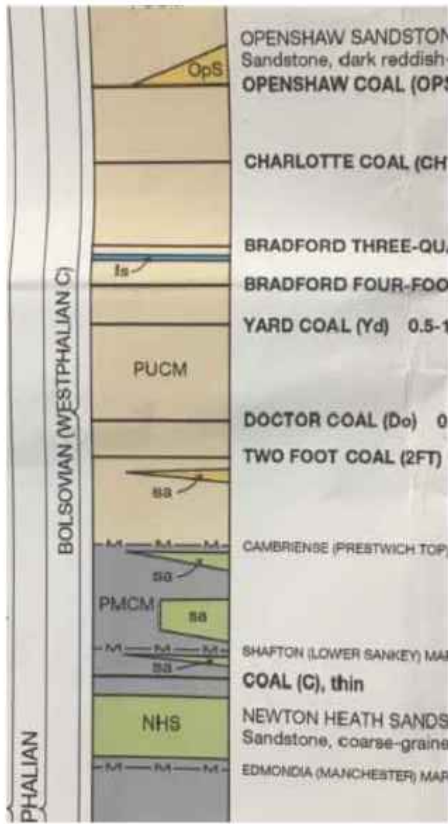
Generalised Vertical Section  
Taken from BGS Sheet SJ89NE

Located to the South West

Situated in South West of Site

Assumed Outcrop

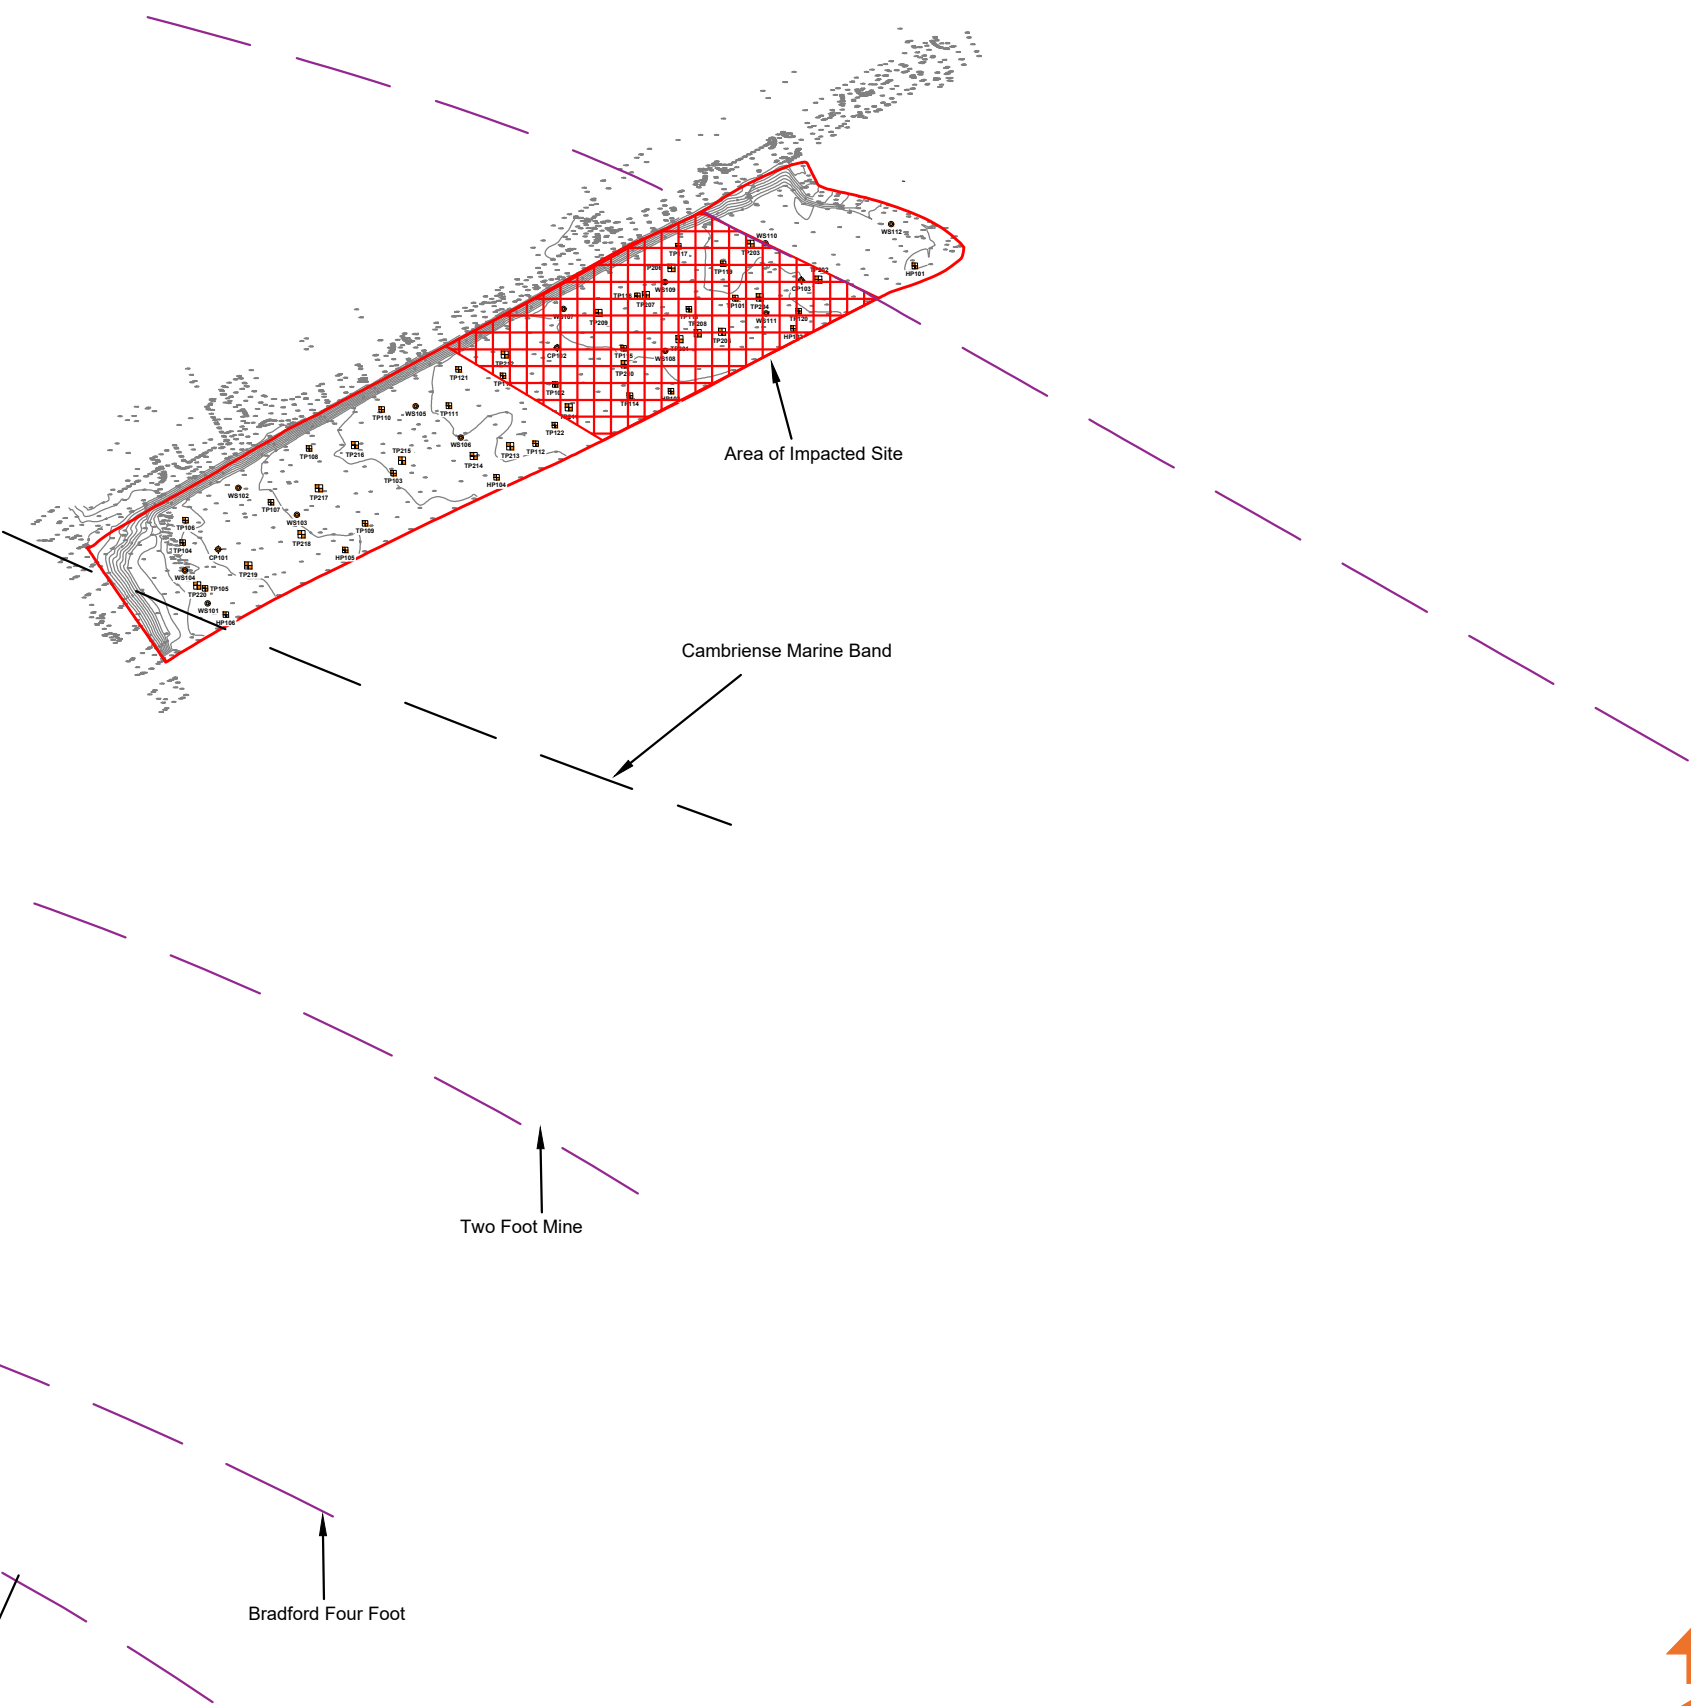
Coal Mining

- Dip and Direction
- Area of Impact
- Coal Seam
- Marine Band
