## Ground Investigation Report

Floodlit Artificial 3G Pitch Refurbishment

Manchester Communications Academy

Document Title: Ground Investigation Report  
Document no.: STV5997-R01 Rev B  
Date: October 2023  
Client: The Football Foundation

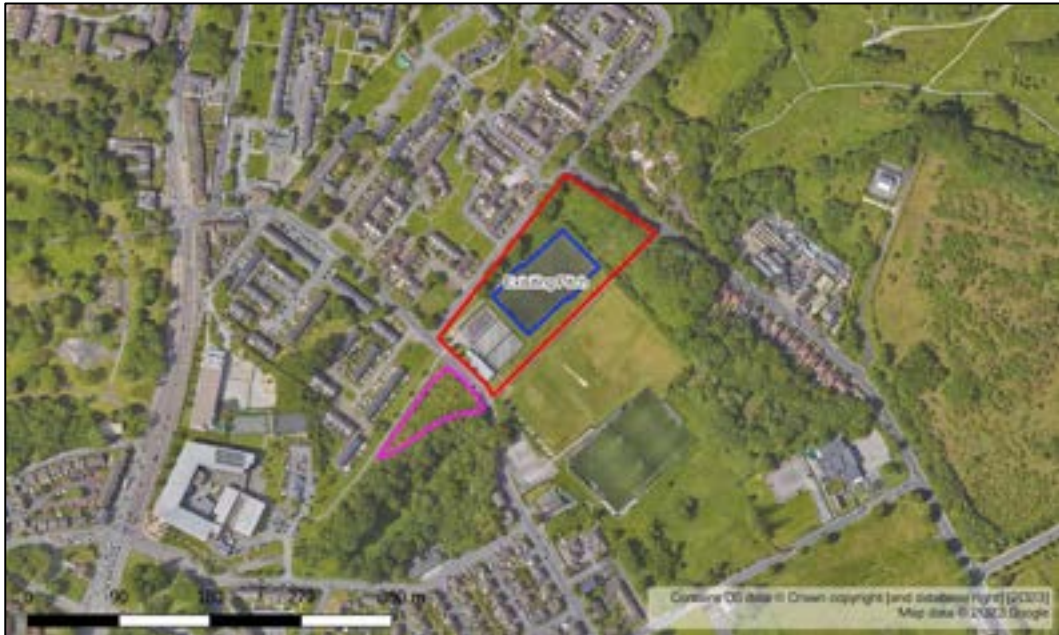
Figure 1-1: Wider site boundary edged in red, FTP area in blue, and proposed parking area in magenta.

- 1.1.1 The proposed development is for the refurbishment and extension of the existing 11v11 3G LED floodlit Football Turf Pitch (FTP) as well as new access from Carisbrook Street. In addition, a new car park is proposed to the southwest of Lathbury Road, see Figure 1-1.

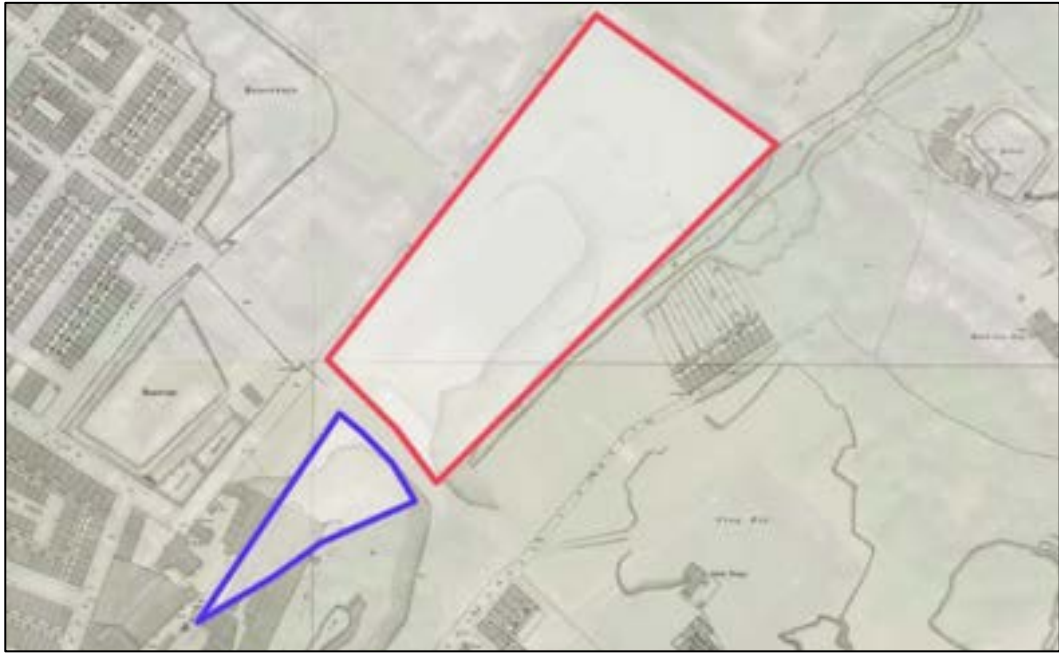
Figure 2-1: 1840s-1890s Historical map extract overlay showing approximate site boundary (red) and the proposed car park (blue)

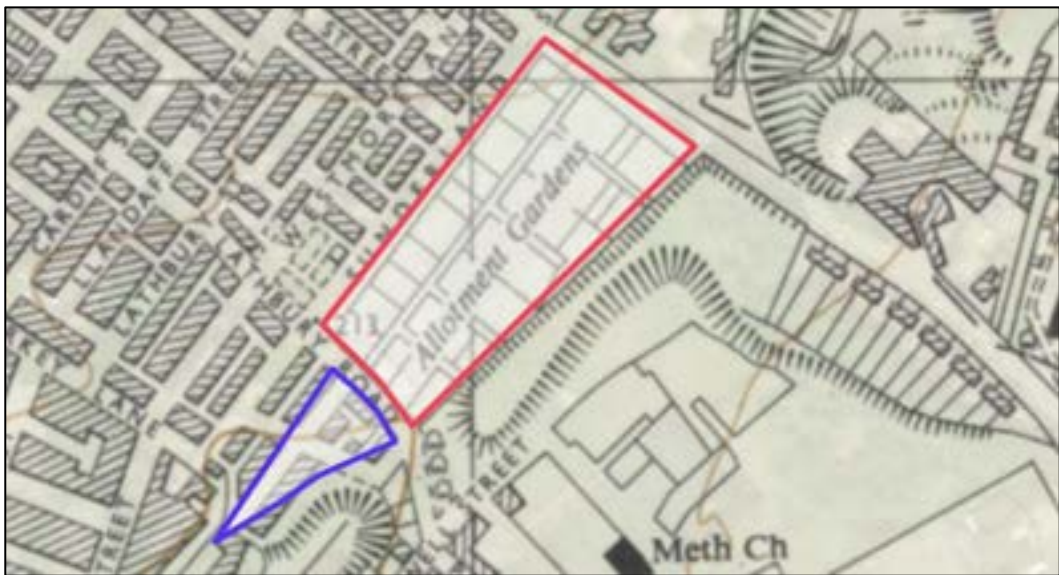
Figure 2-2: 1949-1972 Historical map extract overlay showing approximate site boundary (red) and the proposed car park (blue).

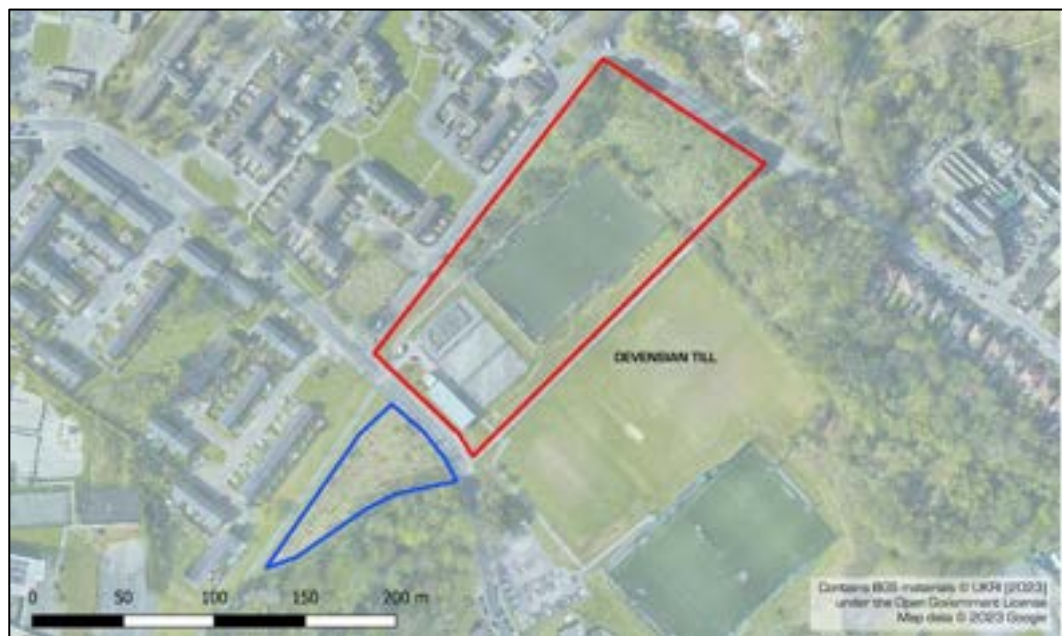
Figure 2-3: Superficial deposits

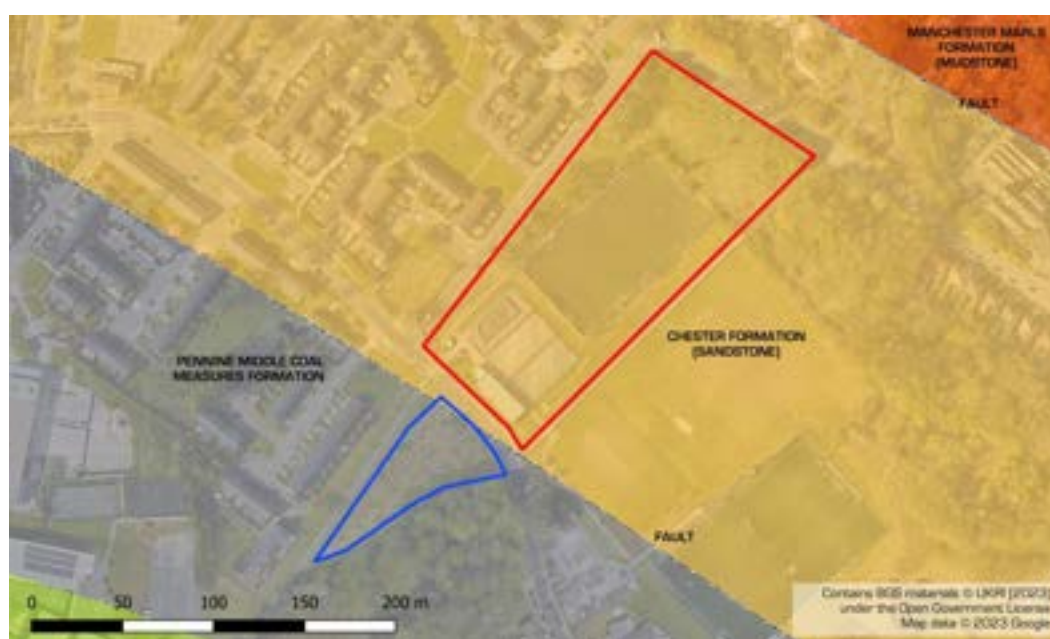
Figure 2-4: Bedrock geology

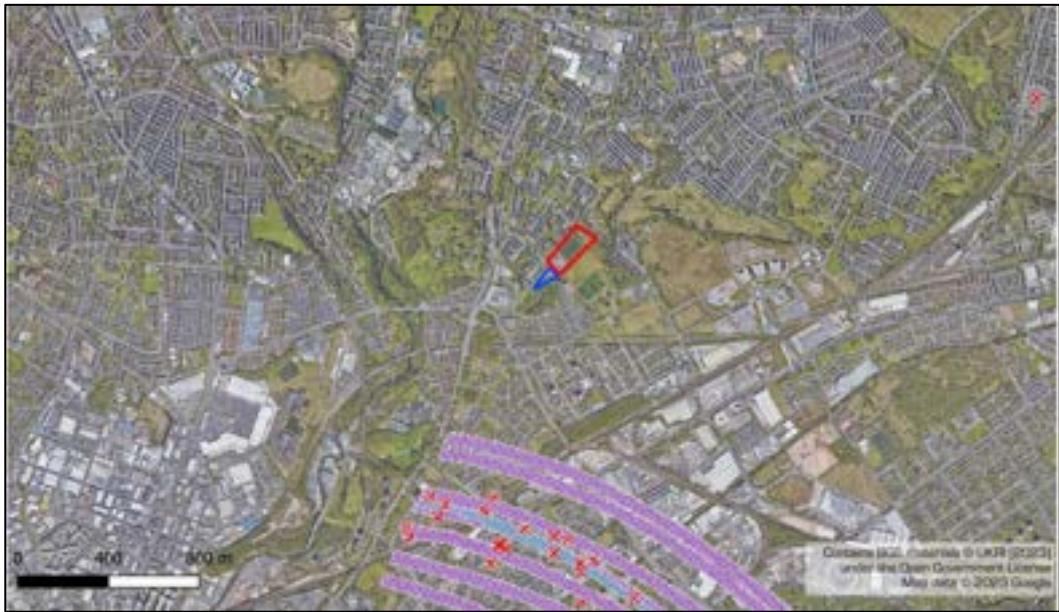
Figure 2-5: Coal Authority viewer extract

2.3.1 Coal Authority mapping data shows the site lies within a Coal Mining Reporting Area, but outside of a Development High Risk Area as shown in Figure 2-5 below.

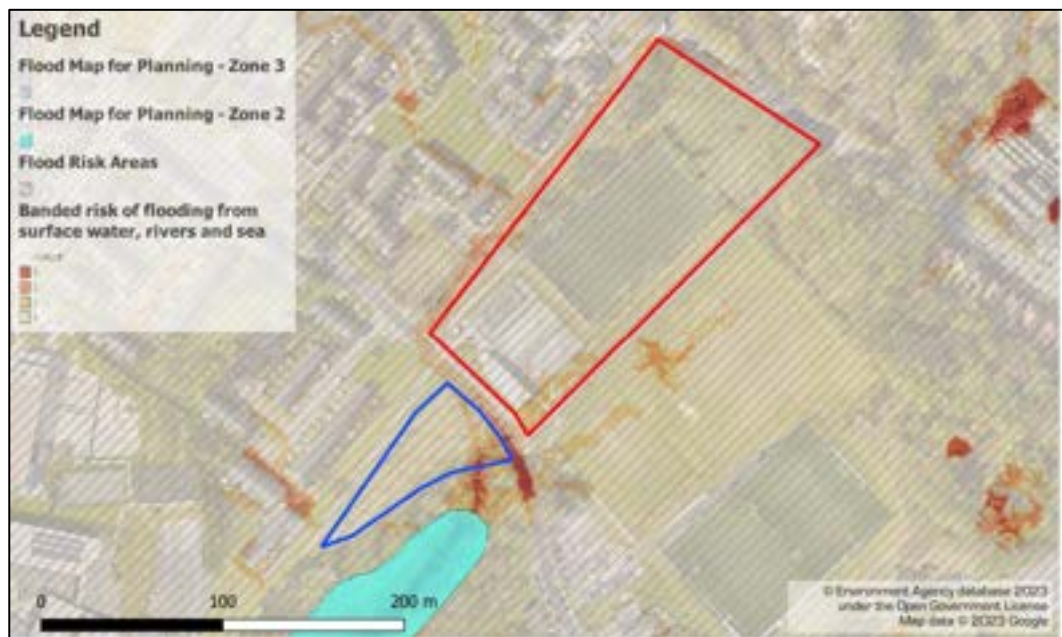
Figure 2-6: Flood risk mapping

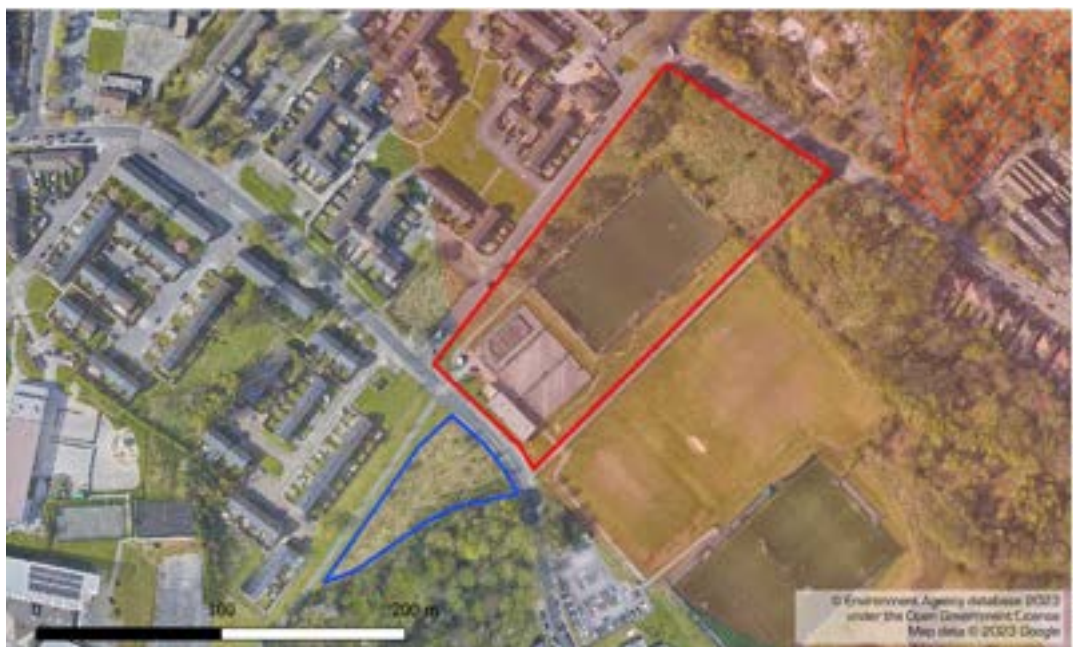
Figure 2-7: Proximity to landfill site (outline of nearest off-site former landfill in red hatching)

- 2.5.1 Open-source Environment Agency landfill mapping data indicates the main Academy site is within 250m of a recorded landfill, as shown in Figure 2-7 below. The proposed car park area is approximately 260m from the landfill.

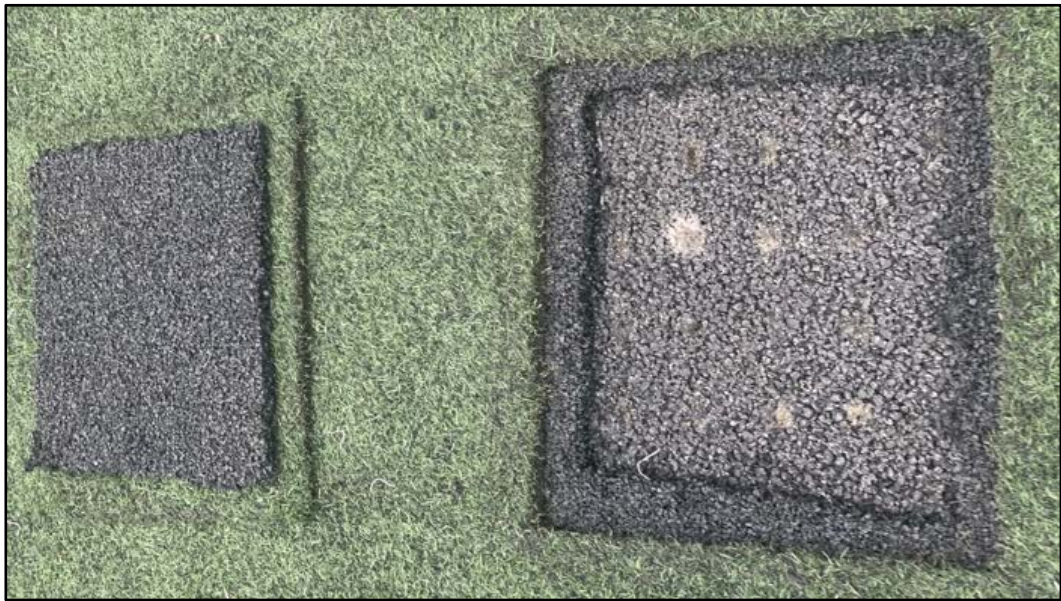
Figure 4-1: Artificial turf and shock pad onto Asphalt

- 4.1.1 Hand excavated trial pits HP01-HP15 were advanced within the existing FTP and encountered an artificial carpet and shock pad (with a total thickness of 80mm) onto an 80mm thick layer of asphalt.
- 4.1.2 Subbase deposits were encountered below the carpet/shockpad/asphalt layer and comprised two layers of limestone gravel between 300mm to 350mm in total thickness.
- 4.1.3 A woven membrane was noted at the base of the subbase in all hand pits.
- 4.1.4 Beneath the membrane, Made Ground subgrade was encountered which consisted of brown clayey sandy gravel of brick, concrete, clinker, wood and ceramic. All hand pits terminated within such deposits.
- 4.1.5 Photographs illustrating the ground conditions within the existing pitch are presented below.

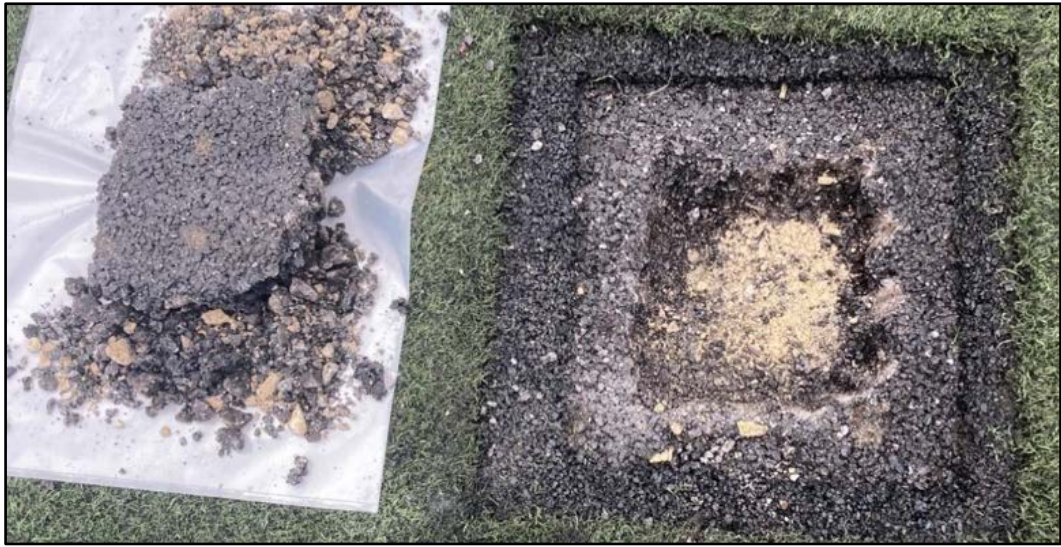
Figure 4-2: Asphalt onto granular subbase in HP14

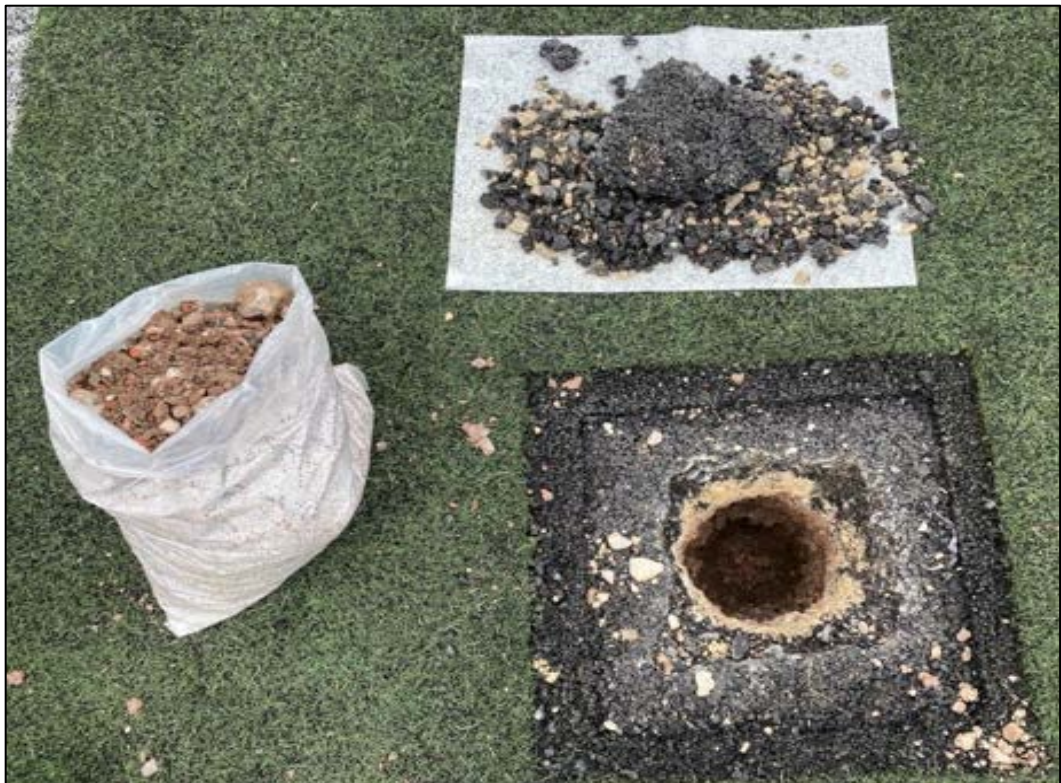
Figure 4-3: HP09 at completed depth showing Made Ground subgrade

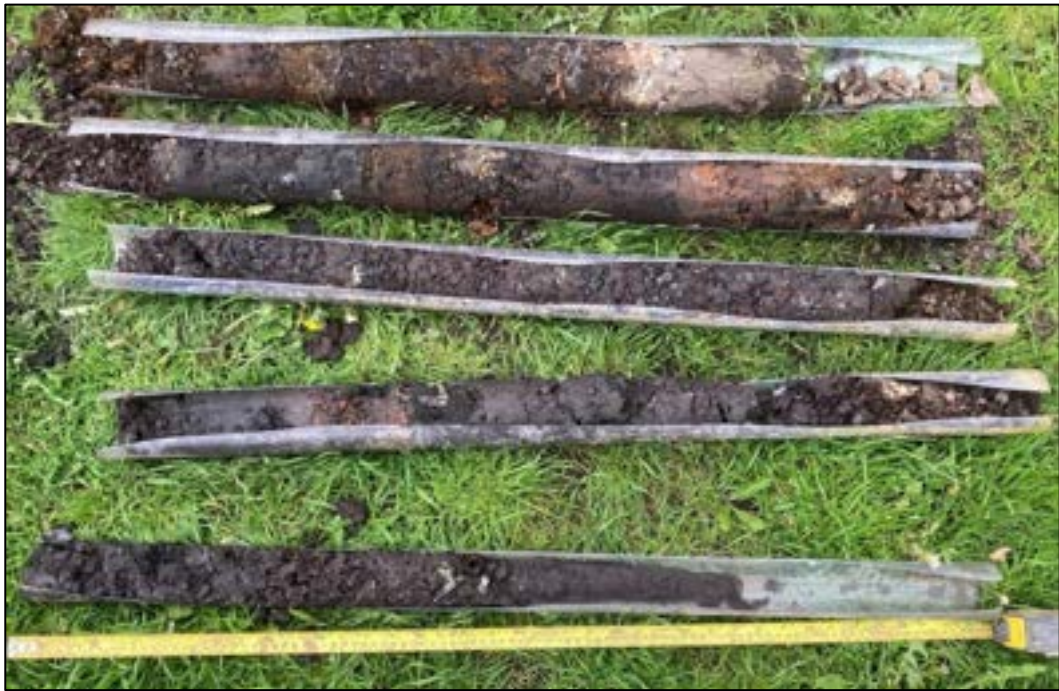
Figure 4-4: Photographic record of soil profile at WS07

- 4.5.1 Suspected perched groundwater was observed as a slow seepage in WS07 at 3.2m depth. Groundwater was not encountered elsewhere.

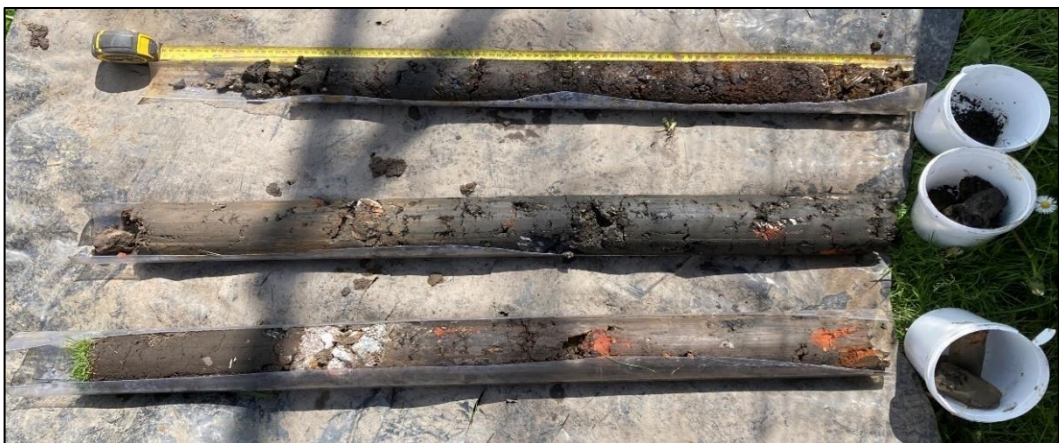
Figure 4-5: Photographic record of soil profile at WS04

- 4.7.1 Refusal was met on an obstruction at 3.6m depth in WS04 within the Made Ground, Otherwise no obstructions or instability was noted during the investigation.
- 4.7.2 Within HP16 A,B,C, there was a suspected concrete base found at varying depths below ground level, the top depth of the observed concrete base was surveyed in HP16A and HP16B and is available within the topographic survey provided under separate cover.

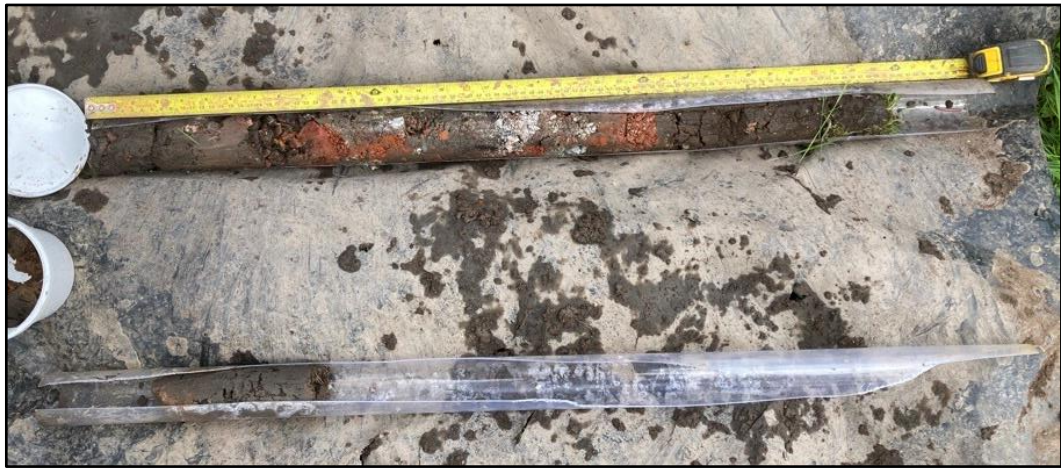
Figure 4-6: Photographic record of soil profile at WS02

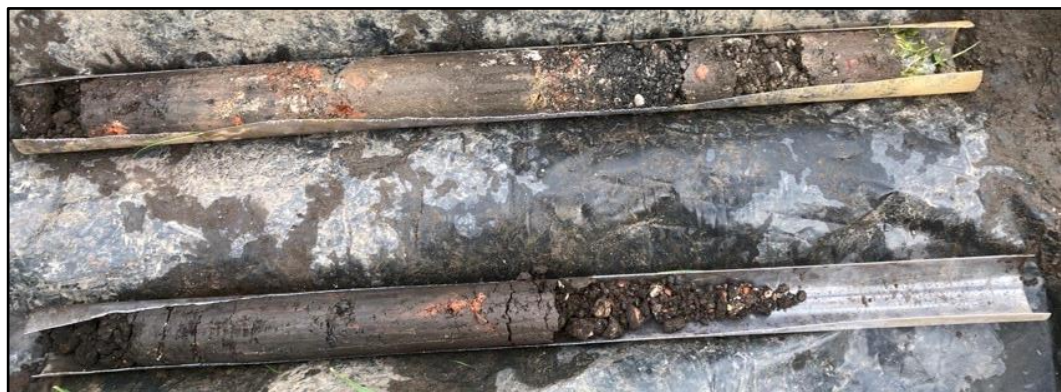
Figure 4-7: Photographic record of soil profile at WS03

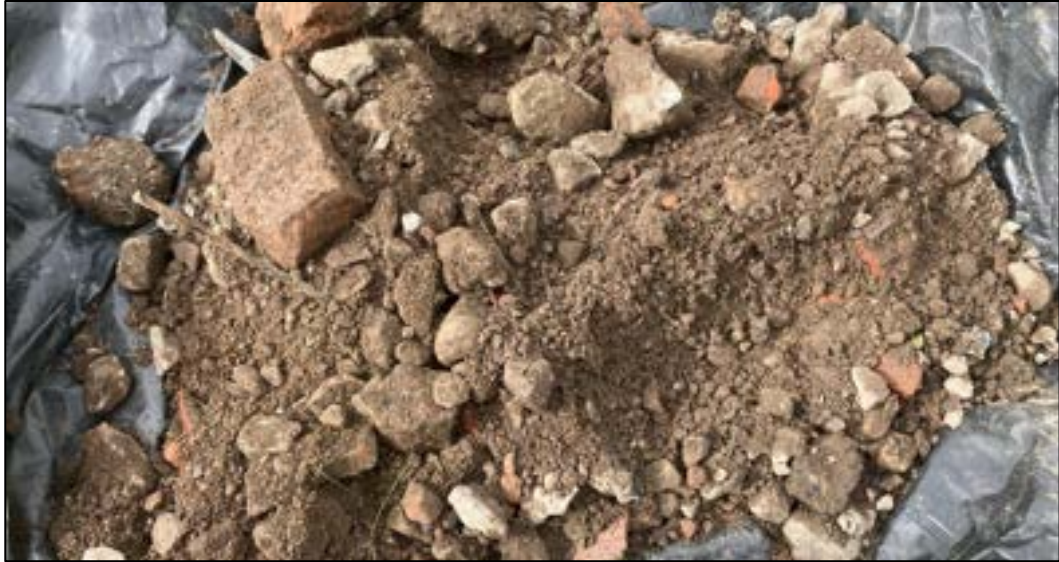
*Figure 4-8: Photographic record of the soil profile at HP16A, comprising coarse grained soils*

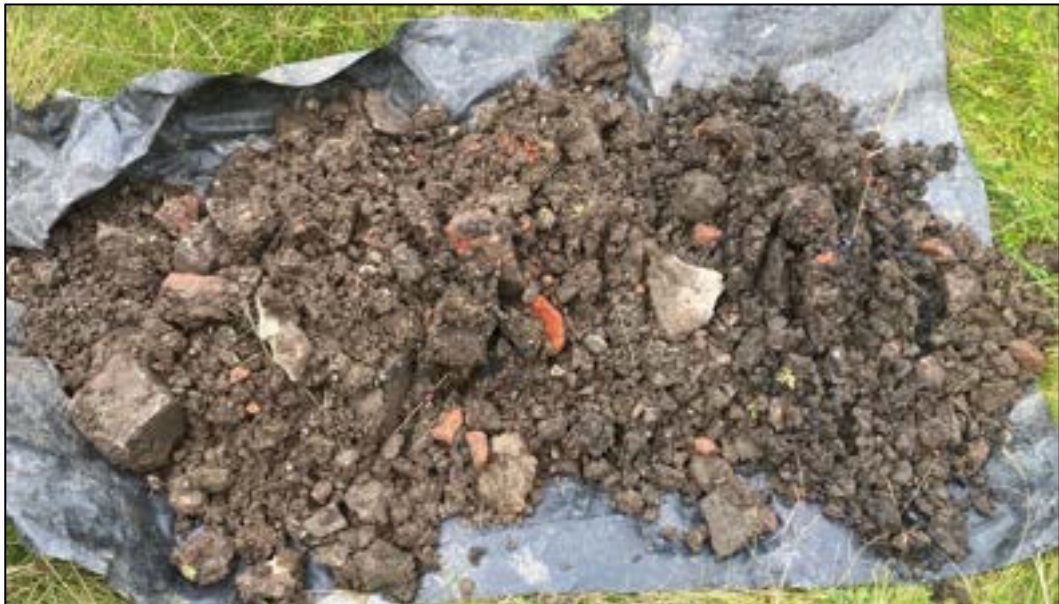
*Figure 4-9: Photographic record of the soil profile at HP17, comprising gravelly, fine grained soils*

- 4.6.1 During the ground investigation works no significant visual or olfactory evidence of contamination was observed, beyond the presence of anthropogenic materials within Made Ground with the exception for a solvent odour noted at a depth of 0.9m within HP17 (area of proposed car park).

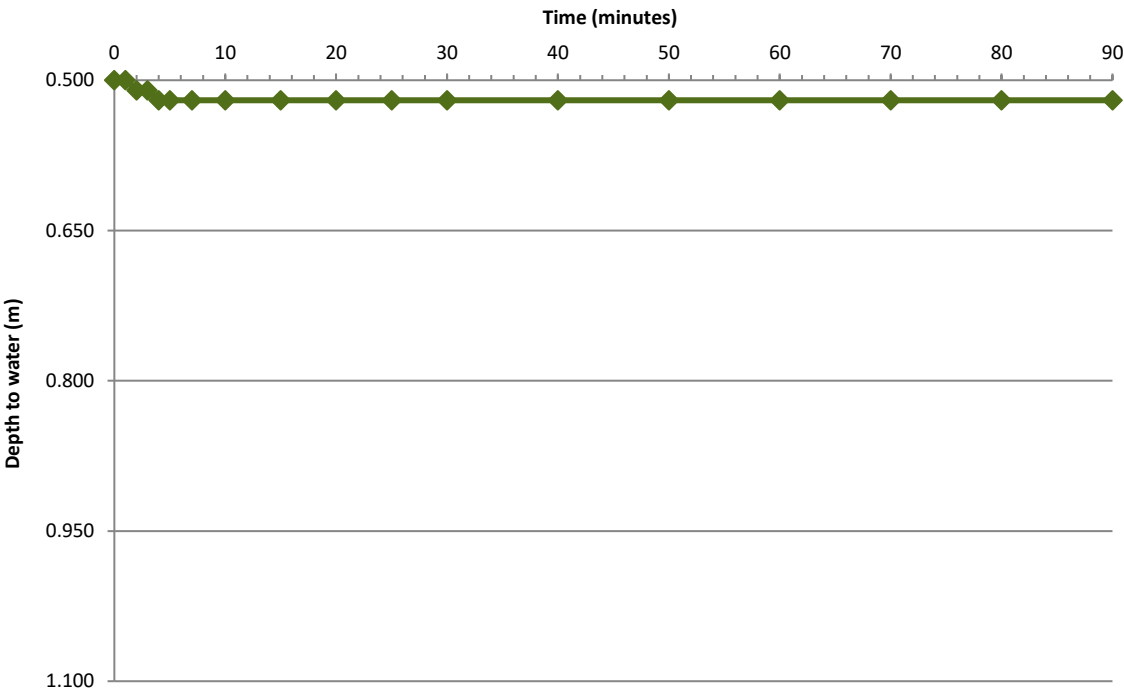
Insufficient infiltration over 90 minutes of monitoring therefore unable to calculate soil infiltration rate.

Soil infiltration test (following BRE Digest 365 2016)

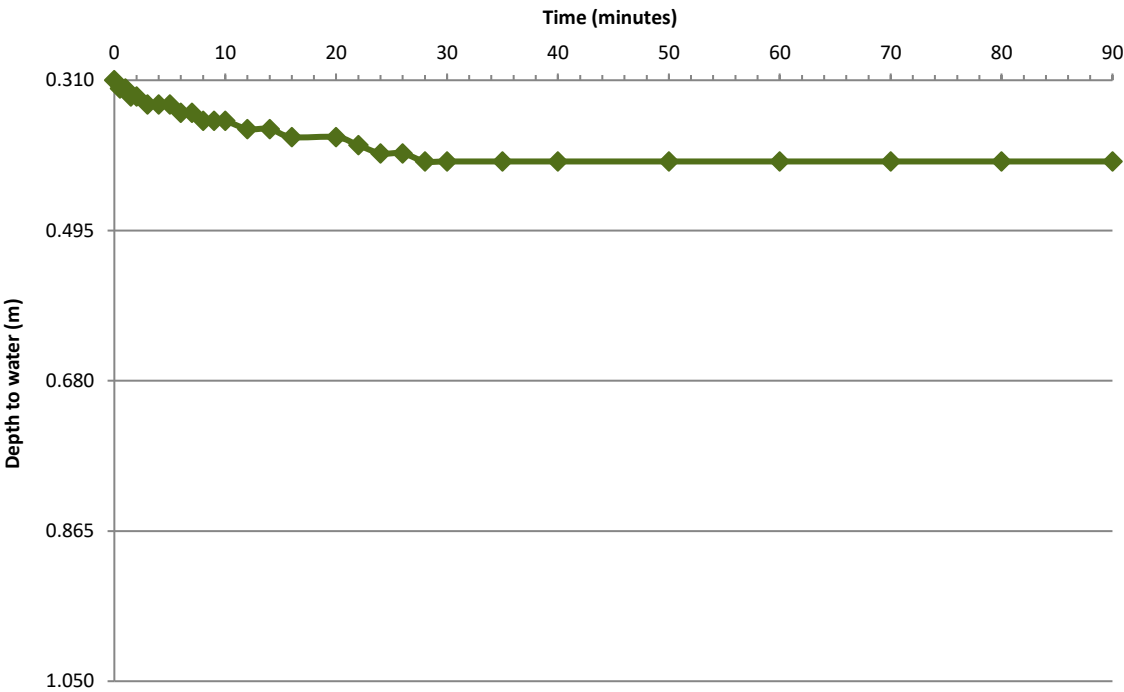
Insufficient infiltration over 90 minutes of monitoring therefore unable to calculate soil infiltration rate.
