# Contaminated Land Phase Two Further Intrusive Investigation for proposed residential development at Land Off Chapel Street, Manchester, M19 3QB.

Burke Developments Ltd,  
Norwood,  
Greenacres,  
Oldham,  
OL4 3EX.

September 2024

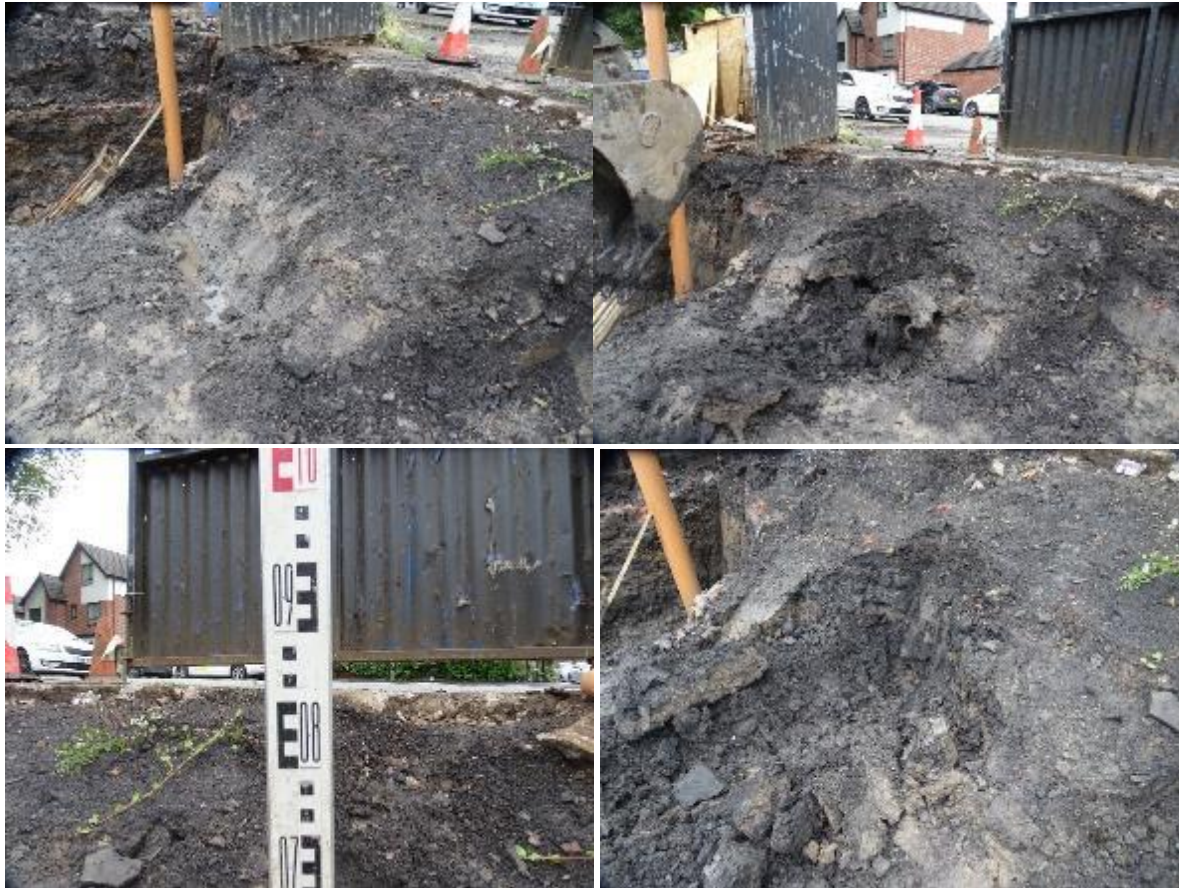
### SP1 – North east rear corner, proposed rear garden

SP 1 – Entrance to site (south boundary)

Excavation 085m

Sample taken from wall clay and gravel.

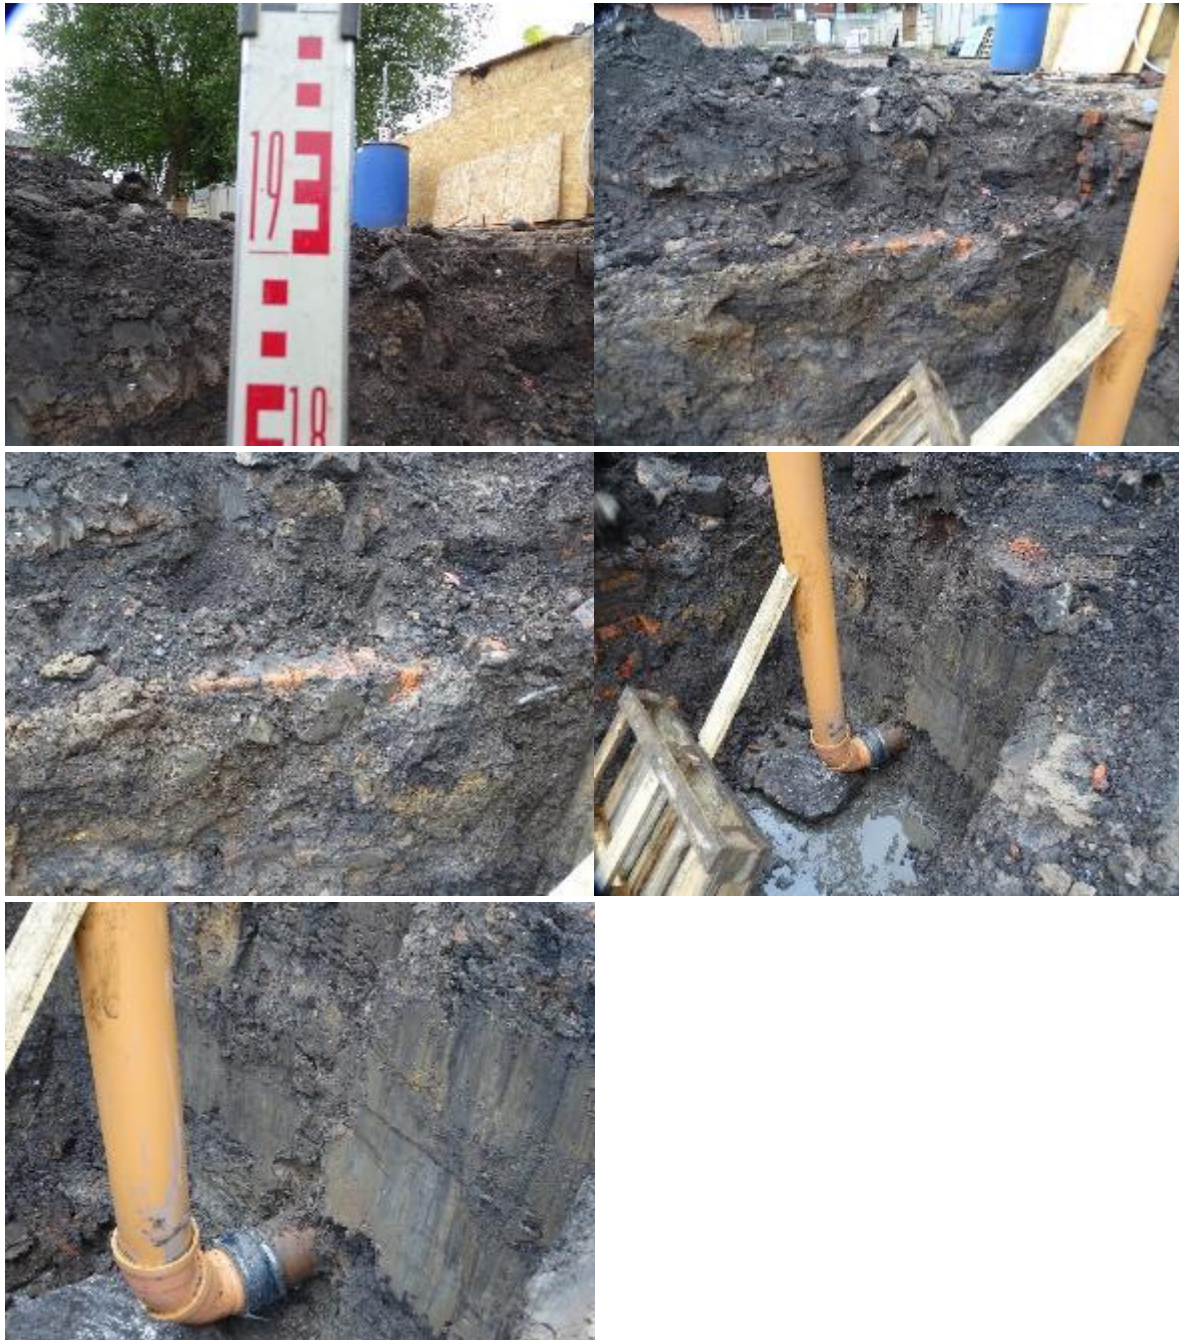
**SP2 – Middle northeast boundary proposed rear garden**

SP 2 – Southern boundary, right of gate, within foundations of previous building.

Excavation to 1.9m, evidence of brick wall and layer of made ground. Gravel and clay

Sampe taken from above wall. clay seen below wall.

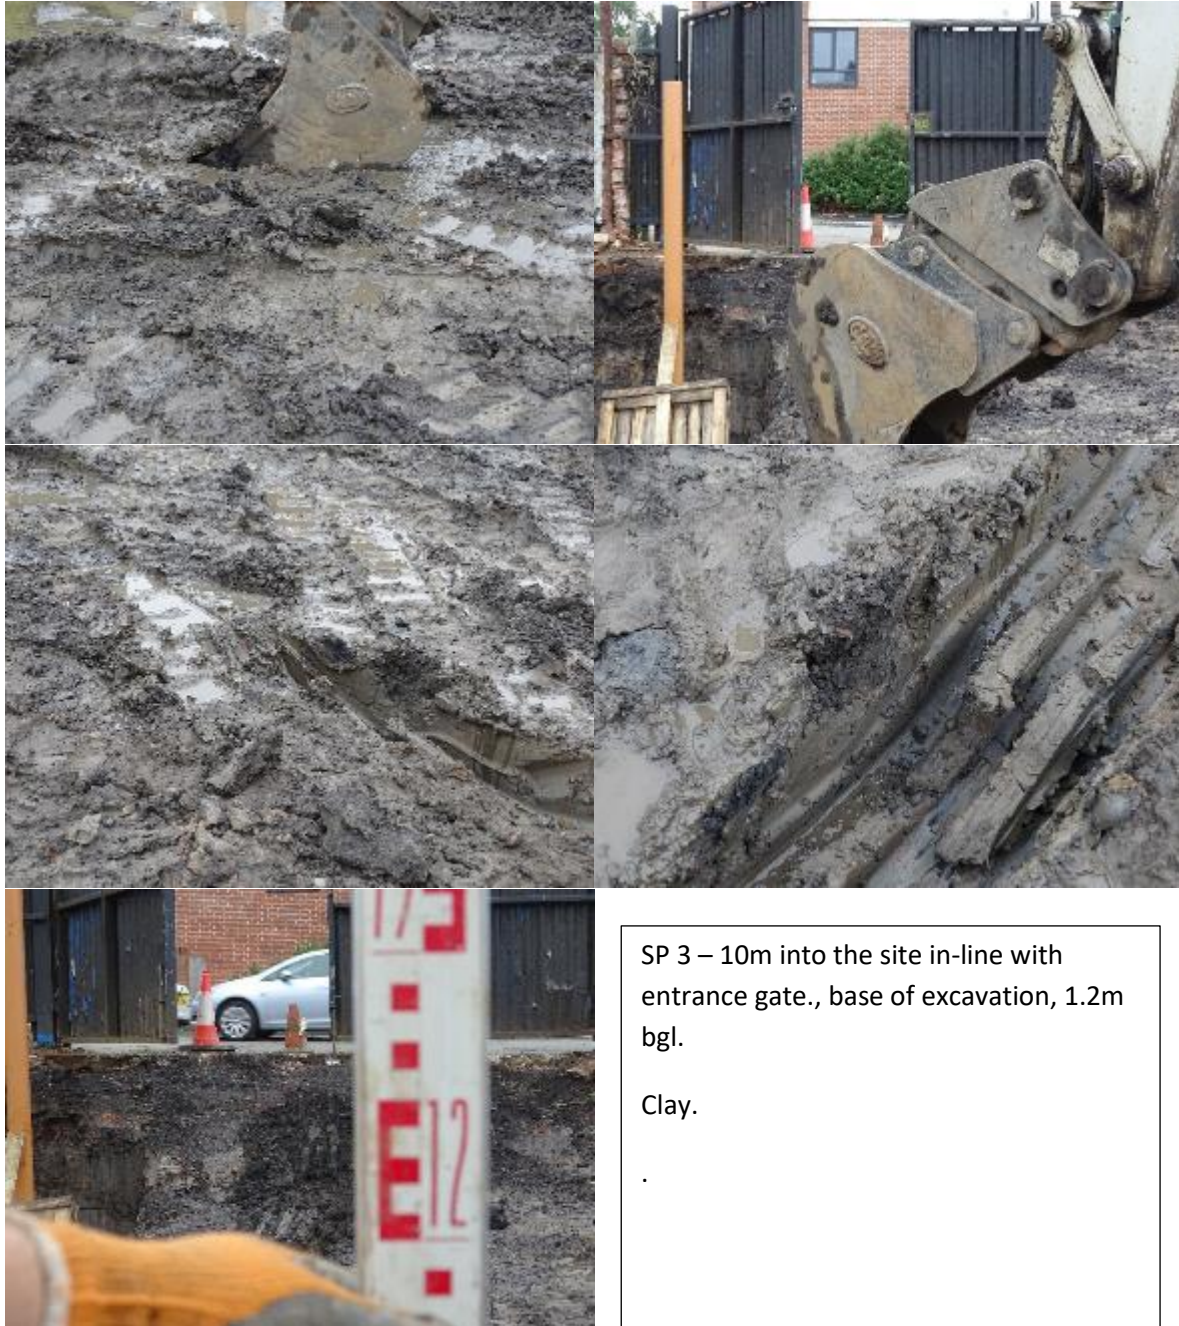
### SP3 – Southeast corner of site proposed rear garden

SP 3 – 10m into the site in-line with entrance gate., base of excavation, 1.2m bgl.

Clay.

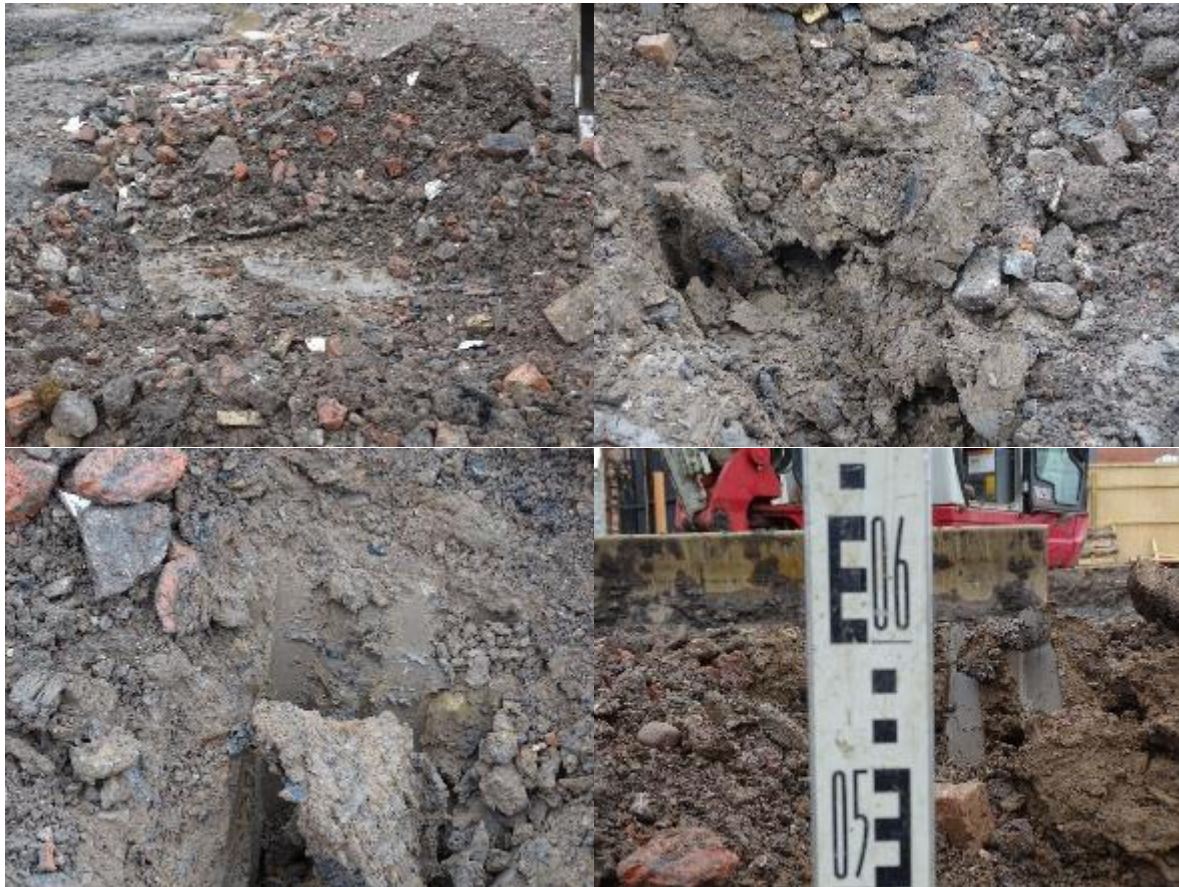
**SP4 – Centre of site, original roadway connecting the two halves and between the buildings.**

SP4 – Centre of site, original roadway connecting the two halves and between the buildings.

Sample from base of excavation, 0.7m clay and gravel.

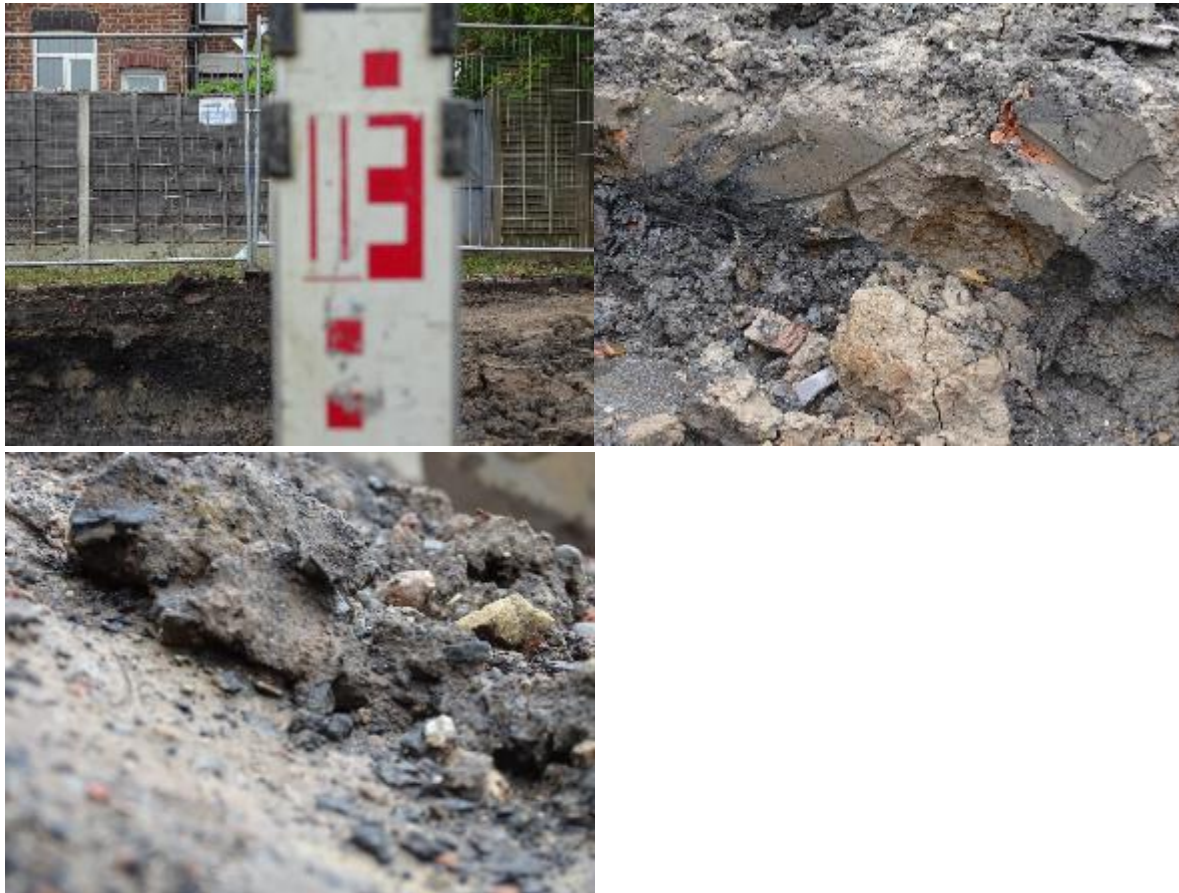
**SP5 – Right Hand side of excavation, 6m from the rear boundary**

SP 5 – Right hand side of excavation, within the wall.

1.1m to bottom, 6m from the rear boundary.

Clay ad gravel.

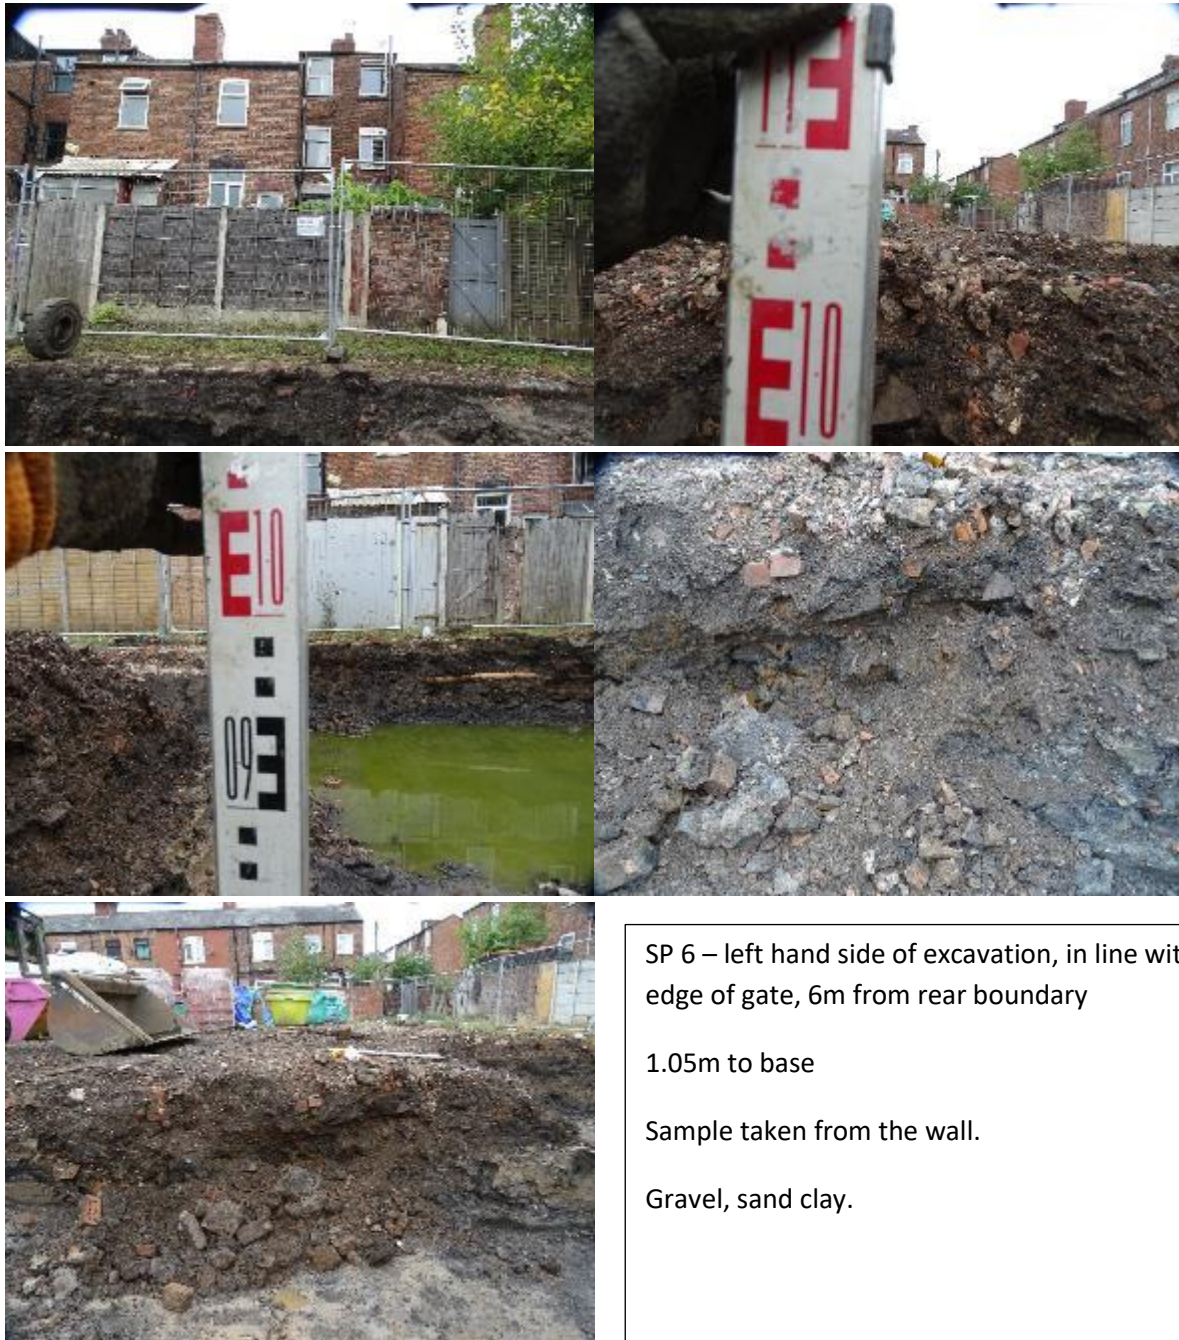
**SP6 – Left Hand side of excavation, 6m from the rear boundary**

SP 6 – left hand side of excavation, in line with edge of gate, 6m from rear boundary

1.05m to base

Gravel, sand clay.

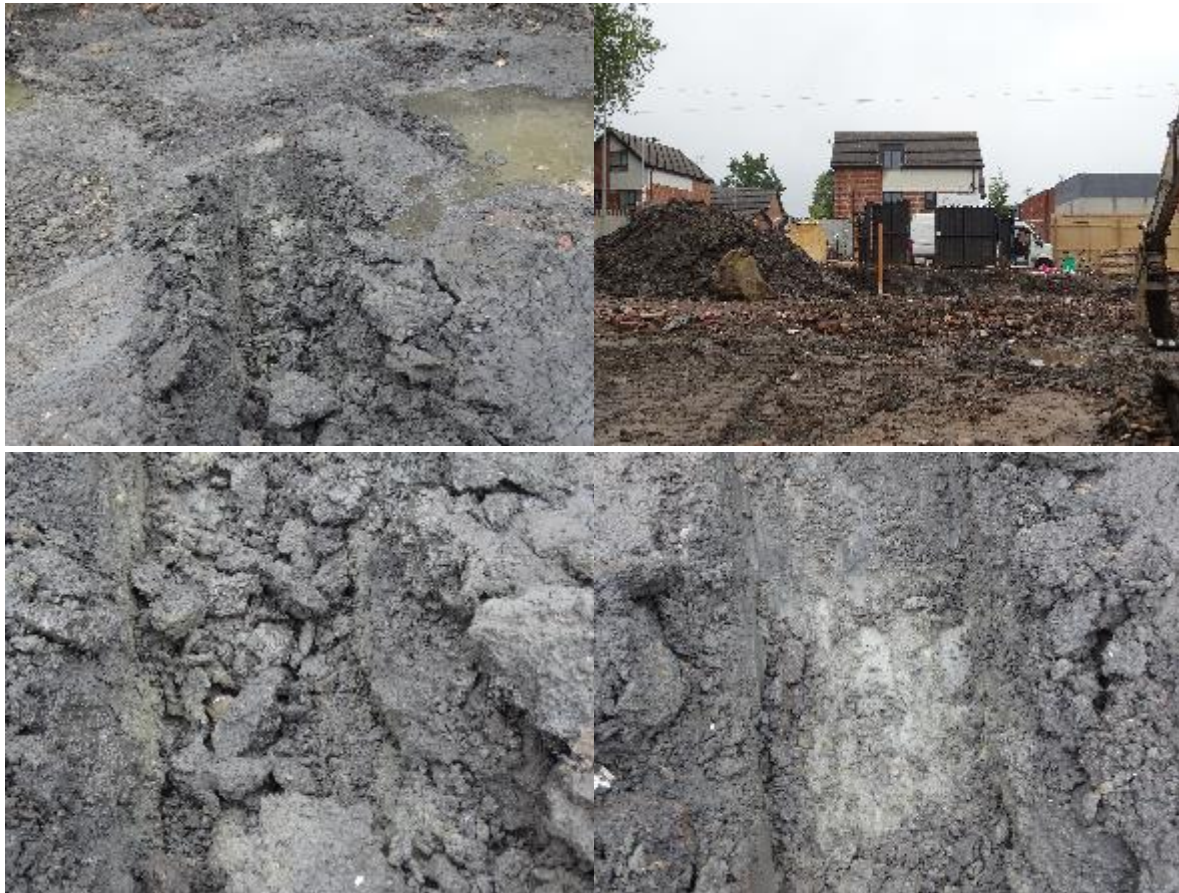
**SP7 – Along northern boundary in-line with entrance gate**

SP7 –northern boundary

Sample from base of excavation, clay.
