| Report type | Phase 3 Remediation Options Appraisal |
| Date | 6 March 2022 |
| Site address | Land to the east of The Fairway, Moston, Manchester, M40 3WS |

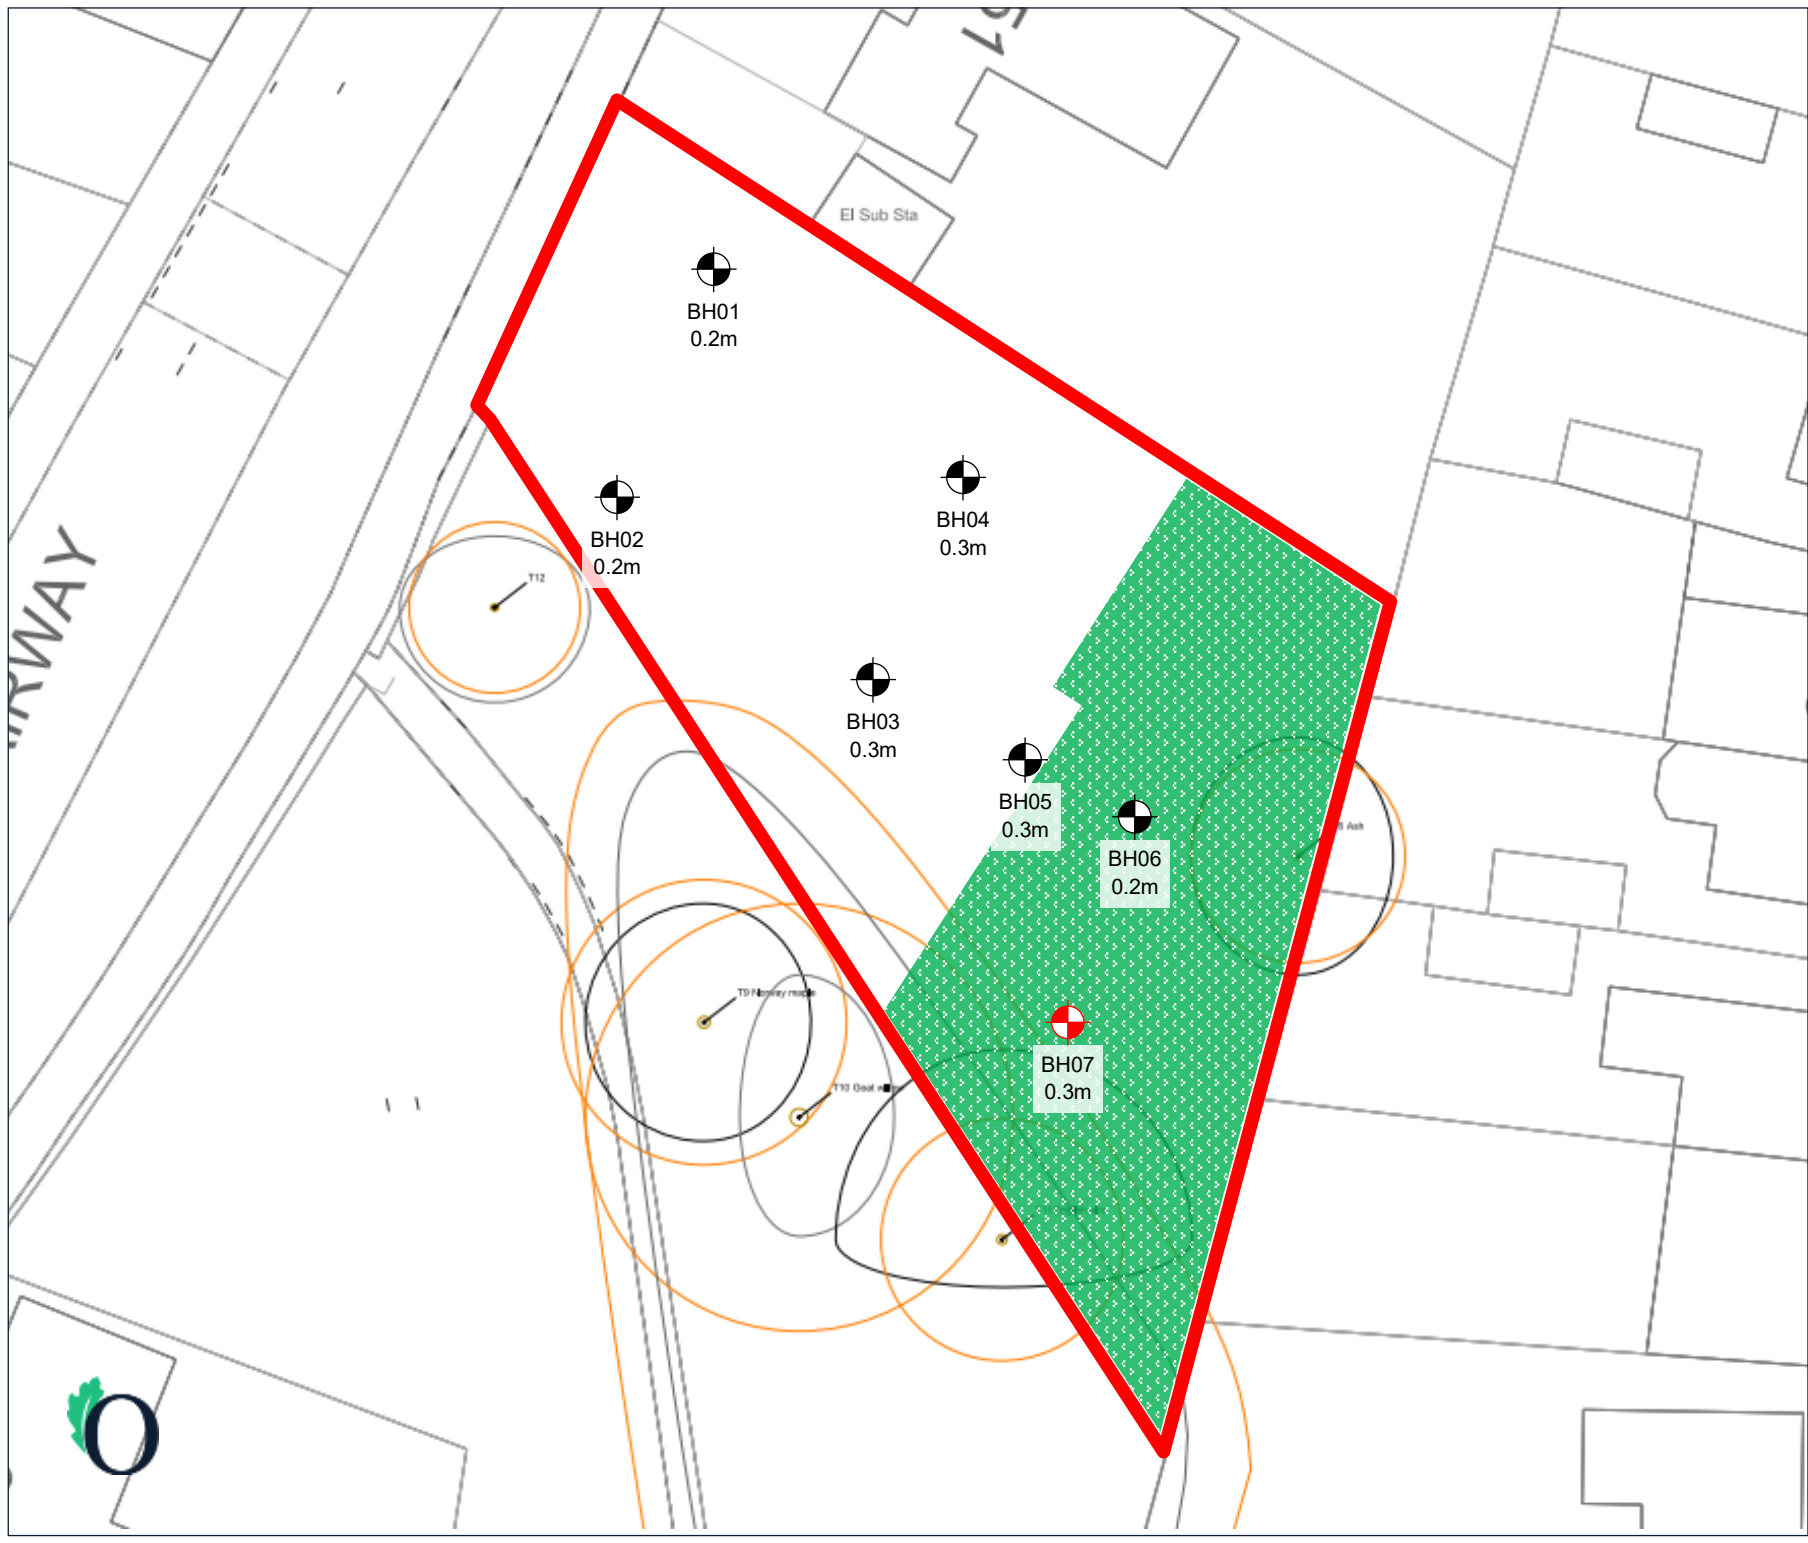
| Appendix A - Site Maps & Plans | |
|---|---|
| Name | Figure 2 |

| Appendix A - Site Maps & Plans | |
|---|---|
| Existing site plan, showing sample locations | |
| | Contaminated sample |
| | Approximate area to be excavated and covered |

A cover layer of clean imported or site-won material should be placed in the excavated area, to a minimum depth of 0.6m. Site-won soils from other previously tested areas of the site, shown to be uncontaminated, can be used as clean cover but should not be used if identified to be made ground or visible signs of contamination are identified during excavation. Clean soil imported to the site, to be used as cover, must be shown to be uncontaminated and compliant with British Standard 3882:2015. Photographic evidence of the depth of cover is required to verify that the required depth of cover has been implemented. The approximate extent of excavation and cover recommended is shown in the appendix.

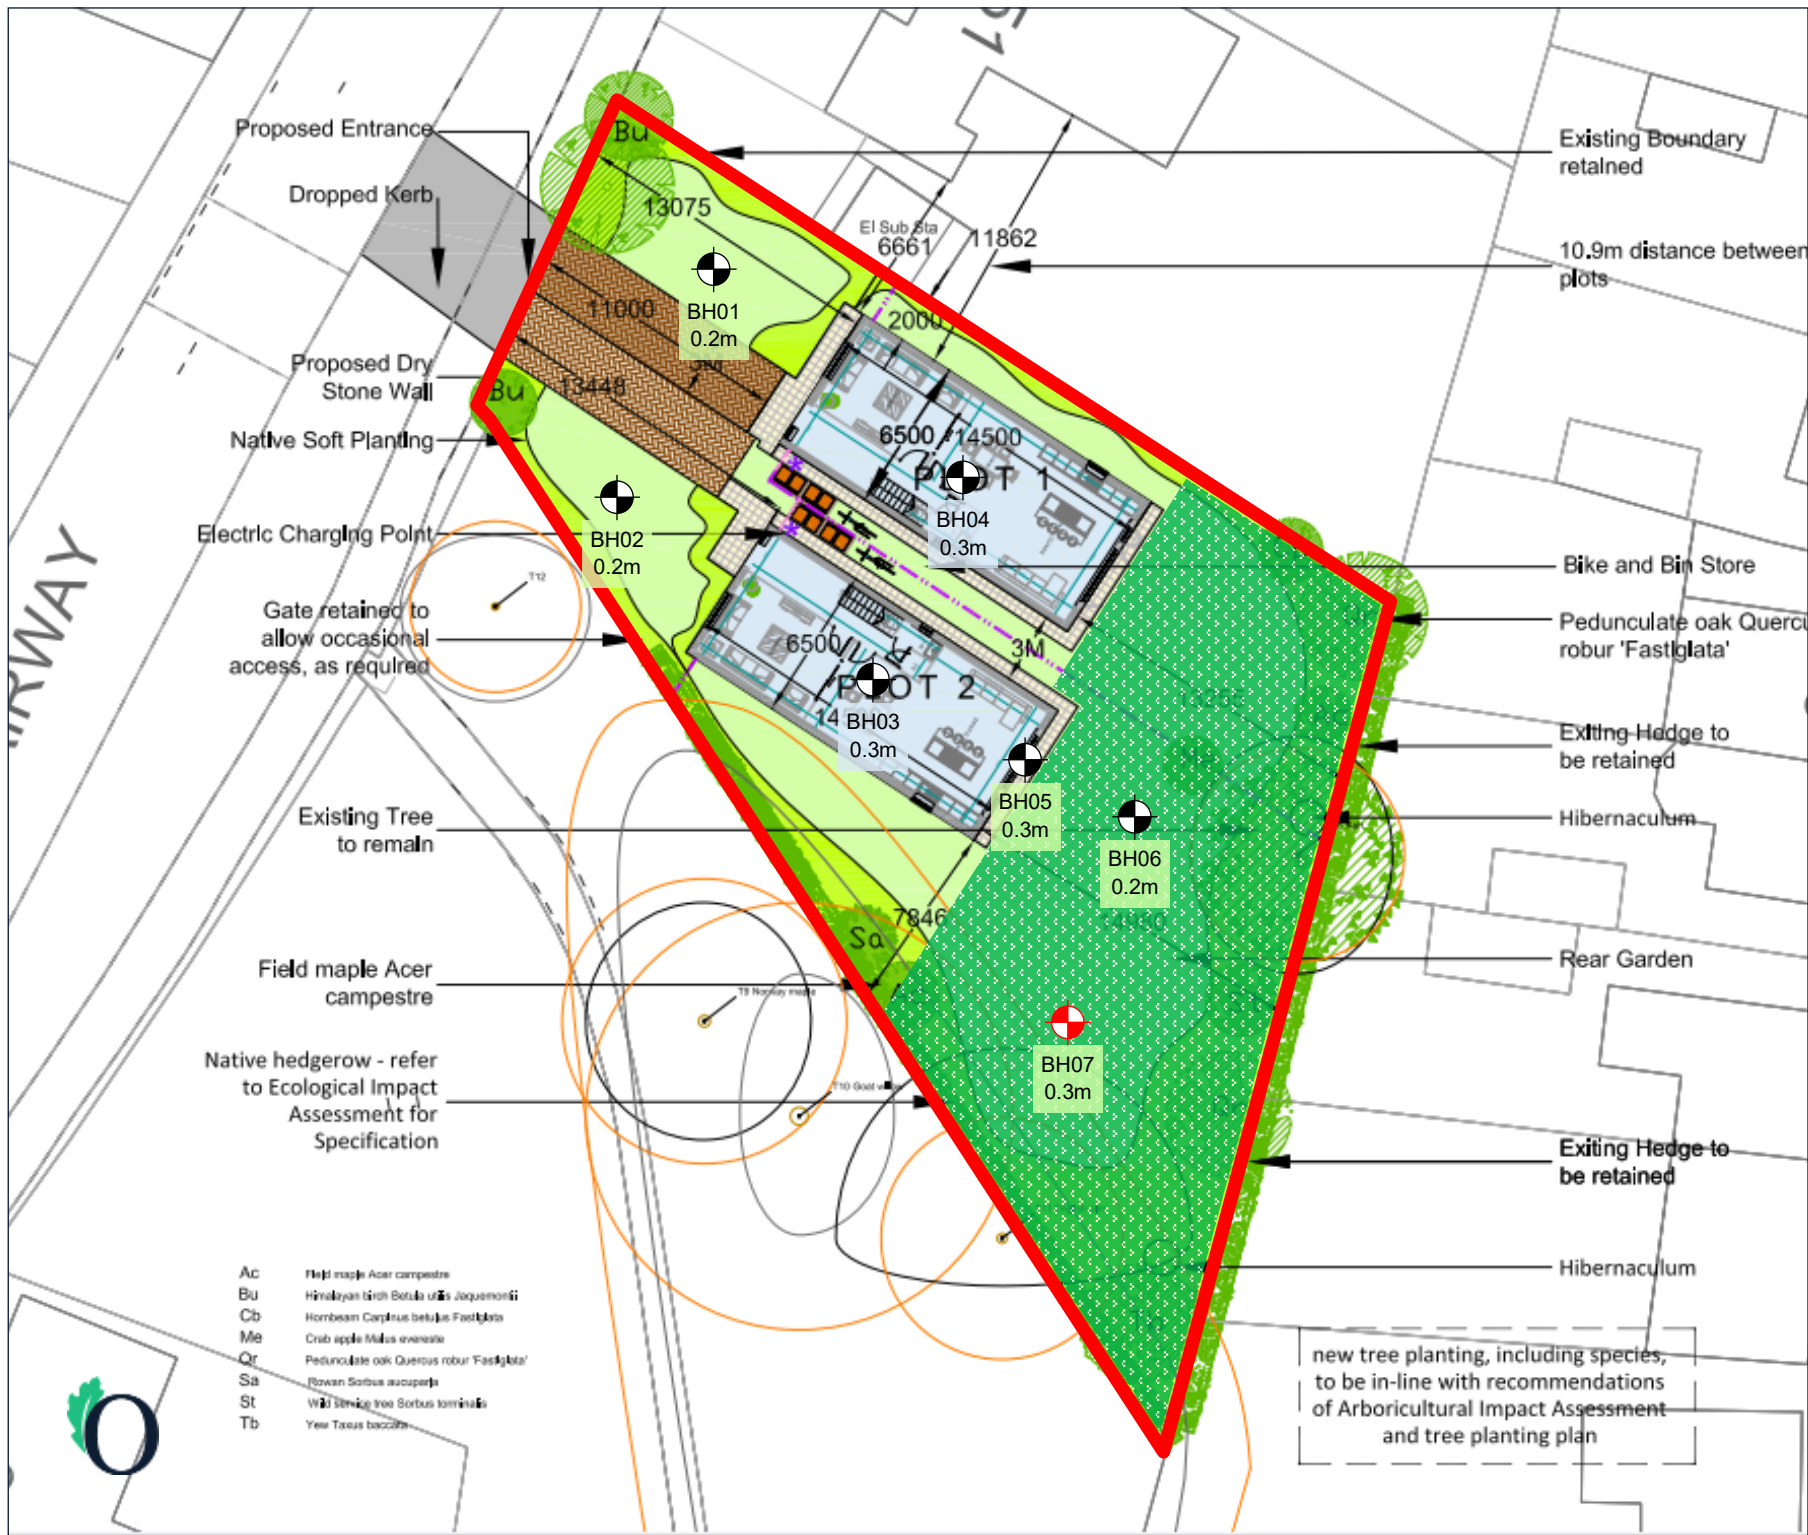
Figure 3

Proposed site plan, showing sample locations

Contaminated sample

Approximate area to be excavated and covered
