# Design and Access Statement

17-23 St Ann's Square  
Rev A - 12th November 2024

JOHNSON PINNEY ARCHITECTS

| 3.0 | Structural Proposal |

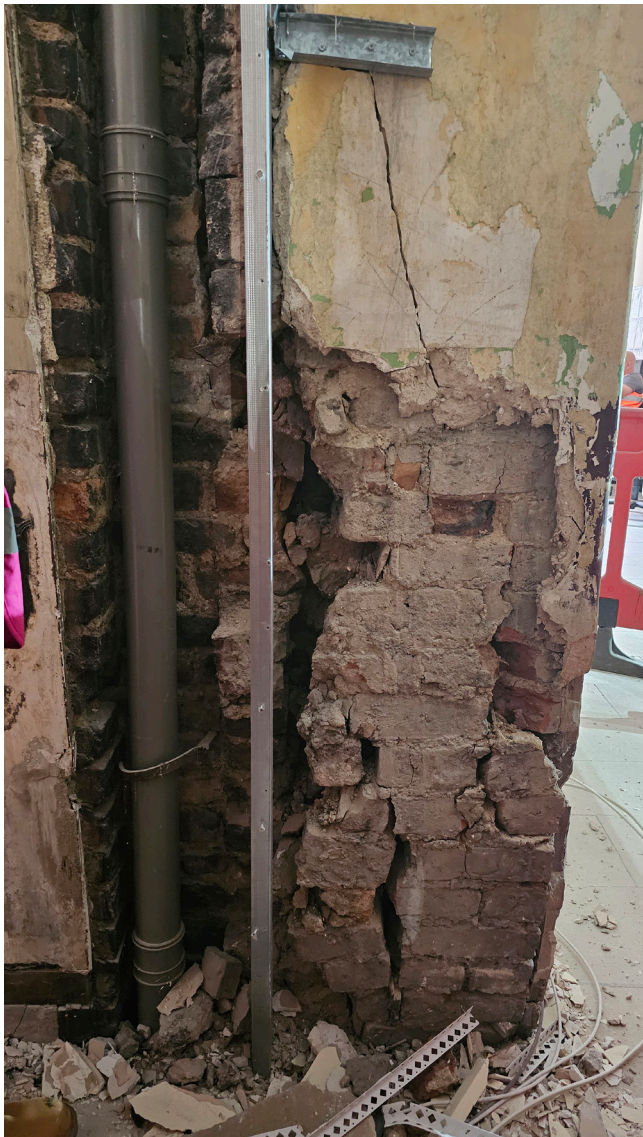
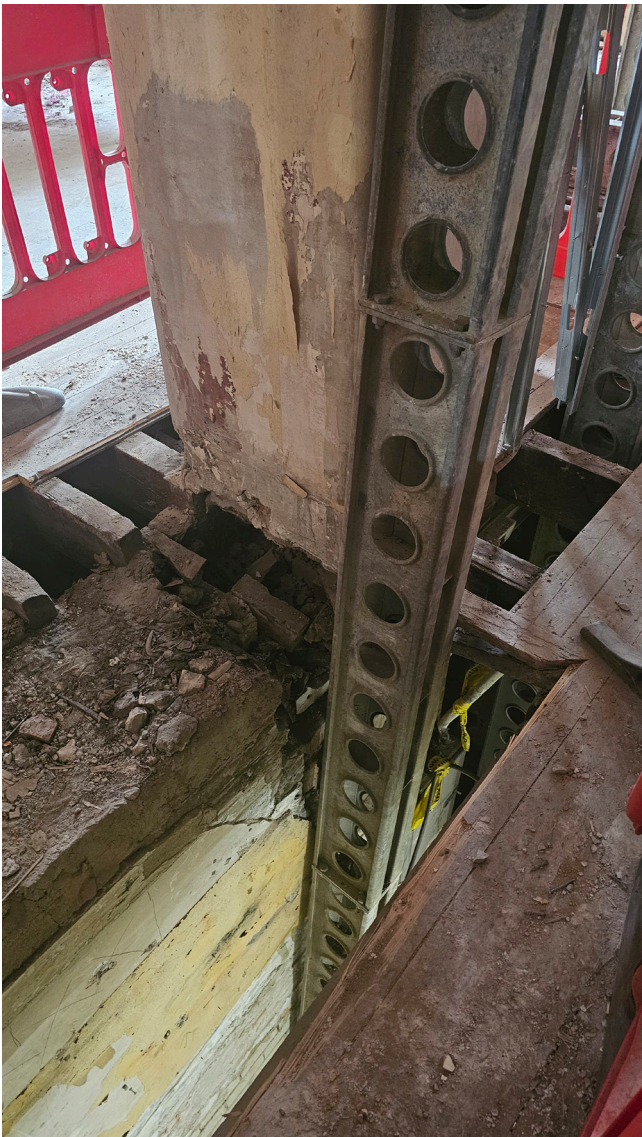
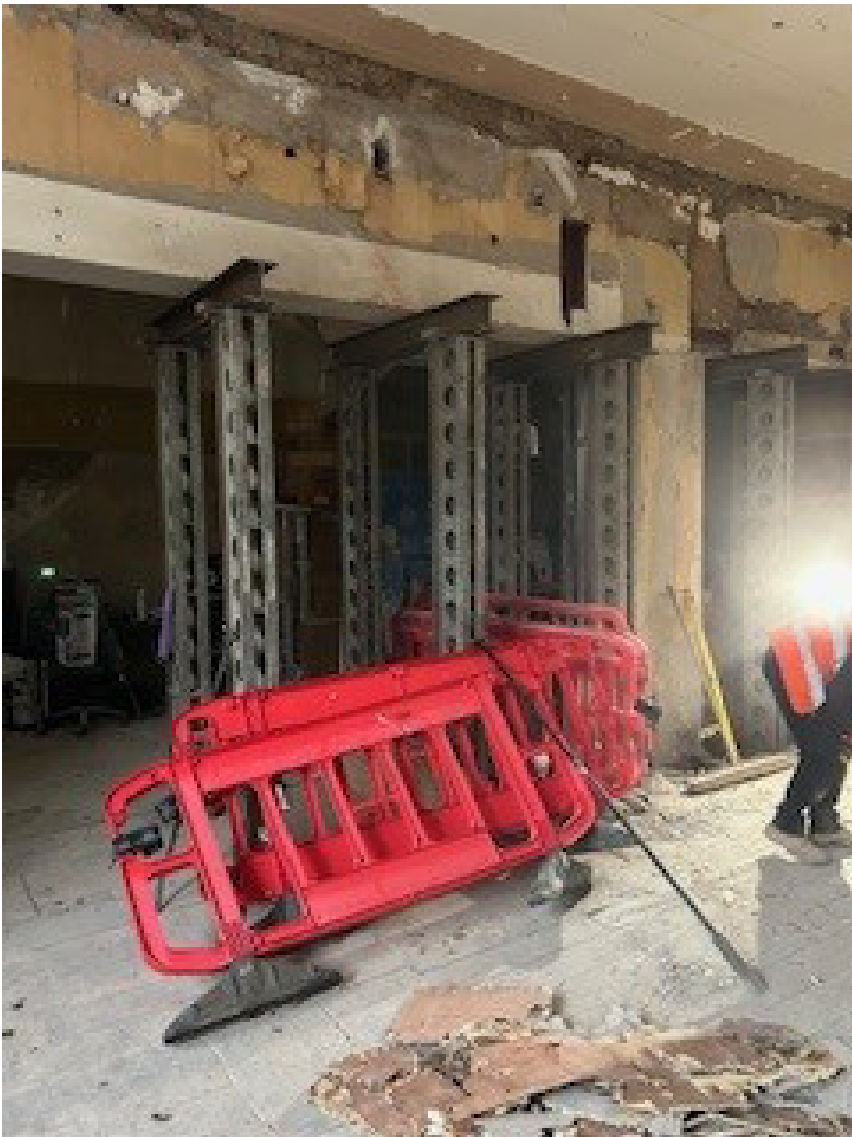
Once all finishes were removed, the existing masonry was fully inspected. Significant vertical cracks were observed at both ends of the pier, which are believed to continue through the entire pier, which have resulted in a section of the existing masonry being separated from the rest of the pier. The base of the pier was also found to be partially supported on existing floor joists with large gaps present between the pier and the wall below.

The inspection also revealed that a portion of the masonry pier, L-shaped on plan, remained in good condition with adequate support at its head and base.

It is believed that the defects are a result of the forming of the adjacent opening, which concentrated load on the masonry in this location.

- 1. Photo showing the corner pier damage
- 2. Photo showing the corner pier damage
- 3. Photo showing the corner pier damage

The proposed works involves a partial rebuild of the existing corner pier. The portion of the existing pier deemed in good condition is to be retained with the remaining portion of brickwork replaced.

The defective section of the corner pier is replaced with high strength engineering brickwork fully toothed and bonded to the retained section of the corner pier. The new section of masonry will be rebuilt to a greater length to allow load spread from walls and floors above into the existing wall below.
