# REMEDIATION STRATEGY REPORT

| job number | C3757/24/E/6619 | date | 03.05.2024 |
| site address | Manchester Metropolitan University,<br>Lower Ormond Road,<br>Manchester,<br>M15 6BX. | | |

## Phase 3: Remediation Statement

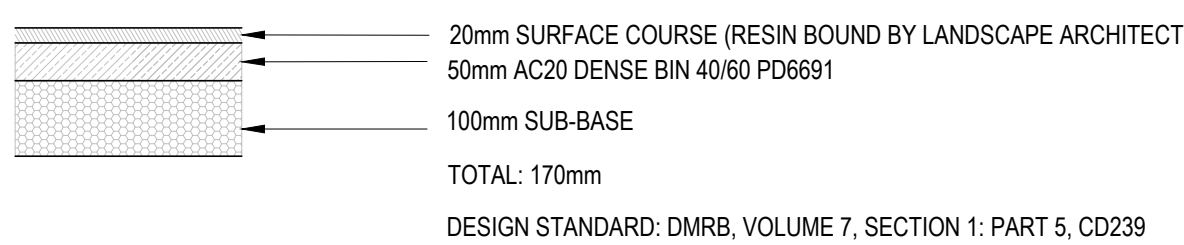
PAVEMENT P7a (TRAFFIC CATEGORY 2)  
RESIN BOUND GRAVEL  
(Scale: 1:10)
