## Enabling Works Handover Document

Victoria Riverside, Manchester

**CLIENT: FEC**

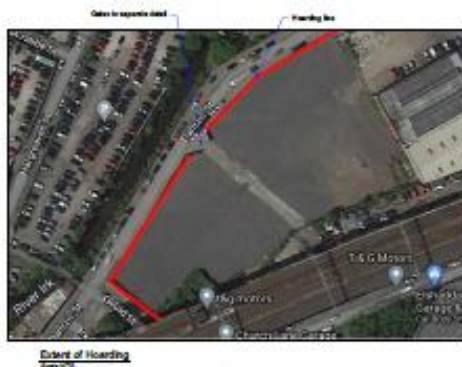
## Temporary works drawing NK-2906-001 Site Hoarding

Hoarding design was completed by NK Engineering on behalf of Henry Construction as instructed by FECIL on the kentledge block design to allow for altering later and painted to RAL 7011 dark grey as per email 06.04.2021.
