**REPORT ON  
GROUND INVESTIGATION  
AT  
BARLOW MOOR ROAD,  
CHORLTON**

| <b>Client:</b> | Liveman Properties Ltd |
| <b>Report Title:</b> | Report on Ground Investigation at Barlow Moor Road, Chorlton |
| <b>Report Number:</b> | AG3093-19-AJ73 |

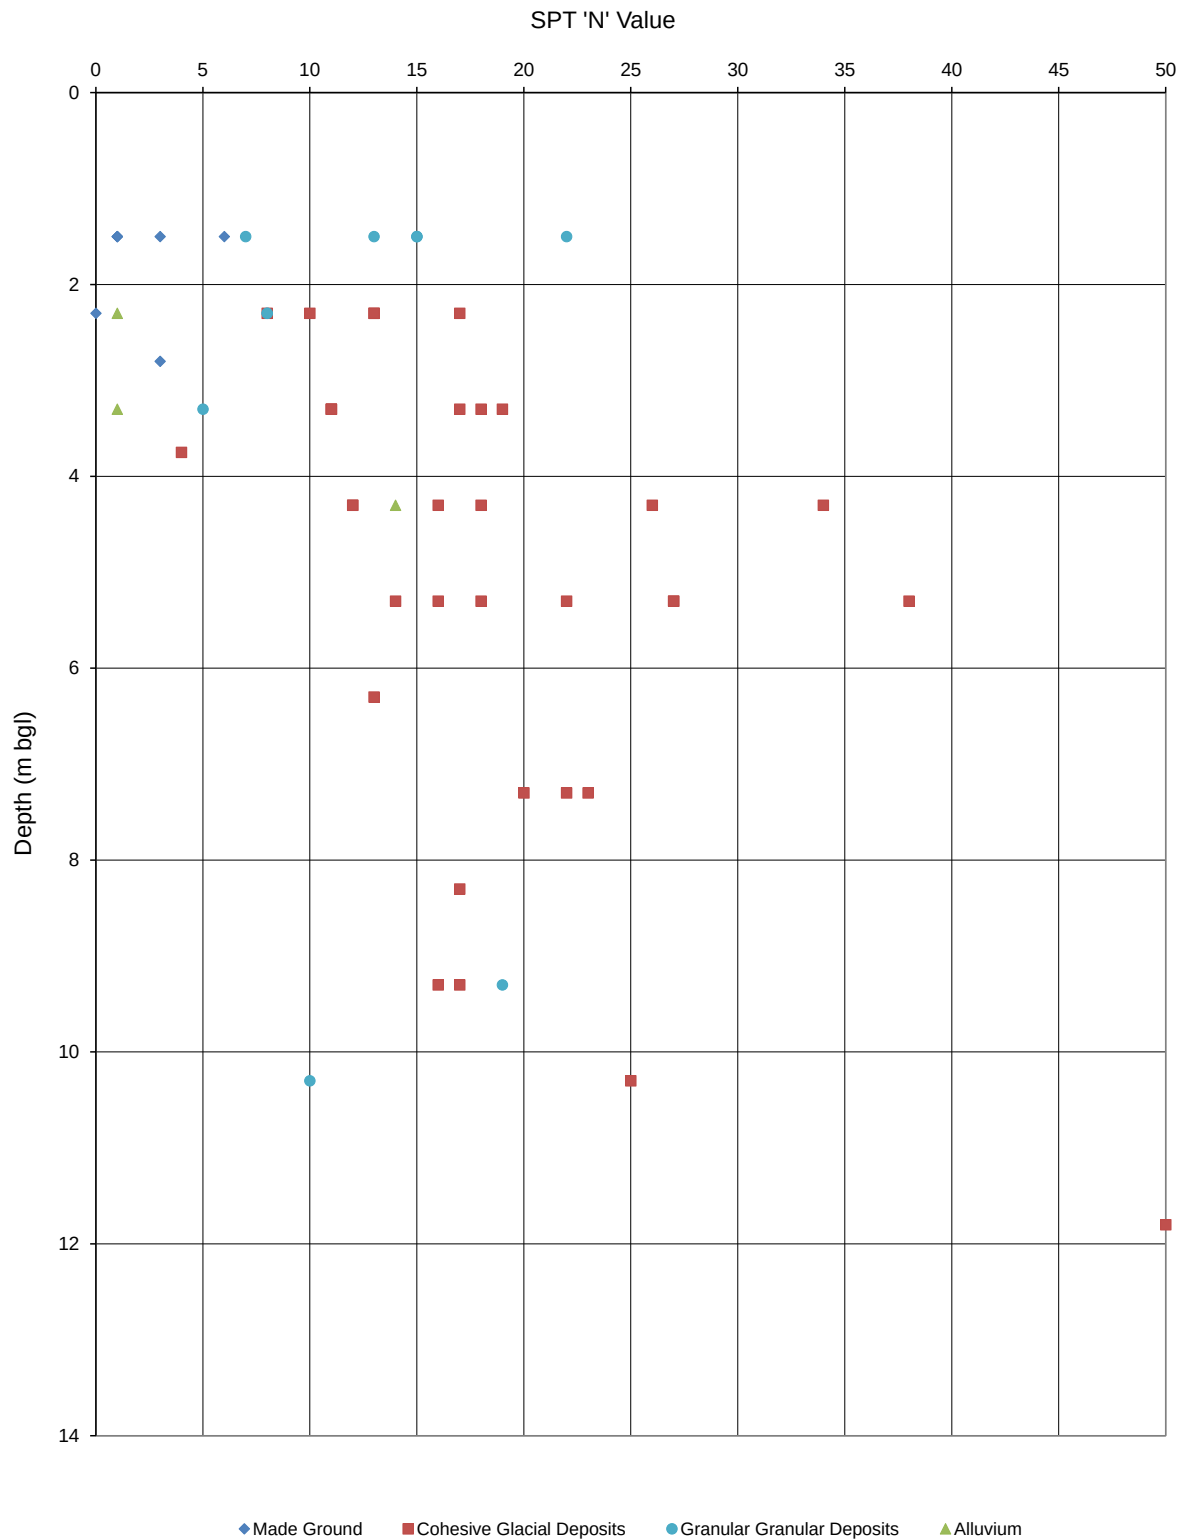
# Uncorrected SPT 'N' Value versus depth

Notes: 1. Values >50 omitted for clarity

Ten SPTs undertaken within the granular Glacial Deposits recorded 'N' values between N=5 (loose) and N=22 (medium dense).

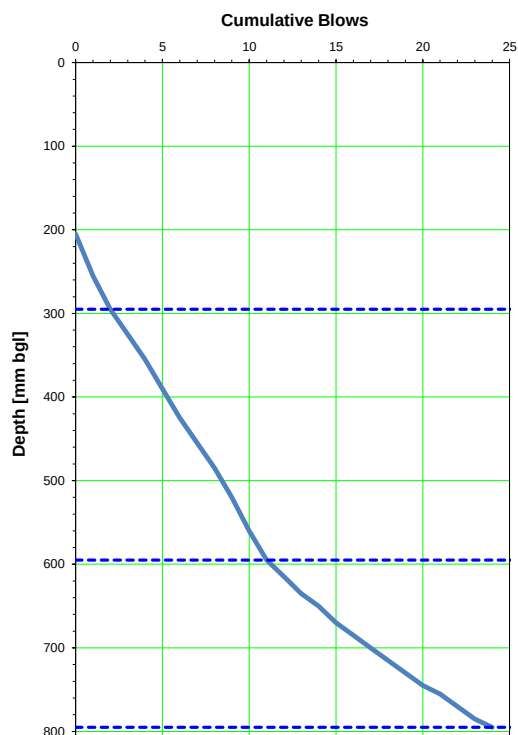
**Notes:** TRL Equation :  $\text{Log}_{10}(\text{CBR}) = 2.480 - 1.057 \times \text{Log}_{10}(\text{mm/blow})$  from IAN 73/06 Revision 1 (2009)  
Tested in accordance with in house method, based upon TRL Road Note 31 & 8

Based on a review of in situ CBR testing carried out, classification testing, soil type, and reference to IAN 73/06, an equilibrium CBR value of 5% is recommended for the granular glacial strata. Due to the inherent variability of the Made Ground, an equilibrium CBR value of 2% is recommended for this stratum.

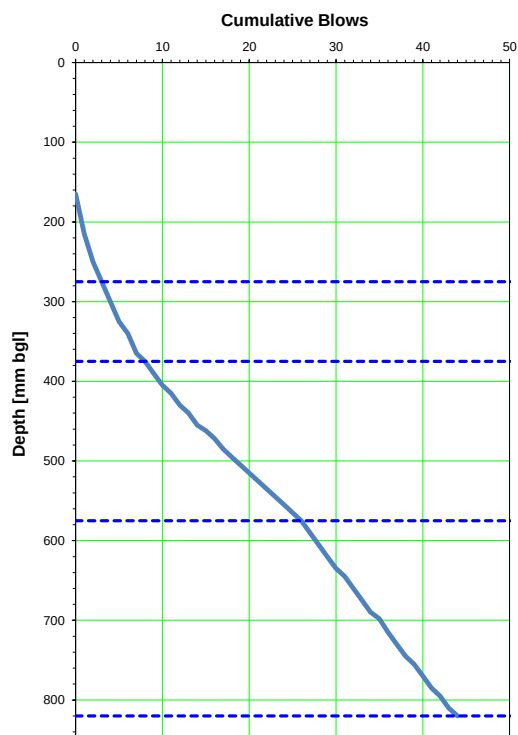
**Notes:** TRL Equation :  $\text{Log}_{10}(\text{CBR}) = 2.480 - 1.057 \times \text{Log}_{10}(\text{mm/blow})$  from IAN 73/06 Revision 1 (2009)  
Tested in accordance with in house method, based upon TRL Road Note 31 & 8

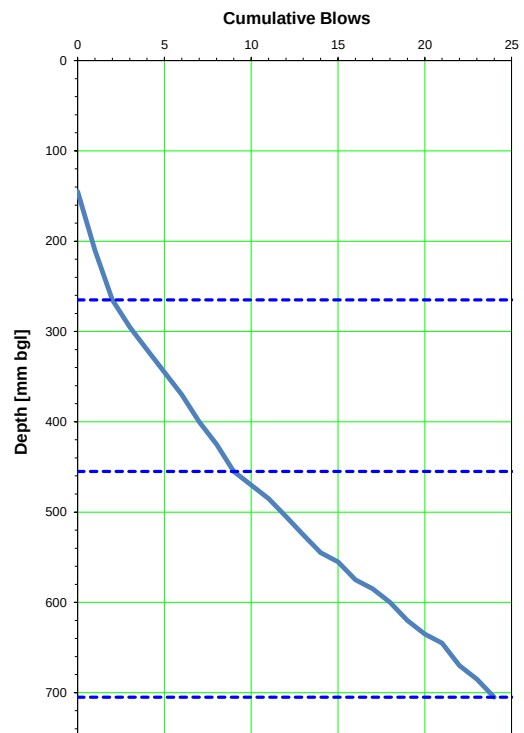
**Notes:** TRL Equation :  $\text{Log}_{10}(\text{CBR}) = 2.480 - 1.057 \times \text{Log}_{10}(\text{mm/blow})$  from IAN 73/06 Revision 1 (2009)  
Tested in accordance with in house method, based upon TRL Road Note 31 & 8

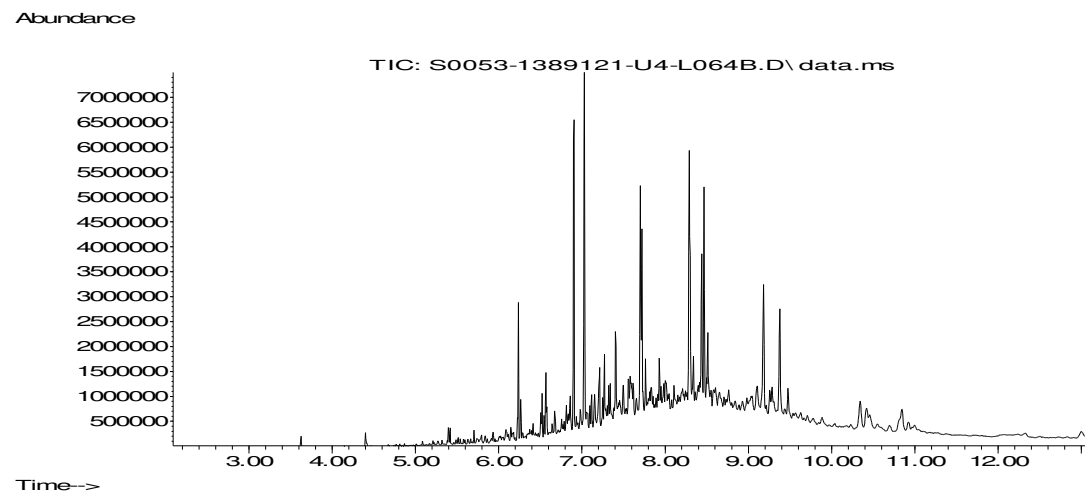
The total ion count (TIC trace) shows a carbon range from C10 to C44.  
The sample TIC trace is complex, showing predominantly aromatic product sources.  
The chromatographic profile is consistent with substituted poly aromatic hydrocarbons.

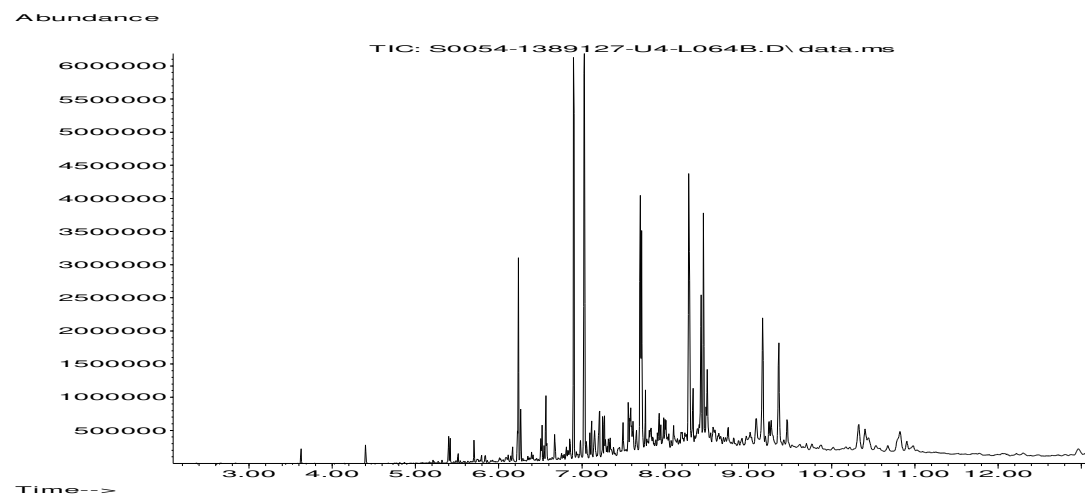
The total ion count (TIC trace) shows a carbon range from C10 to C44.  
Sample does not match with fuel profile, but is consistent of PAH's.

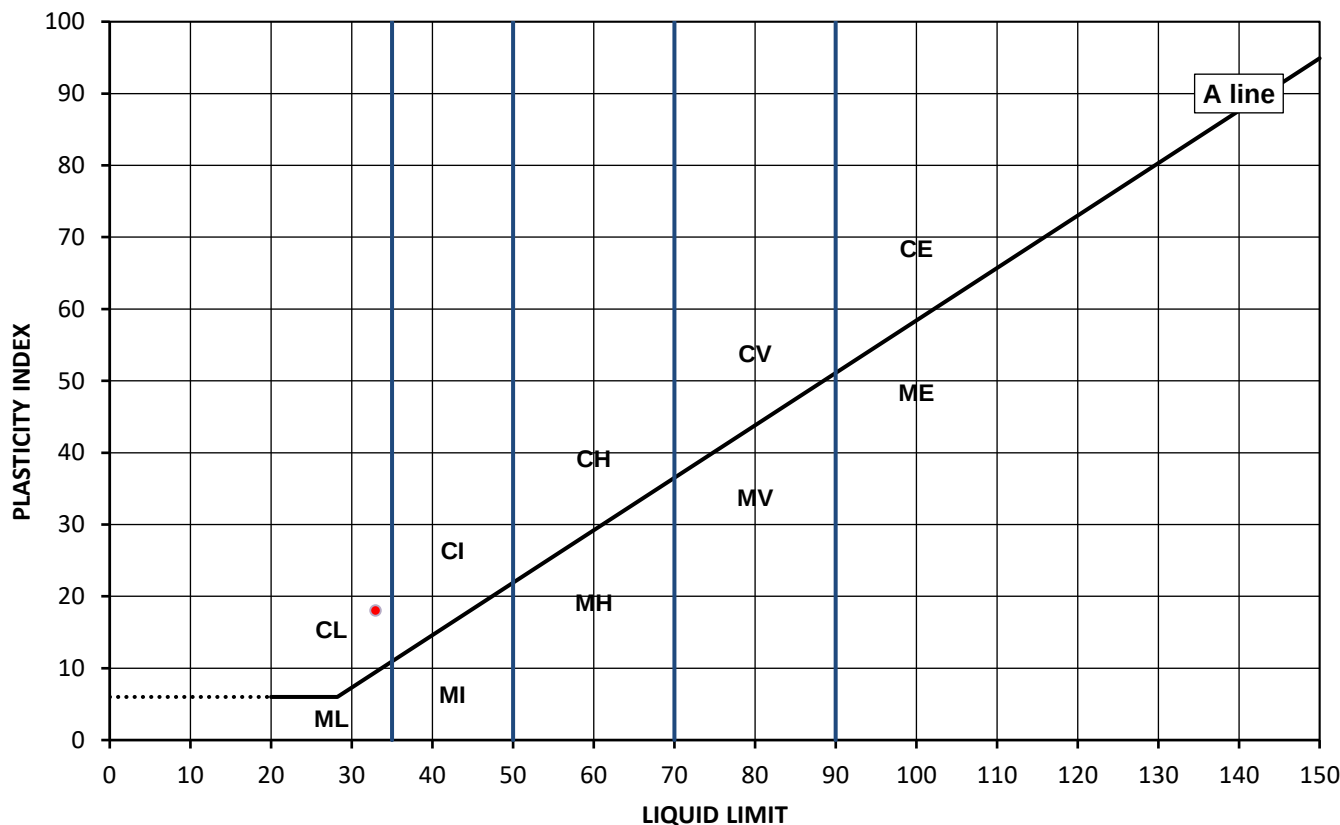
| As Received Moisture Content [%] | Liquid Limit [%] | Plastic Limit [%] | Plasticity Index [%] | % Passing 425µm BS Test Sieve |
|---|---|---|---|---|
| 16 | 33 | 15 | 18 | 83 |

The results of eight Atterberg limits tests carried out on cohesive Glacial Deposits have given plasticity indices of between 12% and 33% (corrected to between 10% and 33%), liquid limits of between 23% and 59%, and plastic limits of between 11% and 26%, indicating the soil to be clay of low to high plasticity and low to medium volume change potential. The results of moisture content tests recorded values of between 11% and 30%.

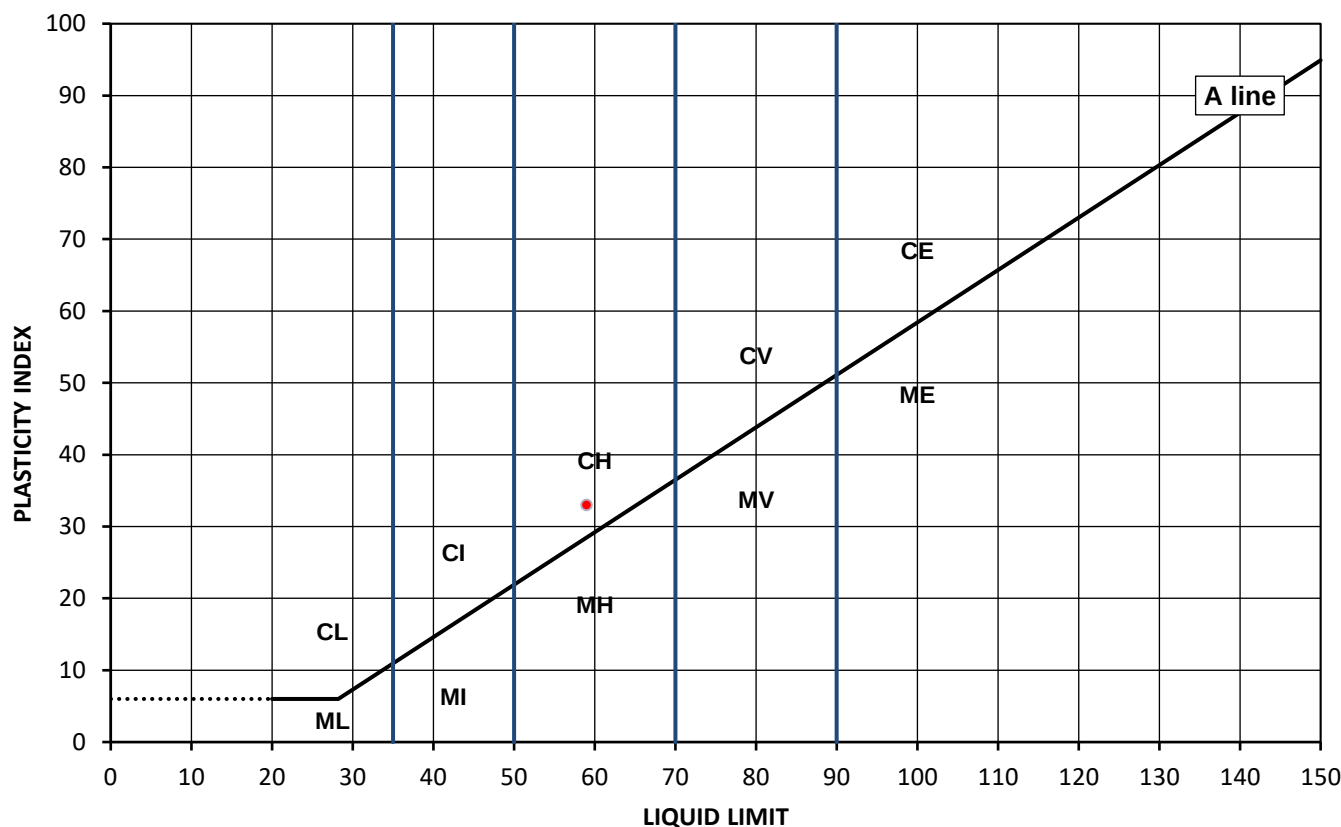
| As Received Moisture Content [%] | Liquid Limit [%] | Plastic Limit [%] | Plasticity Index [%] | % Passing 425µm BS Test Sieve |
|---|---|---|---|---|
| 30 | 59 | 26 | 33 | 100 |
