## Phase II GeoEnvironmental Investigation

Bradstone Road

Manchester

**Report Ref: A2333/18/V2**

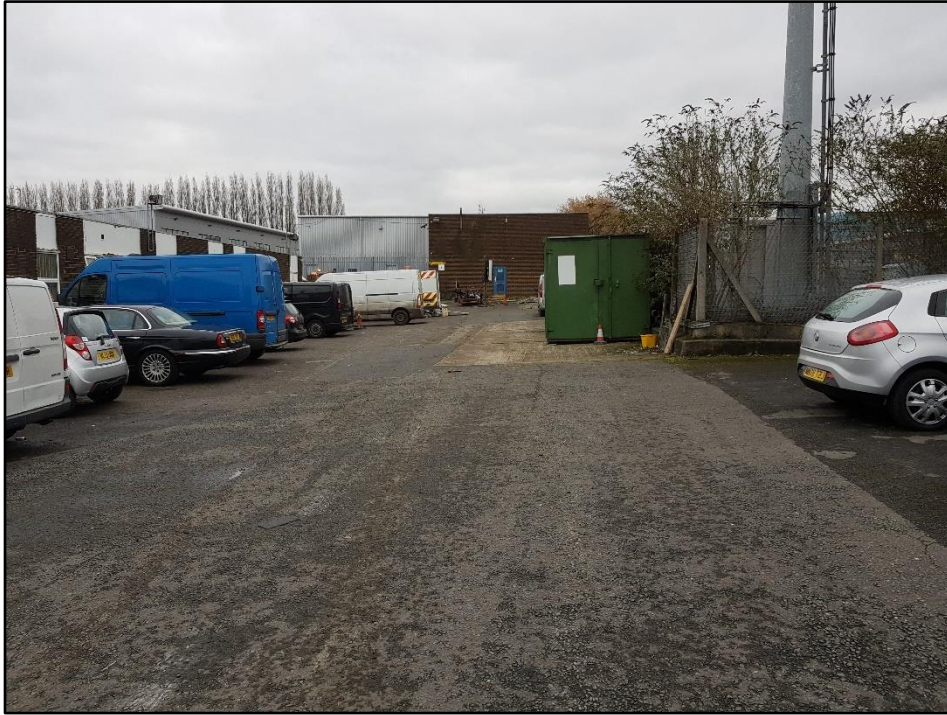
**Figure 3 View across the south of the site during 2017 investigation, facing east.**

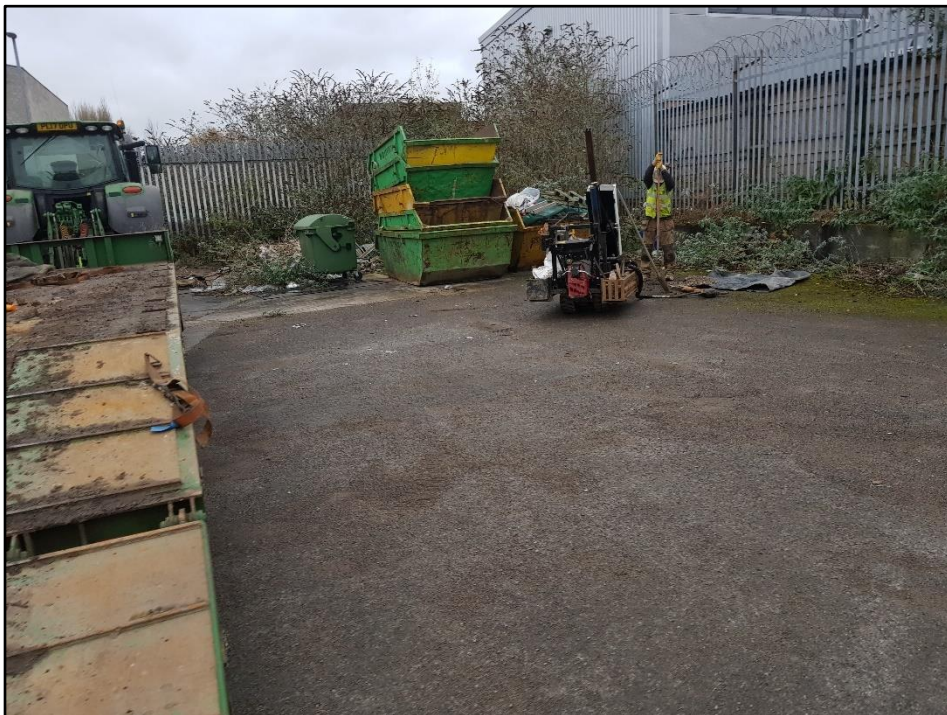
**Figure 4 WS101 drilling in progress during 2017 investigation, facing north.**

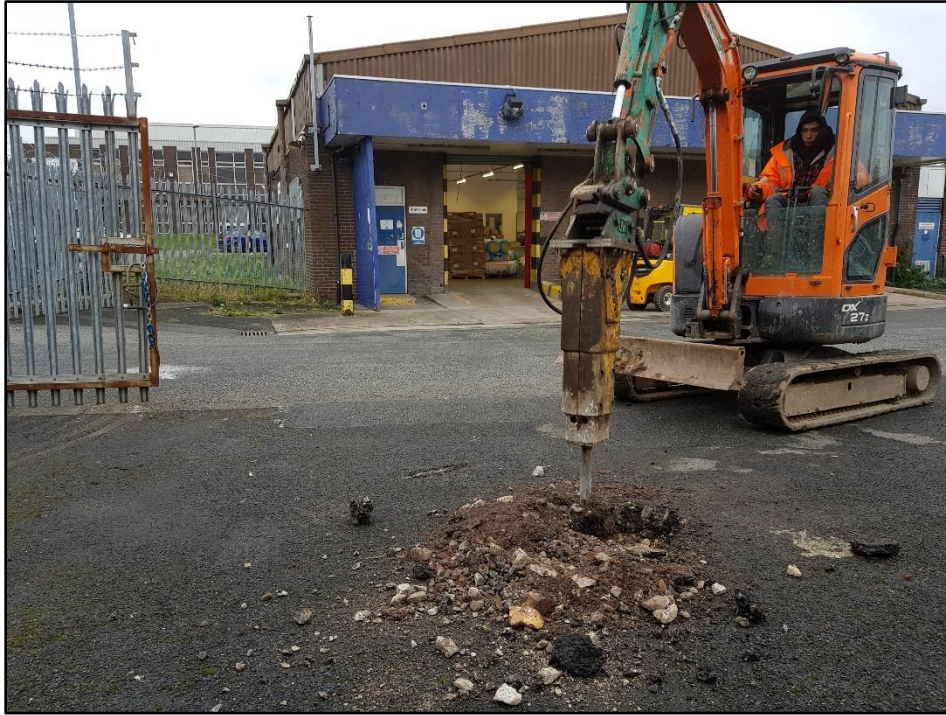
**Figure 5 Excavation in progress during 2017 investigation, southwest of the site.**

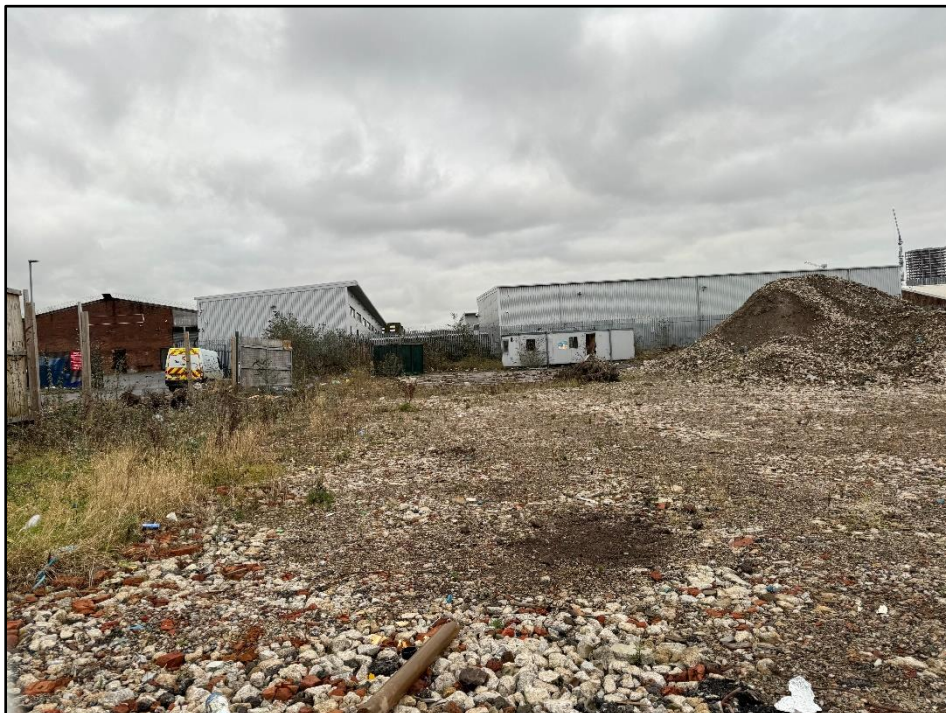
**Figure 6 View across site during 2023 investigation, facing east.**

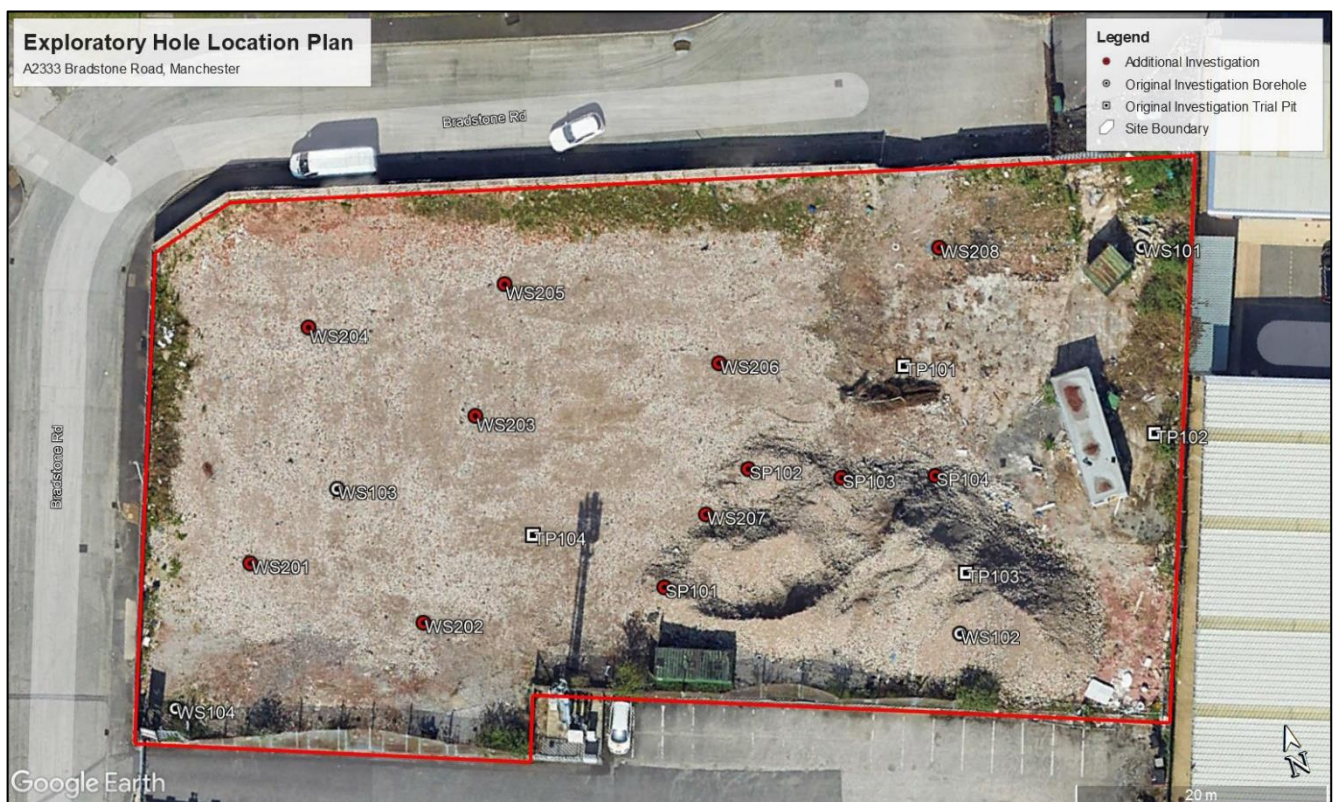
**Figure 8 Exploratory Hole Location Plan**

- Four trial pits (designated TP101-TP04) were excavated by use of a hydraulic excavator, to a nominal depth of 2.30m bgl for the purpose of assessing ground conditions and collecting environmental and geotechnical samples. Exploratory Hole logs for the trial pits are also included in Appendix 1.

- Additionally, four samples were retrieved from a stockpile during the follow-up investigation for environmental testing, located in the southern corner of the site.
