Remediation And Enabling Works  
Validation Report  
Ancoats Dispensary

Reference: 14-274-R2  
Date: August 2022

Ancoats Dispensary  
Old Mill St  
Ancoats  
Manchester  
M4 6EB

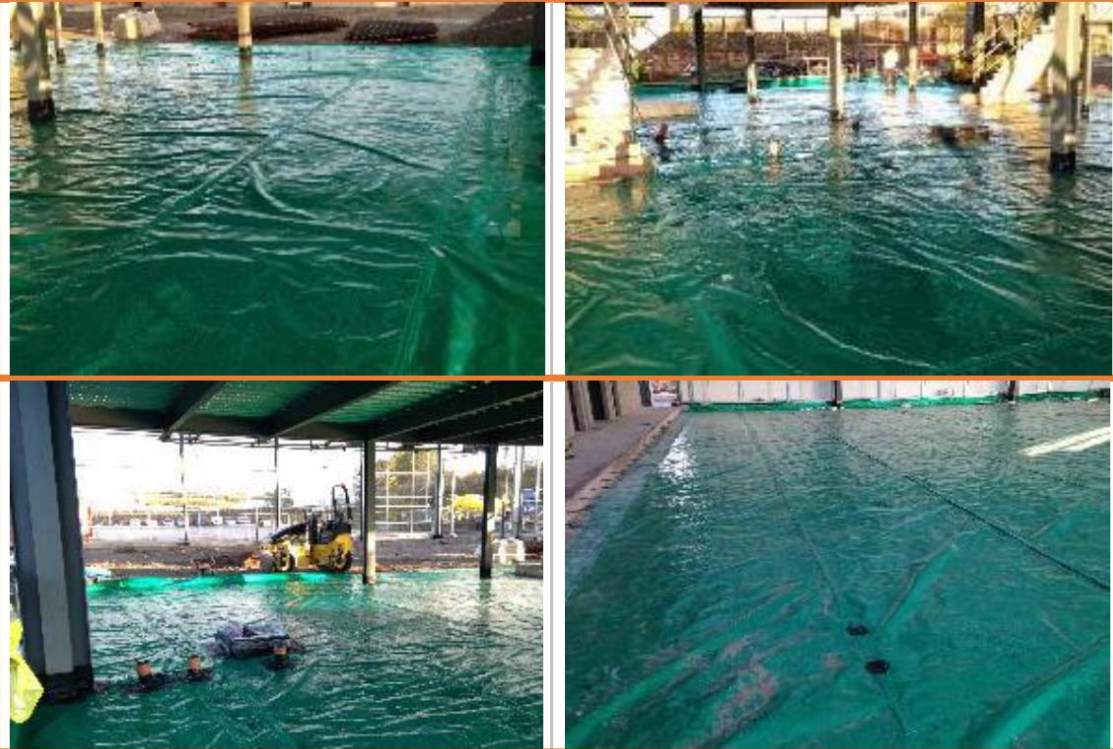
**General Condition of Membrane-Good Condition**

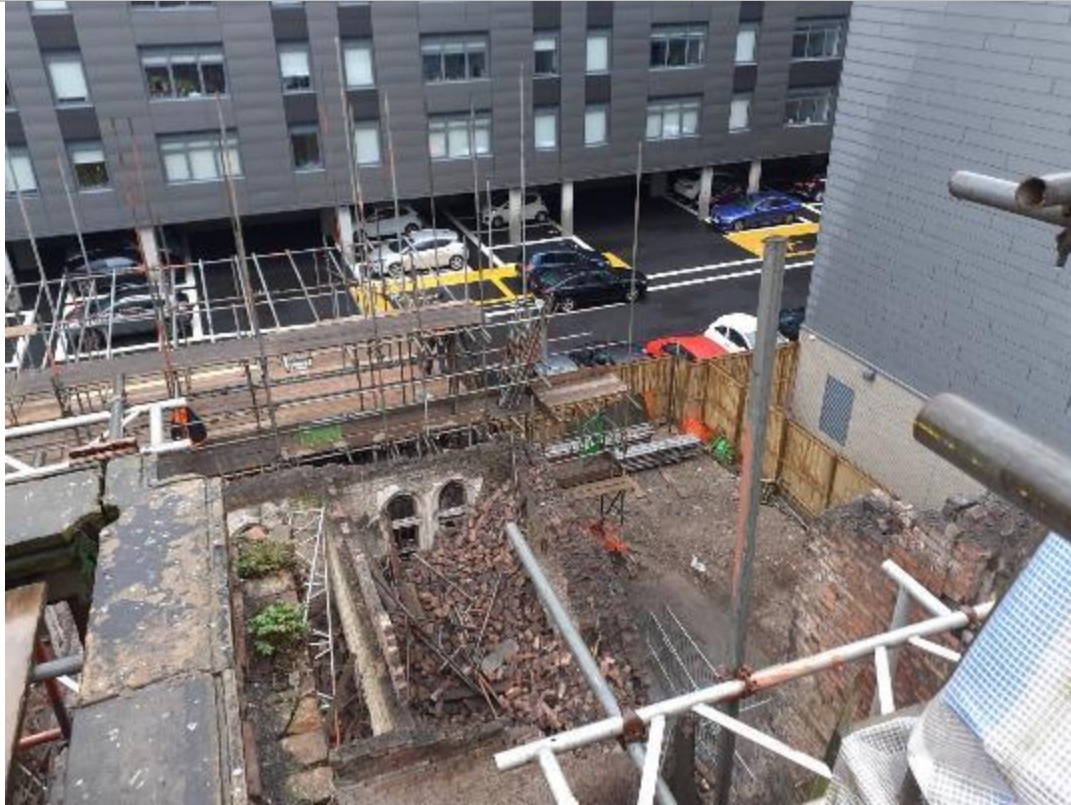
PLATE 1 04/04/2022 – VIEW OF PHASE 1 AREA PRIOR TO DEMOLITION

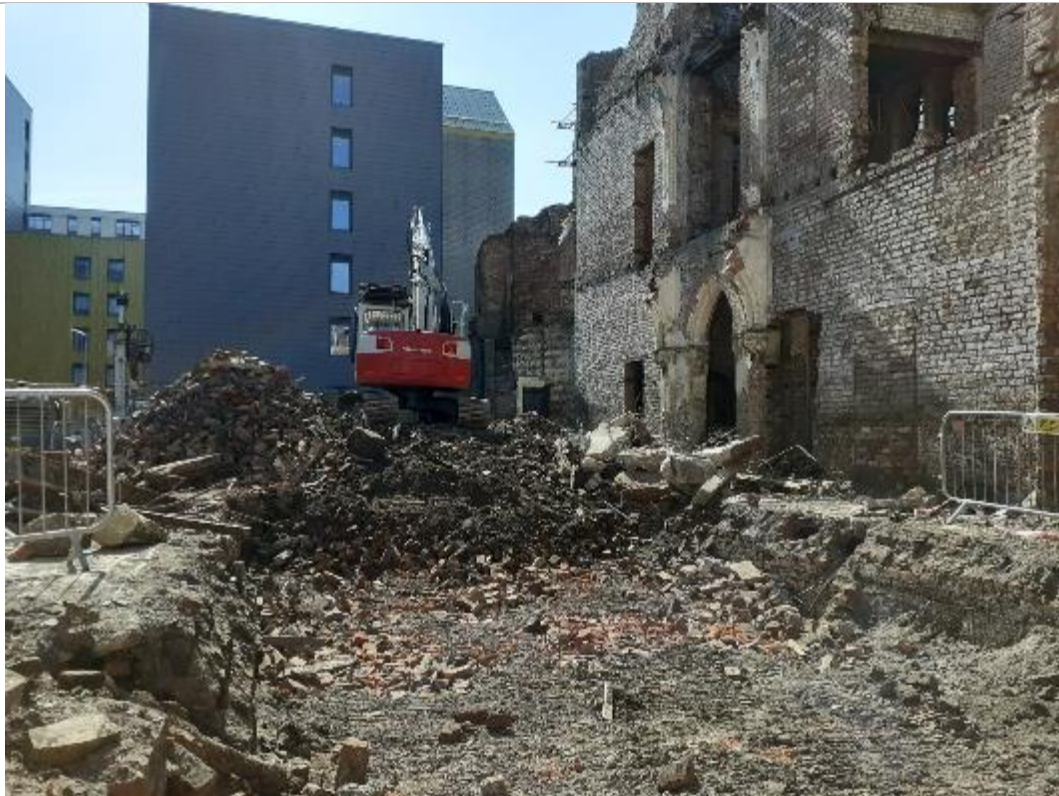
PLATE 2 22/04/2022 VIEW OF THE ONGOING DEMOLITION FACING WEST

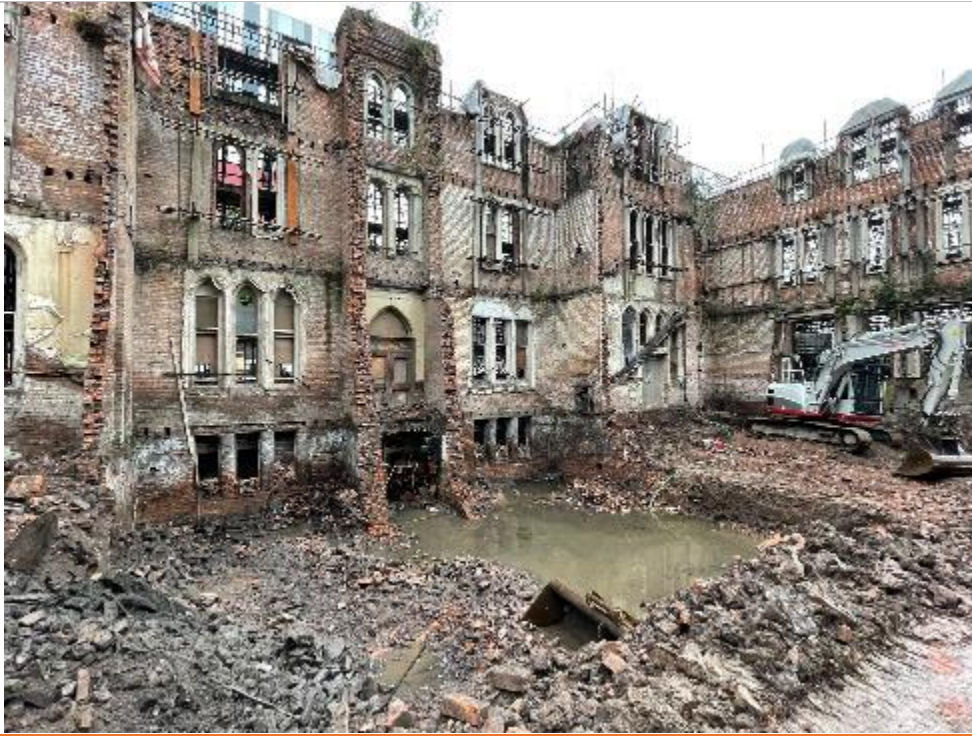
PLATE 3      13/05/2022 – VIEW OF SITE FACING NORTH, WITH FORMER CELLAR IN THE CENTRAL PHASE 2 AREA.

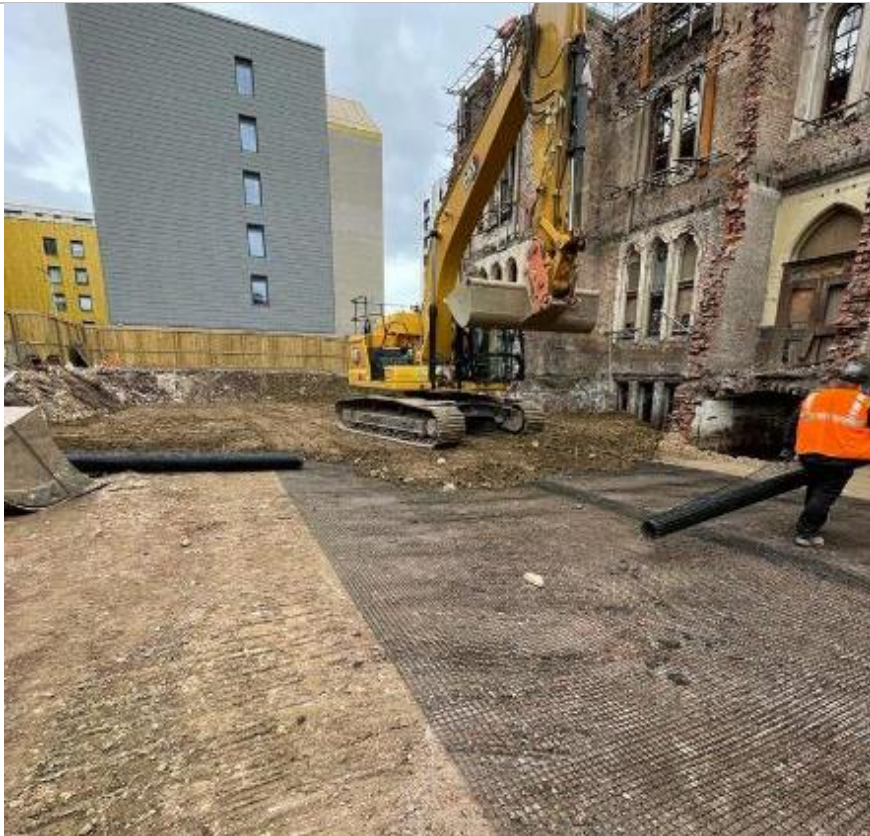
PLATE 4      23/05/2022 LAYING GEOTEXTILE ON UNDERLYING NATURAL GROUND AND INITIAL LAYER OF IMPORTED 6F2.

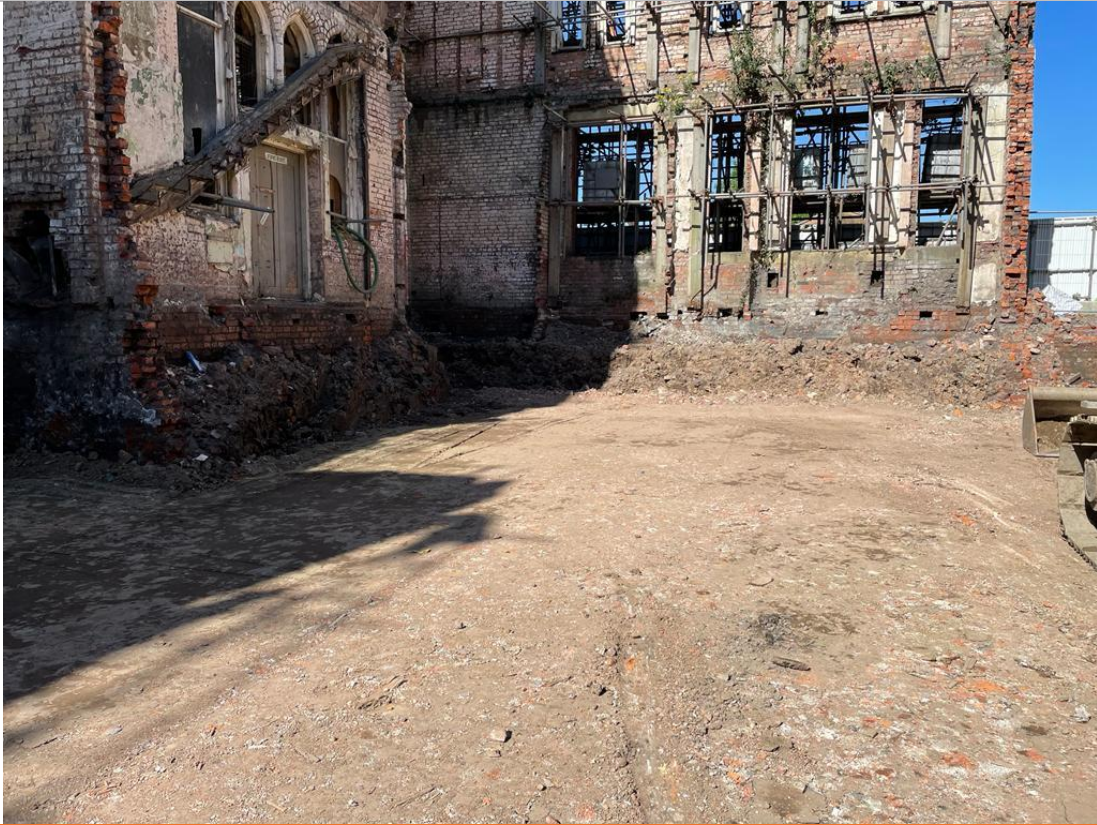
23/05/2022 – VIEW OF FIRST LAYER OF PILE MAT FACING EAST

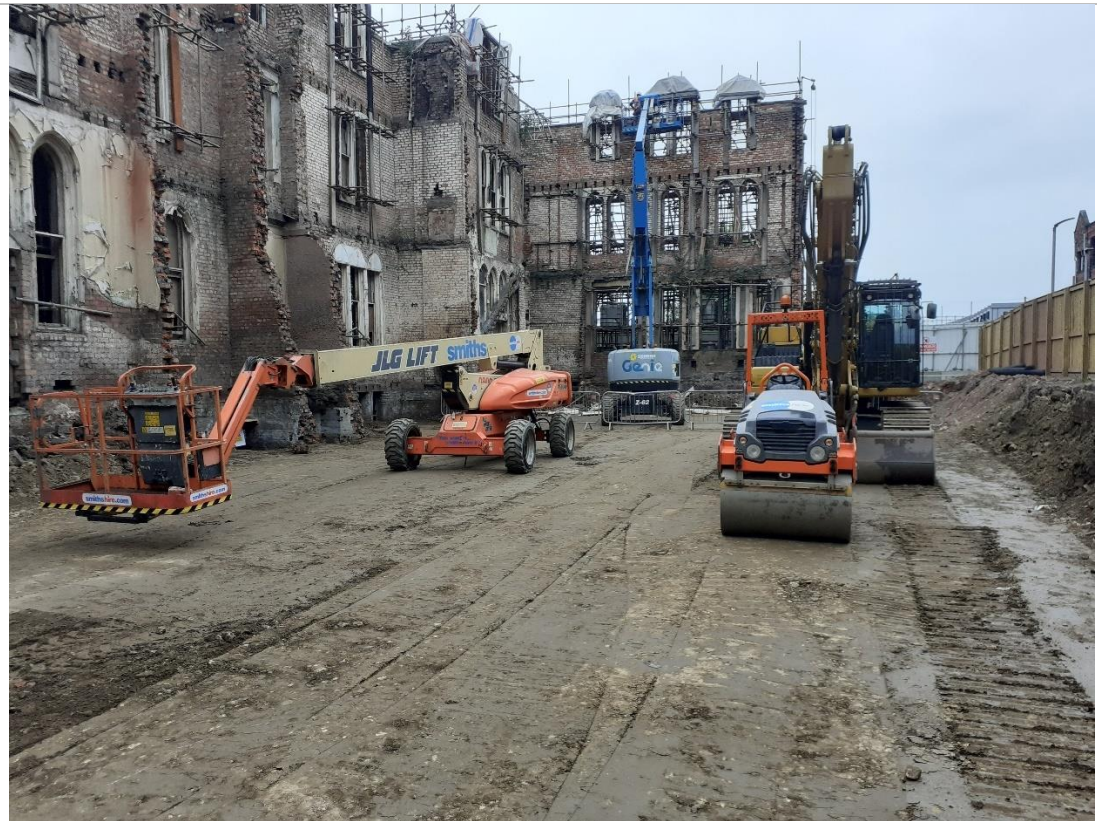
PLATE 6

25/04/2022 VIEW OF THE ONGOING DEMOLITION FACING WEST

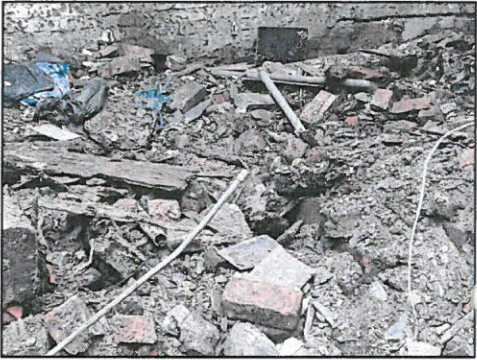
| <b>Location:</b> | Dispensary - Ground floor - Phase 3 - Cement fragments in the debris and rubble | | | <b>Item No:</b> | 1 |
| <b>Asbestos Type:</b> | Chrysotile (1) | <b>Item type:</b> | Sampled | | |
| <b>Condition:</b> | Medium damage (2) | <b>Accessibility:</b> | Moderate | | |

| <b>Recommendation:</b> | Remove if affected by refurbishment works. Manage in-situ otherwise | | | | |

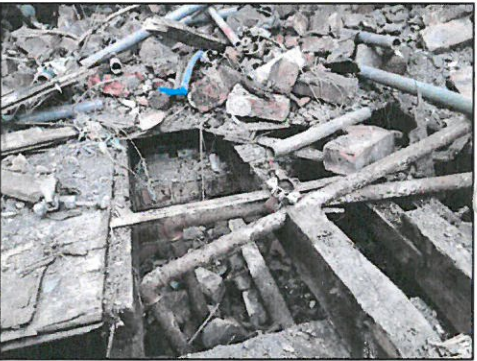
| <b>Location:</b> | Dispensary - Ground floor - Phase 3 - Textile wrap to pipework | | | <b>Item No:</b> | 2 |

| <b>Asbestos Type:</b> | NAD | <b>Item type:</b> | Sampled | | |
| <b>Condition:</b> | N/A | <b>Accessibility:</b> | N/A | | |

| <b>Recommendation:</b> | None | | | | |

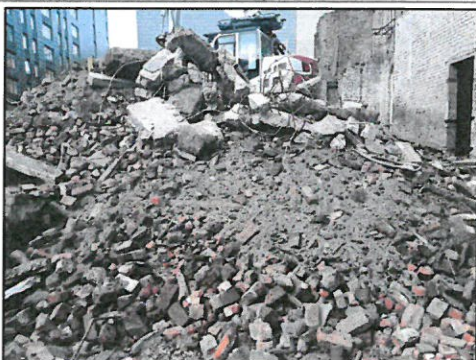
| Location: | Dispensary - Ground floor - Phase 3 - Brick hardcore in debris pile | | | Item No: | 3 |
| Asbestos Type: | Amosite (2) | Item type: | Sampled | | |
| Condition: | Medium damage (2) | Accessibility: | Moderate | | |

| Recommendation: | Remove if affected by refurbishment works. Manage in-situ otherwise | | | | |

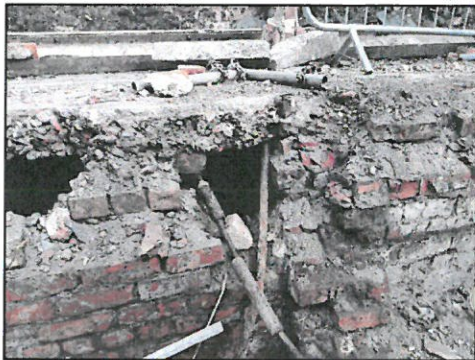
| Location: | Dispensary - Ground floor - Phase 3 - Textile wrap to pipework in the basement | | | Item No: | 5 |
| Asbestos Type: | Chrysotile (1) | Item type: | Sampled | | |
| Condition: | Medium damage (2) | Accessibility: | Moderate | | |

| Recommendation: | Remove if affected by refurbishment works. Manage in-situ otherwise | | | | |

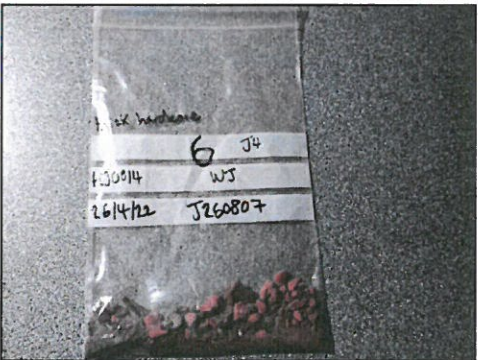
| <b>Asbestos Type:</b> | NAD | <b>Item type:</b> | Sampled | | |
| <b>Condition:</b> | N/A | <b>Accessibility:</b> | N/A | | |

| <b>Recommendation:</b> | None | | | | |

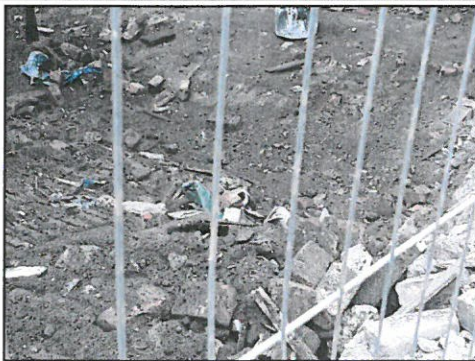
| Location: | Dispensary - Ground floor - Phase 3 - Brick hardcore to the debris on the floor | | | Item No: | 1 | |
| Asbestos Type: | Chrysotile + Crocidolite (3) | Item type: | Sampled | | | |

| Recommendation: | Remove if affected by refurbishment works. Manage in-situ otherwise | | | | | |

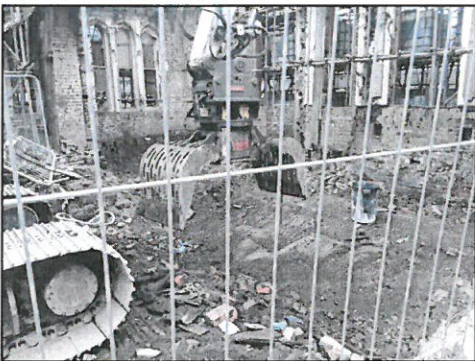
| Location: | Dispensary - Ground floor - Phase 3 - Brick hardcore to the floor in the debris | | | Item No: | 2 |
| Asbestos Type: | Chrysotile (1) | Item type: | Sampled | | |

| Recommendation: | Remove if affected by refurbishment works. Manage in-situ otherwise | | | | |

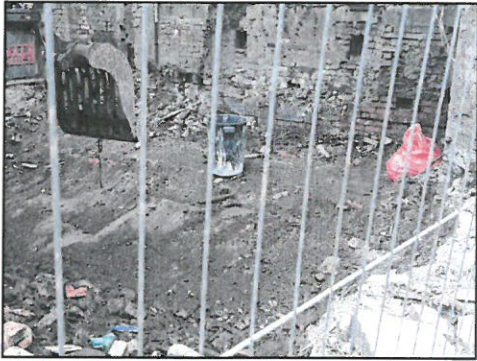
| <b>Location:</b> | Dispensary - Ground floor - Phase 3 - Brick hardcore to the floor in the debris | | | <b>Item No:</b> | 3 |

| <b>Asbestos Type:</b> | NAD | <b>Item type:</b> | Sampled | | |
| <b>Condition:</b> | N/A | <b>Accessibility:</b> | N/A | | |

| <b>Recommendation:</b> | None | | | | |

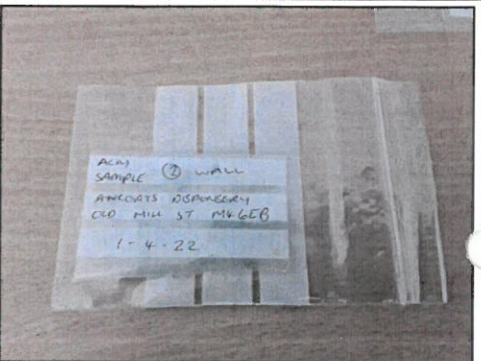
| <b>Location:</b> | Main Building - Ground floor - Property - ACM** wall | | | <b>Item No:</b> | 2 |

| <b>Asbestos Type:</b> | NAD | <b>Item type:</b> | Sampled | | |
| <b>Condition:</b> | N/A | <b>Accessibility:</b> | N/A | | |

| <b>Recommendation:</b> | None | | | | |

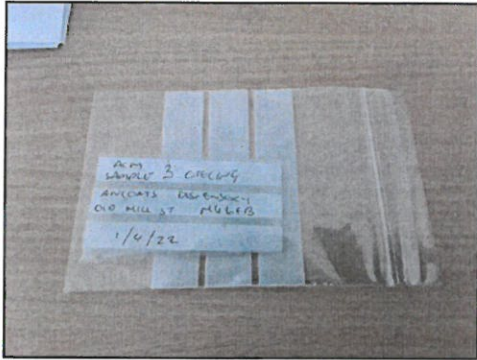
| <b>Location:</b> | Main Building - Ground floor - Property - ACM** ceiling | | | <b>Item No:</b> | 3 |

| <b>Asbestos Type:</b> | NAD | <b>Item type:</b> | Sampled | | |
| <b>Condition:</b> | N/A | <b>Accessibility:</b> | N/A | | |

| <b>Recommendation:</b> | None | | | | |

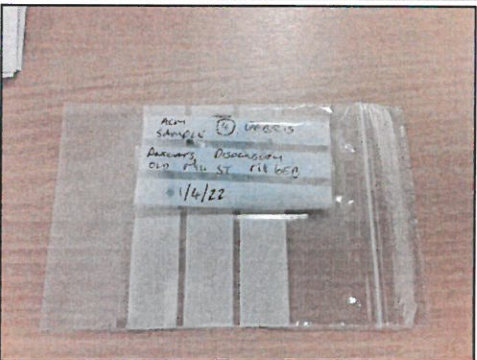
| <b>Location:</b> | Main Building - Ground floor - Property - ACM** debris | | | <b>Item No:</b> | 4 |

| <b>Asbestos Type:</b> | NAD | <b>Item type:</b> | Sampled | | |
| <b>Condition:</b> | N/A | <b>Accessibility:</b> | N/A | | |

| <b>Recommendation:</b> | None | | | | |

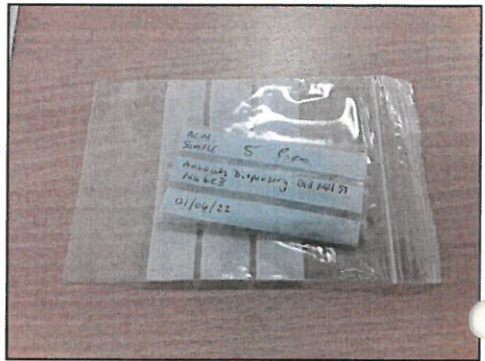
| <b>Location:</b> | Main Building - Ground floor - Property - ACM** pipe | | | <b>Item No:</b> | 5 |

| <b>Asbestos Type:</b> | NAD | <b>Item type:</b> | Sampled | | |
| <b>Condition:</b> | N/A | <b>Accessibility:</b> | N/A | | |

| <b>Recommendation:</b> | None | | | | |

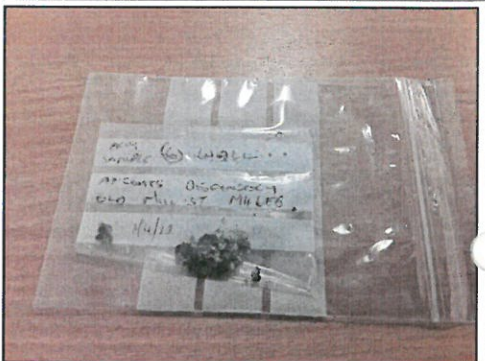
| <b>Location:</b> | Main Building - Ground floor - Property - ACM** wall | | | <b>Item No:</b> | 6 |

| <b>Asbestos Type:</b> | NAD | <b>Item type:</b> | Sampled | | |
| <b>Condition:</b> | N/A | <b>Accessibility:</b> | N/A | | |

| <b>Recommendation:</b> | None | | | | |

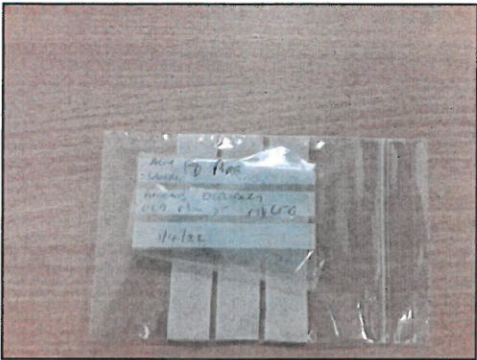
| <b>Location:</b> | Main Building - Ground floor - Property - ACM** pipe | | | <b>Item No:</b> | 7 |

| <b>Asbestos Type:</b> | NAD | <b>Item type:</b> | Sampled | | |
| <b>Condition:</b> | N/A | <b>Accessibility:</b> | N/A | | |

| <b>Recommendation:</b> | None | | | | |

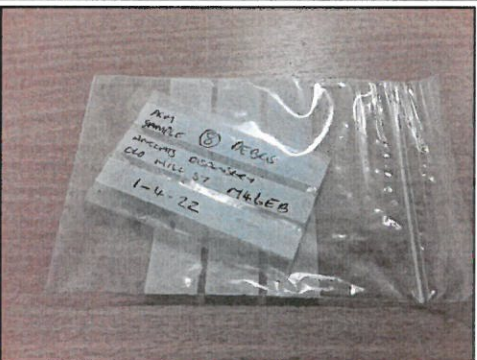
| <b>Location:</b> | Main Building - Ground floor - Property - ACM** debris | | | <b>Item No:</b> | 8 |

| <b>Asbestos Type:</b> | NAD | <b>Item type:</b> | Sampled | | |
| <b>Condition:</b> | N/A | <b>Accessibility:</b> | N/A | | |

| <b>Recommendation:</b> | None | | | | |

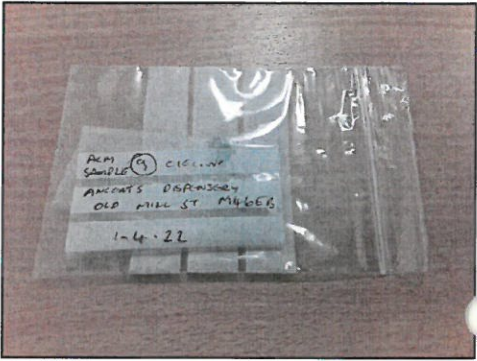
| <b>Location:</b> | Main Building - Ground floor - Property - ACM** ceiling | | | <b>Item No:</b> | 9 |

| <b>Asbestos Type:</b> | NAD | <b>Item type:</b> | Sampled | | |
| <b>Condition:</b> | N/A | <b>Accessibility:</b> | N/A | | |

| <b>Recommendation:</b> | None | | | | |

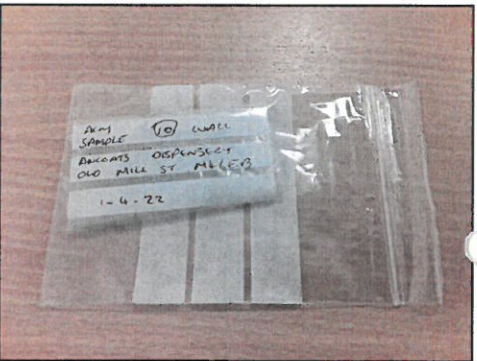
| <b>Location:</b> | Main Building - Ground floor - Property - ACM** wall | | | <b>Item No:</b> | 10 |

| <b>Asbestos Type:</b> | NAD | <b>Item type:</b> | Sampled | | |
| <b>Condition:</b> | N/A | <b>Accessibility:</b> | N/A | | |

| <b>Recommendation:</b> | None | | | | |

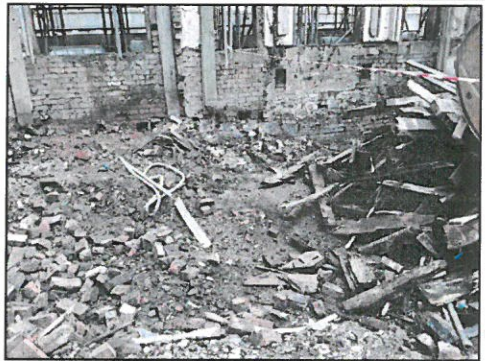
| <b>Location:</b> | Dispensary - Ground floor - Phase 3 - Brick hardcore to the floor | | | <b>Item No:</b> | 1 |

| <b>Asbestos Type:</b> | NAD | <b>Item type:</b> | Sampled | | |
| <b>Condition:</b> | N/A | <b>Accessibility:</b> | N/A | | |

| <b>Recommendation:</b> | None | | | | |

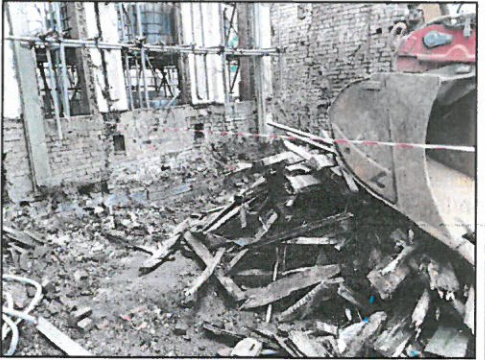
| <b>Location:</b> | Dispensary - Ground floor - Phase 3 - Brick hardcore to the floor | | | <b>Item No:</b> | 2 |

| <b>Asbestos Type:</b> | NAD | <b>Item type:</b> | Sampled | | |
| <b>Condition:</b> | N/A | <b>Accessibility:</b> | N/A | | |

| <b>Recommendation:</b> | None | | | | |

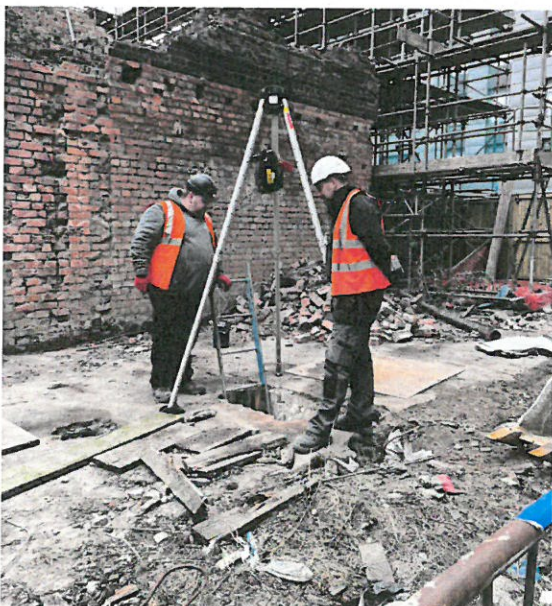
**BASEMENT FLOOR DEMOLITION PLAN**

Reassurance air tests located around the area of work to ensure there is no rise in airborne fibre levels during works being carried out within the tunnel.

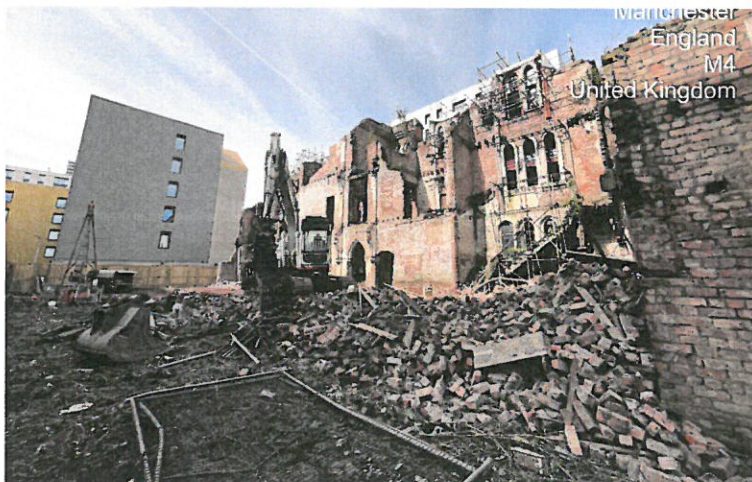
GROUND FLOOR DEMOLITION PLAN  
1:100

Reassurance air tests located around the area of excavation to ensure there is no rise in airborne fibre levels during works being carried out. Personal test located on the excavator driver.

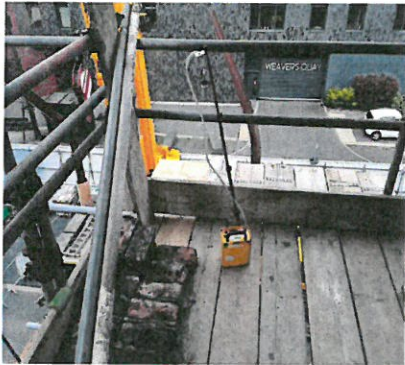
| TIME | COMMENTS / SITE LOG | PHOTO |
|---|---|---|
| 09:45 | BECL analyst deployed 2x reassurance air tests located around the area of work to ensure there is no rise in airborne fibre levels during work. The reassurance air samples were flowed at 8.2 litres of air per minute, for 60 minutes, drawing in excess of 480 litres of air per sample. This air test is to reassure there is no rise in airborne fibre levels whilst the work is being done. Please see site plan and photographic evidence for air test locations. | |

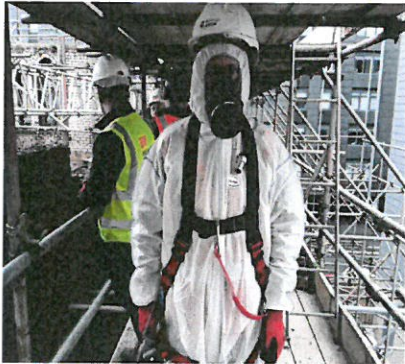
| TIME | COMMENTS / SITE LOG | PHOTO |
|---|---|---|
| 09:55 | BECL analyst deployed 1x occupational air test to Bradley Demolition operative Darren Wademan who was seen removing brickwork. Darren was seen wearing type 5/6 coveralls, safety footwear and a half face respirator. The occupational air test was deployed to his left hand side and was positioned within 200mm of his breathing zone. The occupational air sample was flowed at 2.0 litres of air per minute for 60 minutes collecting a total sample of 120 litres. Please see photographic evidence. | |

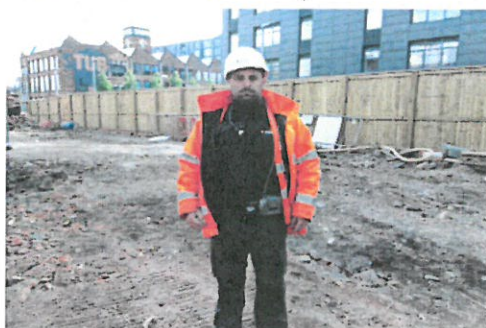
Date: 26/04/2022 09:41:51  
Time:  
Comments:  
LU0081 - Chris Thompson

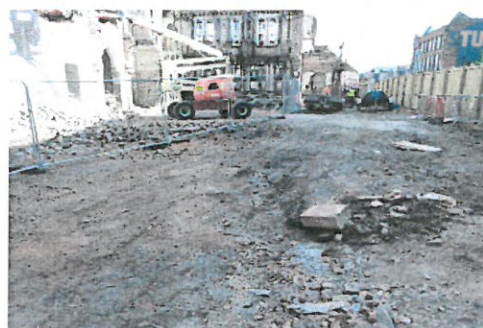
Date: 26/04/2022 10:54:28  
Time:  
Comments:  
Rear of building

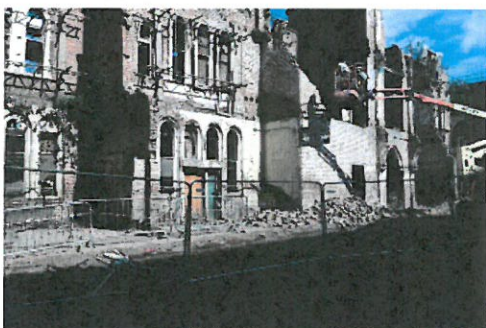
Date: 26/04/2022 10:54:39  
Time:  
Comments:  
Rear of building

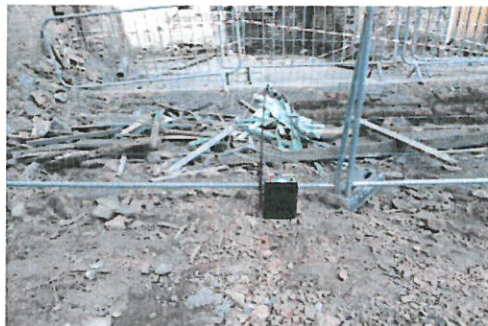
Date: 26/04/2022 09:45:01  
Time:  
Comments:  
LU0078 - Rear left

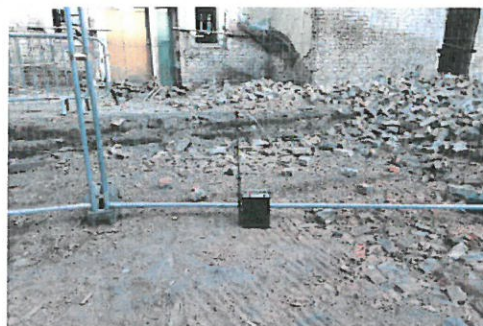
Date: 26/04/2022 09:46:26  
Time:  
Comments:  
LU0079 - Rear right

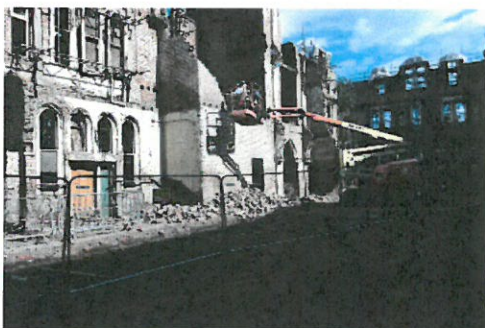
Date: 26/04/2022 10:54:02  
Time:  
Comments:  
Rear of building

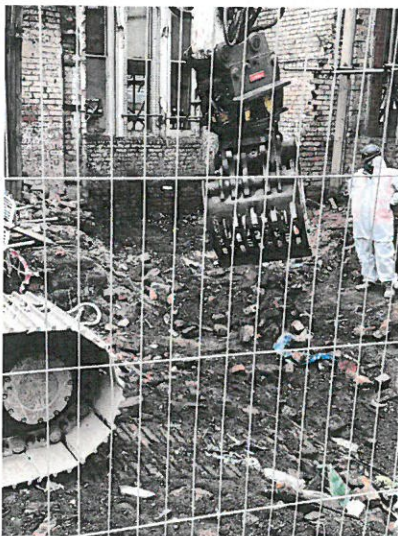
**Overview:** Reassurance air monitoring carried out whilst asbestos was removed from area 3 ground floor adjacent to the NE elevation. Personal air monitoring was also place on one of the two operatives within the area. 3no pumps set up in various locations around the pick site. All reassurance air monitoring passed with fibre concentration level being calculated as being below the limit of quantification <0.01f/ml

Reassurance air tests located around the area of excavation to ensure there is no rise in airborne fibre levels during works being carried out. All hazardous substances were placed in a skip which was then sealed

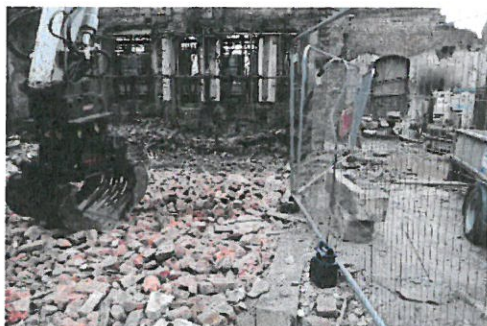
Date: 28/04/2022 09:22:30  
Time:  
Comments:  
KZ0378 Rear of old Dispensary, Right side.

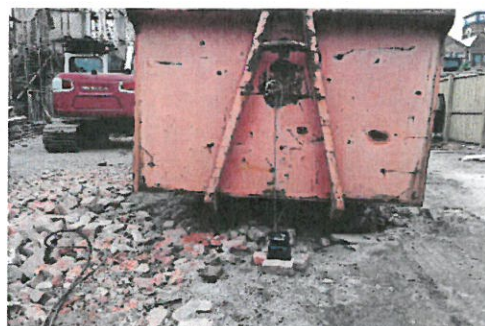
Date: 28/04/2022 09:24:48  
Time:  
Comments:  
KZ0379 Next to waste skip

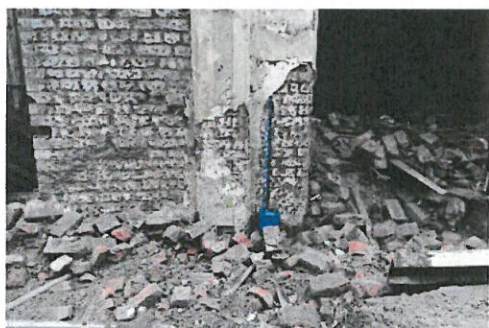
Date: 28/04/2022 09:26:35  
Time:  
Comments:  
KZ0380 rear of old Dispensary Left side.

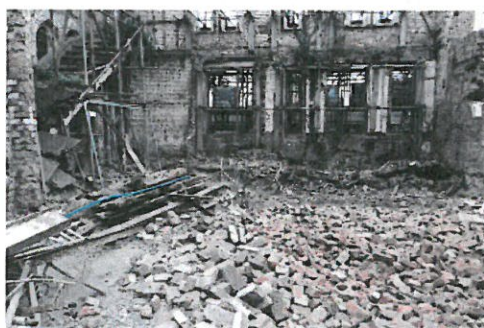
| Comments on air monitoring and activities taking place before/during the air monitoring |
|---|
| Reassurance air testing during removal of Asbestos debris. There is general building debris and rubble caused by demolition works which has created dust which could affect results, sample pumps were placed to the right hand side of the work area, one to the left side and one next to the waste skip, the weather conditions were 7°C cloudy with a light changeable breeze. All Reassurance air tests passed with the airborne fibre concentration level being calculated as being below the limit of quantification <0.01f/ml |

Date: 28/04/2022 09:27:21  
Time:  
Comments:  
Asbestos debris area
