Redby Street, Manchester

## Phase 2 Geo-Environmental Investigation, Risk Assessment and Remediation Strategy

**Job Number:** LKC 22 1260

**Client:** Create It Studios Ltd

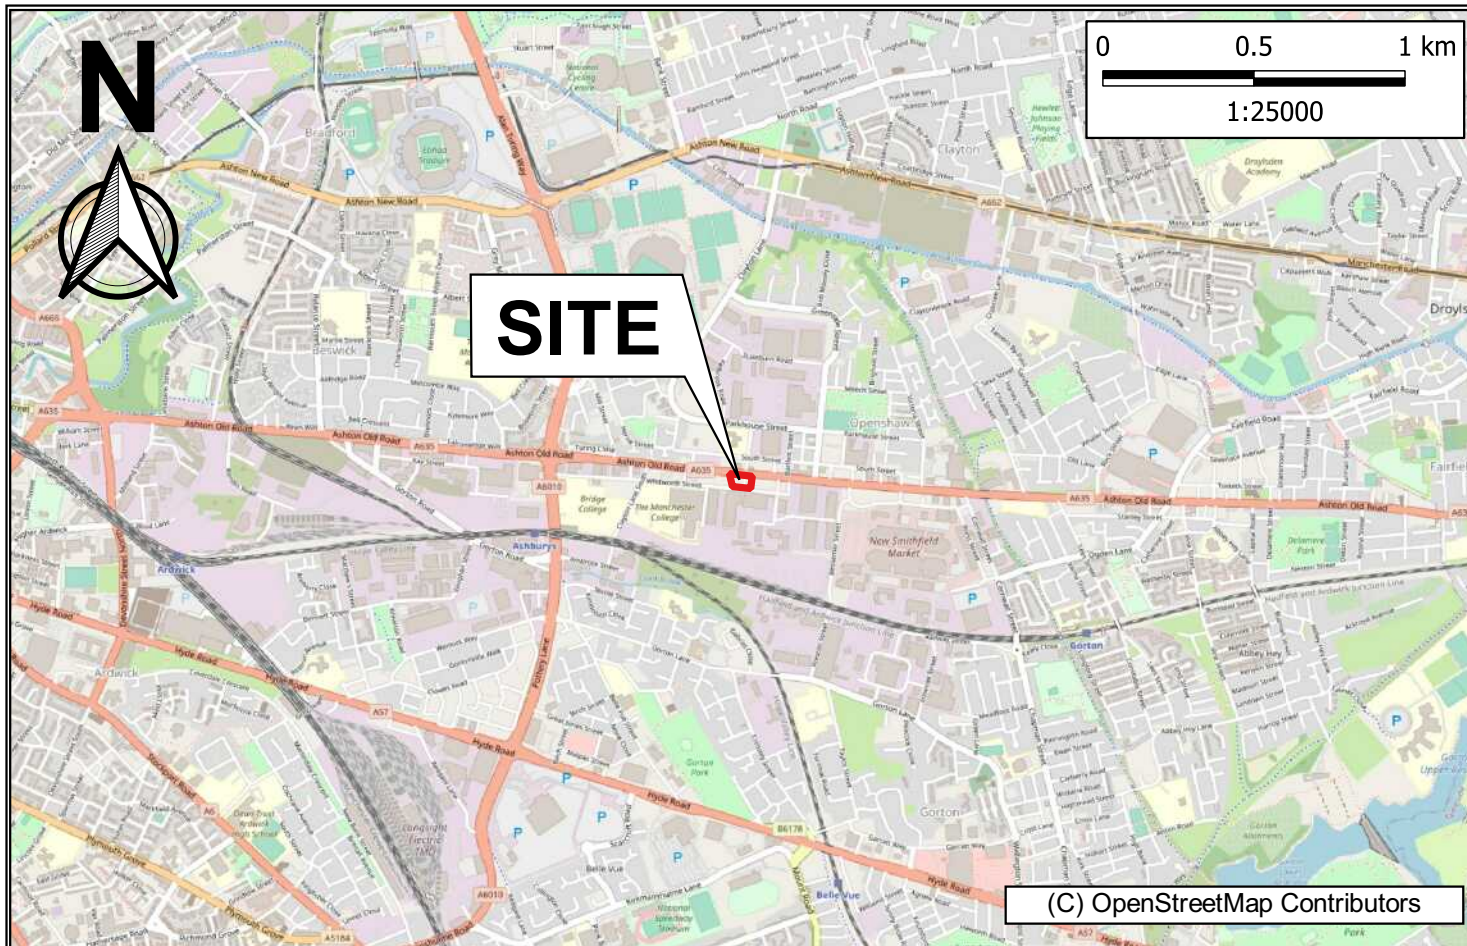
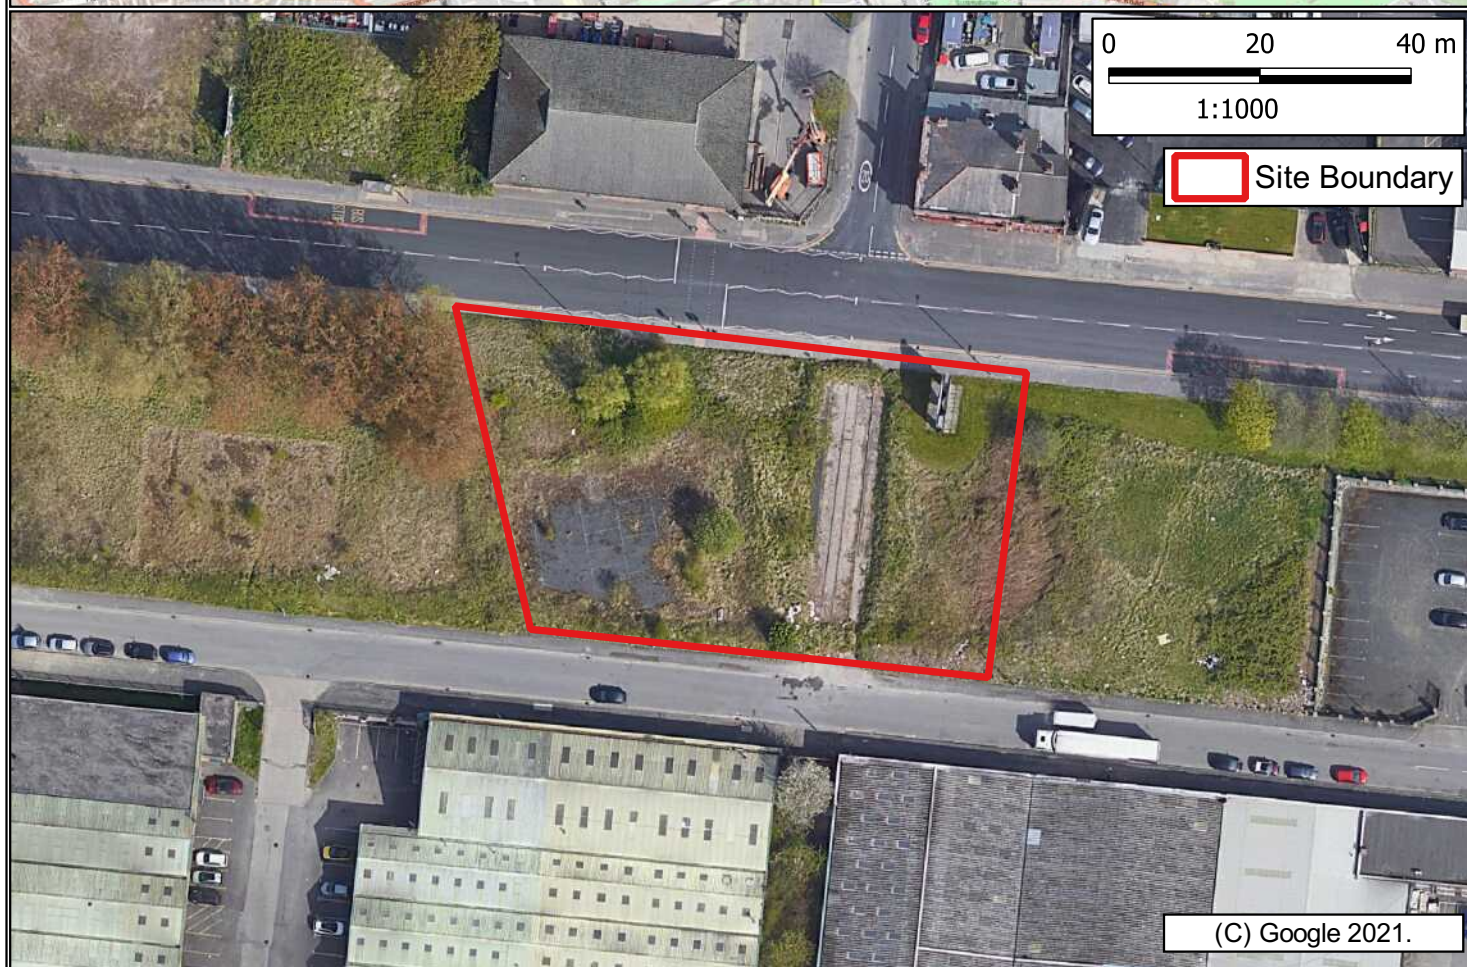
| Job No.:<br>LKC 22 1260 | Drawn By:<br>JW | Checked By:<br>EK | Drawn:<br>May 2022 | Figure:<br>1 | Revision: | | |

| Client:<br><br>Create It Studio Architects | | | | Title:<br><br>Site Location &<br>Boundary Plan | | | |

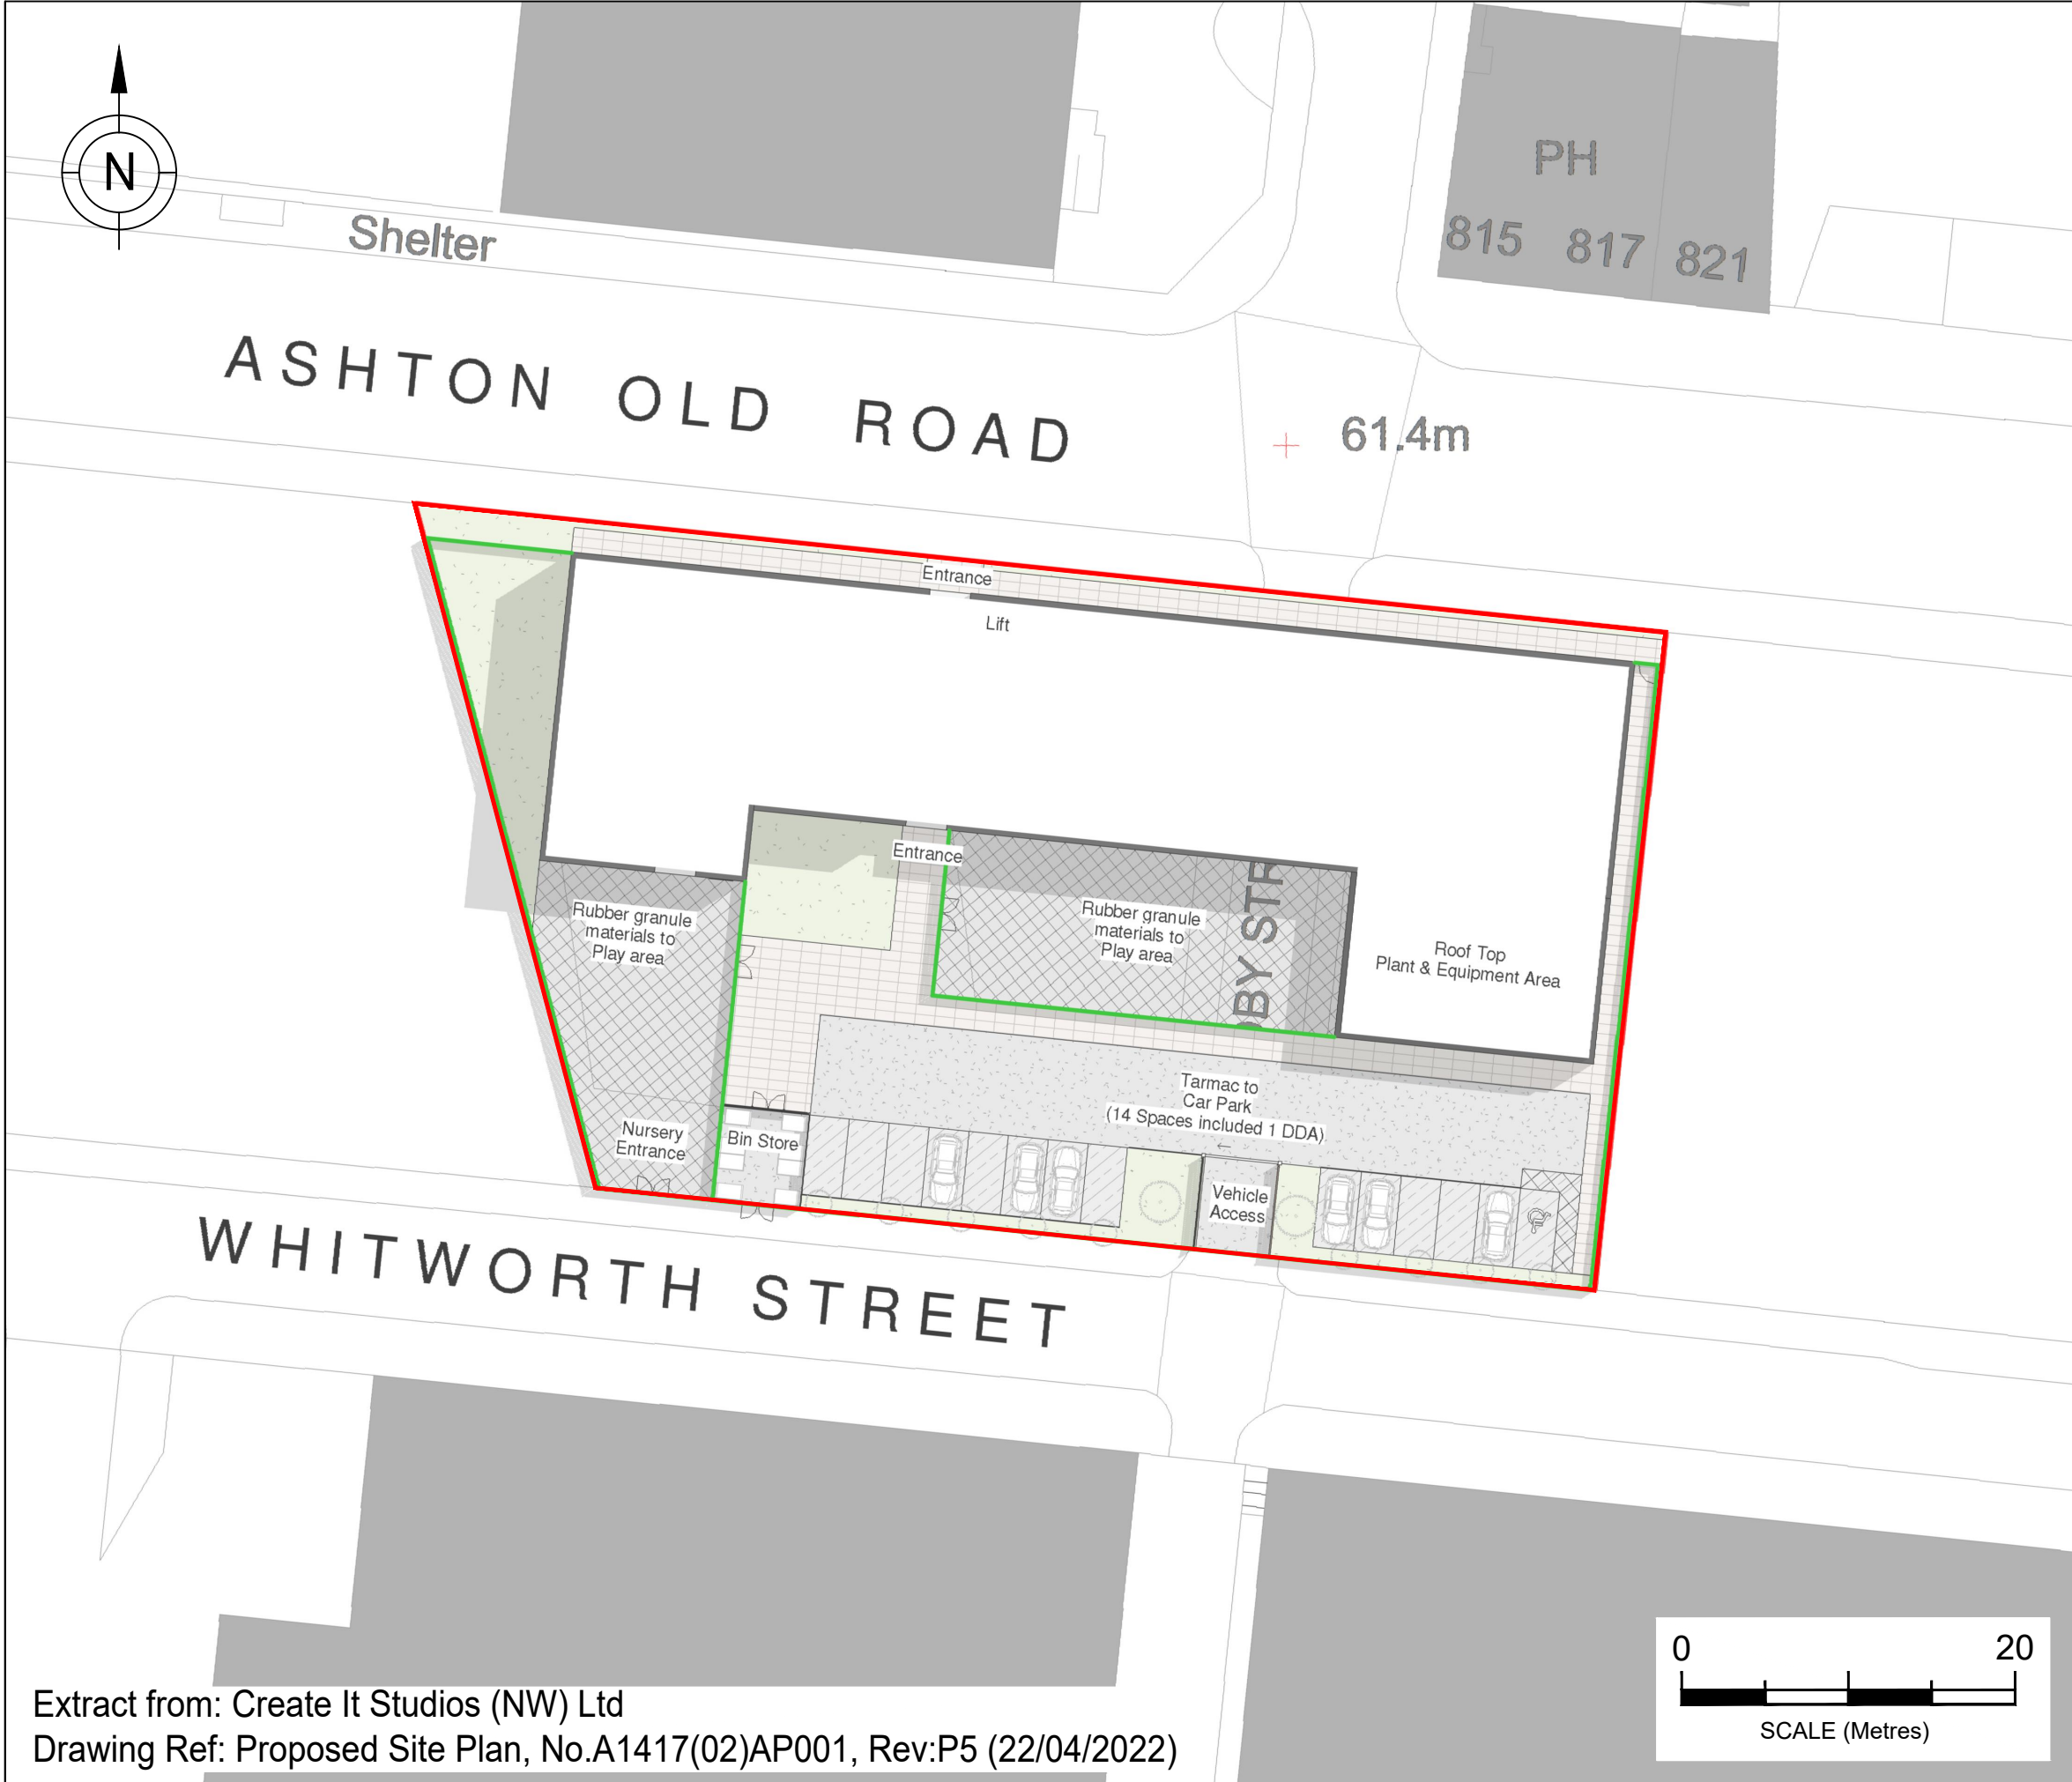
- Site Boundary
- Window Sample Borehole (WS)
- Dynamic Probe (DP)
- Hand Dug Trial Pit (HD)
