**Re: Infiltration testing at 'Greenbrow Social Club'.**

Dice Environmental have been instructed by BTP Architects to complete 2No. Soakaway tests in accordance with BRE365 at 'Greenbrow Social Club, Wythenshaw, Manchester, M23 2TU'.

## INSITU SOAKAWAY TEST RESULTS

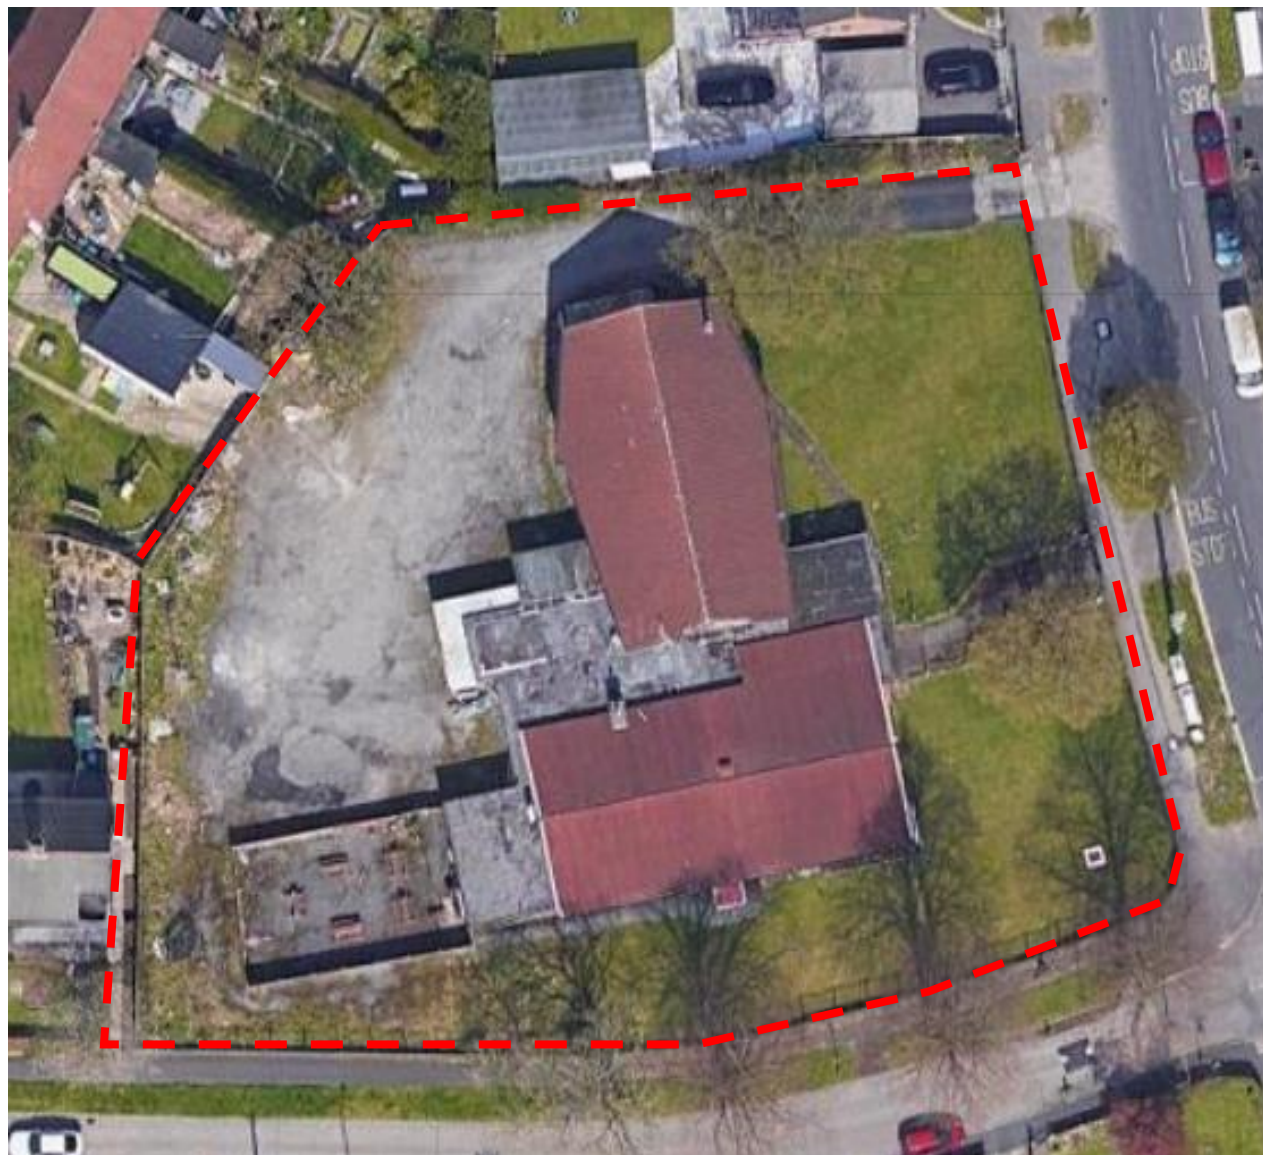
Fig.2

Site Layout

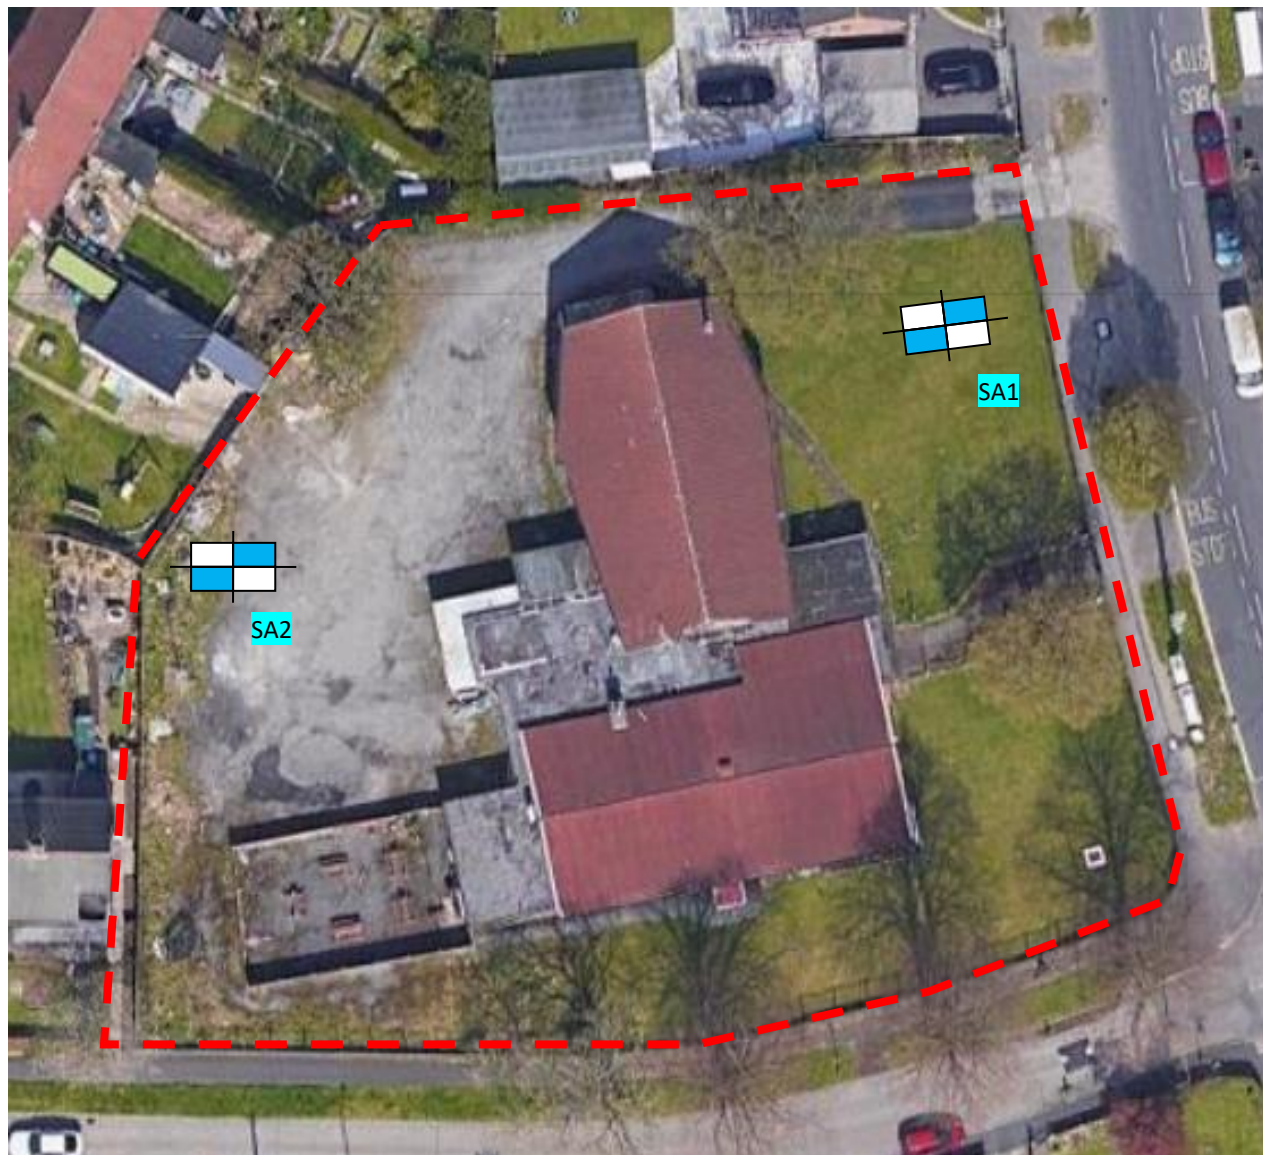
Fig.3

SI Plan

Trial Pit with  
Infiltration Testing

Infiltration test locations are highlighted in Appendix A.

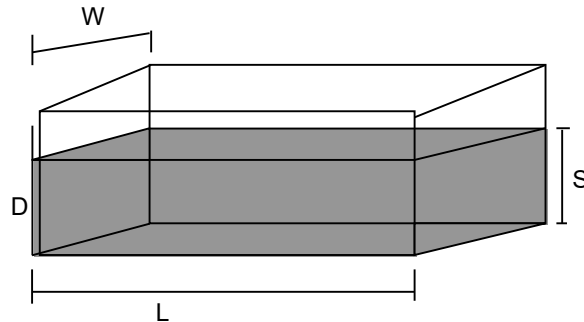
### Sketch plan of test zone

D = Depth of test pit = 1.4

W = Width of test pit = 0.8

L = Length of test pit = 1.8

S = Storage depth (of water) = 0.82

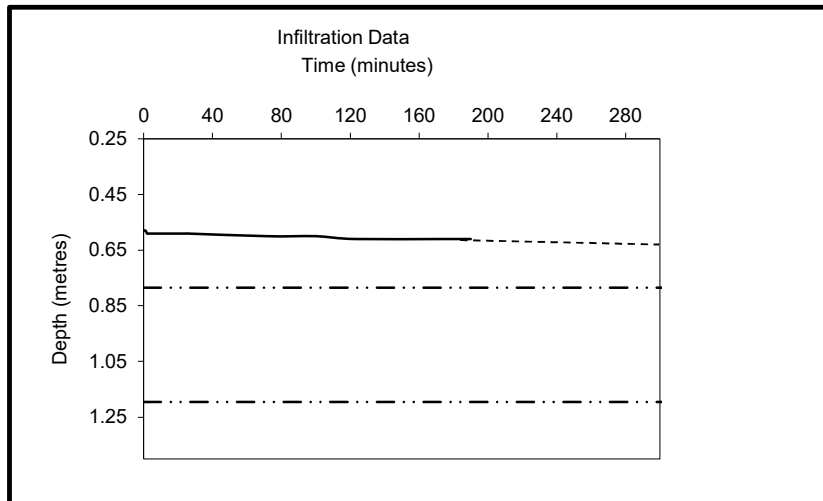
### Soakaway Test Run 1

Extrapolation of results indicate that the soakaway would fail to drain 75% of the start volume within a 24hr period.

Therefore, this test is considered to have failed, and soakaways are not considered to be viable in this location.

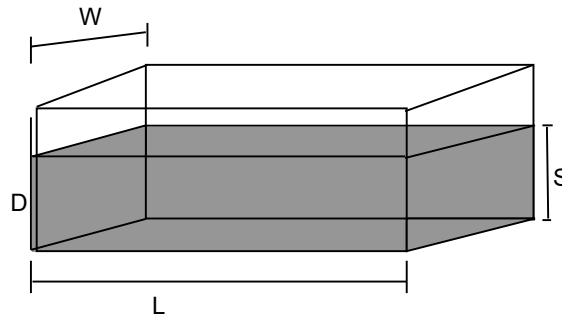
## Sketch plan of test zone

D = Depth of test pit = 1.7

W = Width of test pit = 1.0

L = Length of test pit = 1.8

S = Storage depth (of water) = 1.09

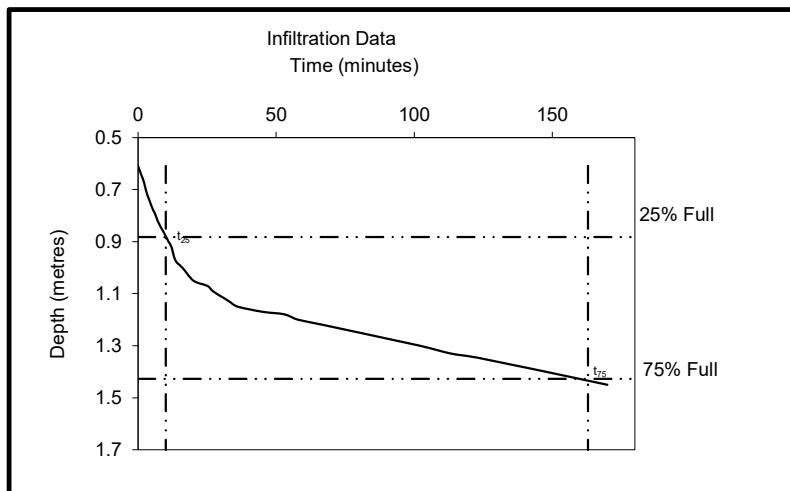
## Soakaway Test Run 1

$$S = 1.09 \text{ m} \quad a_{p50} = 4.85 \text{ m}^2 \quad V_{p75-25} = 0.981 \text{ m}^3$$

From the above graph,

$$t_{p25} = 10 \text{ (min)} \quad t_{p75} = 163 \text{ (min)}$$

$$\text{Soil Infiltration Rate: } f = \frac{V_{p75-25} \times N}{a_{p50} \times t_{p75-25}} \quad f_{run1} = 2.20E-05 \text{ m/s}$$

$$\text{or } = 7.93E-02 \text{ m/hr}$$

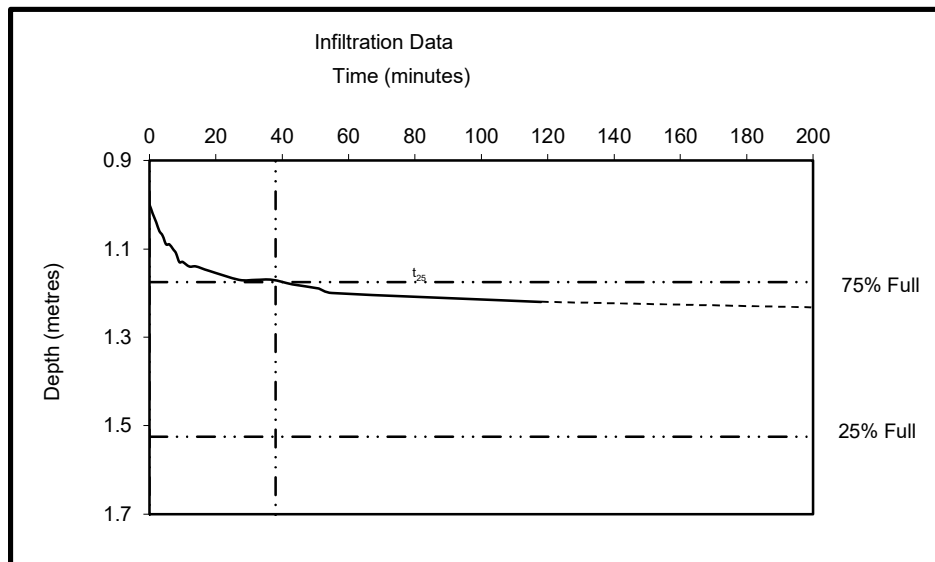
**Soakaway Test Run 2**

Extrapolation of results indicate that the soakaway would fail to drain 25% of the start volume within a 24hr period.

Therefore, this test is considered to have failed, and soakaways are not considered to be viable in this location.
