# GEOSHIELD Verification Report

REPORT NUMBER: 005

PROJECT: Abraham moss leisure centre.

MEMBRANE SPECIFICATION: Verified in accordance CIRIA 735.

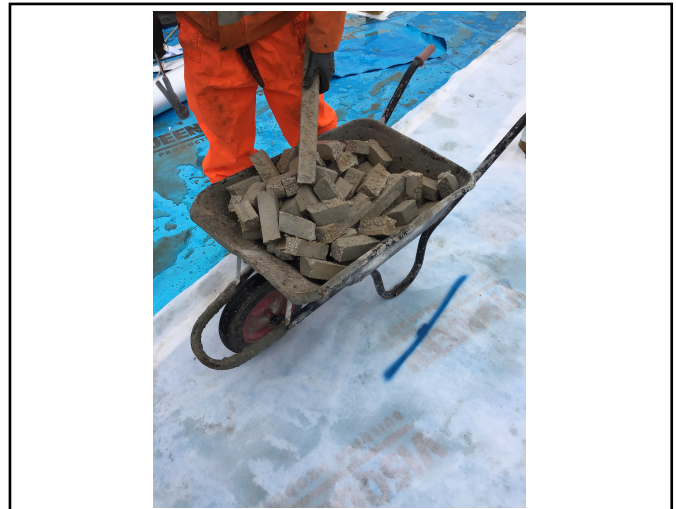
Protective Fleece has been installed to the Visqueen Standard Gas Barrier, this is designed to protect the membrane from follow on trade and UV light damage. This has also been overlapped stopping any areas from being exposed.

The right photo shows the fleece installed protecting the membrane from steel mesh and any other follow on trades.

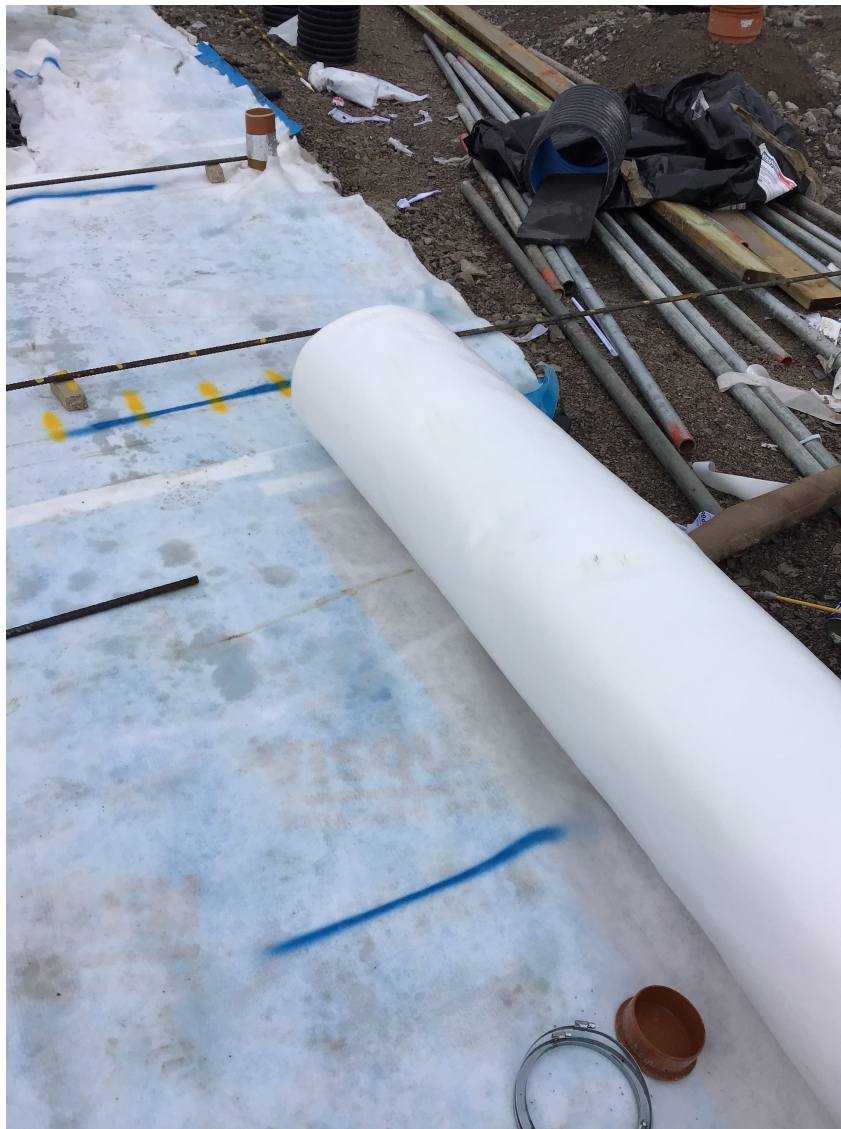
Concrete spacers have been applied on top of the protective fleece to help reduce the risk of damage that can be caused to the membrane by sharp edges of steel mesh.
