# Manchester Art Gallery

Heritage Assessment  
June 2024

Project name: Manchester Art Gallery  
Project number: 9518

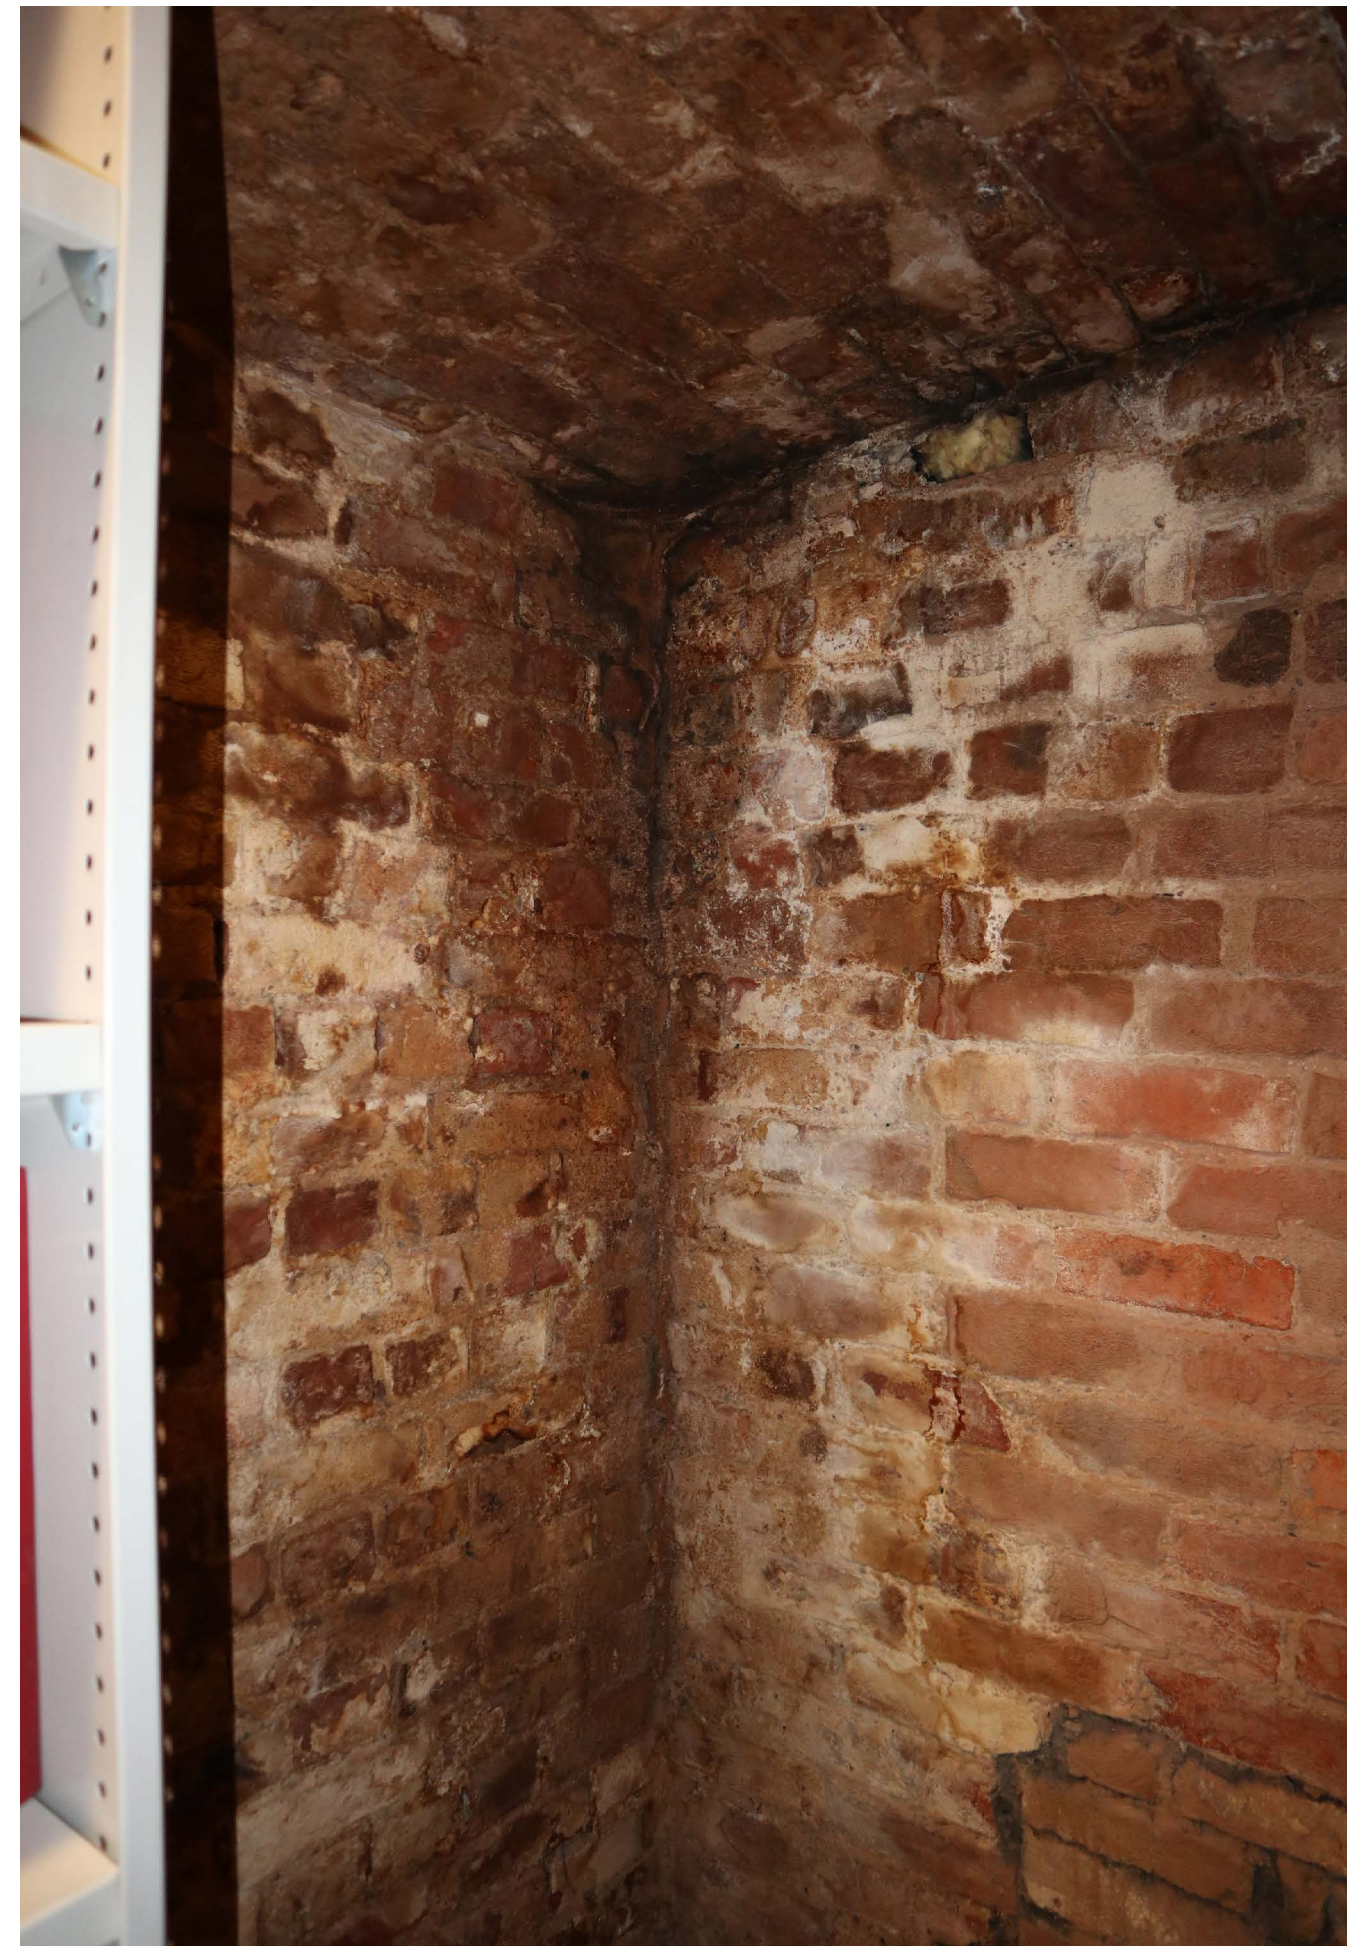
In the basement storage room (B01-B2-024), the new cavity drain and lining will also be taken up over the full extent of the Jack arch ceiling. This is due to the room extending beyond the first floor building line, with the ceiling susceptible to water ingress from above. The new wall lining and finish will result in a change in appearance from the existing exposed brick work, however is necessary to ensure the basement spaces are watertight and the existing water ingress issues are effectively addressed.

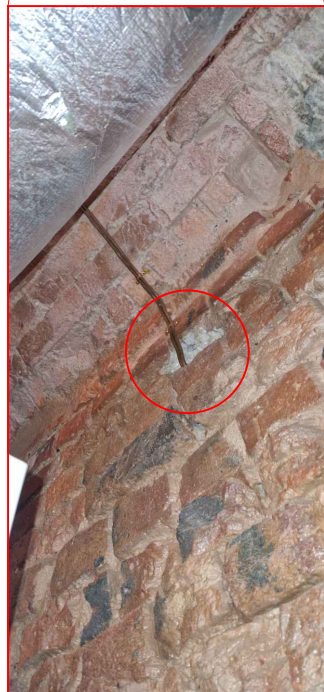
## Opening in wall

- New brickwork to be inserted into opening as R11.5 and pointed as R12, ensuring cable is protected during works.
- Opening to be cut in cavity drainage membrane to suit cable width, and sealed around aperture with butyl tape as specialist supplier's design and details

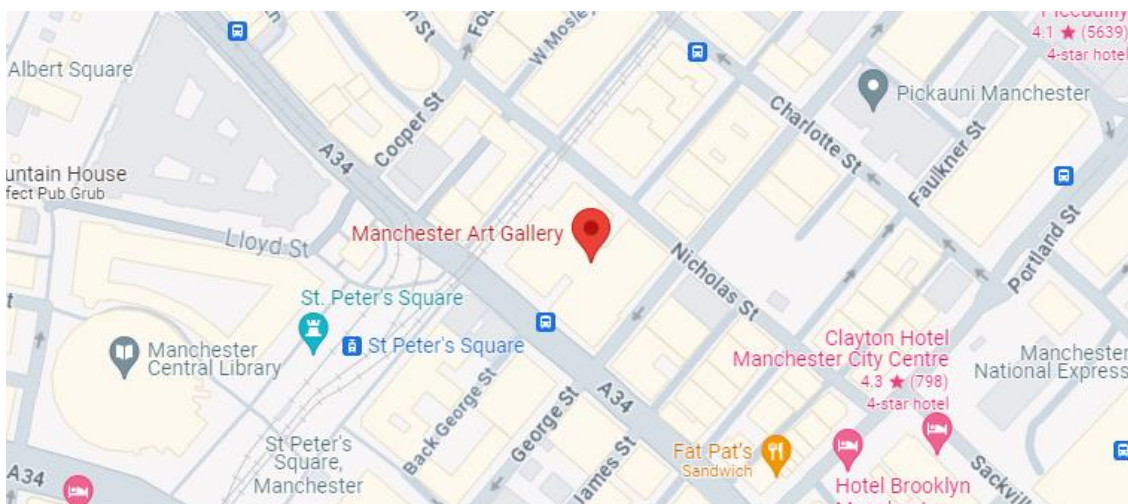
**Figure 1:** Location and Local Environment, Mossley St, Manchester, M2 3JL

WJ Structures were tasked with finding a cleaning method that could be undertaken safely but that did not compromise the safety of the operatives undertaking the works. Upon review of the sample outcomes, we would recommend the best option to be a Microstrip clean. This methodology has ensured arises of the existing impervious sodium silicate coating, detail of brick has been kept and little to no face of the brick has been cleaned off. The Microstrip was the fastest of the 2 operations. Therefore, on a cost and programme basis, we would propose the use of the microstrip cleaning system, should it be accepted by the conservation officer. It's important to note that it is the responsibility of the main contractor to instruct WJ Structures Ltd on which samples to proceed with after their discussion with the local authority, client, and CA.

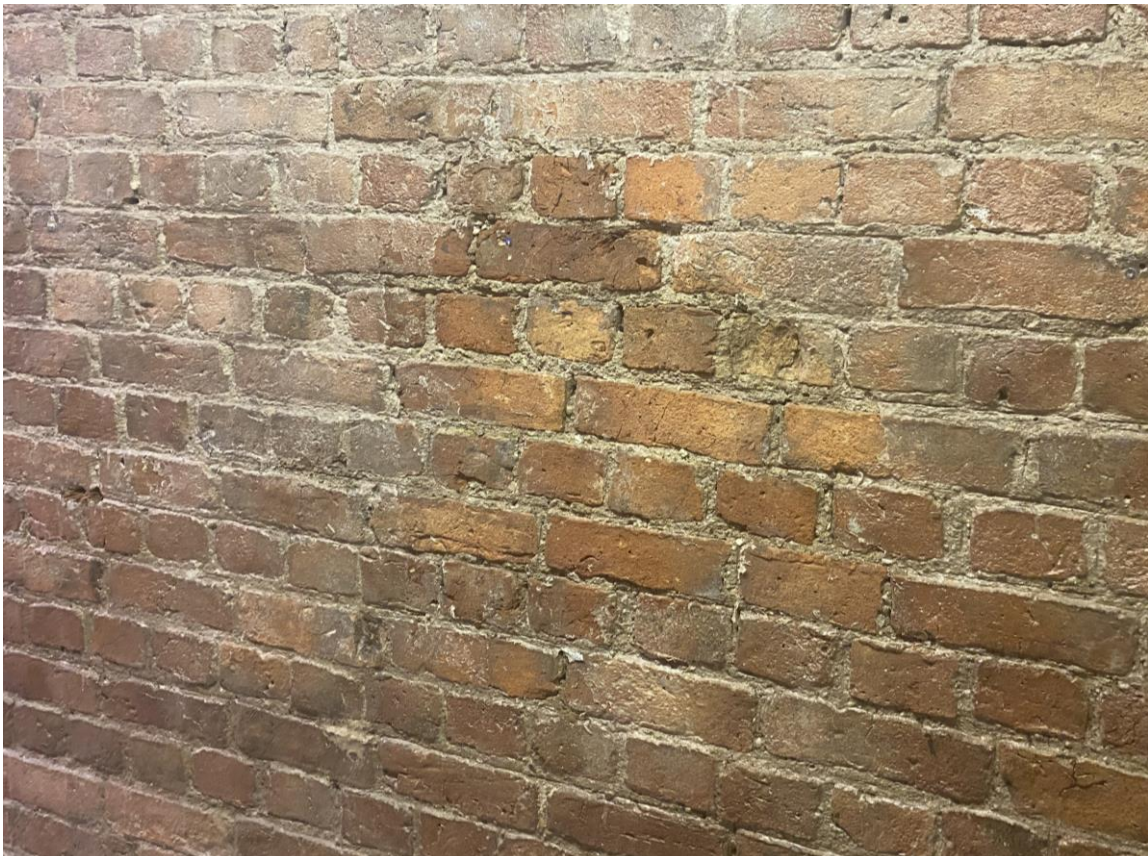
**ThermaTech:** 150-500 PSI – temp. 150 degrees – fan tip nozzle.

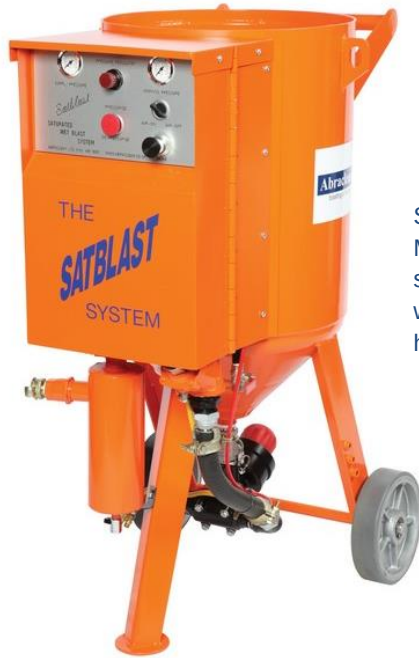
SAT Blast  
Machine –  
shown  
without  
hoses

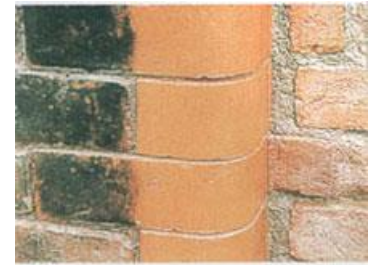
SAT Blast in operation  
cleaning metal and brick

The versatile SatBlast is a fully saturated wet blasting system which offers a modern solution for environmentally friendly blast cleaning. The SatBlast has been developed to provide controllable abrasive cleaning power.

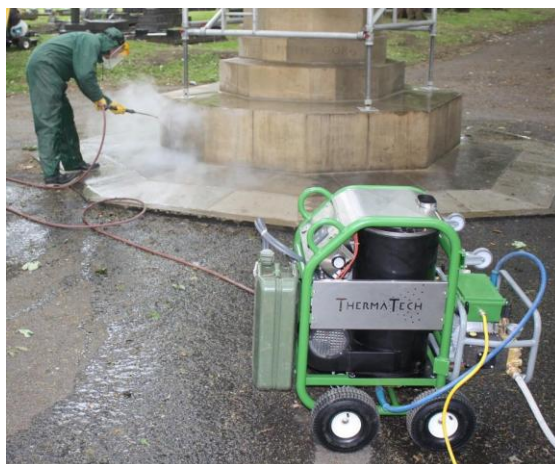
All ThermaTech systems have been built with Digital Temperature Control. The critical feature of this is not that it provides a digital instantaneous display of the temperature, but that the temperature fluctuation is kept to a minimum. Conventional hot machines (including many other superheated/steam types) use capillary thermostats, which result in a wide temperature range at lower operating pressures and thus equally wide changes in the spray shape and intensity through the heating cycle (the thermostat regulates the temperature by switching the boiler in and out). The controls built into the ThermaTech maintain much tighter temperature control and therefore spray shape over the cycle. The standard 110v system and trigger arrangement has a water flow rate of 4-8.5 litres min<sup>-1</sup>. Standard option pressure is adjustable from 30-140bar\*.
