# Geo-Environmental Investigation & Assessment

Our Lady's RC High School, Blackley

Report No. 9670G-WML-XX-ZZ RP-G-0002

April 2021

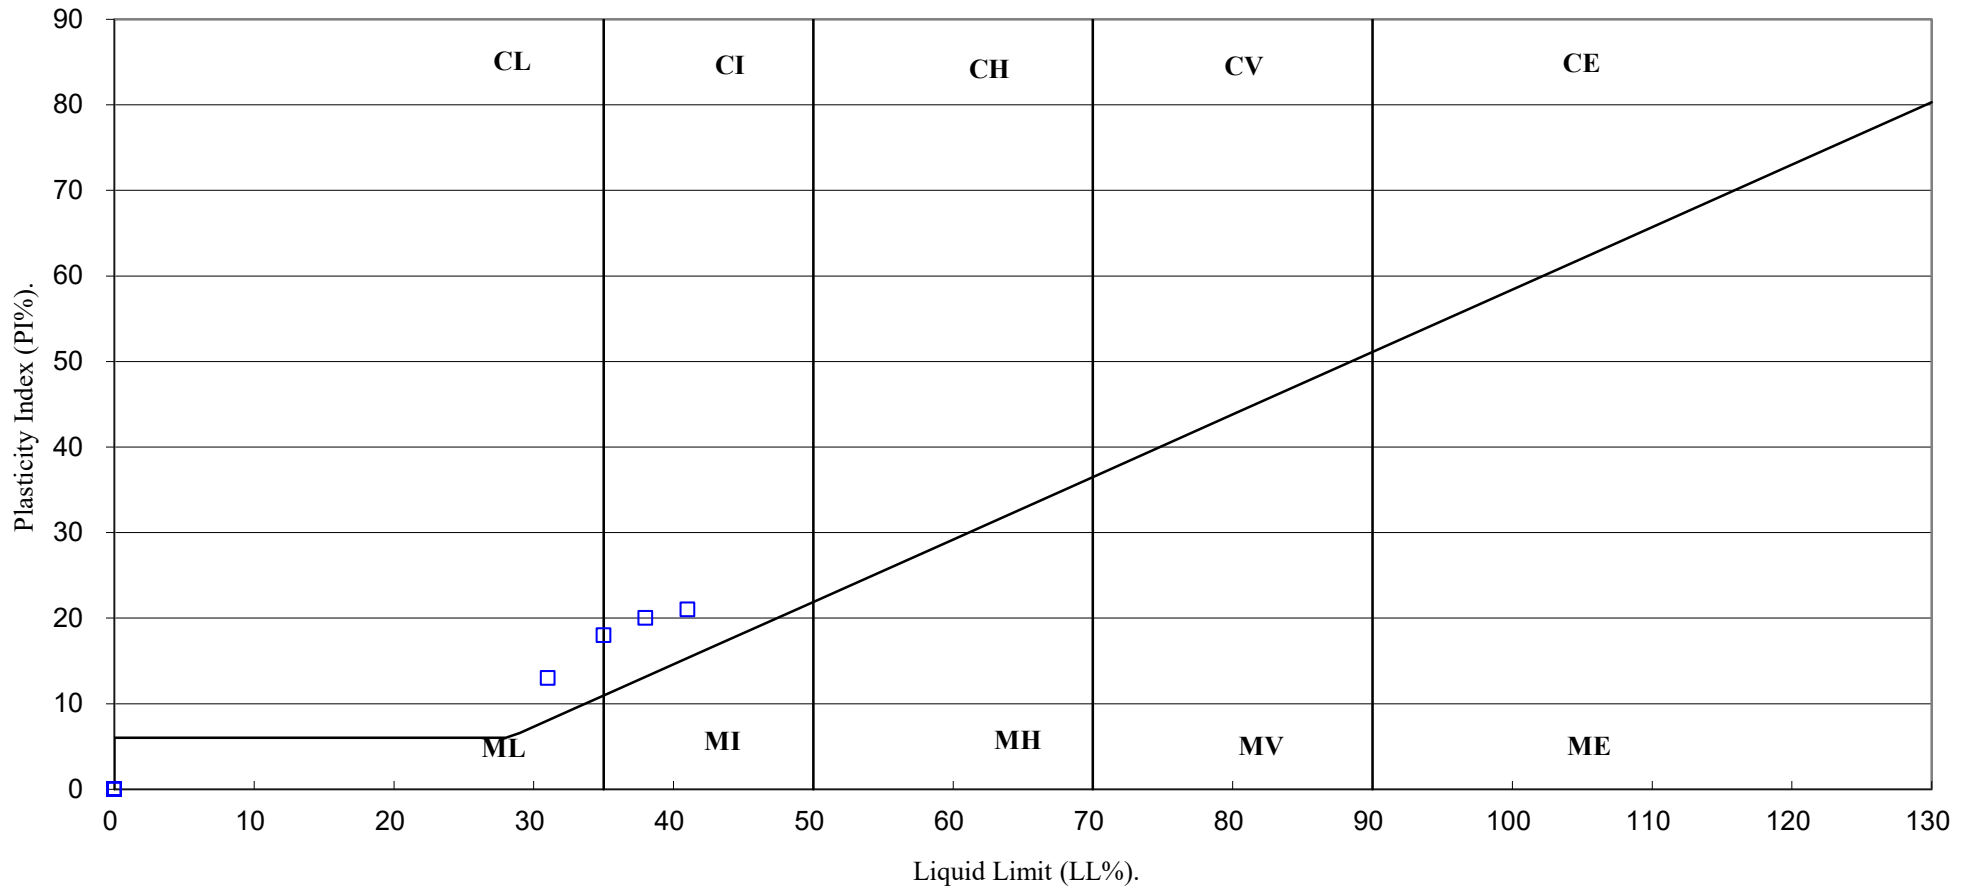
# PLASTICITY CHART FOR CASAGRANDE CLASSIFICATION.

- 5.15□ Limited laboratory classification testing on the Glacial Till/re-worked Glacial Till provided natural moisture content values of 17 to 22%. Liquid limits of 31 to 41% with corresponding plasticity indices of 13 to 21% indicate clay of low to intermediate plasticity with plastic limit values of 18 and 20% (modified to 12 to 21%) indicating low to medium volume change potential.
