PLOT 10b FIRST STREET,  
MEDLOCK STREET,  
MANCHESTER,  
M15 4GU

POST-EXCAVATION  
ASSESSMENT REPORT

## **An Assessment of an Archaeological Excavation at Plot 10b, First Street, Medlock Street, Manchester, M15 4GU**

**Site Code:** FSB23

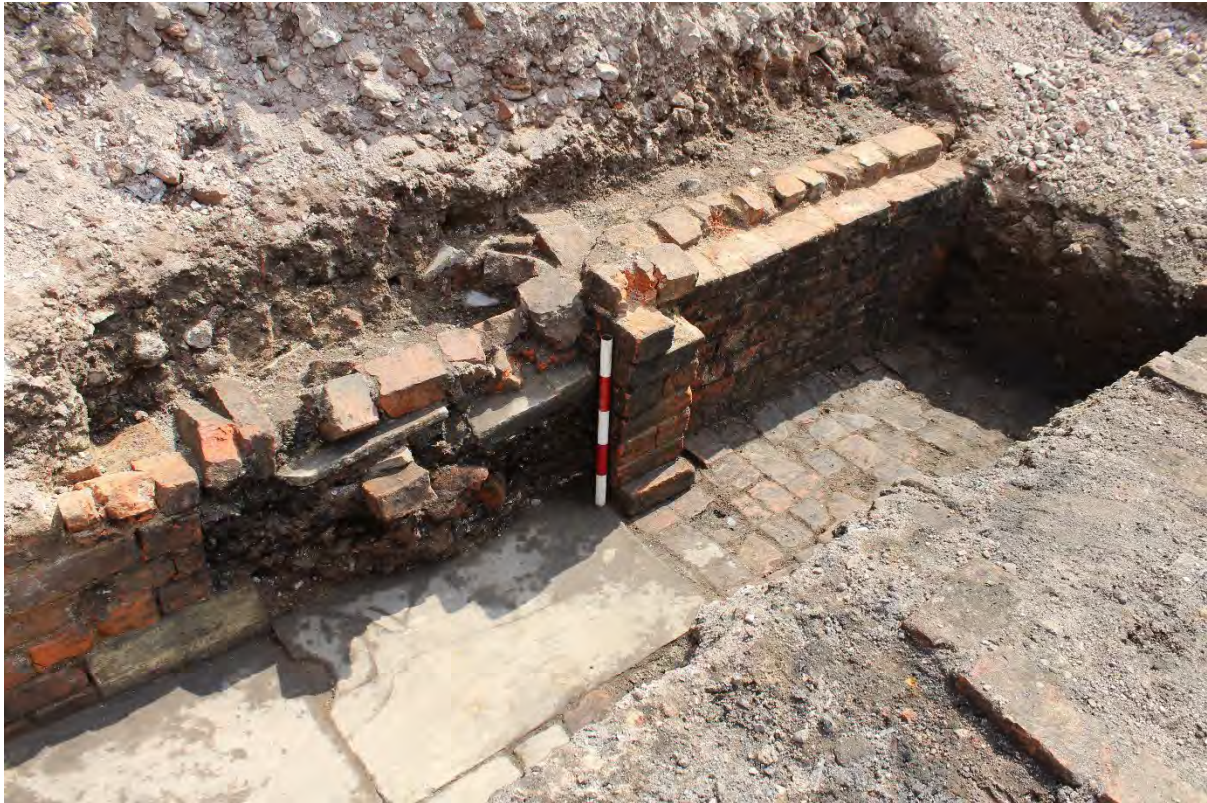
Plate 1: Cellar walkway H1-4 (Phase 2), Agnes Street south, looking south.

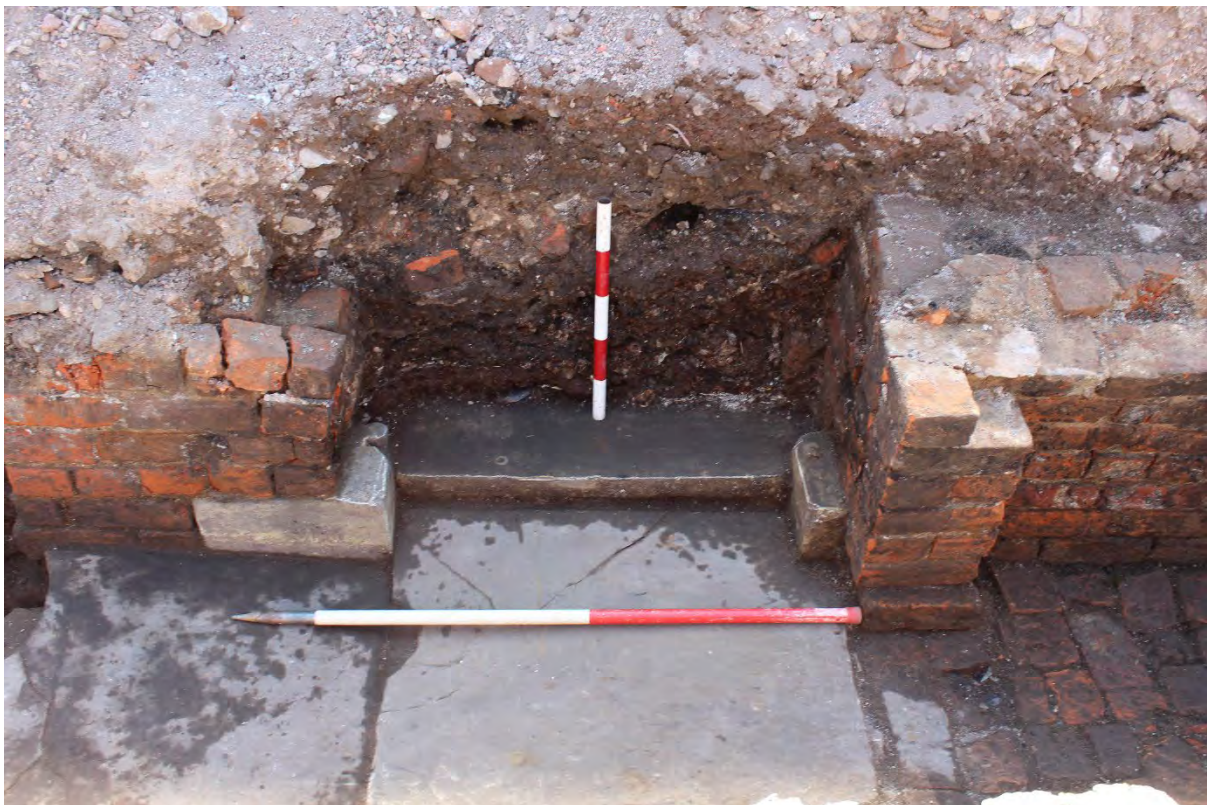
Plate 2: Entrance (31) along cellar walkway H4, looking southeast, 0.50m and 1m scale.

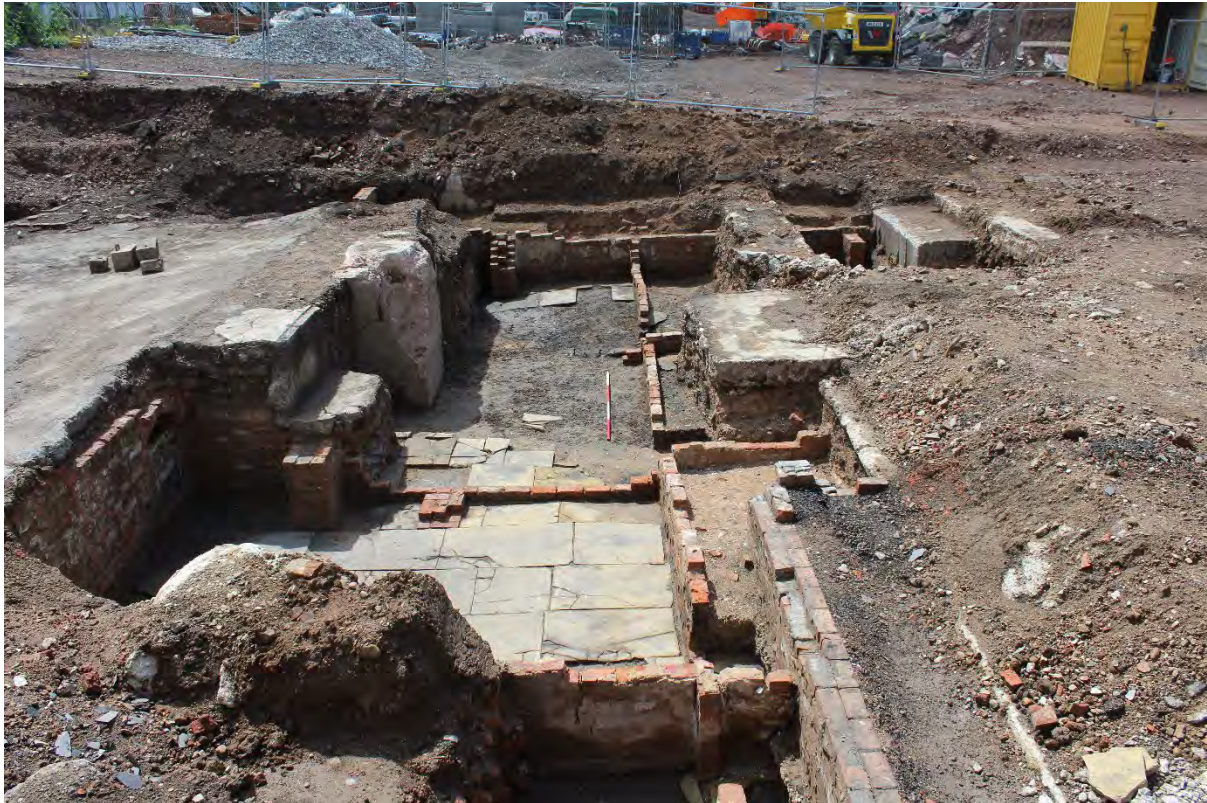
Plate 3: Phase 2 H6, H7 and H8, with Phase 3 concrete factory foundation structures, looking southwest, 2m scale.

- 7.3.9 H6 (Plate 3 & Plate 4) shared partially surviving internal cellar Wall (76) with H5, upon which traces of plaster whitewash were noted, and party Wall (50) with H11 to the north. Evidence for whitewash and traces of darker paint were also noted on both faces of the latter in each of the cellar rooms it defined (H6 - H11). The west extent of H6 was defined by cellar and retaining Wall (56) (Figure 8, s4 & s6) and the Agnes Street frontage by Wall (54) (in section only), providing an area of at least c.13.60m<sup>2</sup> useable subterranean space in a square room approximately 3.4m x 4.4m in size.

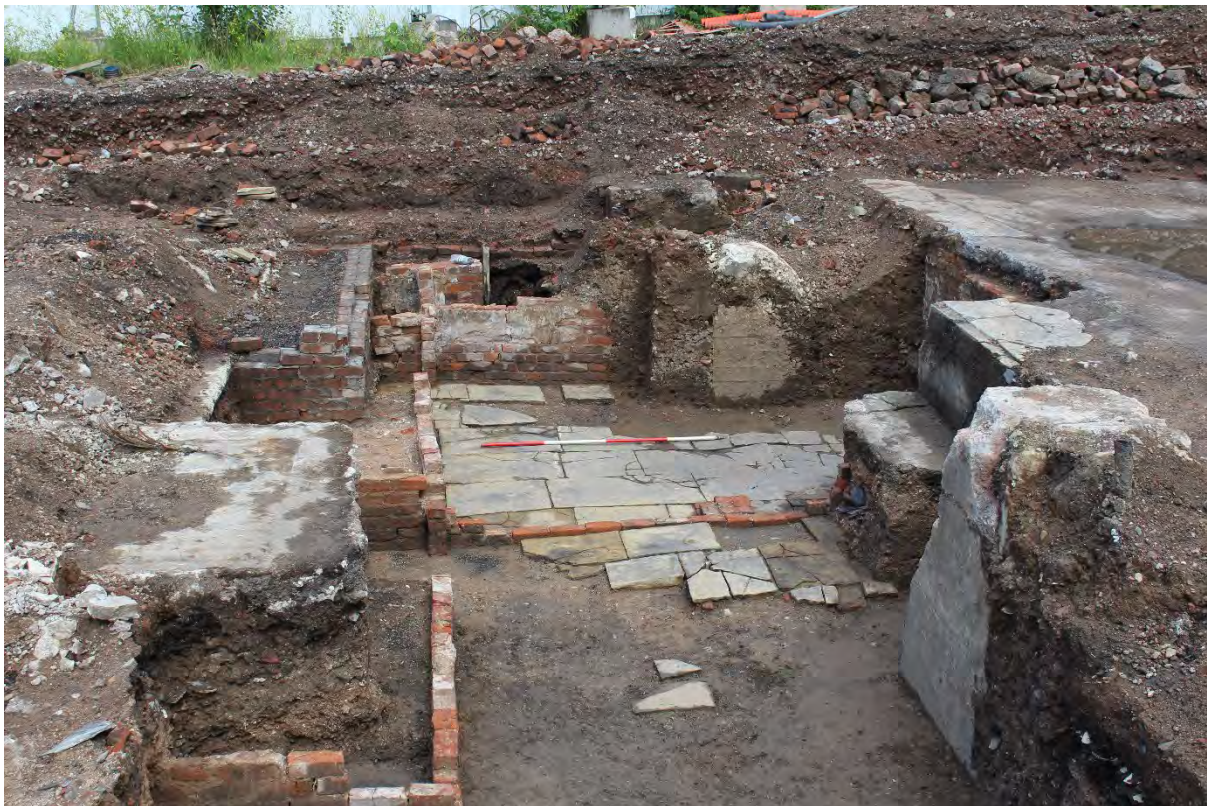
Plate 4 Phase 2, H6, 7, and 8, looking northeast, 2m scale.

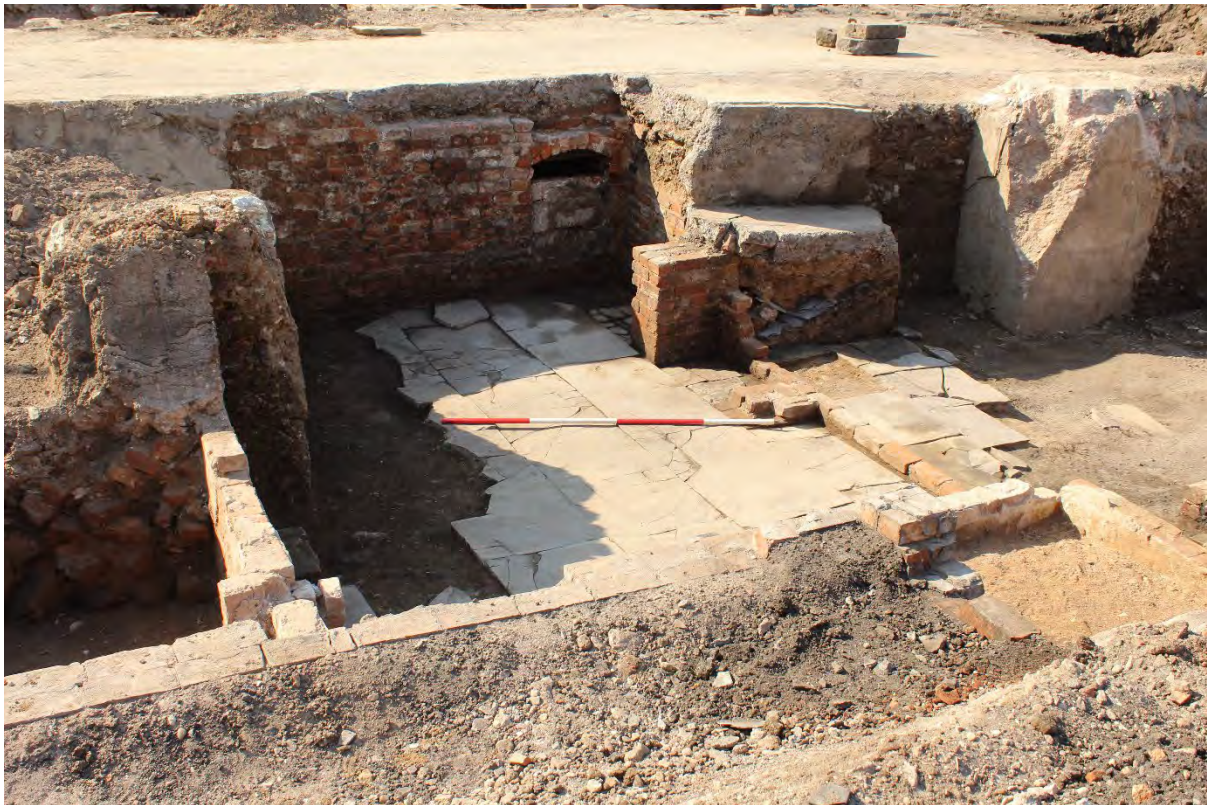
Plate 5: Floor (60) H6 construction, looking southwest, 2m scale.

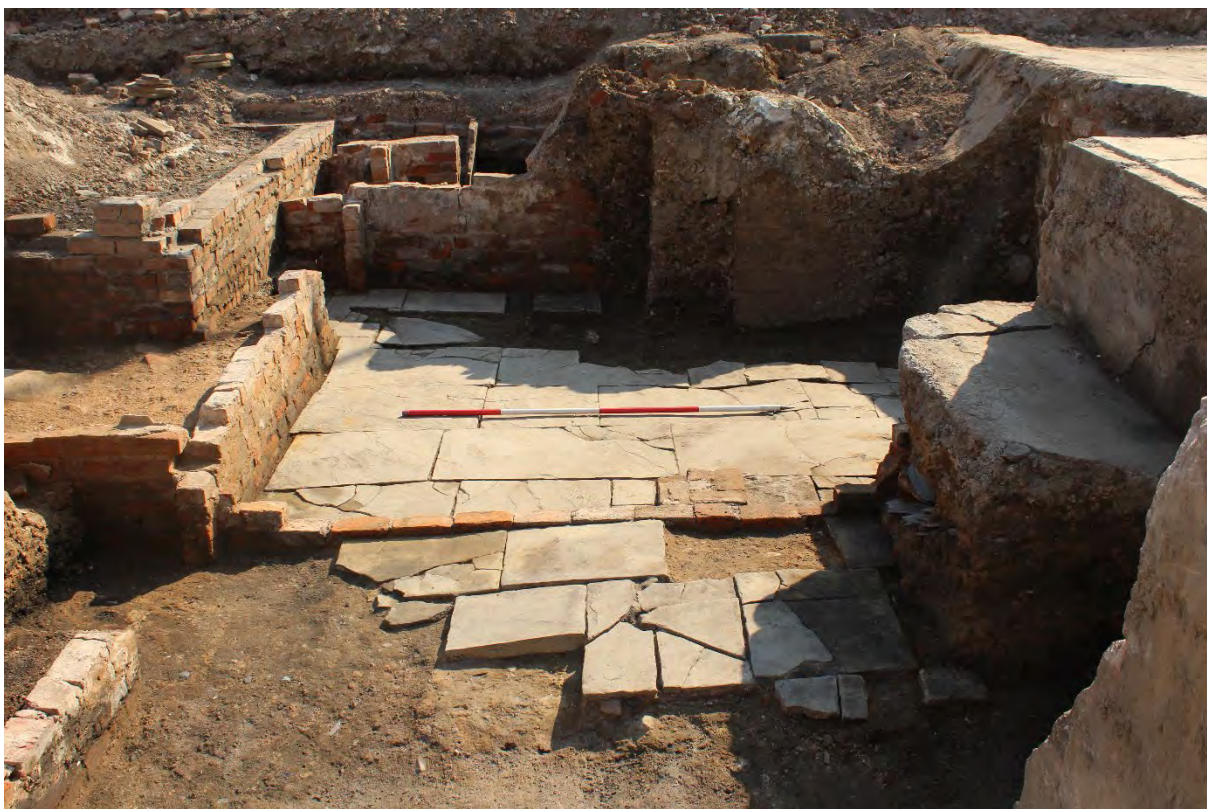
Plate 6: Phase 2 H6 construction, showing Floor (60), looking northeast, 2m scale.

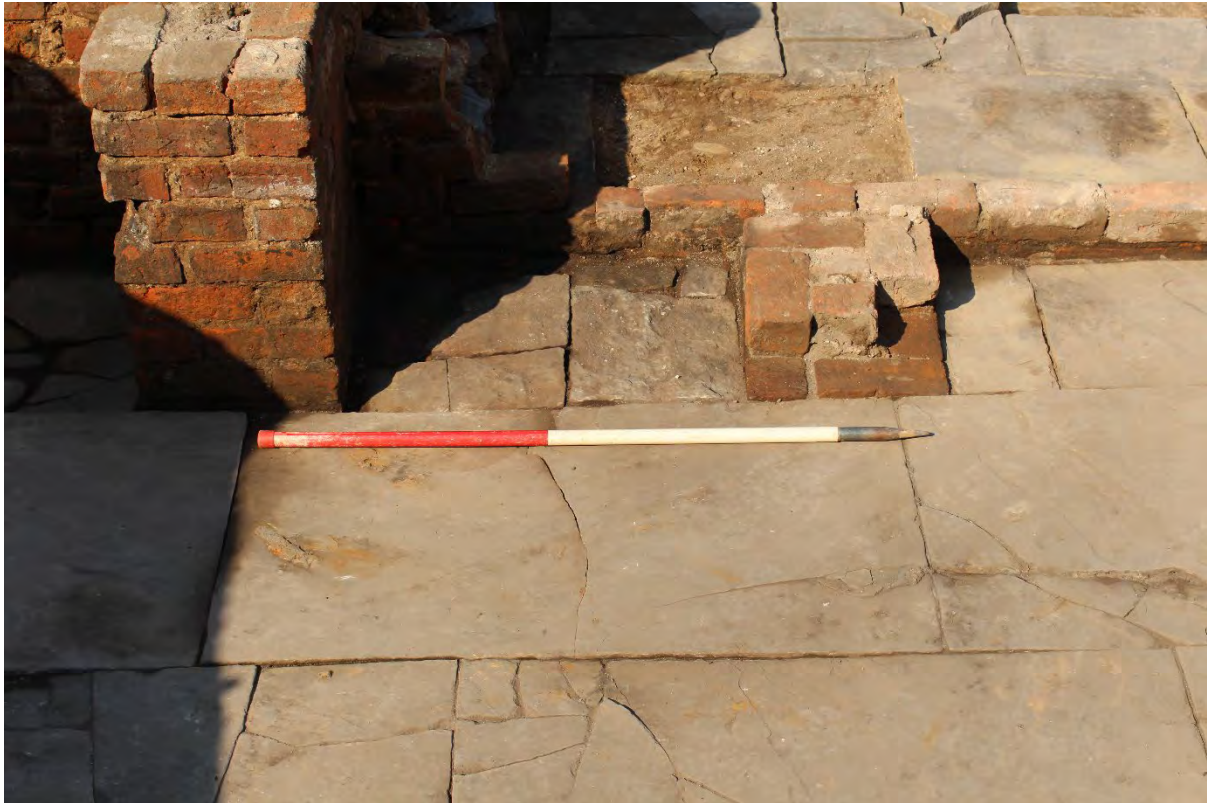
Plate 7: Fireplace (57) (58), H6, looking southeast, 1m scale.

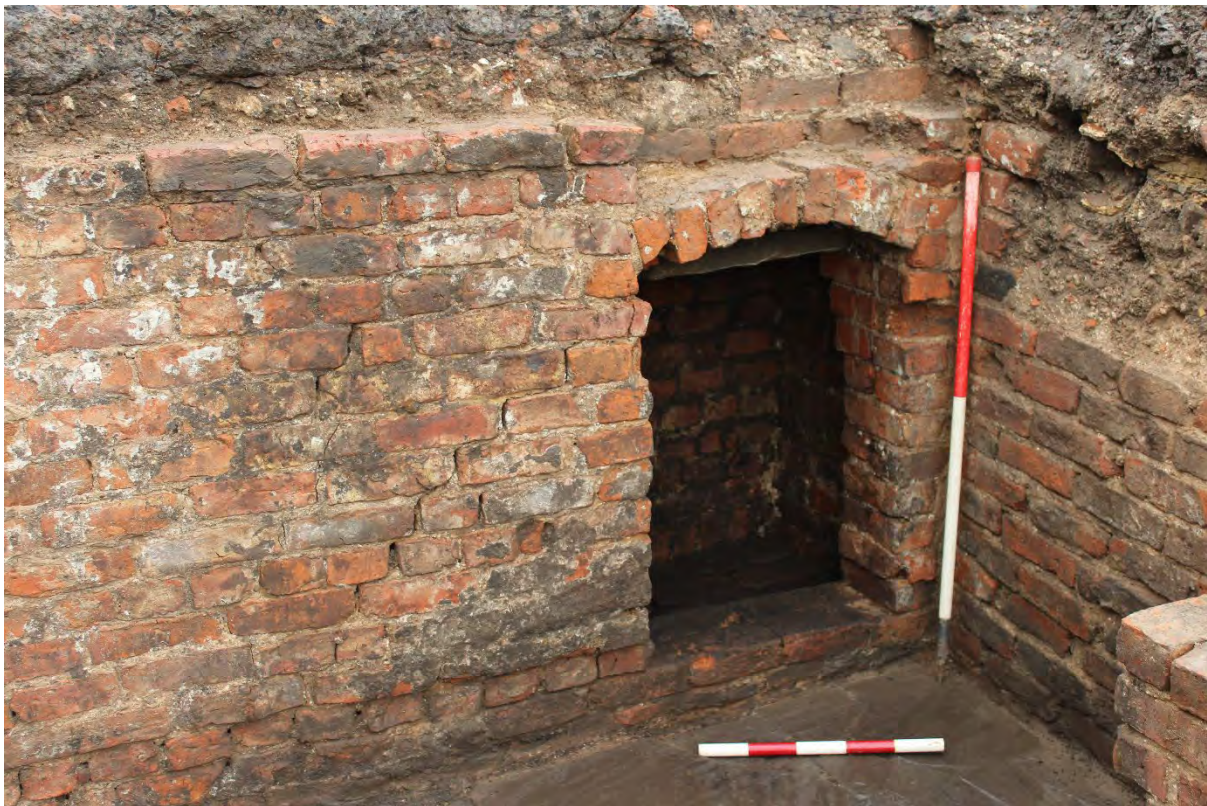
Plate 8: Possible coal chute (55) (56), looking southeast, 0.50m and 1m scale.

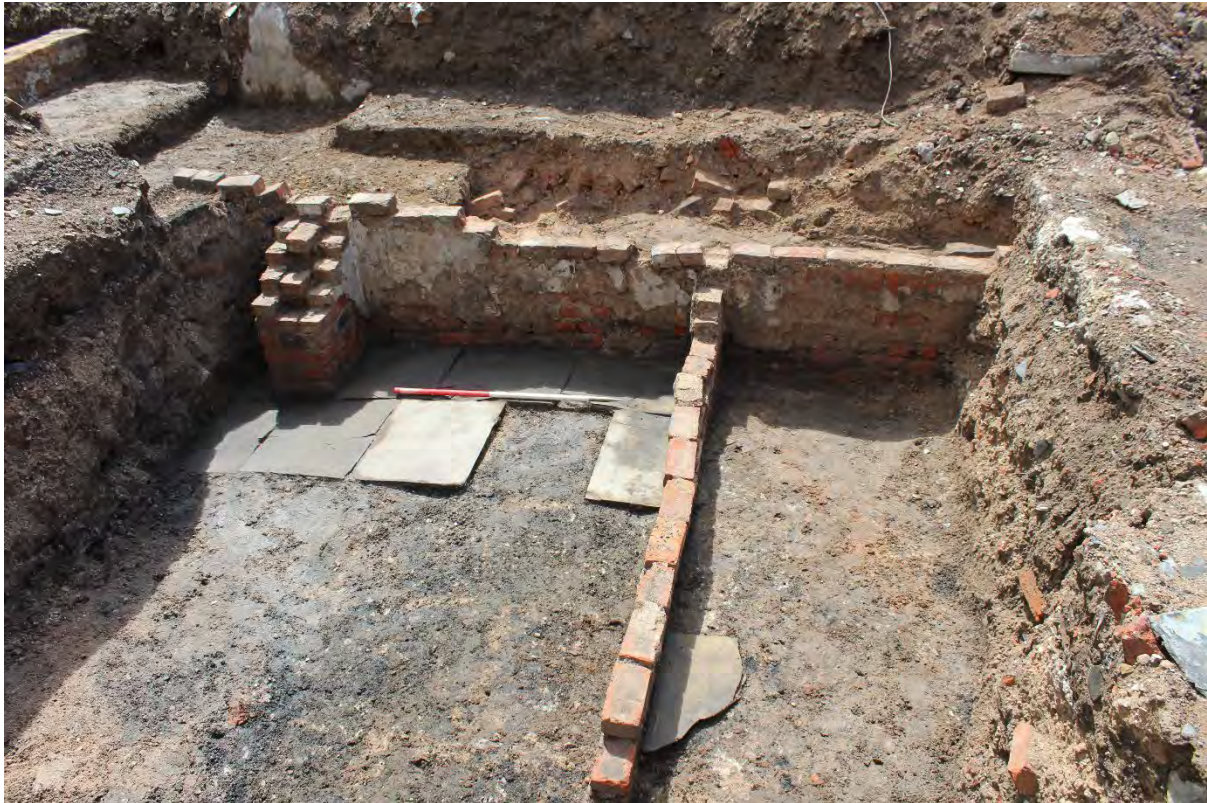
Plate 9: H8 cellar with plaster remnant on Walls (46) (49), looking southwest.

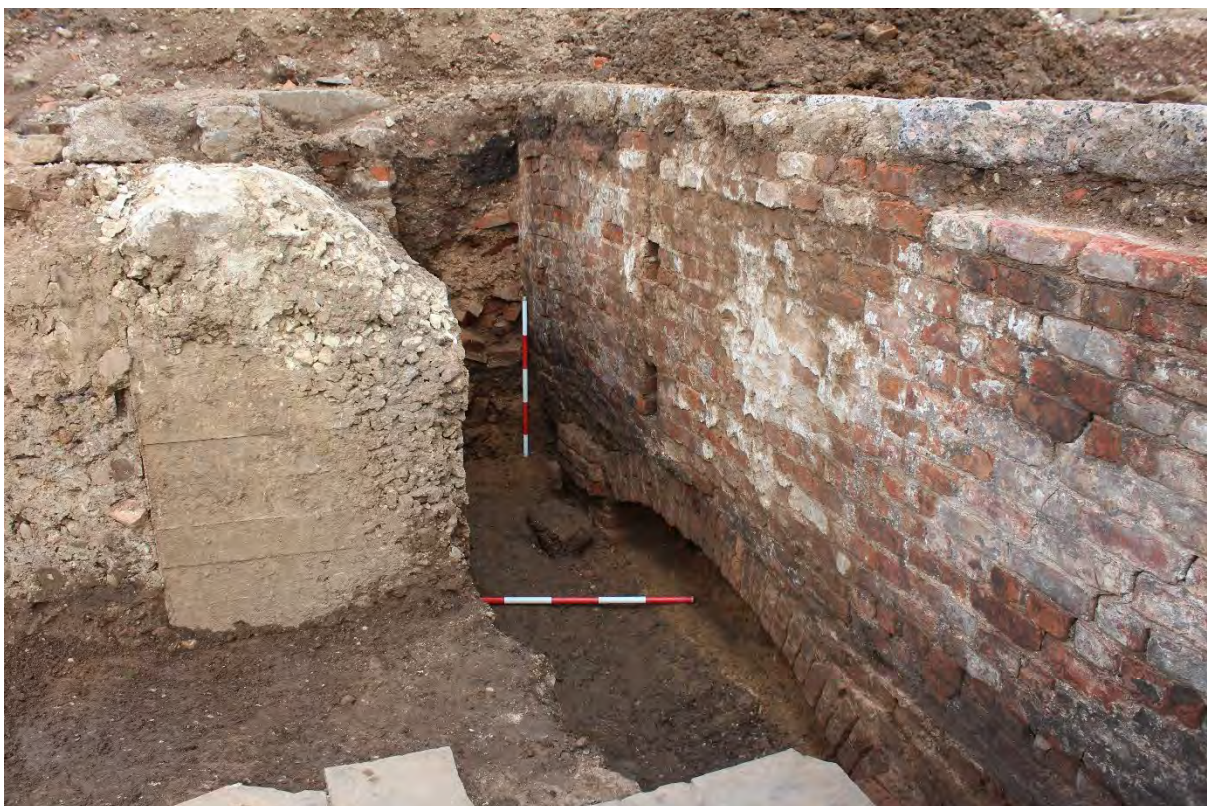
Plate 10: Phase 2 arches integral to Walls (46)/(54), looking southeast, 2 x 0.50m scale.

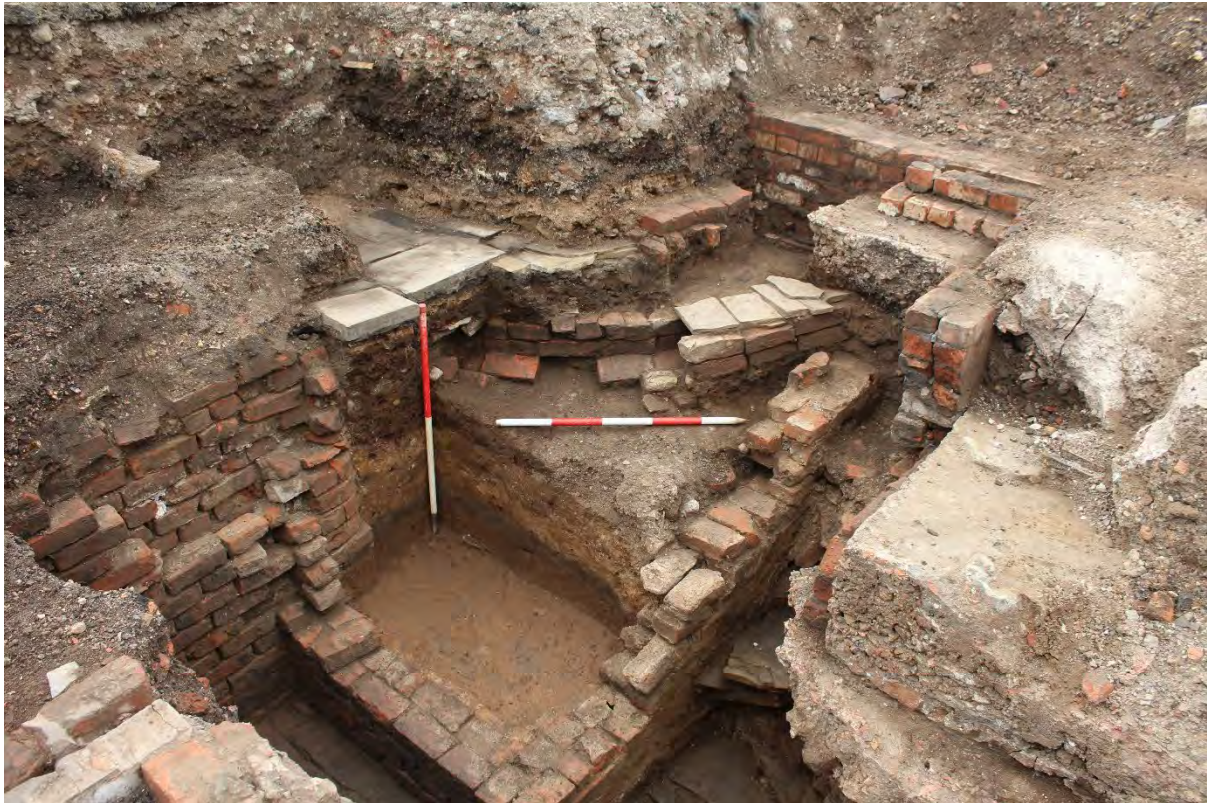
Plate 11: H13 yard with Drain (158), looking northeast, 2x 1m scale.

7.3.21 Occupying the northeast of H13 yard, the remains of roughly northeast/southwest aligned Drain (158) was revealed and sample excavated over a length of c.1.50m and width of c.0.50m. Founded upon mid- yellow/brown clay sand levelling layers (145) and the levelled general demolition backfill (146), stone slabs of between 250 x 180mm and 400 – 350mm in size, with stretcher laid bricks forming the main structure, were consolidated with a loose brown/grey sand silt construction backfill (159). The channel of Drain (158) was laid at approximately 29.42m aOD and filled by a loose dark brown/grey sand silt (164), c.0.20m thick and likely representing disuse (but discussed here). A yellow/brown sand silt layer (160) c.0.10m thick, prepared the ground above Drain (158) for Floor (161) (29.92m aOD), comprising flagstones sized between 150 x 200mm – 350 x 550mm.

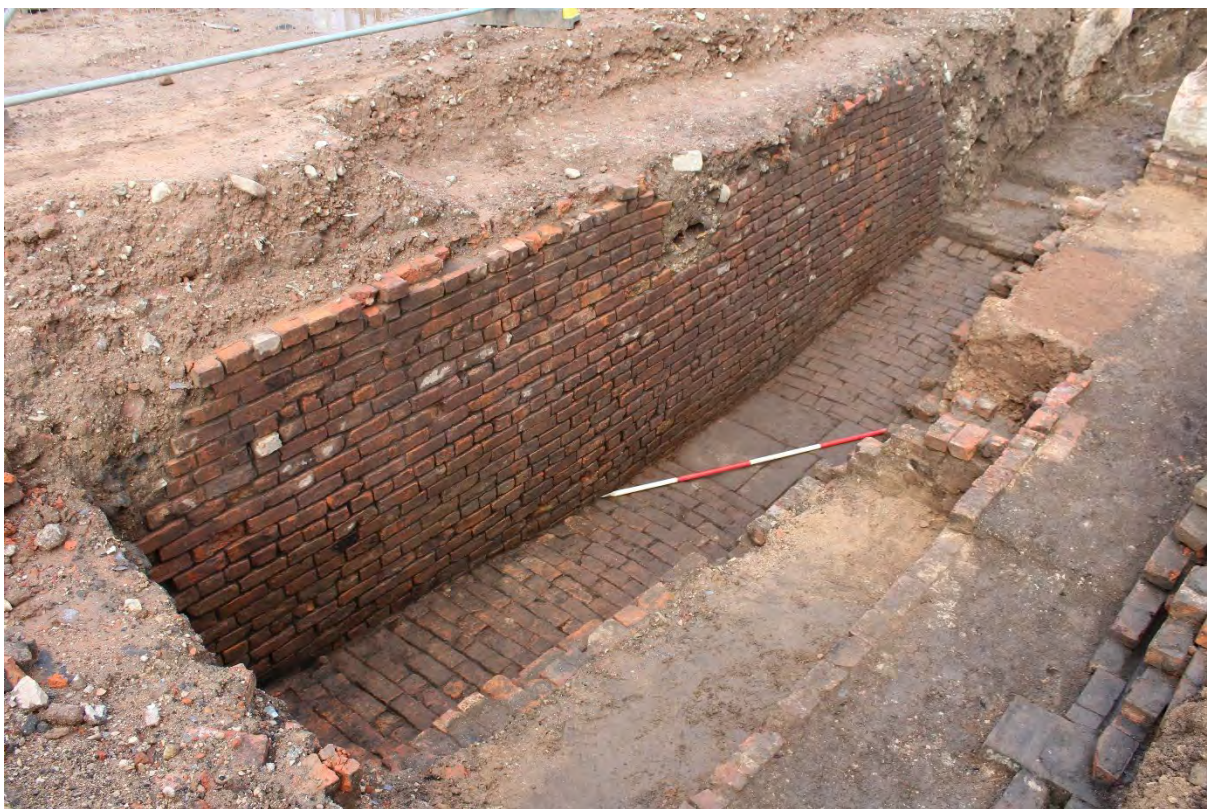
Plate 12: Phase 2.1 Irving / Poplar Street G5 'privy' construction, Floor 179, looking west, 2m scale.

- 7.4.4 Floor (179) (Plate 12 & Plate 13), constructed upon dark clay sand (185) (Figure 9, s9) and mid- grey sand (186) levelling layers, was composed from handmade red bricks laid flat in the passageway, with a broad, although slightly irregular declivity of between 8° - 12° from both north (29.26m aOD) and south to an area of York flagstones (28.69m aOD) in the central space and threshold. An upright flagstone was set against the rear of the recessed space, possibly as waterproofing. A single step into the passage was noted at the north extent, at the truncation from aforementioned factory construction cut.

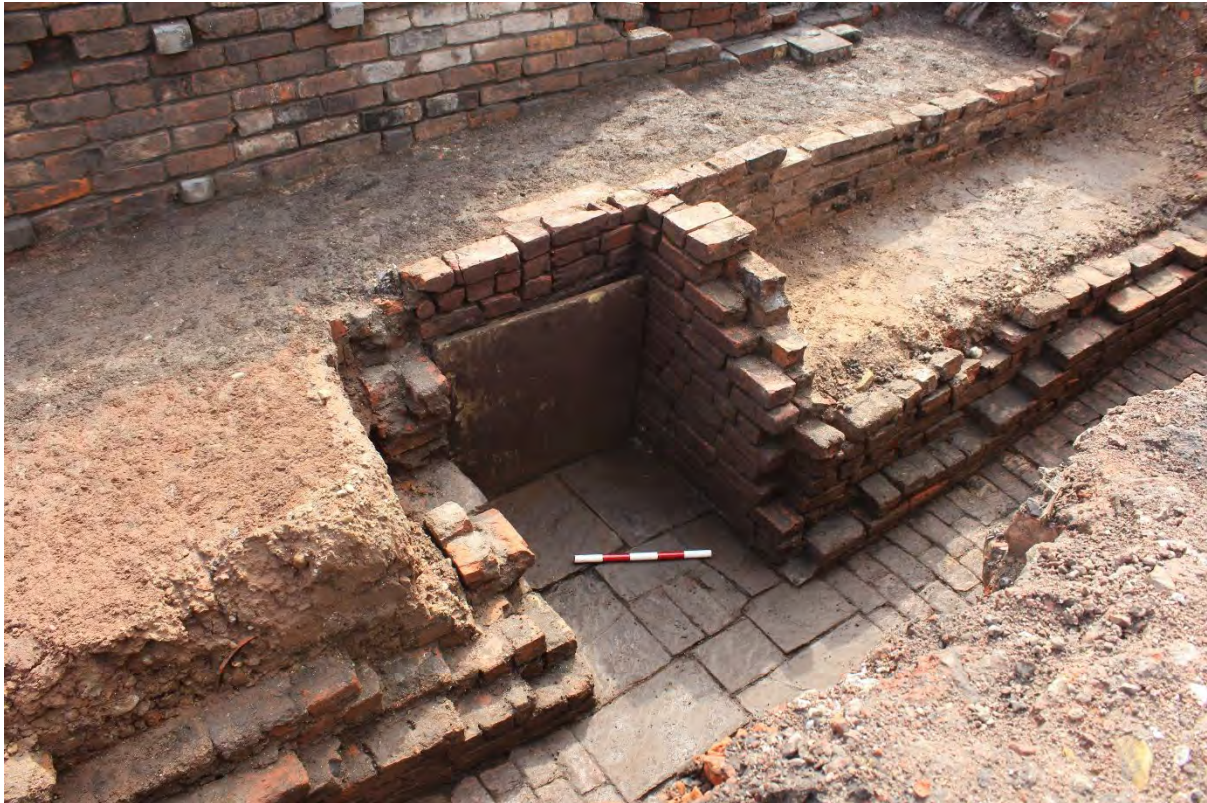
Plate 13: Recess in G5 'privy' between Walls (166) and (175), looking southeast, 0.50m scale.

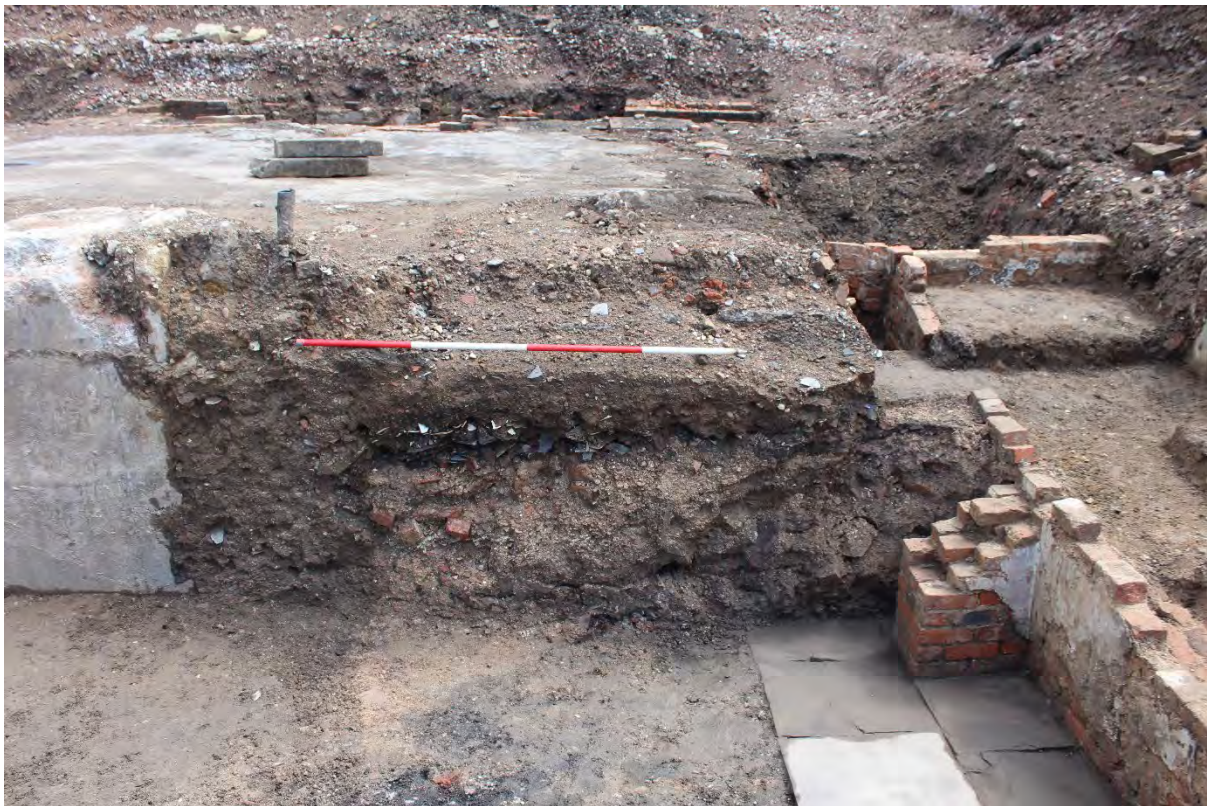
Plate 14: Cellar disuse backfill G6 (45), looking southeast, 2m scale.

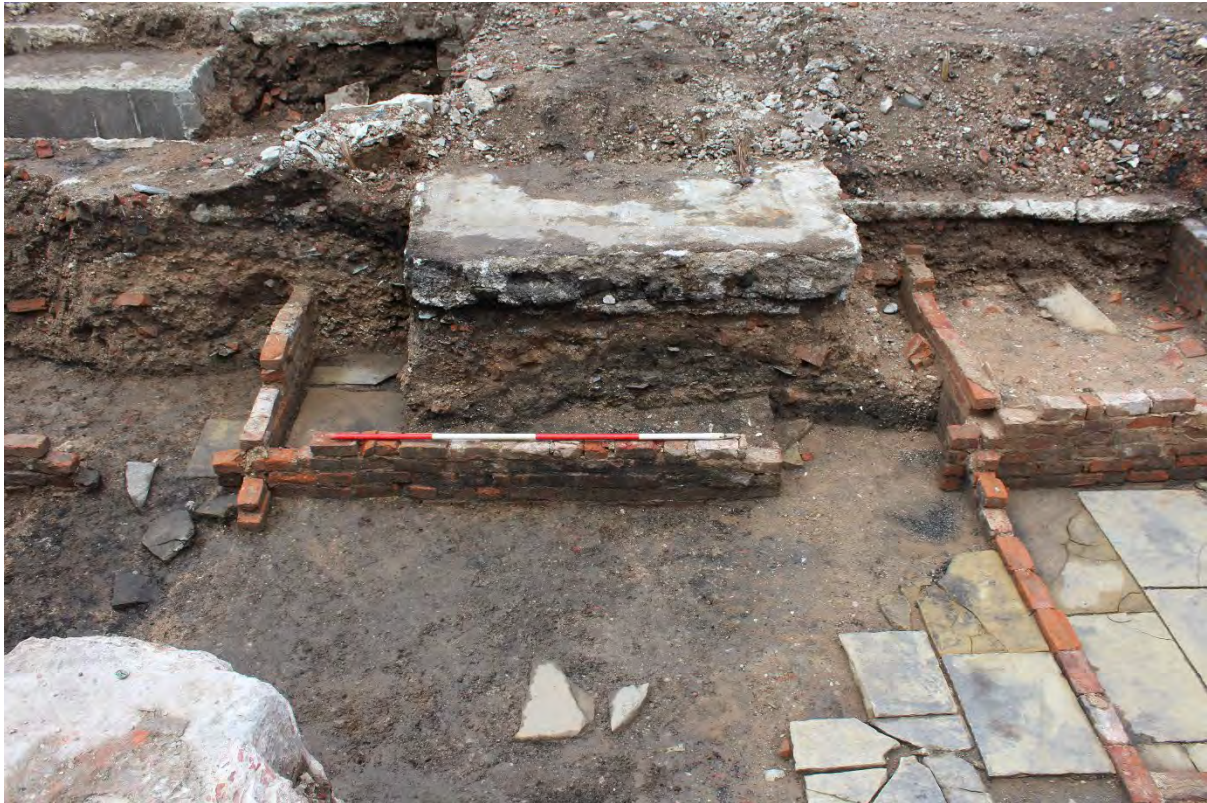
Plate 15: Modern concrete structure on H10 cellar disuse backfill, looking northwest, 2m scale.

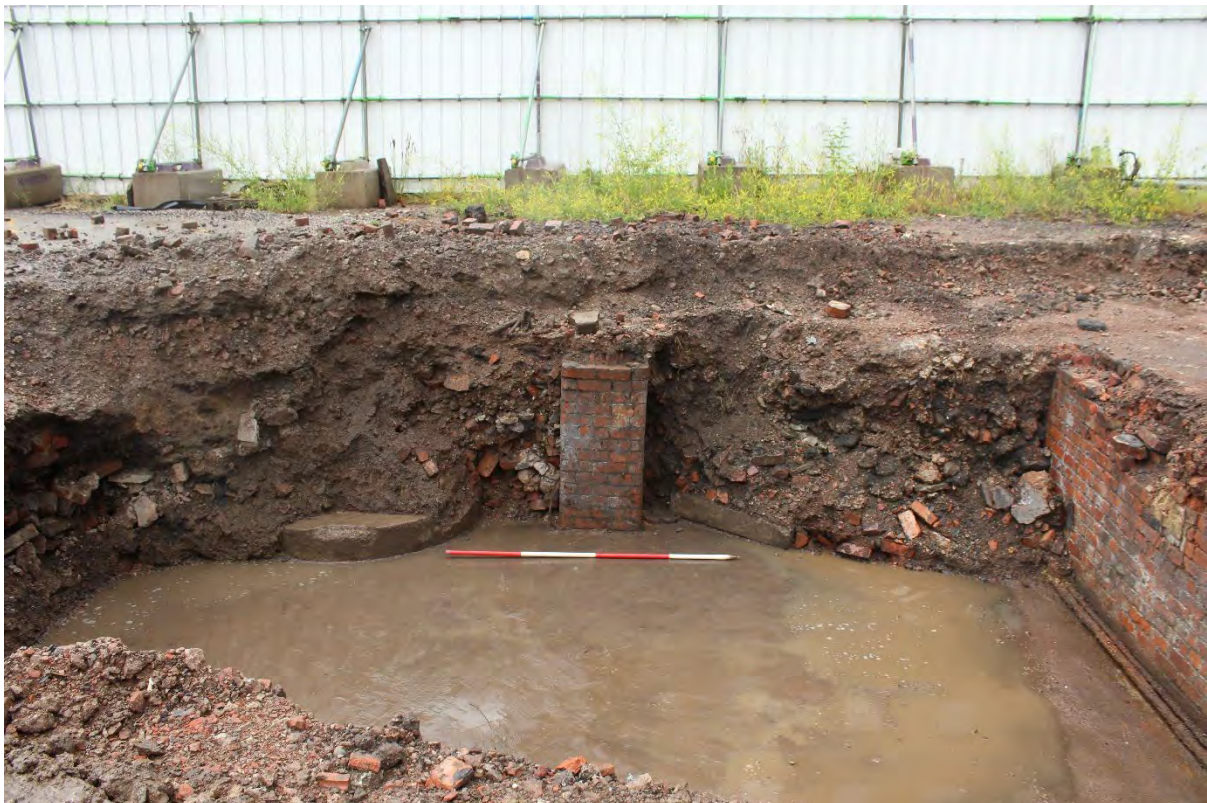
Plate 16: Phase 3 construction, factory Floor east (112), looking northeast, 2m scale.

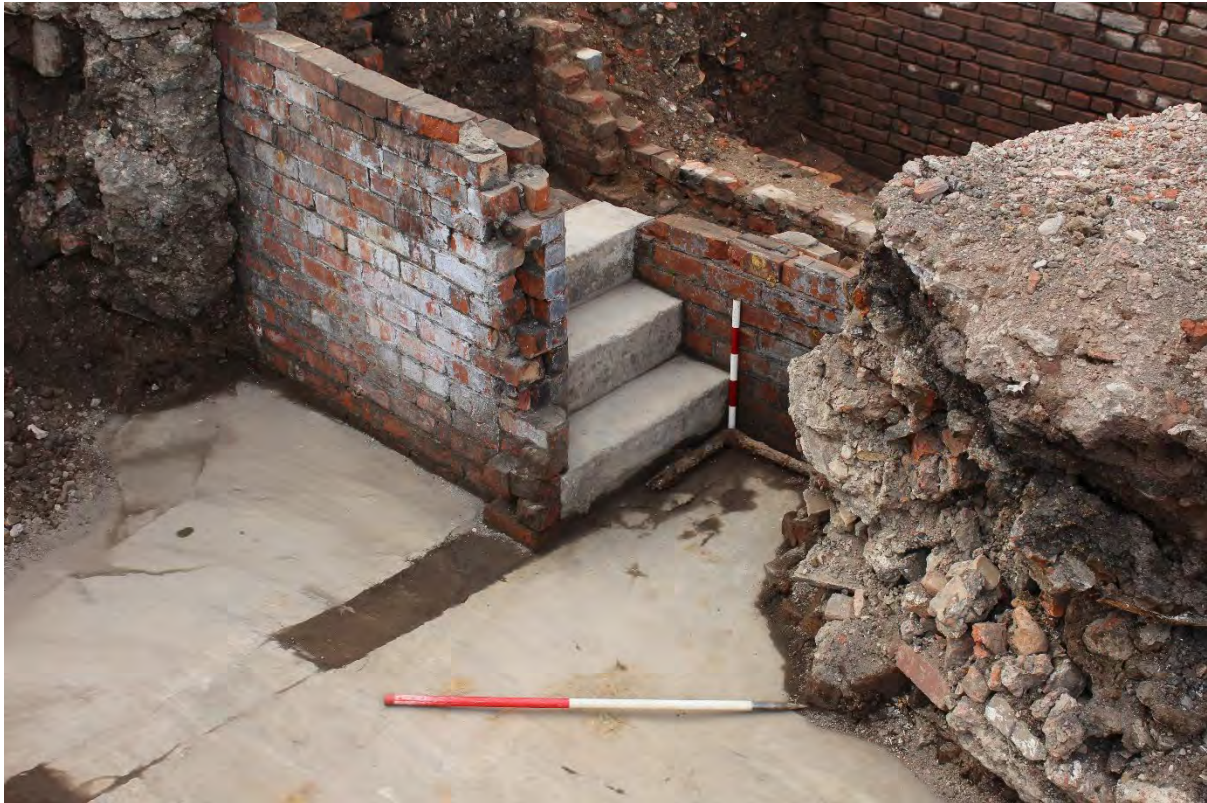
Plate 17: Factory Floor west (112) with steps (171) and Wall (172), looking south, 1m scale.

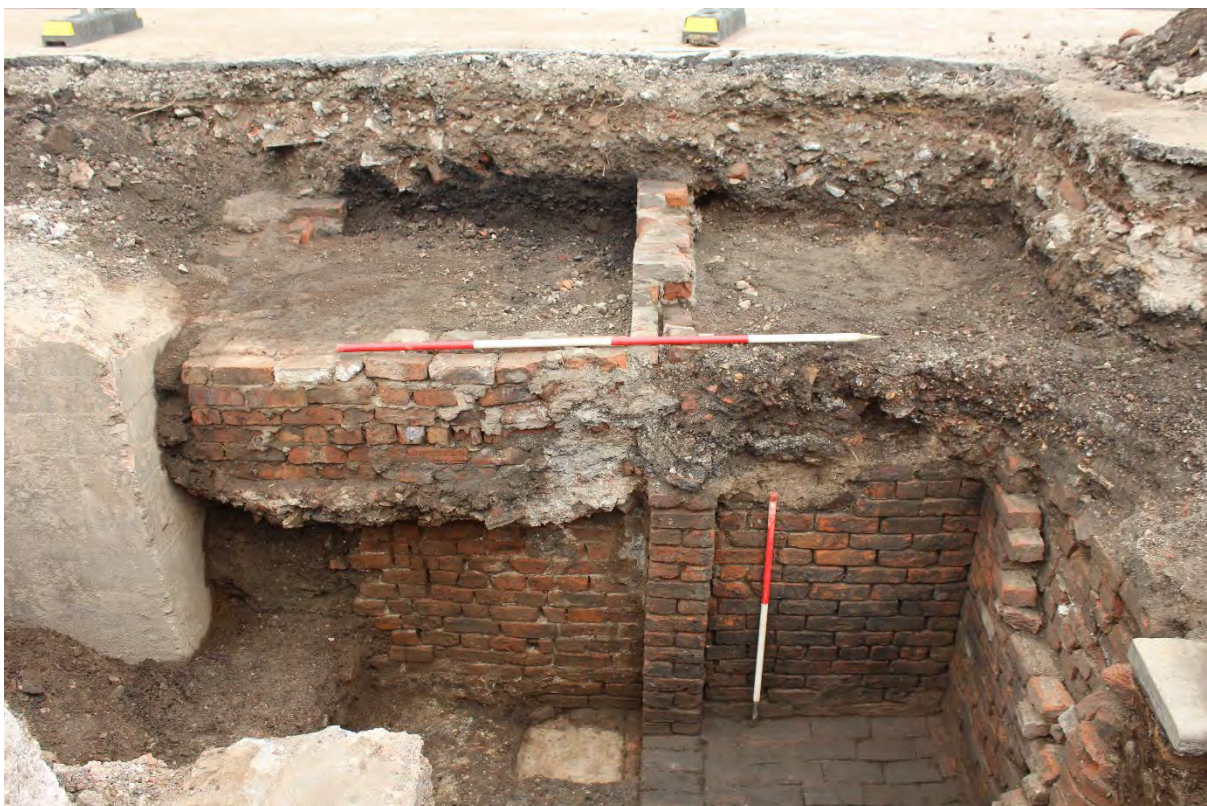
Plate 18: Phase 3 G8 construction Wall (140) above Phase 2 Wall (154) H13 yard, looking southwest, 1m and 2m scale.

7.3.20 The layout for the H13 yard was incomplete, defined by Wall (162) to the northwest and Wall (154) (Plate 18) to the southwest (Figure 10, s8). Evidence for a three-walled rectangular internal subterranean structure, at least c.1.30 x 1.0m in plan, was represented by inverted 'T-shaped' partition Wall (157), within a vertically sided, flat-based construction cut [153] (Figure 10, s8), filled with general backfill (146). The function of this structure was unclear, but it was paved with a red brick floor (155) at 28.51m aOD, stained with a dark possible coal waste deposit and accessed from the south. It was conceivably a coal chute. Wall (157) continued across the structure to the northeast extent, giving a width to the enclosed space of roughly 3.15m. An occasionally surviving coat of green/grey plaster was noted on the internal (northwest) face of Wall (154). A break in Wall (162) related to brick column (156) (Figure 10, s8) was tentatively interpreted as the position for steps descending to the cellar.

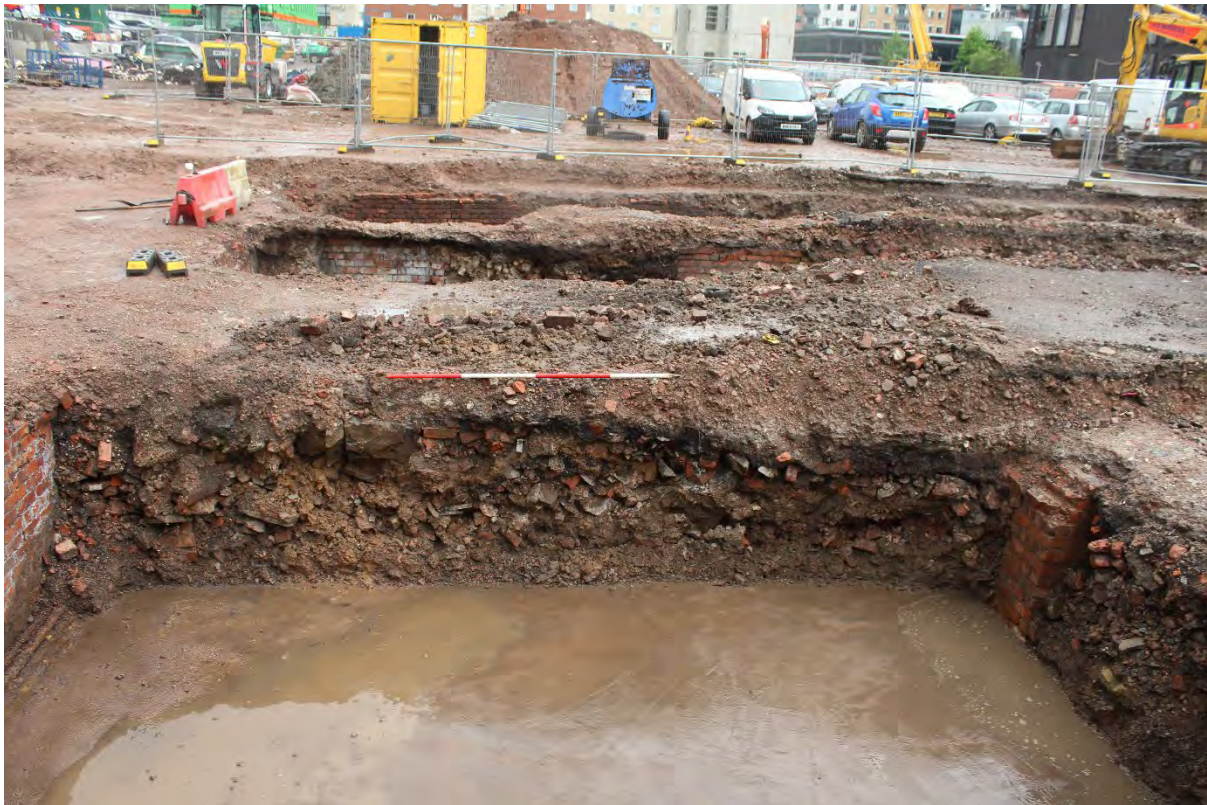
Plate 19: Factory basement G9 demolition backfill, looking southwest, 2m scale.
