The National Trust

Castlefield Viaduct  
Phase 2

Remedials  
Lattice Girders  
Diagonal Outstands

| ID | CVI-ARUP-ZZ-ZZ-DR-S-4012 | | |

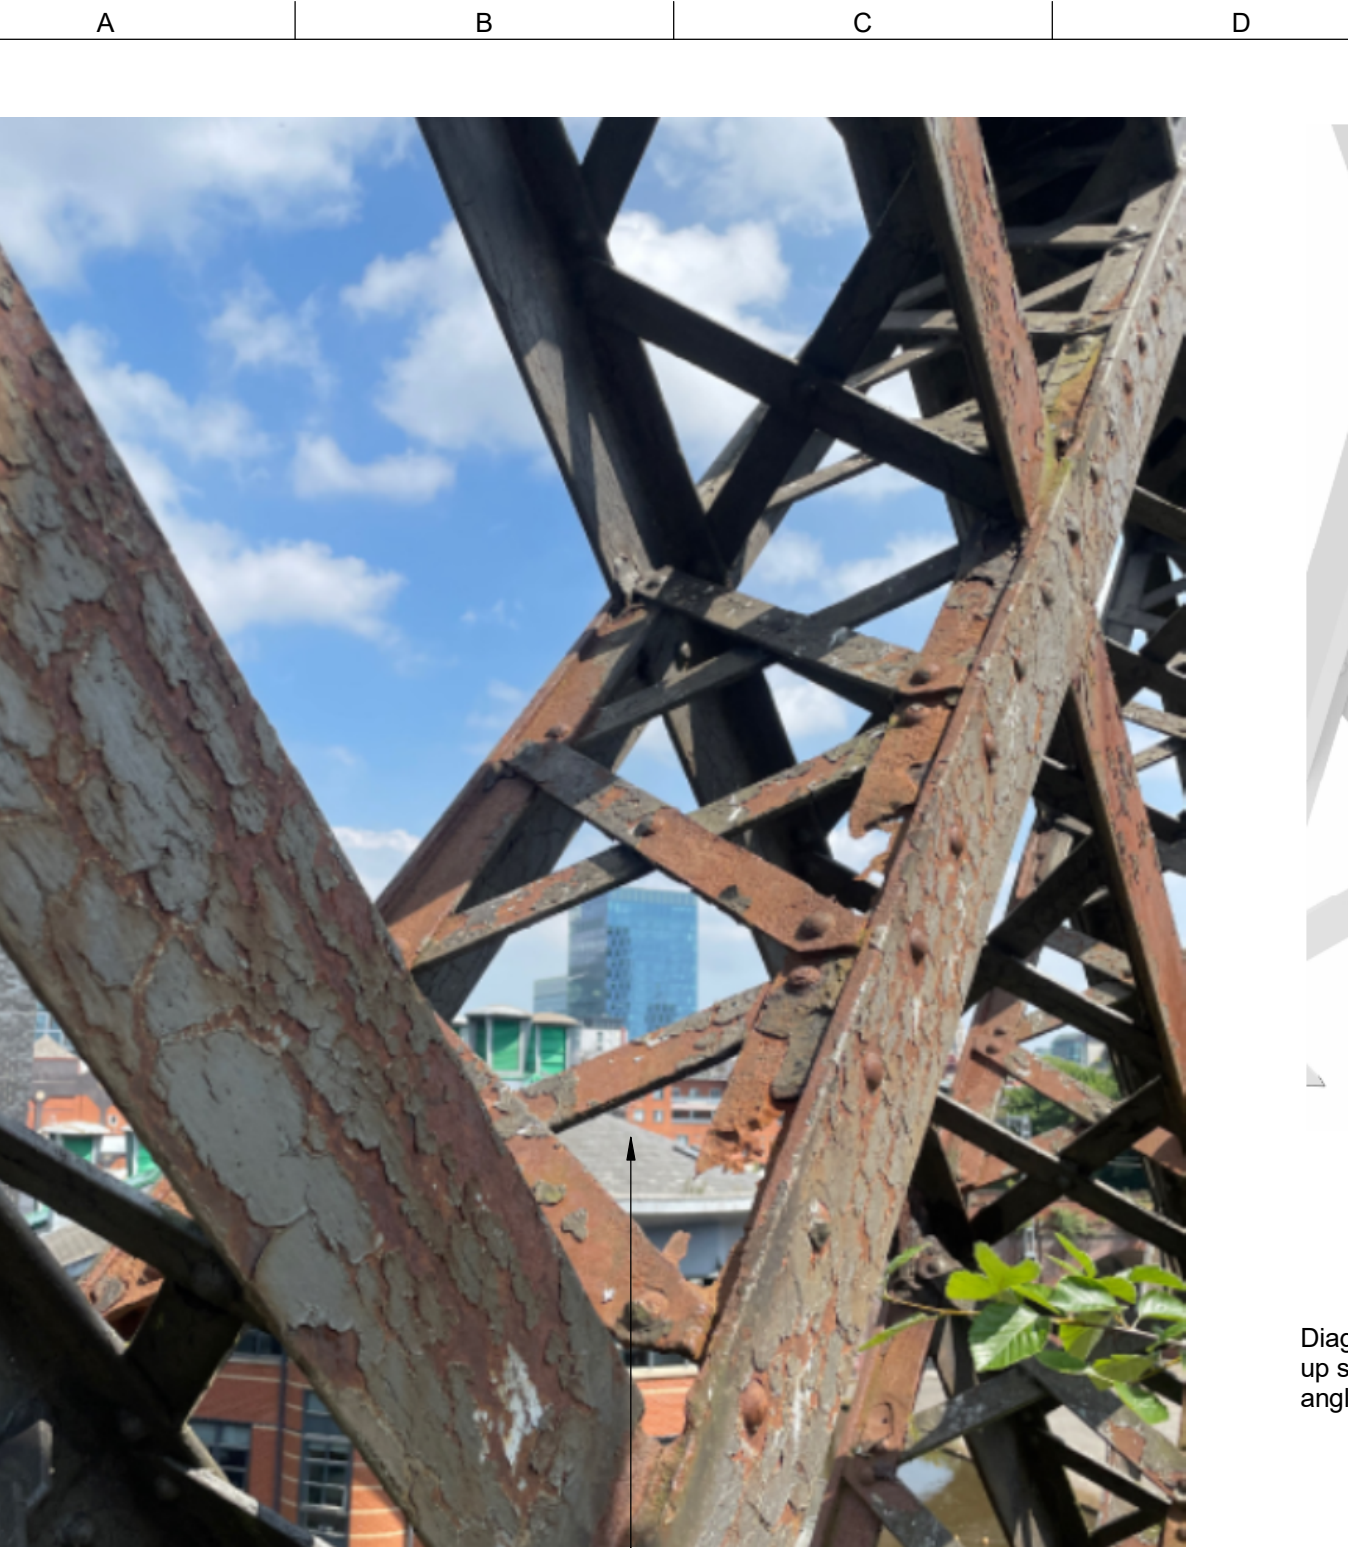
**Example 1**  
- outstand to built-up rivetted diagonal, with rivets for connection to incoming cross bracing  
- angle to inside runs between continuous diagonals in opposite direction, typically with 3 bays of X-bracing  
- at least 2 holes per length of outstand

**Step 1**  
- corroded angle (assumed to built-up rivetted diagonal) assumed removed in whole between opposite diagonals, i.e. across 3 bays of X-bracing  
- existing rivets to X-bracing, and from corroded angle into flat, to be over-reamed and removed

**Step 2**  
- replacement steel angle in same position  
- to be same thickness and dimensions as existing  
- to be carefully offered between free ends of X-bracing where possible, assuming some movement to free plates  
- Note: option to install angle in smaller lengths could be reviewed upon review of buildability

**Step 3**  
- 24mm dia holes drilled through new angle in position of previous rivets  
- new M22 HSFG dome-headed bolts from new angle into existing plates

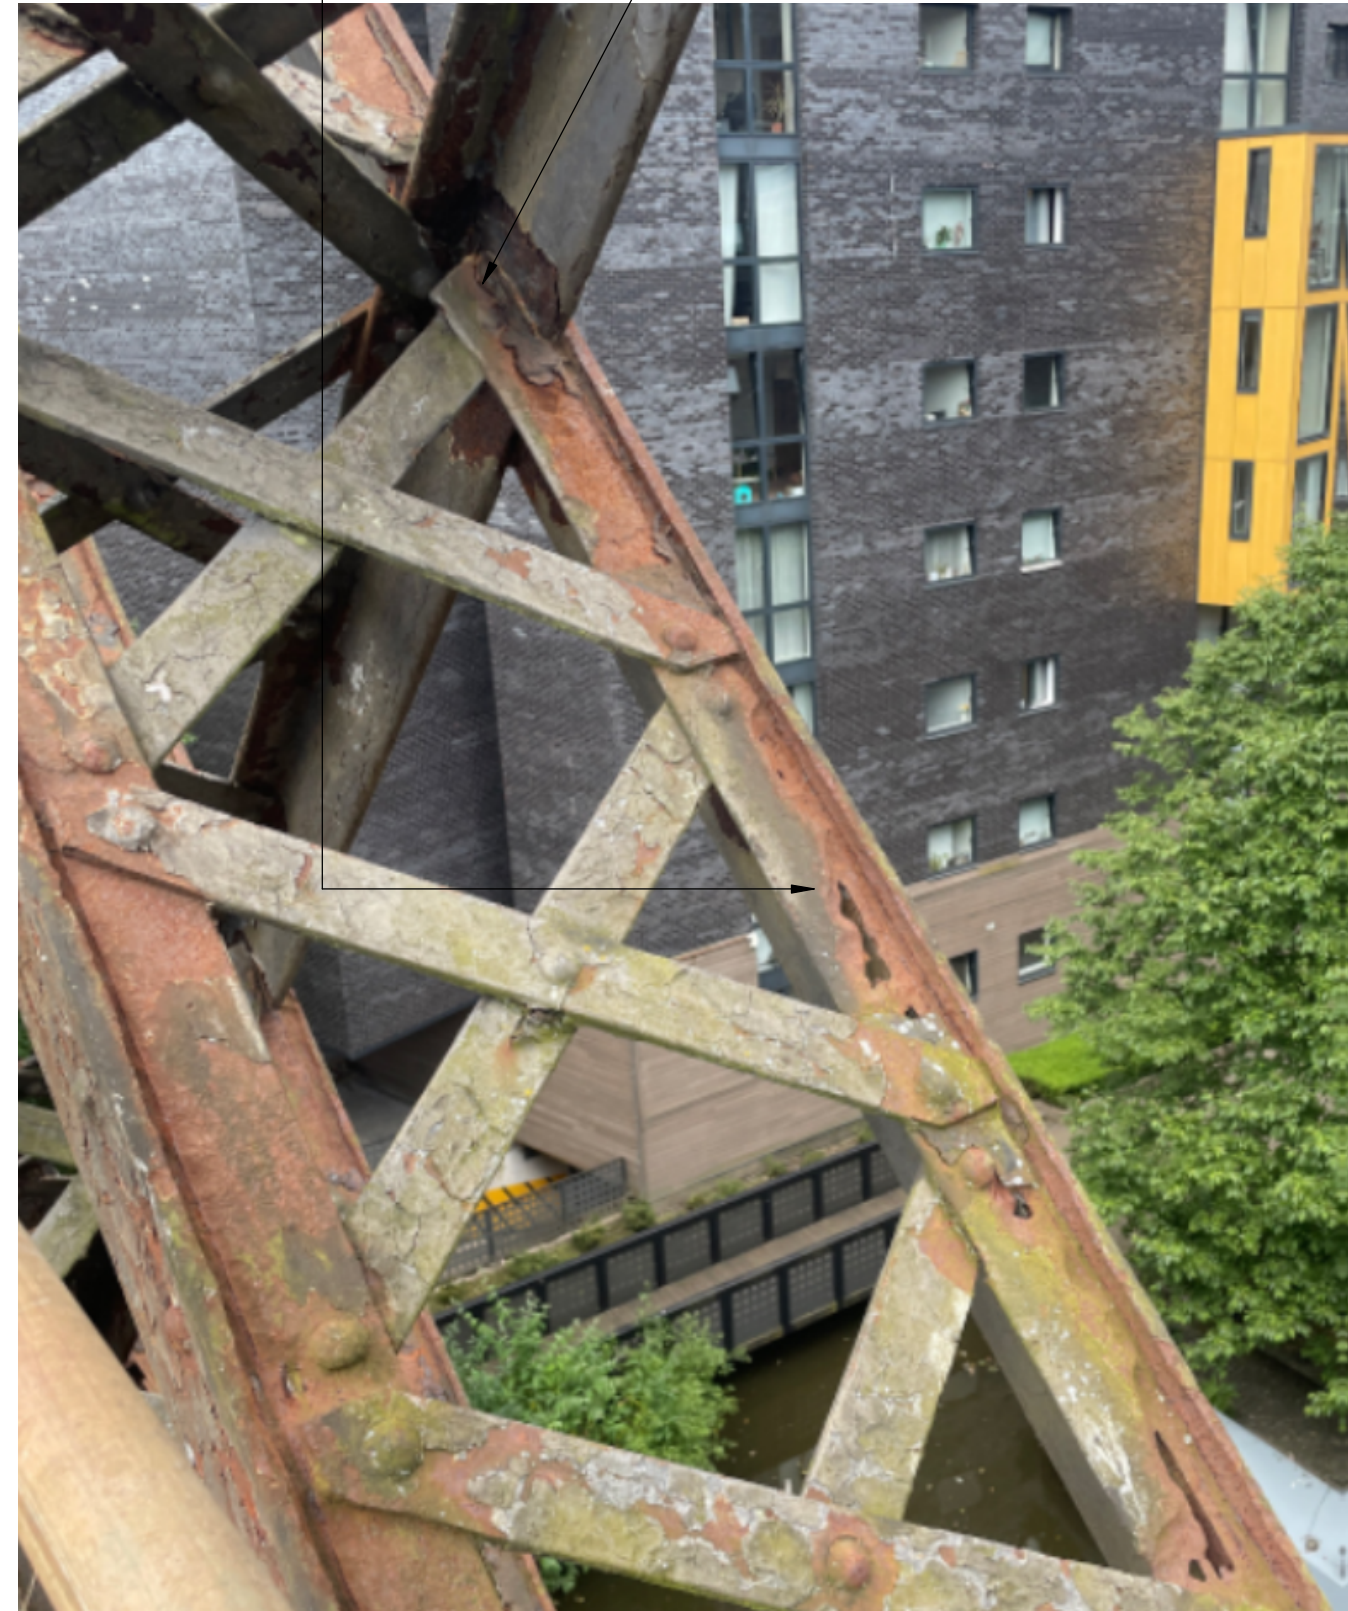
**Example 2**  
- loss of section to outer angle in this example, across 2 bays of X-bracing  
- at least 2 holes per length of outstand

Note conditions with outstand running through to rear of opposing diagonal

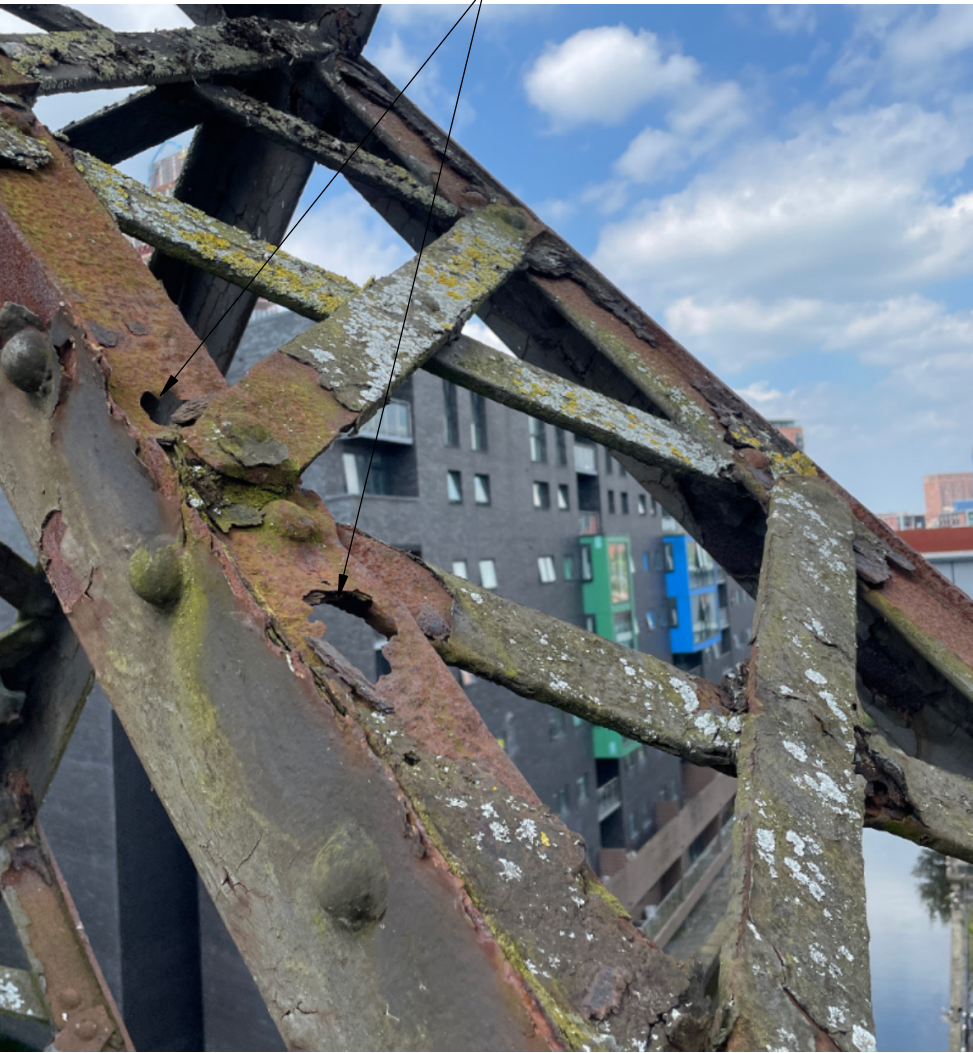
**Example 3**  
- loss of section to inner angle, either side of X-bracing connection  
- at least 2 holes per length of outstand
