# Phase 1 Desktop Study

Land at Peary Street, Manchester

Social Sports Society

| TITLE | NAME | SIGNATURE | DATE |
|---|---|---|---|
| Report Reference | 4637-ROC-ZZ-XX-RP-ES-P1DTS1 | | |

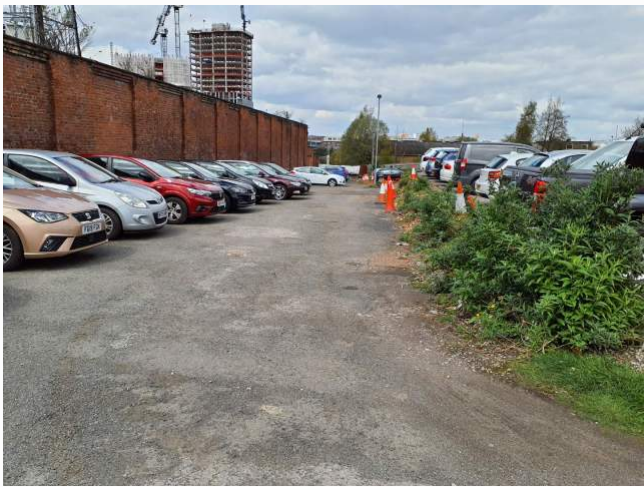
| OTHER | West of site | N | A gravel path or driveway lined with parked cars on the left and orange traffic cones on the right. A brick wall is visible on the left side. |

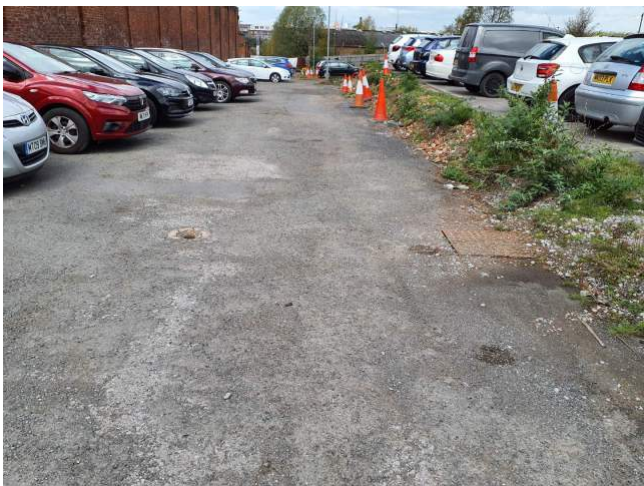
| OTHER | Manhole and gully | N | A gravel path with a manhole cover in the foreground. Parked cars are visible on the left, and orange traffic cones are on the right. |
