**Land at  
6 Loom Street, Manchester, M4 6AN  
(125037/FO/2019)**

**Monitoring and Recording of Geotechnical  
Investigations prepared on behalf of  
The Forshaw Group**

Document Ref: 1028.R01a  
July 2024

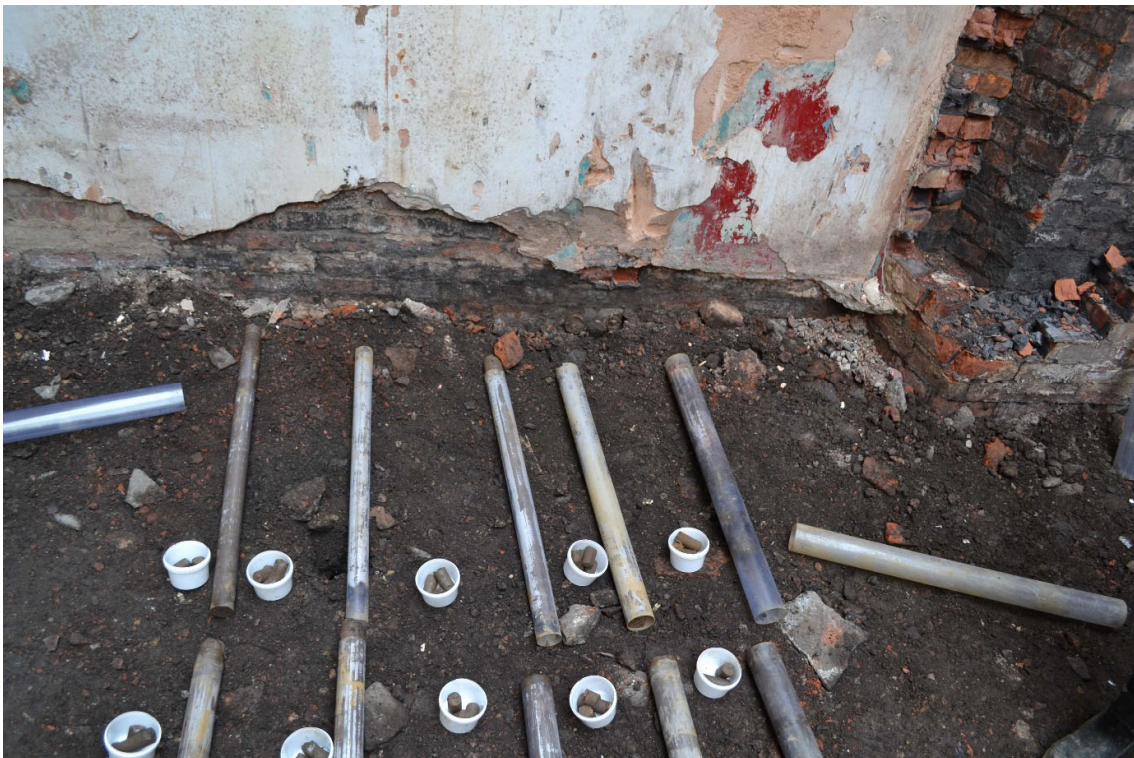
**Plate 2: Arisings from Borehole 1**

| | | | | <h1>Borehole Log</h1> | | | | Borehole No.<br><b>WS101</b><br>Sheet 1 of 1 | |
|---|---|---|---|---|---|---|---|---|---|
| | | 0.10 | ES | | | | MADE GROUND: Dark brown slightly clayey sandy gravel. Gravel is medium to coarse angular of brick, metal, ceramic and clinker. | | |
| | | 1.00 | SPT | N=9 (1,2/2,2,2,3) | 1.20 | | Firm light grey mottled orange brown slightly gravelly CLAY. Gravel is fine sub-angular of mudstone and sandstone. | 1 | |
| | | 1.50 | U | | | | Stiff medium strength to very stiff high strength brown slightly gravelly CLAY. Gravel is fine to coarse angular to sub-angular of sandstone and mudstone. | | |

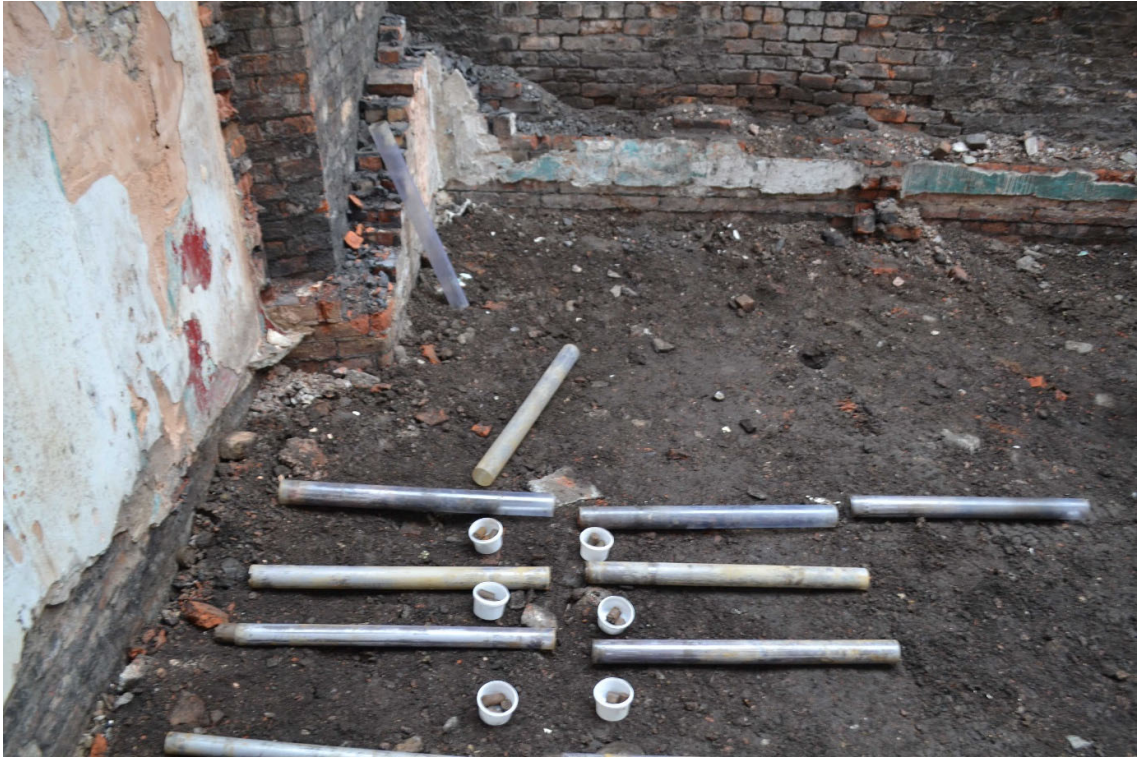
**Plate 3: Arisings from Borehole 2**

| Well | Water Strikes | Sample and In Situ Testing | | | Depth (m) | Level (m) | Legend | Stratum Description | |
|---|---|---|---|---|---|---|---|---|---|
| | | 0.30 | ES | | 0.30 | | | MADE GROUND: Dark brown slightly clayey sandy gravel. Gravel is medium to coarse angular of brick, metal, ceramic and clinker. | 1 |
| | | 0.70 | ES | | | | | Stiff medium strength light grey mottled orange brown slightly gravelly CLAY. Gravel is fine sub-angular of mudstone and sandstone. | |

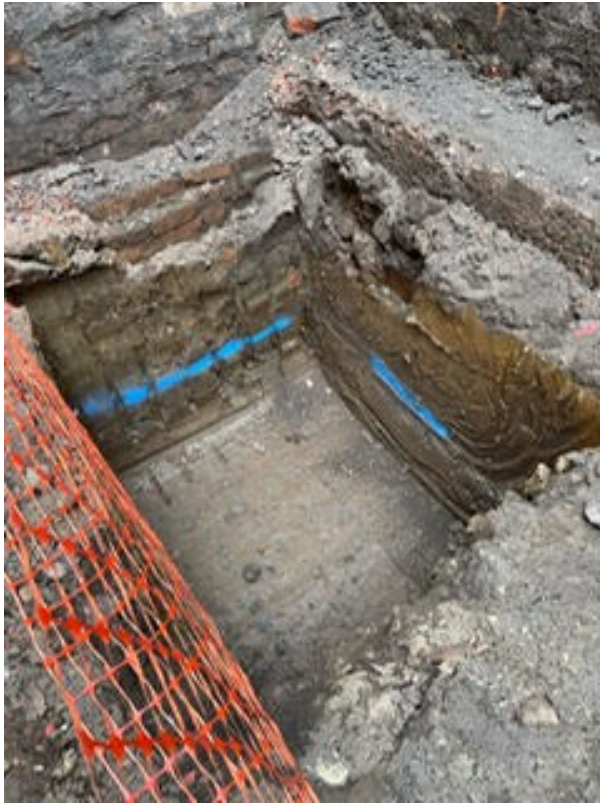
Although there was no archaeological watching brief maintained during development groundworks a series of photographs of the excavated foundation reception pits have been provided by the groundworks contractor (Appendix A). These show a consistent deposit of geologically lain and undisturbed gravelly clay overlain by Made Ground.

**Plate 4: Foundation reception pit sections showing gravelly clay which was a geologically lain material consistent in composition with the broad geological definition of Devensian Till**

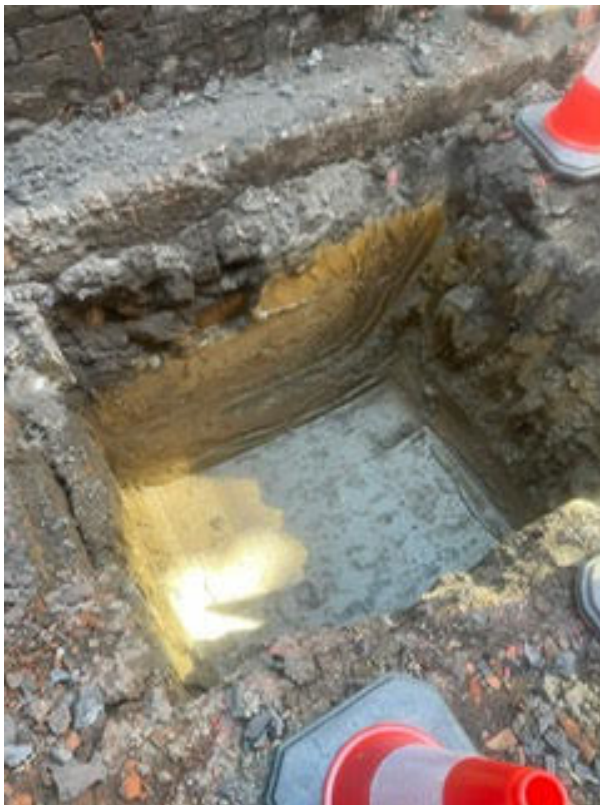
**Plate 5: Foundation reception pit sections showing gravelly clay, a geologically lain material consistent in composition with the broad geological definition of Devensian Till**

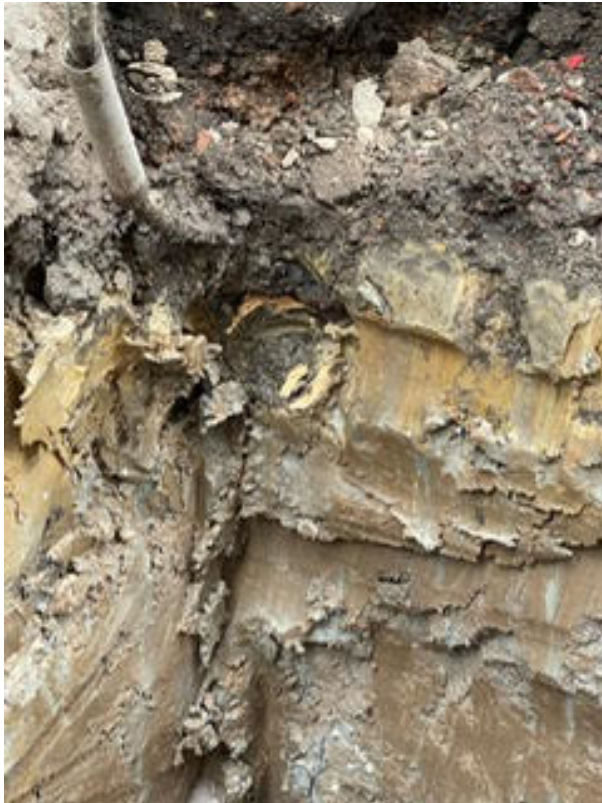
**Plate 6: Foundation reception pit sections showing gravelly clay, a geologically lain material consistent in composition with the broad geological definition of Devensian Till**

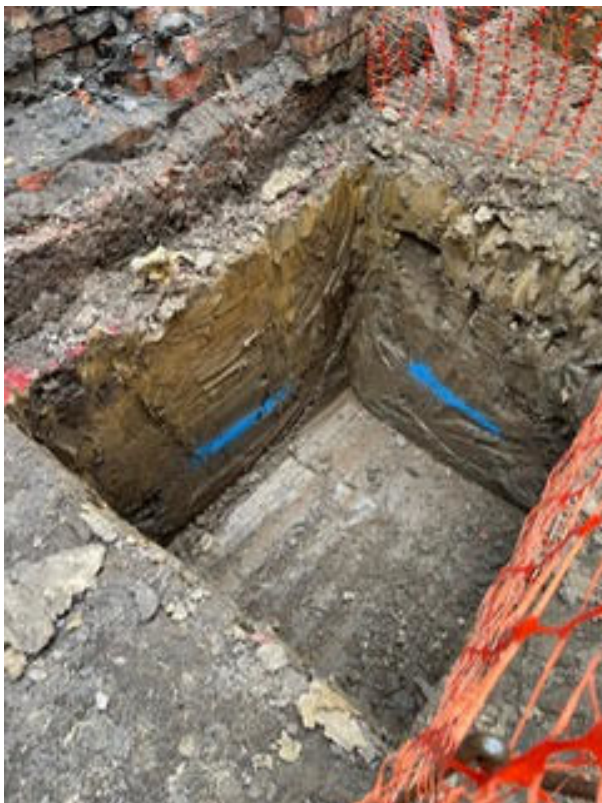
**Plate 7: Foundation reception pit sections showing gravelly clay, a geologically lain material consistent in composition with the broad geological definition of Devensian Till**

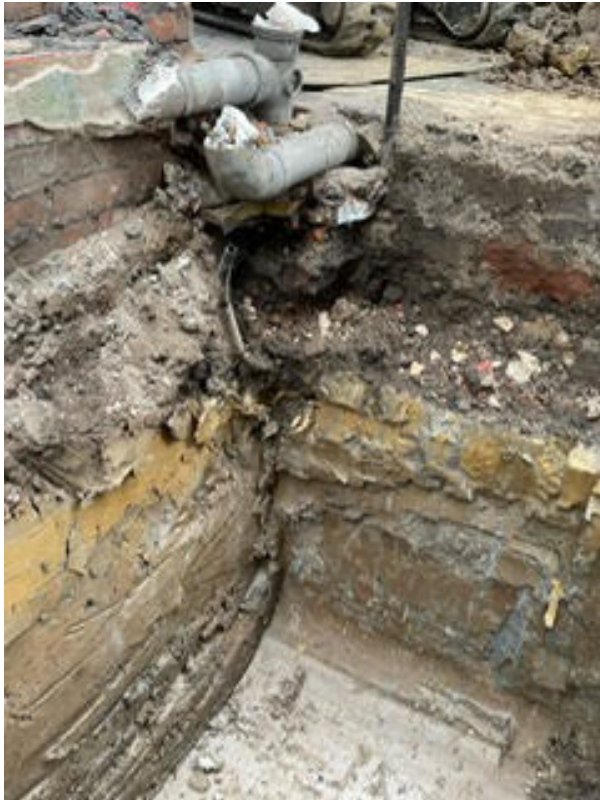
**Plate 8: Foundation reception pit sections showing Made Ground surmounting gravelly clay.**
