Ref: 15-798-L1  
Date: December 2023

## **SUPPLEMENTARY GEOENVIRONMENTAL INVESTIGATION ANCOATS GREEN, JERSEY GREEN**

### **1.1. BACKGROUND**

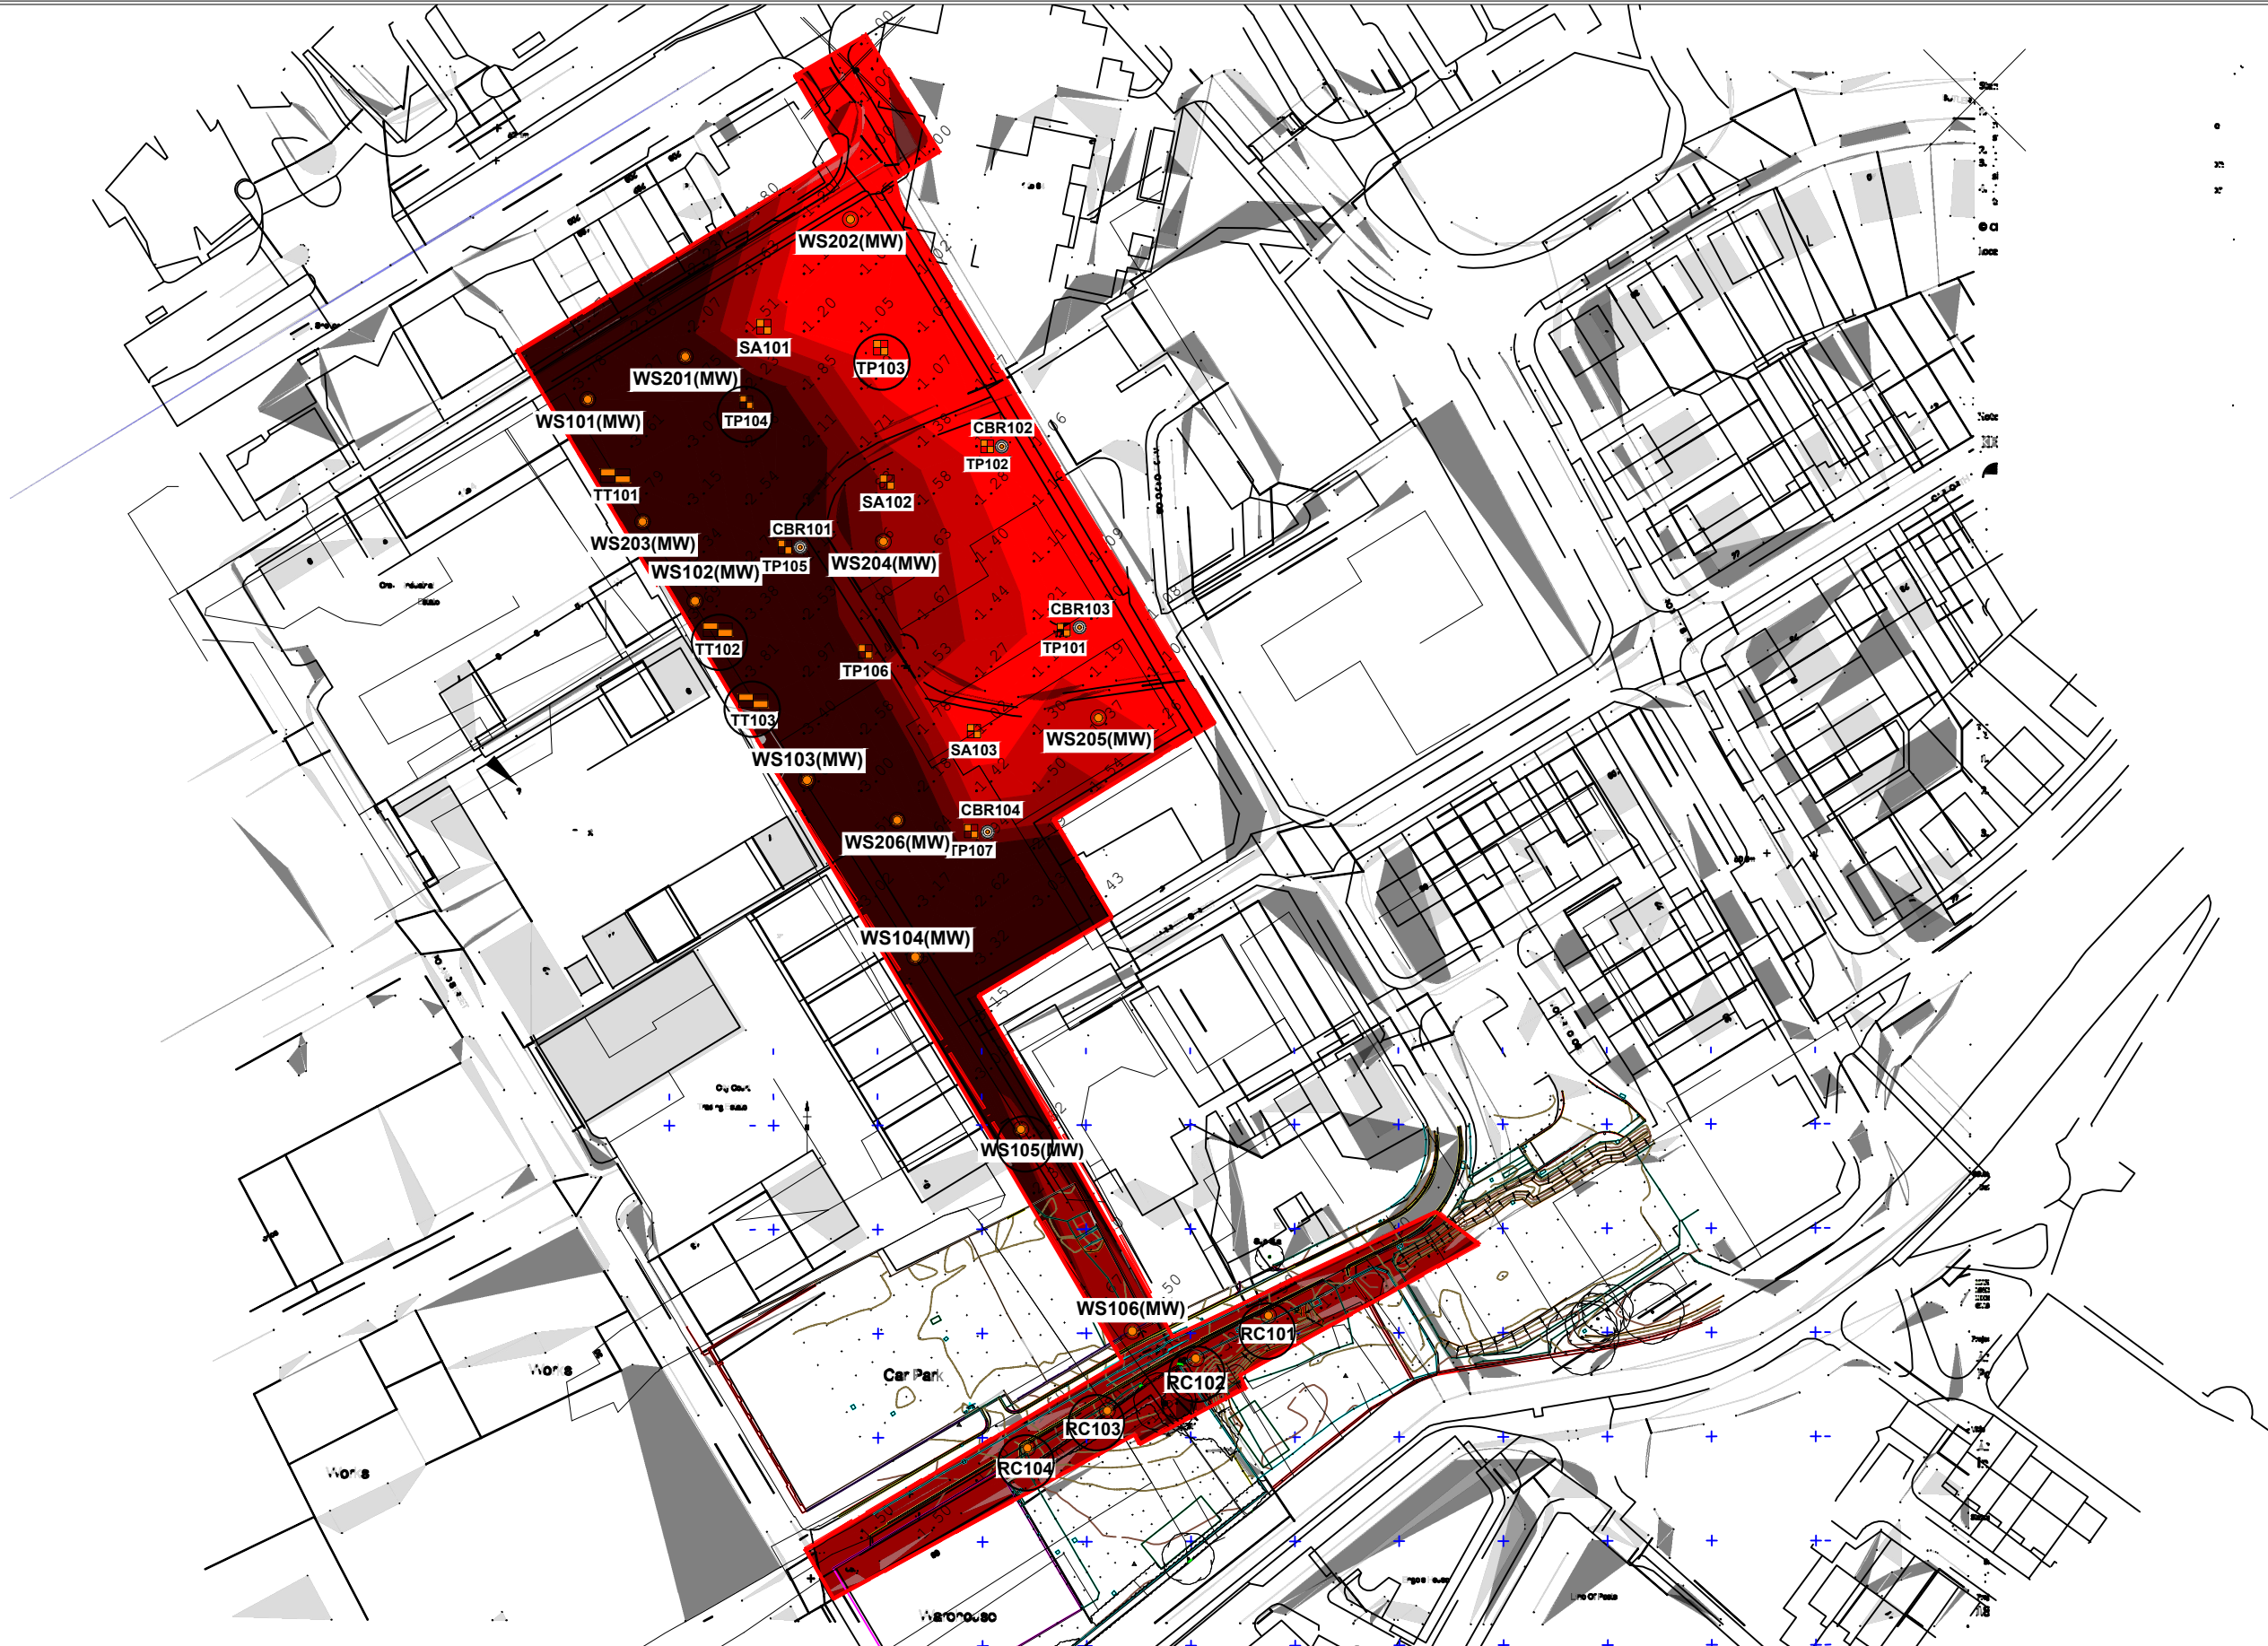
- Location Symbols
- WS101 Approximate Window Sample Probehole Location
  - TP101 Approximate Trial Pit Location
  - SA101 Approximate Soakaway Test Location
  - RC101 Approximate Rotary Borehole Location
  - Base of Made Ground Not Identified

- Made Ground Depth (m)
- Depth of Made Ground 0.90 - 1.19m
  - Depth of Made Ground 1.20 - 1.49m
  - Depth of Made Ground 1.50 - 1.79m
  - Depth of Made Ground 1.80 - 2.09m
  - Depth of Made Ground 2.10 - 2.39m
  - Depth of Made Ground >2.40m

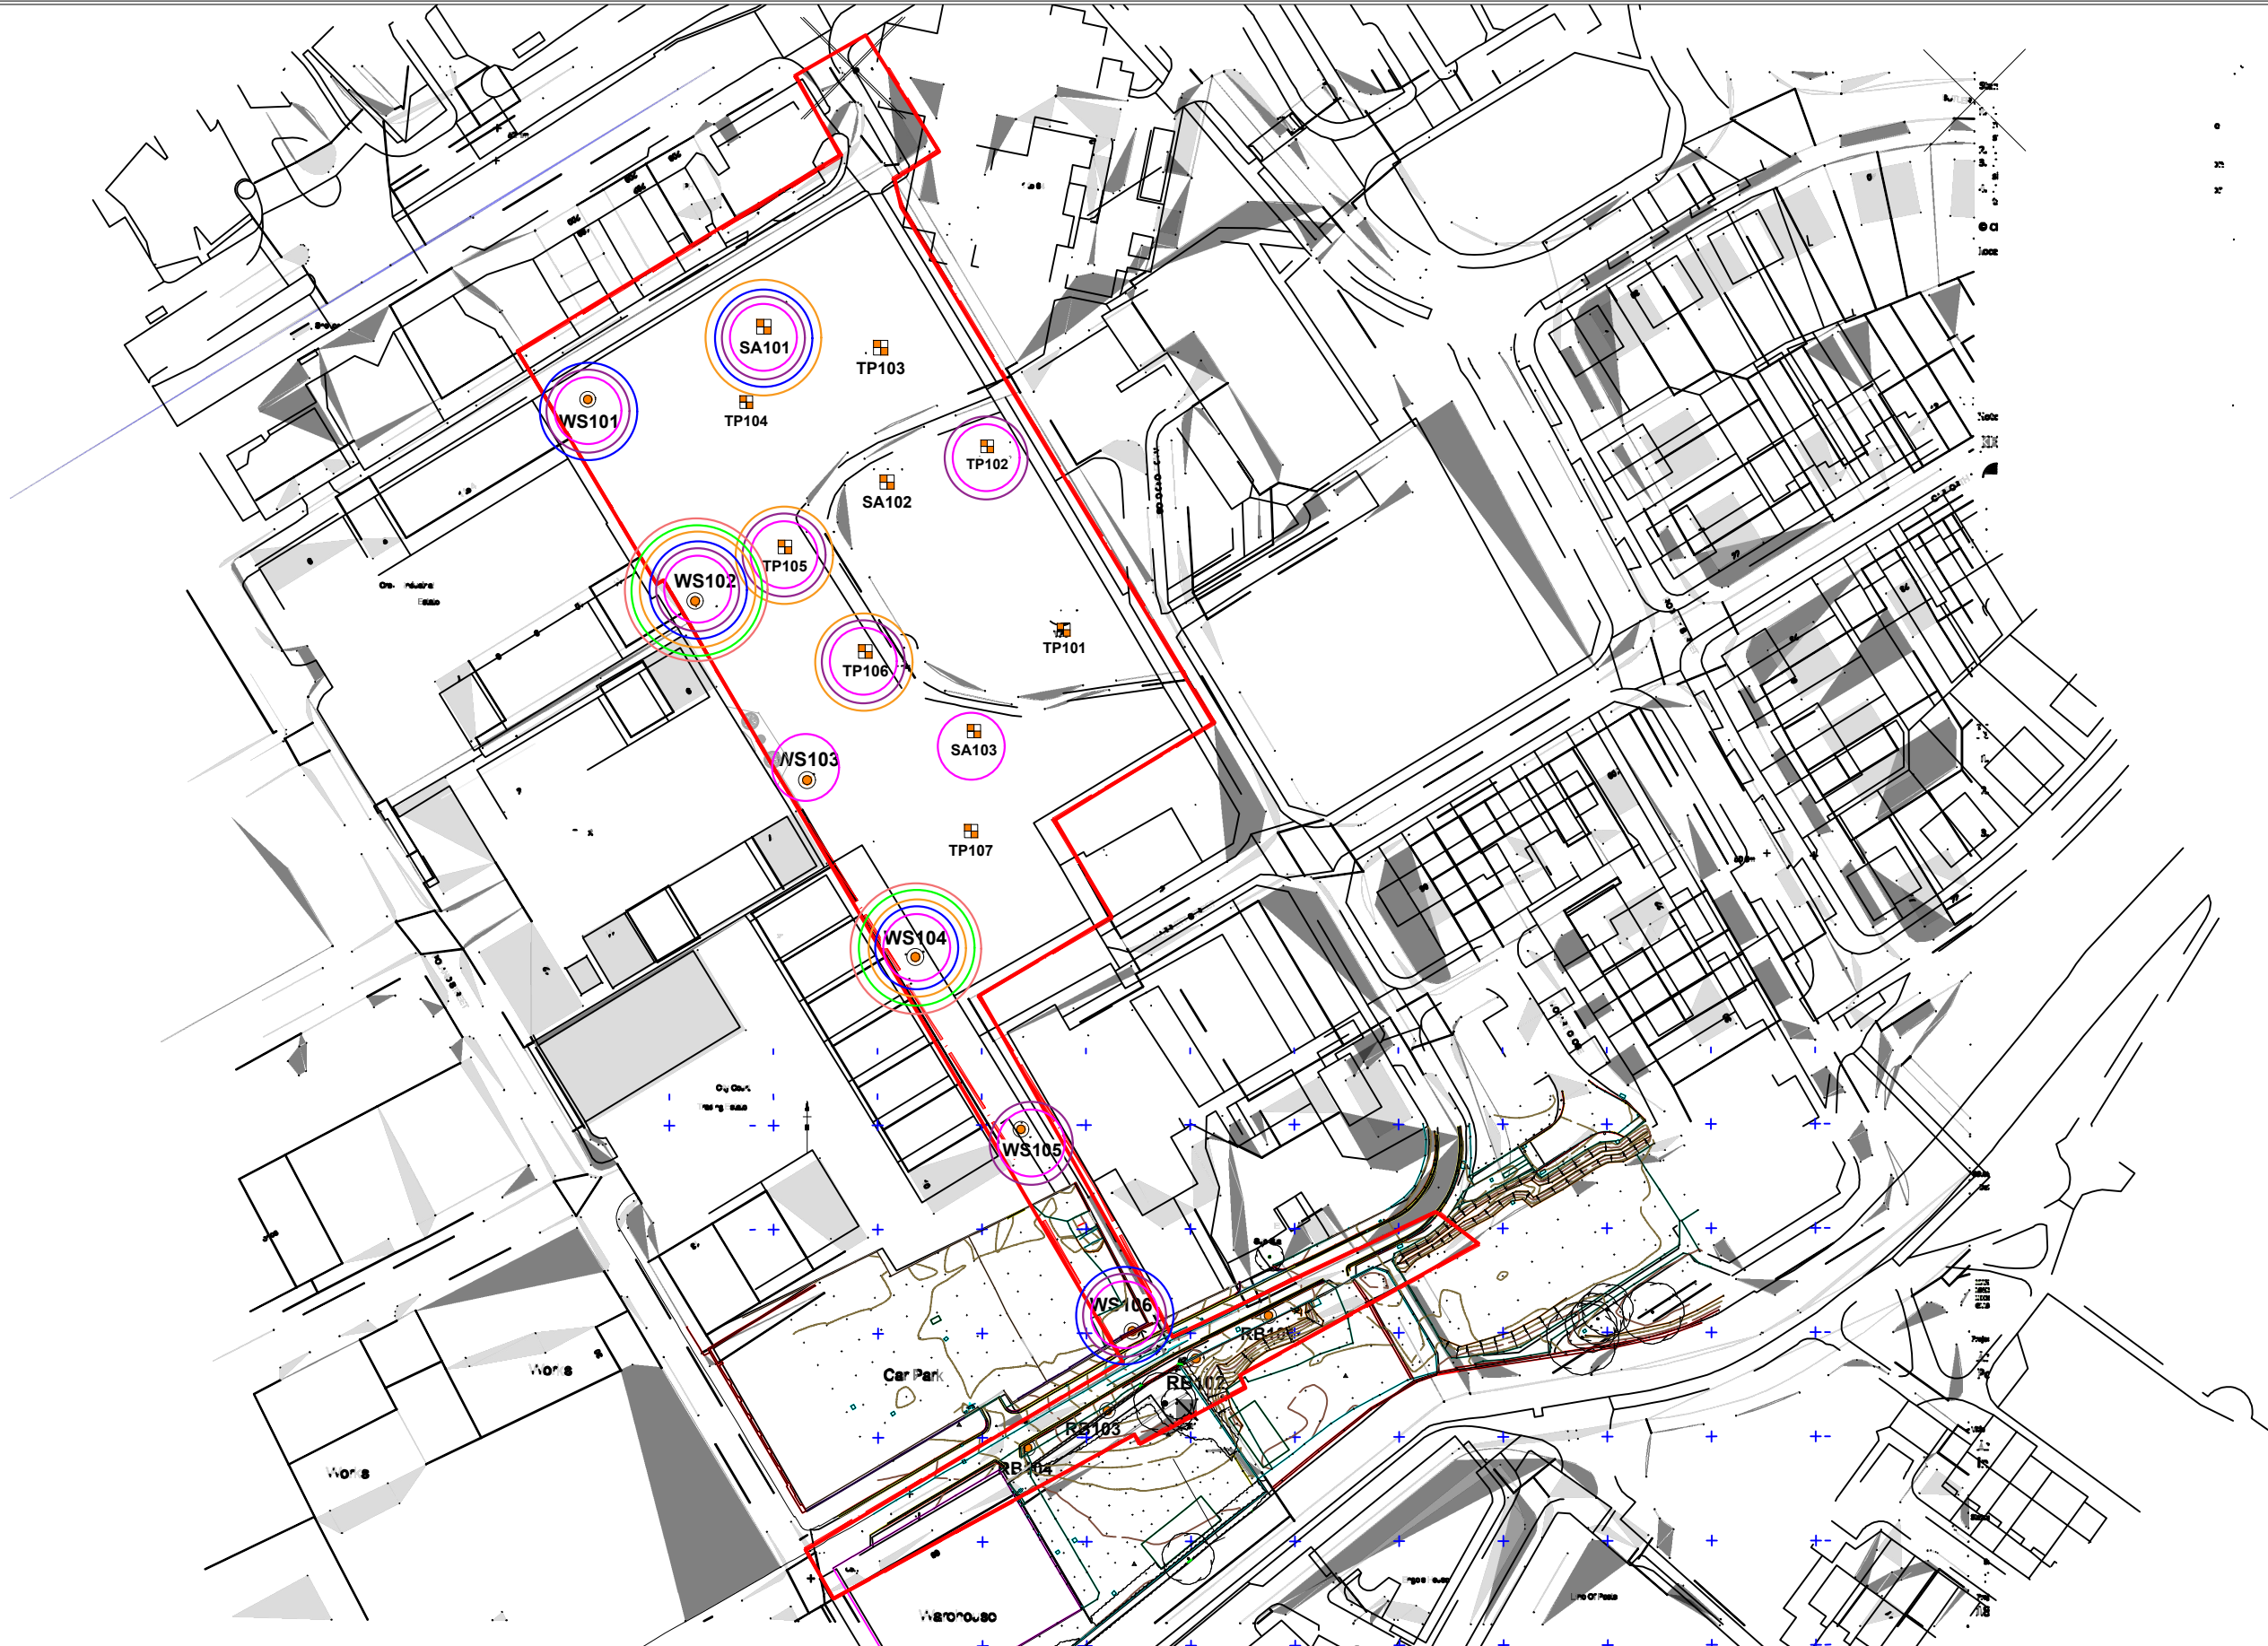
- Location Symbols**
- WS101 Approximate Window Sample Probehole Location
  - TP101 Approximate Trial Pit Location
  - SA101 Approximate Soakaway Test Location
  - RB101 Approximate Rotary Borehole Location

- Development Constraints**
- Heavy Metals
  - PAH
  - TPH
  - Napthalene
  - VOCs
  - SVOCs

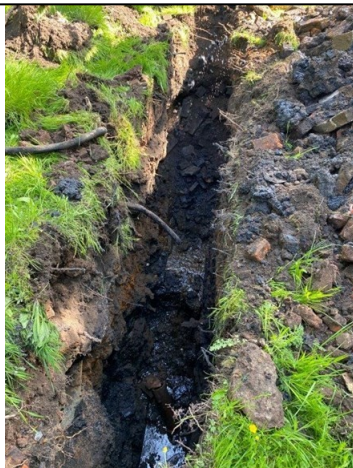
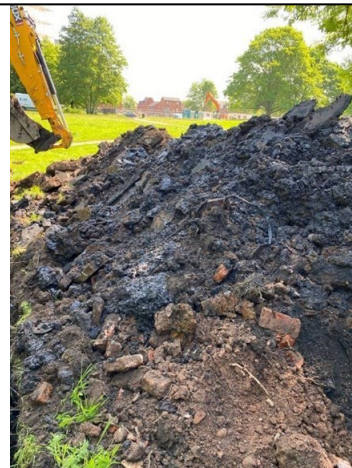
TT101

Remarks: 1. Complete. 2. Strong hydrocarbon odour from 2.2 m bgl. 3. Hydrocarbon sheen from 2.2 m bgl. 4. Unstable from 2.1 m bgl.

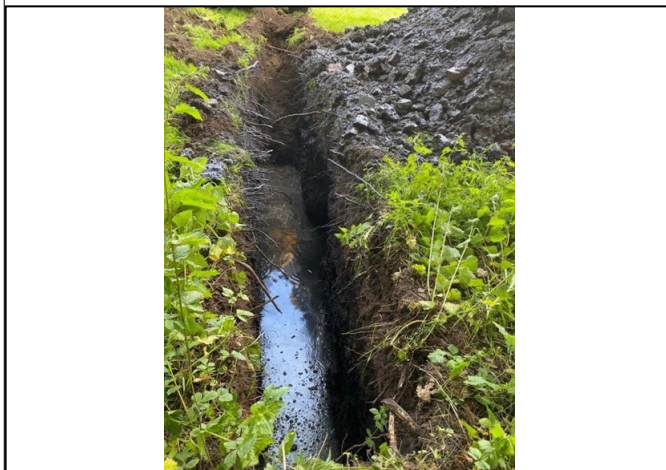
TT102

Remarks: 1. Complete. 2. Strong hydrocarbon odour from 2.2 m bgl. 3. Hydrocarbon sheen from 2.2 m bgl. 4. Unstable from 2.2 m bgl. 5. Rapid water ingress from 2.2 m bgl.

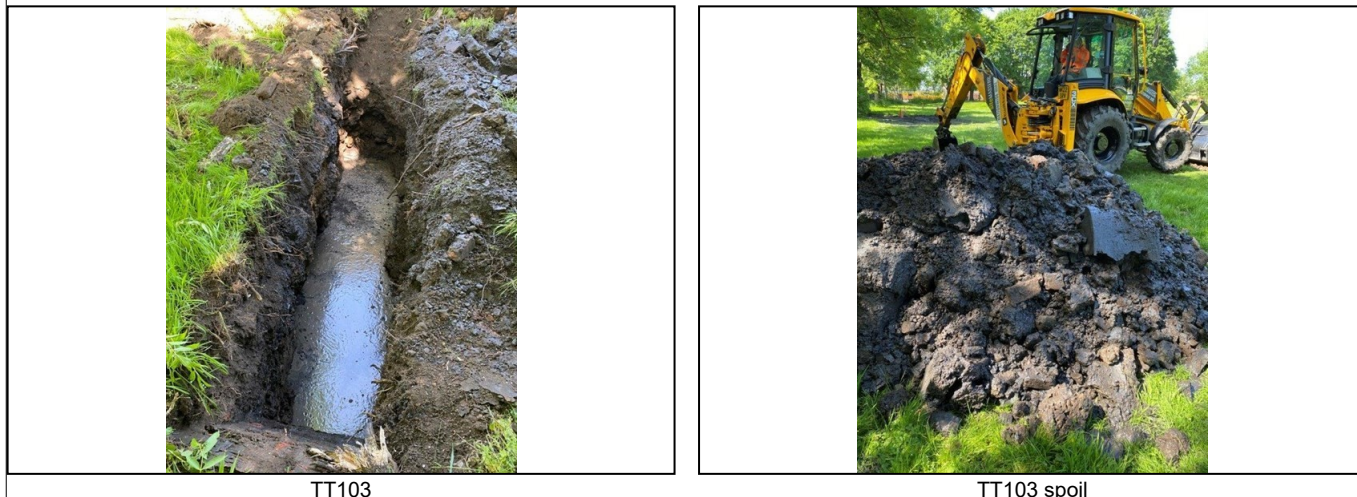
Made Ground in the location of the infilled canal generally comprises reworked topsoil overlying brown slightly clayey very sandy gravel to circa 2.20 m bgl and dark brown to black very sandy very gravelly clay to 3.60 – 4.20 m bgl. In TT102 and TT103 this was underlain by grey sandy gravelly clay to 3.90 m bgl. The gravel has continents of sandstone, mudstone, concrete and brick and the clay has constituents of metal, glass, wood, ceramic, tar, ash and rubber refuse material. A strong hydrocarbon odour was noted within all three trial trenches in this location.
