Townsend Water Engineering | Ltd.  
69 Liverpool Road  
Chester  
CH2 1AW

Jennifer Atkinson  
Manchester City Council  
PO Box 532  
Town Hall  
Manchester  
M60 2LA  
8<sup>th</sup> August 2024  
Planning Permission: 140311/FO/2024

An objection to the development at Pitsford Rd (140311/FO/2024) was received by Manchester City Council on the 26/07/2024. Below is the objection that this letter is commenting on (found in italics)

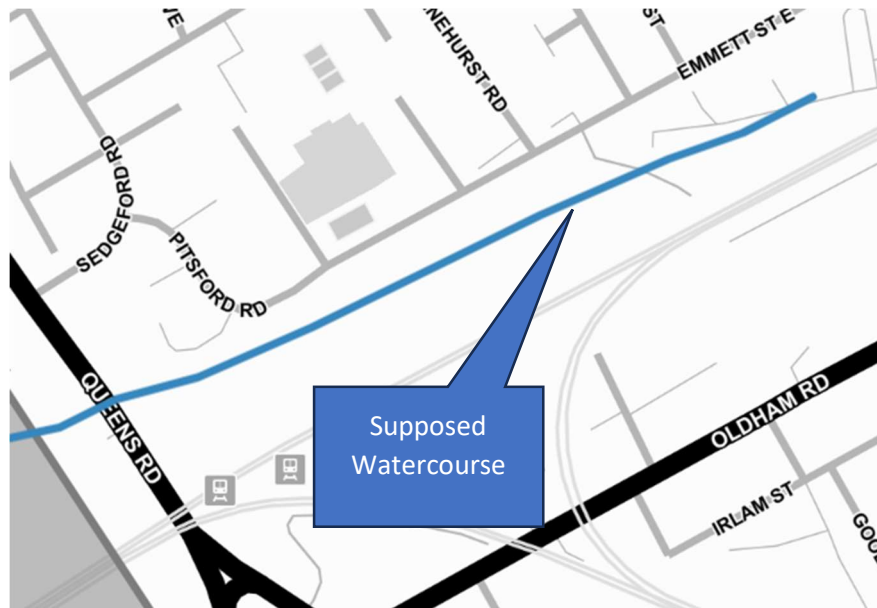
Figure 1: Map indicating the hidden watercourses

Please find below in figure 1 a map indicating Newton Brook a culverted watercourse. According to the map the culverted water runs through the site from east to west. A site visit was undertaken to prove if there as a culvert there.

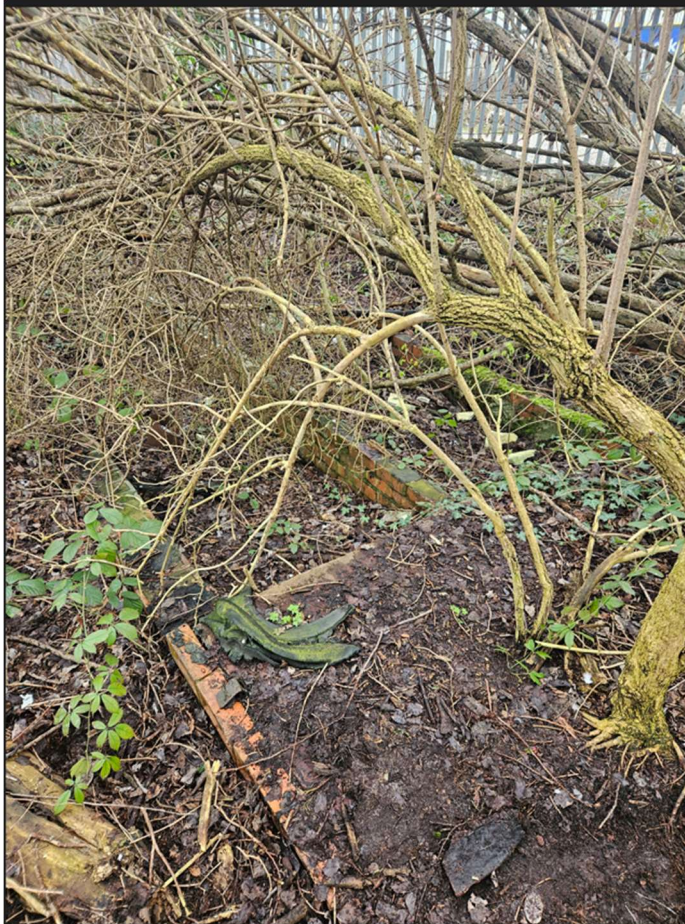
*Figure 3: Manhole 3*

Manhole 3 is completely infilled and has a tree running through it. Please see below in figure 3 the photo of manhole 3.

Bellway undertook a CCTV survey and there was no connection between manhole 3 and 2 .

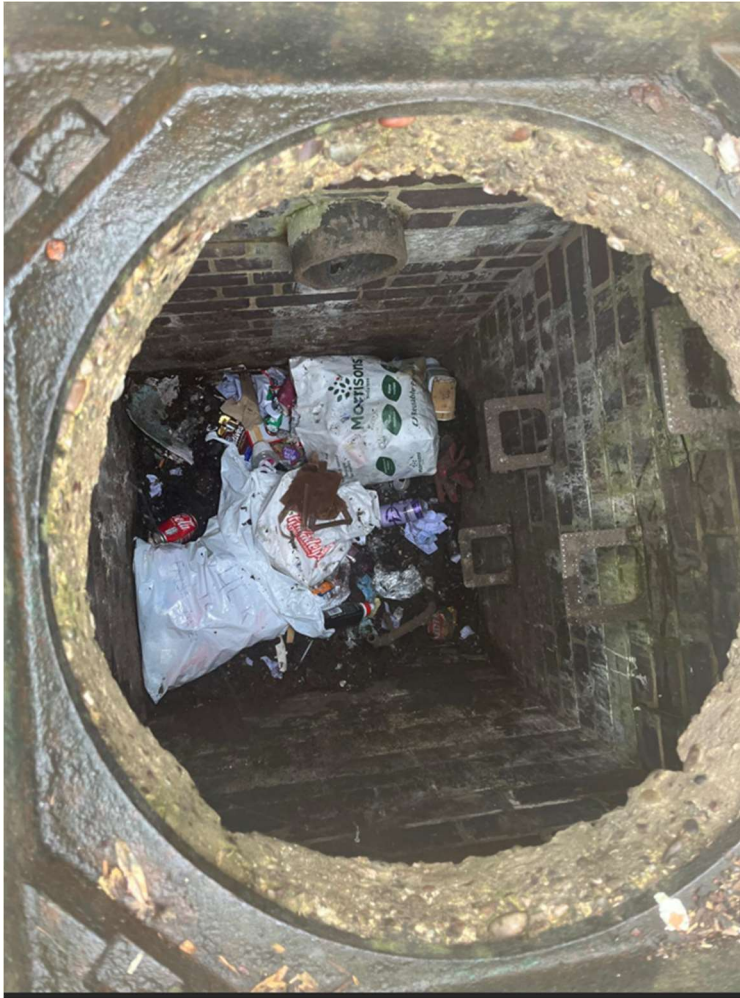
*Figure 5: Manhole 1*

Finally manhole 1 was completely blocked with rubbish, please see Figure 5 indicating the manhole 3.
