# Site Investigation Report

164086.1.USI

Auger were commissioned by Admiral (Subs) to undertake a site investigation and CCTV inspection of the underground drainage within the area of concern (AOC) at the property.

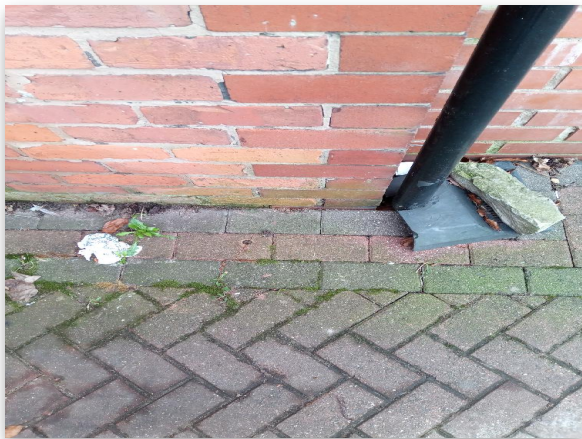
Fig 1.1: Trial Hole 1 Location

Trial hole 1 was completed in the requested location and reached the requested depth. The footing was discovered.

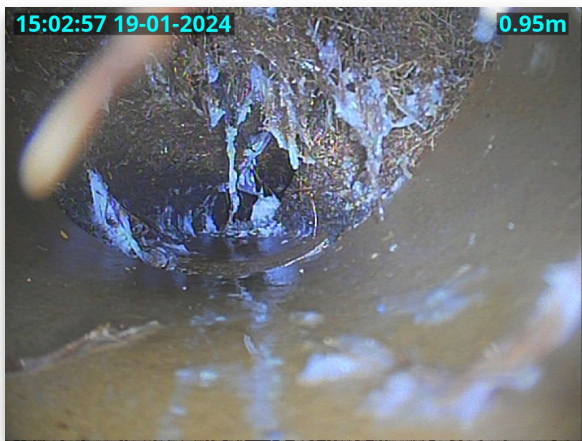
Fig 2.1: Line 1

We were unable to complete a full CCTV survey of line 1 due to encountering frozen root mass just downstream of the restbend.

Line 1: Root cutting and jetting downstream to clear the line and then completing a CCTV survey to determine the line route and condition.

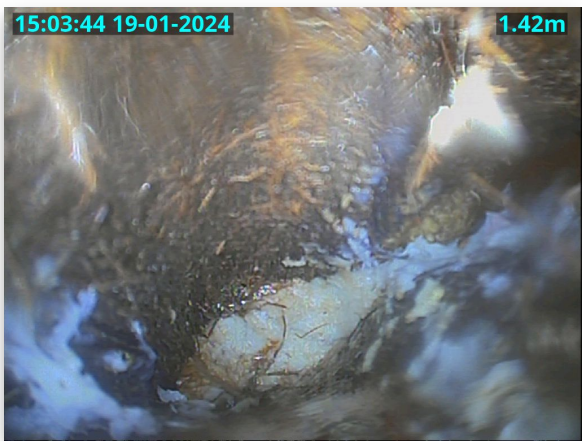
Fig 2.2: Line 2

We were unable to complete a full CCTV survey of line 2 due to encountering a frozen root mass just downstream of the restbend.

Line 2: Root cutting and jetting downstream to clear the line and then completing a CCTV survey to determine the line route and condition.

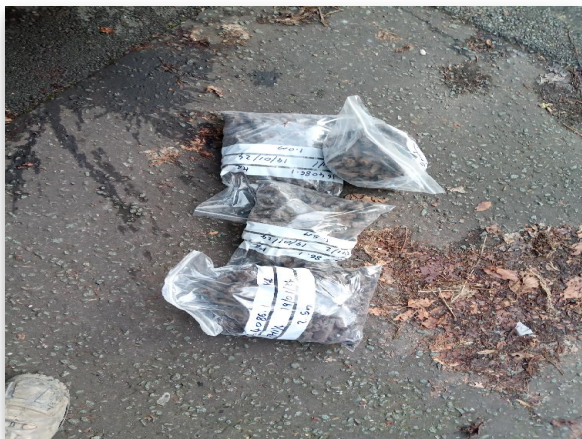
Fig 3.1: Trial hole 1 soil samples

Root samples were taken at 1.0m and 1.5m. Soil samples were taken at 1.0m, 1.5m, 2.0m and 2.5m.
