# Manchester Art Gallery

## Written Scheme of Investigation for removal and replacement of Roof Lantern

| Document Title | Written Scheme of Investigation for Evaluation at Manchester Art Gallery, Manchester |
| Document Type | Written Scheme of Investigation |

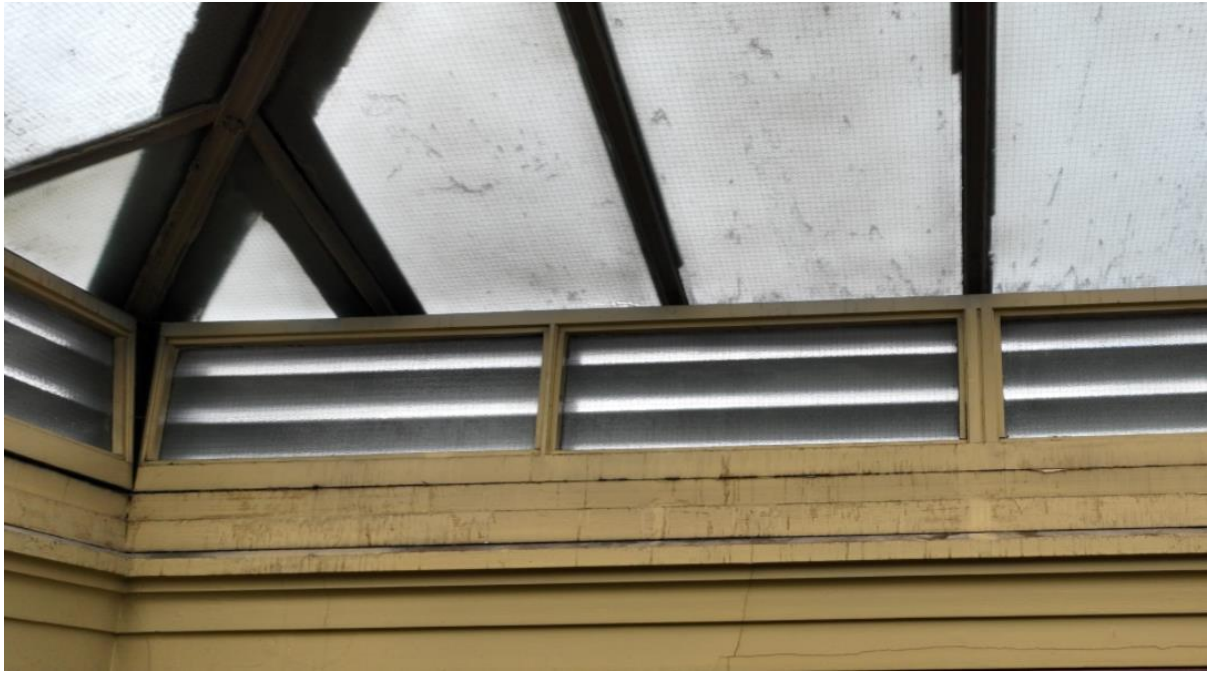
*Fig 3.* Current roof lantern, showing failure of louvres frame and water ingress. Photo by Robertson Group Ltd. 2024.

Safety, maintenance and water ingress issues around the current lantern light have been highlighted, with the opportunity to replace, allowing improvement in the maintenance, eradicate water ingress and improve the thermal performance of the glass within. This will improve lux levels for the collections and create a more comfortable environment for visitors, staff and objects.

Fig 3: Photograph of current roof lantern, showing dilapidation and water ingress

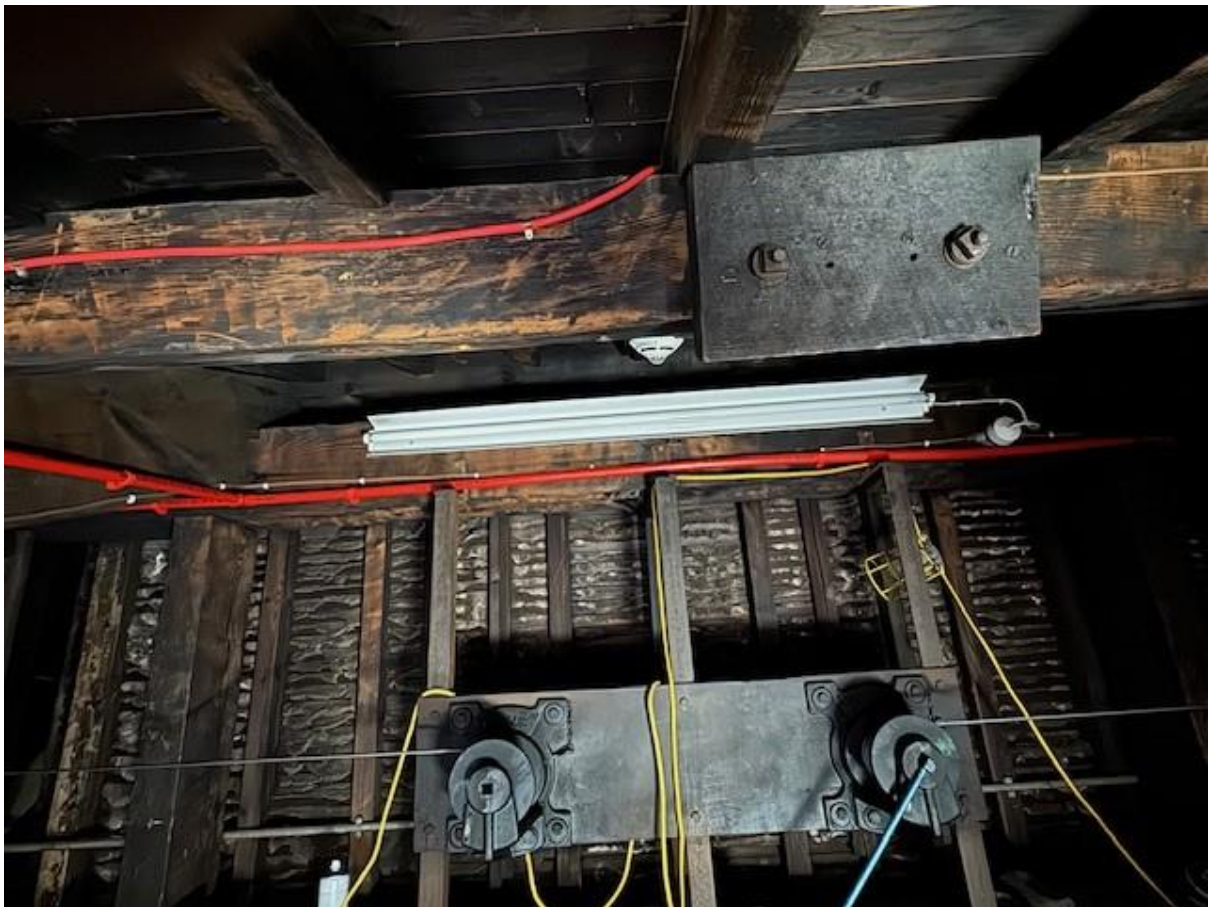
*Fig 4.* Internal roof space, showing timber ring beam and plaster & lathe construction. Photo by author 2024.

Fig 4: Photograph of roof access, internal view of timbers and plaster & lathe
