## VICTORIA PARK PROBATION CENTRE – POST DEMOLITION SI REPORT

### 1 BACKGROUND

LK Consult Ltd (LKC) has been commissioned by Britttania Victoria Ltd to carry out a post demolition site investigation at Victoria Park Probation Centre in order to support the discharge of contaminated land conditions. The site is a former probation centre with associated grounds and car park which will be redeveloped for residential houses and apartments.

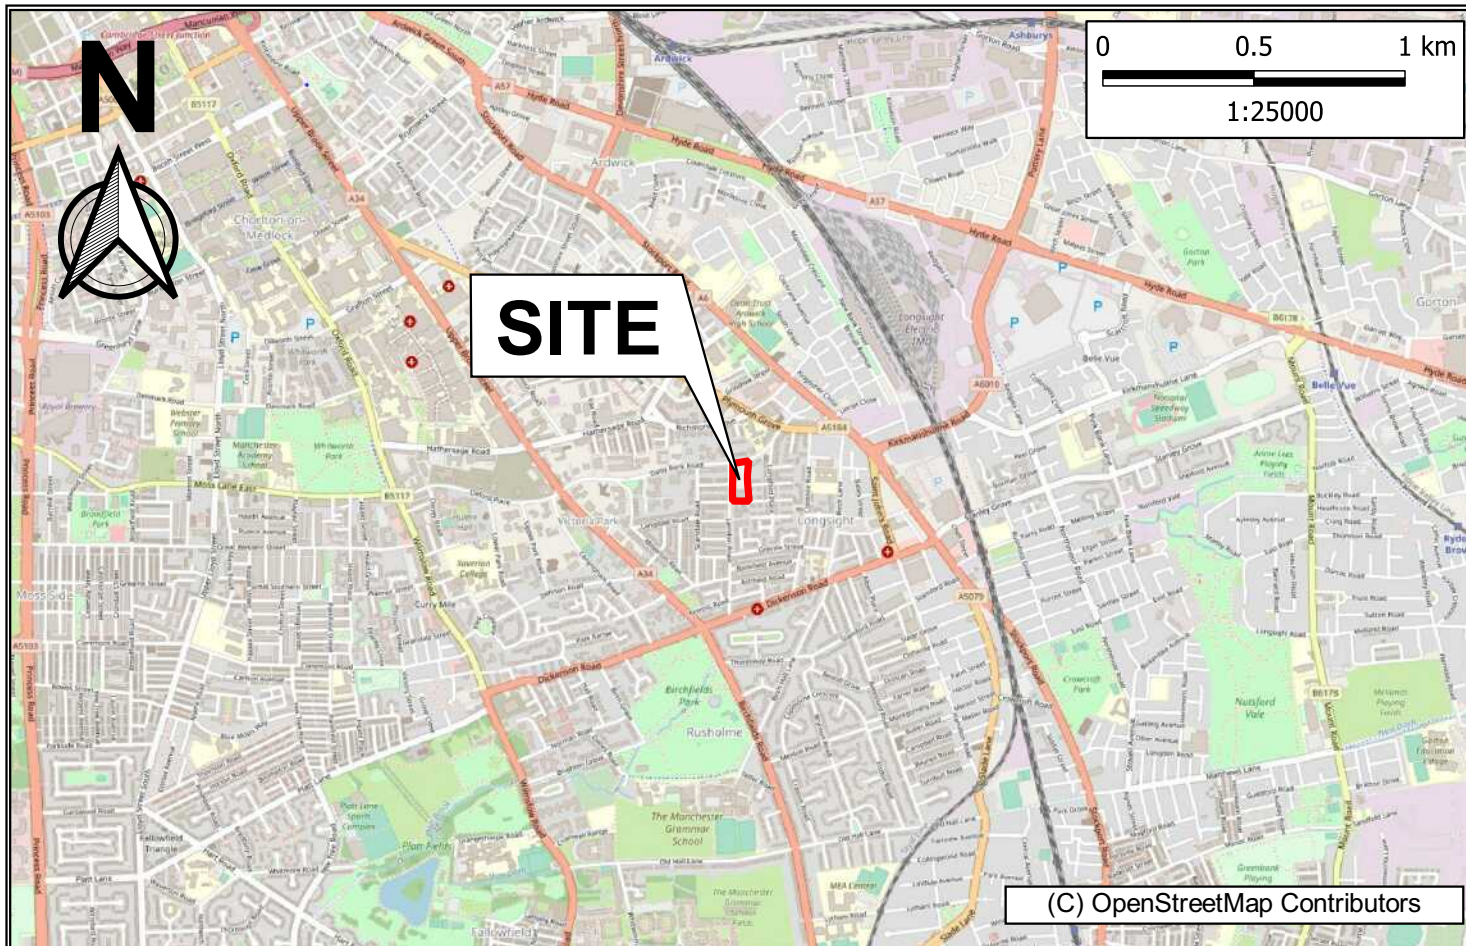
| Site:<br><br>Victoria Park Probation Centre | | | | Scale (see scale bar):<br><br>1:25,000 &<br>1:2,000 @ A4 | | | Figure:<br><br>1 |

A summary of the site details is presented in Table 1.1. Figure 1 indicates the site location and boundary. Figure 2 indicates the proposed development.

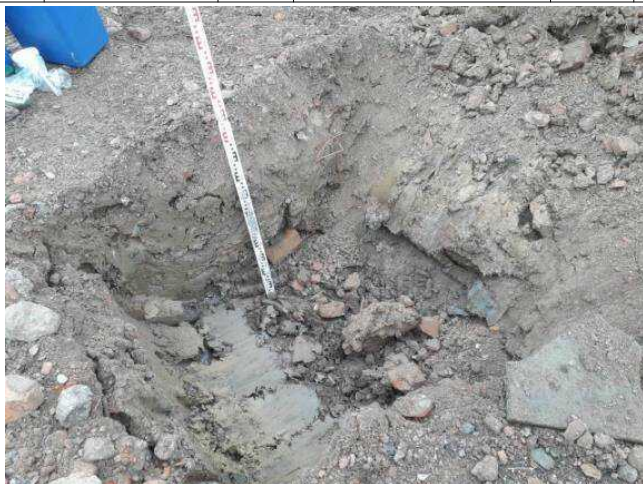
| Depth (m) | Sample / Tests | Water Depth (m) | Field Records | Level (mOD) | Depth (m) (Thickness) | Description | Legend | Water |
|---|---|---|---|---|---|---|---|---|
| 0.80 | SV 86.67kPa | | 90kPa, 80kPa, 90kPa/Av. 86.67 | | 0.80 (0.30) 1.10 | Stiff to very stiff consistency high strength brown and light grey mottled slightly gravelly sandy silty CLAY with occasional rootlets. Sand is fine to coarse. Gravel is fine to coarse, sub-angular to sub-rounded comprising mudstone and sandstone. Clay is friable. | | |

Pit dry and stable.

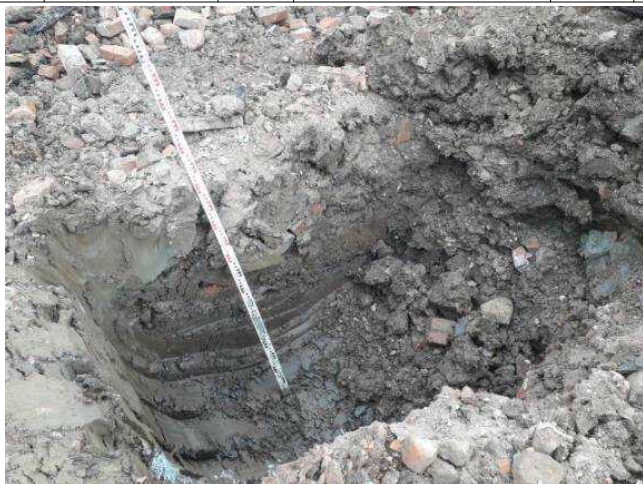
| Depth (m) | Sample / Tests | Water Depth (m) | Field Records | Level (mOD) | Depth (m) (Thickness) | Description | Legend | Water |
|---|---|---|---|---|---|---|---|---|
| 1.30 | SV 91.67kPa | | 90kPa, 95kPa, 90kPa/Av. 91.67 | | (0.70) | | | |

Pit dry and stable.

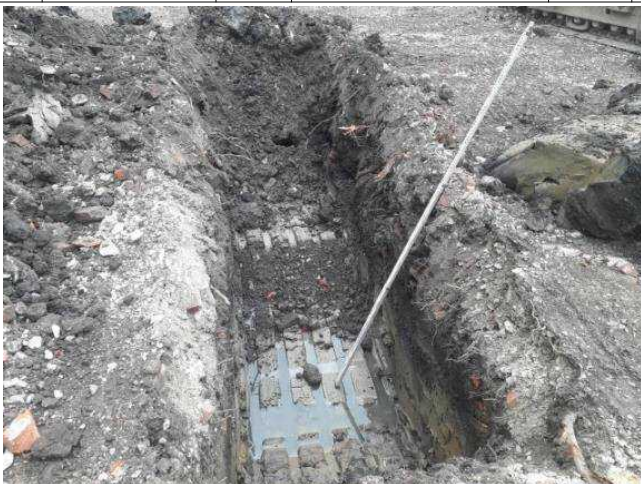
Perched water encountered at approximately 1.50mbgl in central area of pit. Initial moderate inflow of water, which stopped after approximately 1 minute. Pit unstable in upper 1.00m - collapse in north eastern wall of pit.

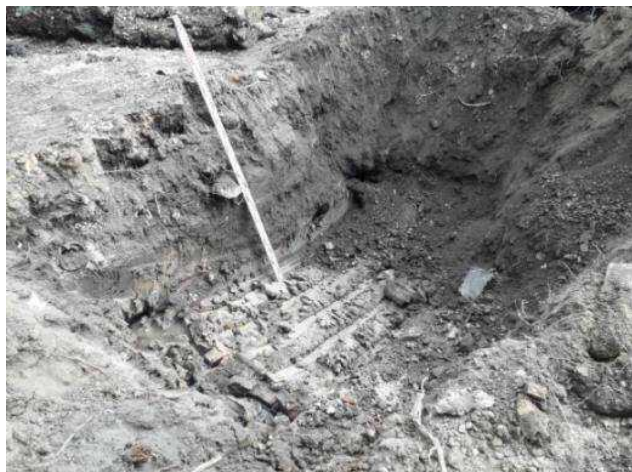
| Depth (m) | Sample / Tests | Water Depth (m) | Field Records | Level (mOD) | Depth (m) (Thickness) | Description | Legend | Water |
|---|---|---|---|---|---|---|---|---|
| 1.30 | SV 58.33kPa | | 60kPa, 60kPa, 55kPa/Av. 58.33 | | 1.20<br>(0.40) | Stiff consistency medium strength orangish brown and light grey slightly sandy silty CLAY. Sand is fine to medium. Ceramic drain in western wall of pit at 1.20mbgl surrounded by bricks. | | |

Pit dry and stable.

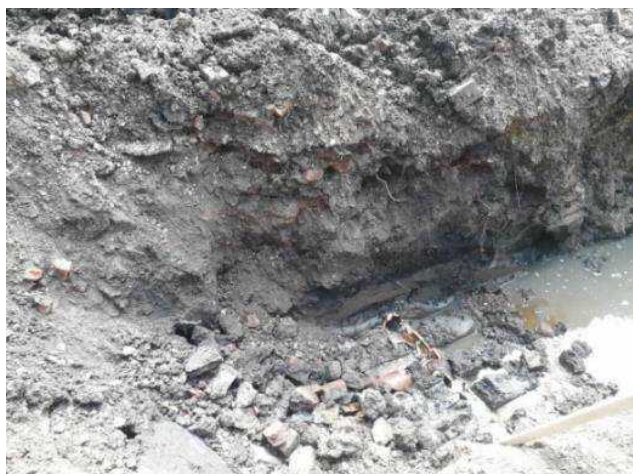
Perched water present in base of trial pit from ceramic drains. Pit unstable in upper 1.00m.

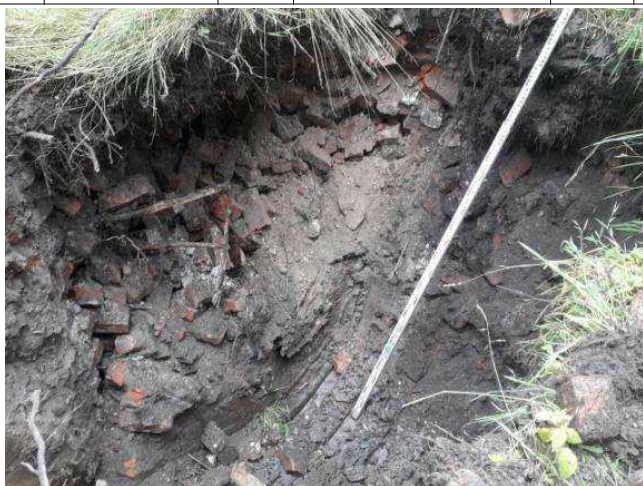
Pit collapsing in upper 1.50m.  
Pit dry.  
Unable to take shear vane readings in clay strata as strata too friable.
