# Lever Street, Manchester

Preliminary Ecological Appraisal

The NXQ Building, Manchester

Reference: 81-633-R1-2

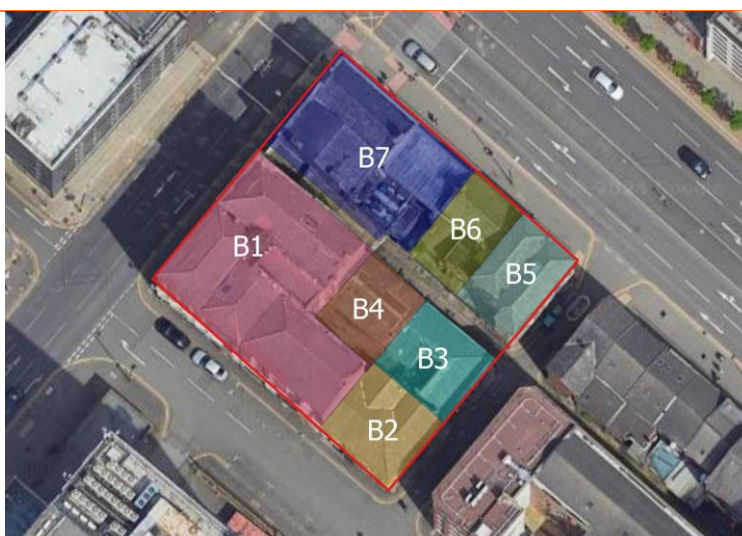
FIGURE 2.1 BUILDING LOCATIONS AND REFERENCES

The survey involved undertaking a systematic search of the buildings on-site, searching for signs of bats, or spaces where bats would be able to access. No trees were located within or adjacent to the site boundary. The survey was undertaken utilising suitable binoculars and ladders to access all areas where safe to do so. The methodology followed that described in *Bat Surveys for Professional Ecologists, 4th Edition* (Collins, 2023). Please refer to Figure 2.1 for building locations and references.

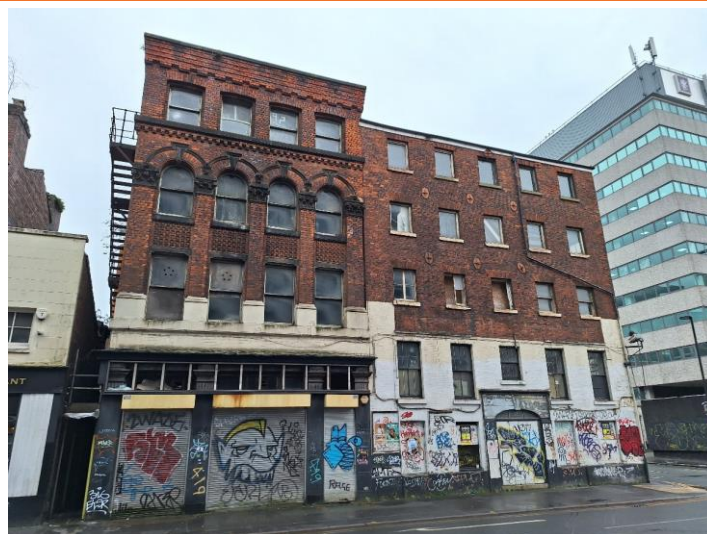
PLATE 1      SHOWING BUILDING

The majority of the site comprised a series of occupied and unoccupied commercial buildings. Some buildings had been colonised in part by butterfly-bush (*Buddleja davidii*).

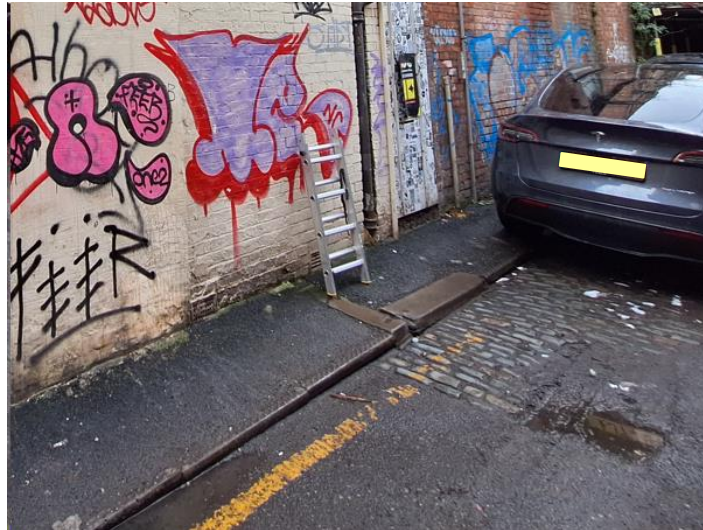
PLATE 2      SHOWING HARDSTANDING

Little Ancoats Street was present in the centre of the site allowing access between Lever Street and Little Lever Street to the north-west and south-east, respectively. Little Ancoats Street comprised tarmac and cobble hardstanding. The hardstanding had been colonised in part by moss species.

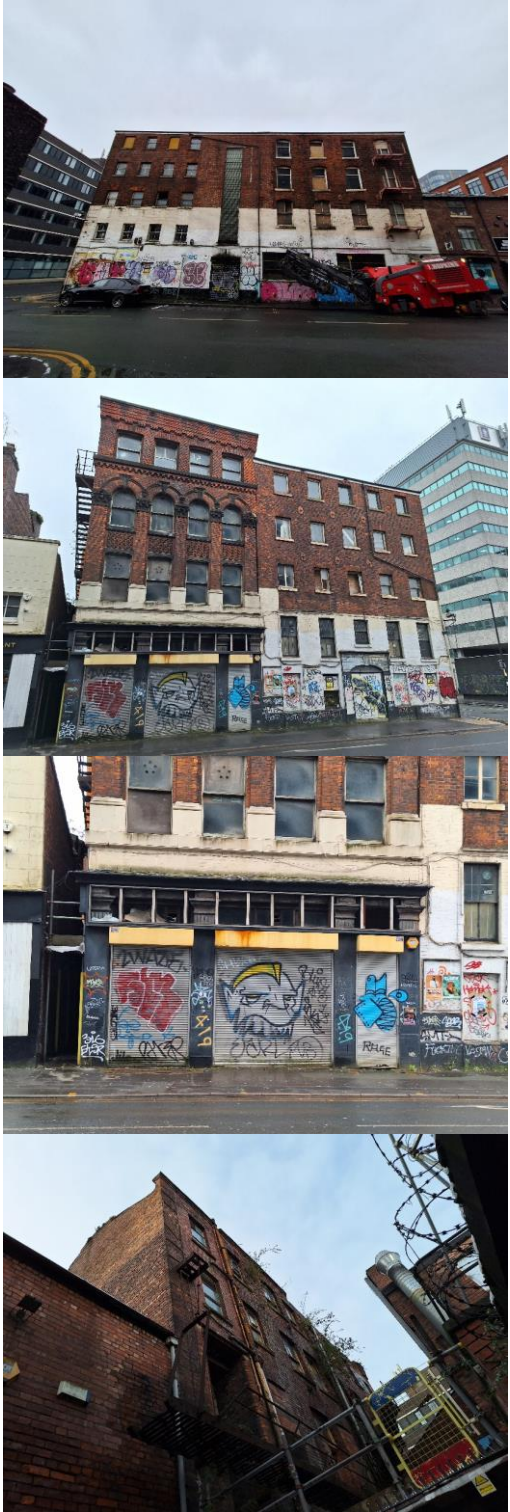
| REF. | DESCRIPTION | PHOTOGRAPH |
|---|---|---|
| B1 | <p>Building 1 (B1) was located in the south-west of the site and comprised a disused five-storey building, comprising red brick walls and four pitched tile hip roofs. It is understood that the building has been unoccupied for at least ten years. The brickwork was generally in good condition, however access points were noted on the south-west aspect. Superficial damage was also noted, however no features that could be utilised by roosting bats were identified.</p> <p>Multiple windows were noted on the south-west, north-west and north-east aspects of the building. The windows were generally in poor condition, with multiple broken windows noted on the south-west and north-west aspects.</p> <p>An access point was noted on the roof the north-west of the building (A1) – which was identified from ground level through the top floor window. This access point could potentially lead into the loft void, which may have the potential to support a large number of bats, including a maternity roost.</p> <p>The roofs could not be inspected during the survey due to the height of the buildings not allowing a suitable viewing angle.</p> <p>An internal inspection of the building was not undertaken due to health and safety concerns.</p> <p>Due to the building having the potential to support maternity roosts, B1 was assessed as having <b>High</b> bat roosting potential.</p> | |

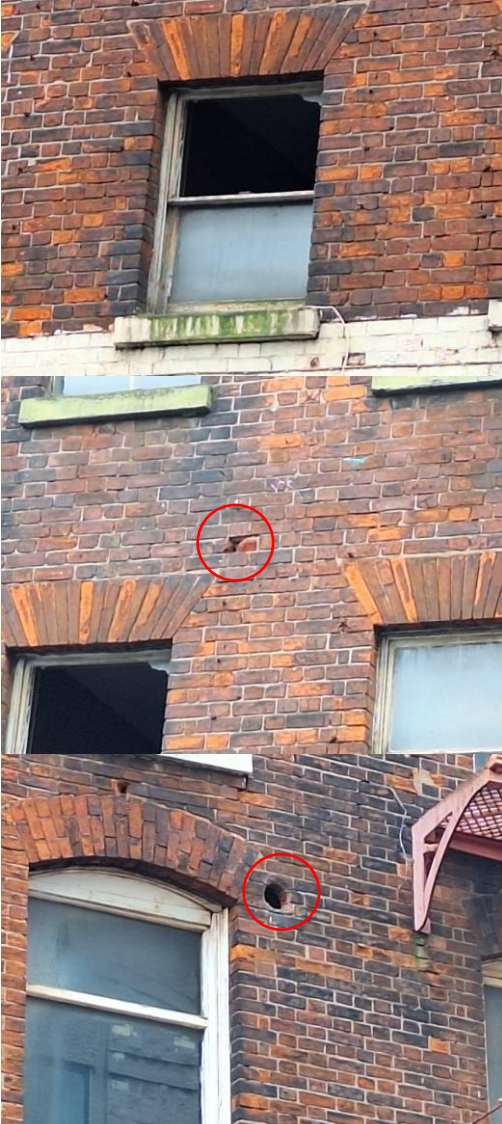
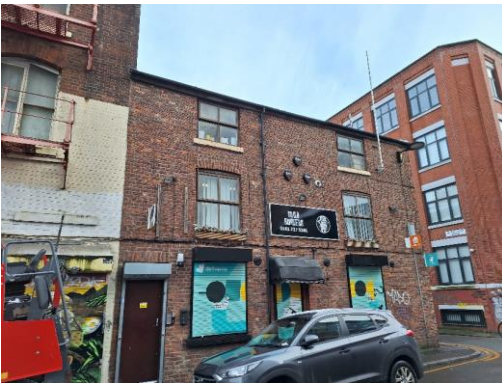
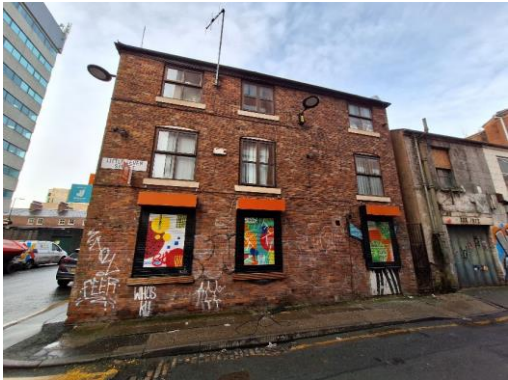
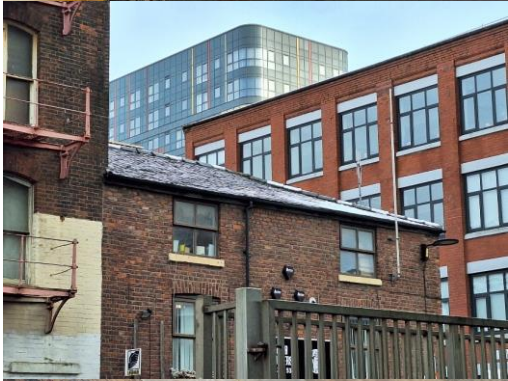
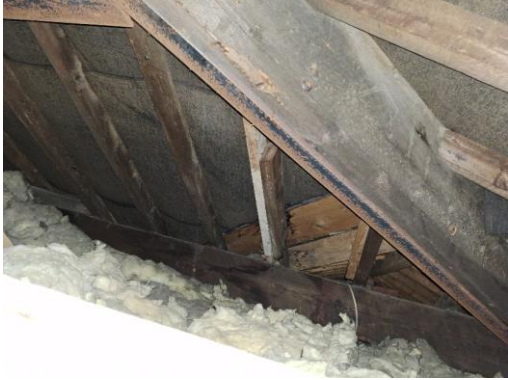
| REF. | DESCRIPTION | PHOTOGRAPH |
|---|---|---|
| B2 | <p>Building 2 (B2) was a three-storey building located in the south of the site, currently occupied by commercial tenants. The building comprised red brick with an L-shaped tile roof with a hip gable on the north-east aspect.</p> <p>The brickwork and mortar was in good condition. No features that could be utilised by roosting bats were identified.</p> <p>Casement windows with wooden frames were noted on the south-west and south-east aspects of the building. The windows were generally in good condition, with no cracks or crevices around the</p> | |

| REF. | DESCRIPTION | PHOTOGRAPH |
|---|---|---|
| | <p>window frames and brickwork that could be used by opportunistic crevice-dwelling bat species.</p> <p>The roof could only be inspected on the south-west aspect due to the height of the building, however no lifted roof tiles were noted. Utilising aerial images, the roof on the south-east and north-east aspects appear to be in good condition, however, some lifted roof tiled may be present which could be utilised by crevice dwelling bat species.</p> <p>An internal inspection of the building and roof void was undertaken during the survey. No evidence of roosting bats was identified during the internal inspection. No access points were observed within the loft void, and can therefore be discounted as a potential roost feature.</p> <p>B2 was assessed on a precautionary basis, as some lifted roof tiles may be present on the south-east and north-east aspects. Any lifted roof tiles would only be able to support small numbers of crevice dwelling bat species. Considering the lack of access points within the loft void, B2 was therefore assessed as having <b>Low</b> bat roosting potential.</p> | |

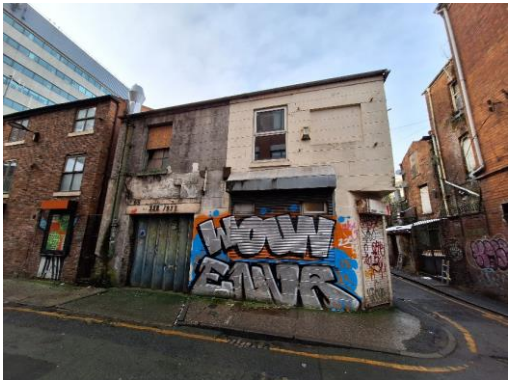
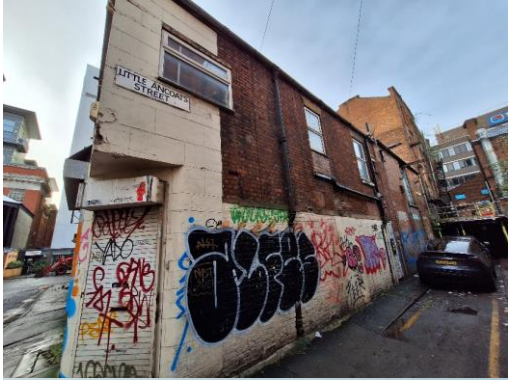
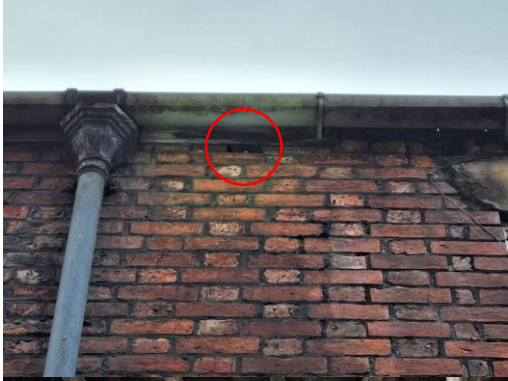
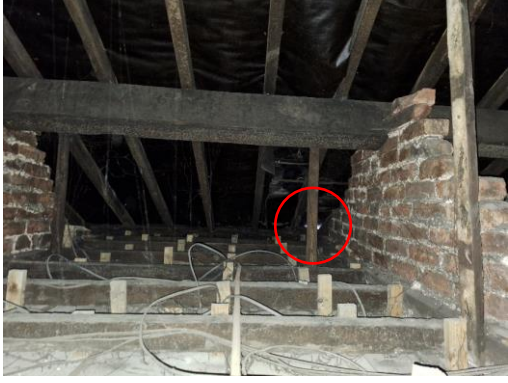
| REF. | DESCRIPTION | PHOTOGRAPH |
|---|---|---|
| B3 | <p>Building 3 (B3) was an unoccupied two-storey building located in the south-east of the site. The building comprised red brick with an L-shaped tile roof. Concrete render was noted on the south-east and north-east aspect of the building. The render was in poor condition, and had come away in parts on the south-east aspect. No cracks or crevices within the render were identified that could be utilised by opportunistic bat species. The render had been painted cream in parts, which would allow for easier identification of bat staining, if present. However, no staining was identified.</p> <p>The brickwork and mortar was mostly in good condition, with no features that could be utilised by</p> | |

| REF. | DESCRIPTION | PHOTOGRAPH |
|---|---|---|
| | <p>roosting bats identified. However, a missing brick was identified on the north-east aspect which may allow bats entry into the loft void.</p> <p>Casement windows with uPVC frames were noted on the south-east and north-east aspects of the building. The windows were generally in good condition, however, a broken window which was partially boarded up was present on the south-east aspect. No cracks or crevices around the window frames and brickwork were present that could be used by opportunistic crevice-dwelling bat species.</p> <p>The roof could not be inspected externally during the survey due to the height of the buildings not allowing a suitable viewing angle. Utilising aerial images, the roof appears to be in good condition, however, some lifted roof tiled may be present which could be utilised by crevice dwelling bat species.</p> <p>An internal inspection of the building and roof void was undertaken during the survey. No evidence of roosting bats was identified during the internal inspection. An access point into the roof void was identified during the inspection of the roof void (A2). The loft void may have the potential to support a large number of bats, including a maternity roost.</p> <p>Due to the building having the potential to support maternity roosts, B3 was assessed as having <b>High</b> bat roosting potential.</p> | |

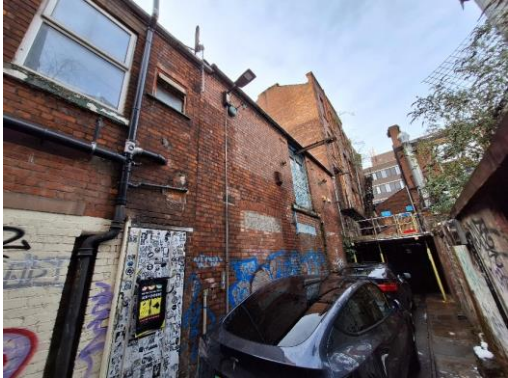
| REF. | DESCRIPTION | PHOTOGRAPH |
|---|---|---|
| B4 | <p>Building 4 (B4) was located in the centre of the site and comprised a two-storey building with a pitched tile roof. B4 could not be accessed internally during the survey. It is understood that B4 is connected internally to B1.</p> <p>The brickwork and mortar was in good condition, with no obvious cracks or crevices that could be utilised by opportunistic bat species. No windows were present.</p> | |

| REF. | DESCRIPTION | PHOTOGRAPH |
|---|---|---|
| | <p>The roof could not be inspected externally during the survey due to the height of the buildings not allowing a suitable viewing angle. Utilising aerial images, the roof appears to be in good condition, however, some lifted roof tiled may be present which could be utilised by crevice dwelling bat species.</p> <p>B4 was assessed as having <b>Low</b> bat roosting potential on a precautionary basis, as some lifted roof tiled may be present on the south-east and north-east aspects.</p> | |

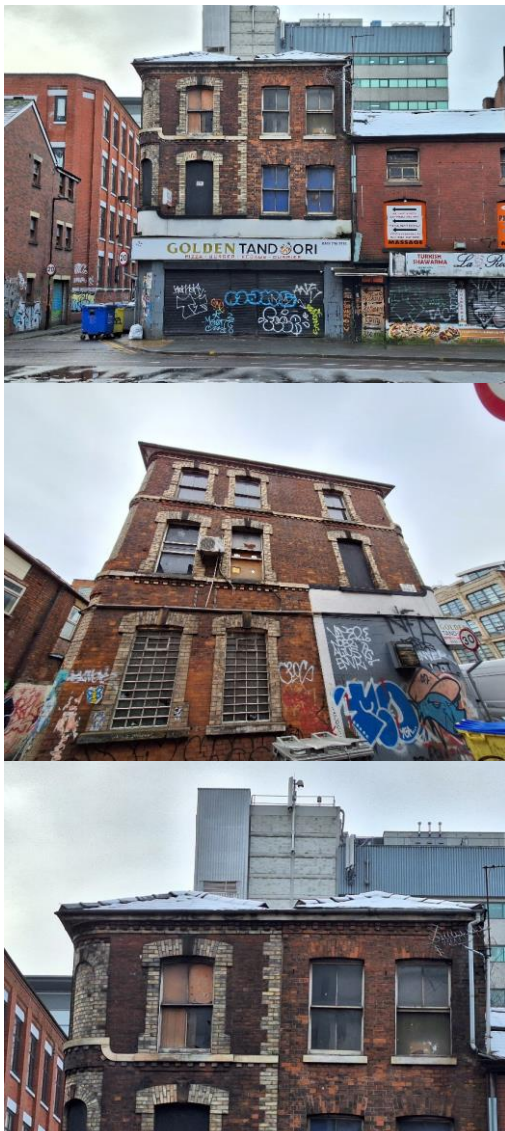
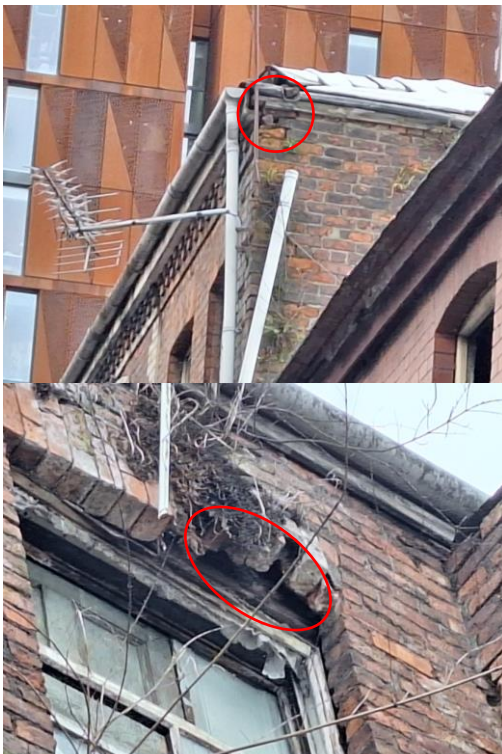
| REF. | DESCRIPTION | PHOTOGRAPH |
|---|---|---|
| B5 | <p>Building 5 (B5) was located in the north-east of the site and comprised an occupied three-storey building, with red brick walls and two pitched tile hip roofs.</p> <p>The brickwork and mortar was mostly in good condition, however, damaged brickwork was noted on the northern corner of the building at the top of the wall plate. This damaged brickwork may potentially lead into the loft void, which may have the potential to support a large number of bats, including a maternity roost. Damaged brickwork could also provide roosting opportunities for crevice-dwelling bat species (F1).</p> <p>Multiple sash and casement windows were noted on the south-west, north-west and north-east aspects of the building. The windows were generally in good condition on the north-east and south-east aspects; however, the windows were badly damaged on the south-west aspect, with some access points that could potentially lead into a sash box cavity (A3).</p> <p>The roofs could not be fully inspected on the south-east and south-west aspects during the survey due to the height of the building not allowing a suitable viewing angle. Utilising aerial images, the roof appears to be in good condition, however, some lifted roof tiled may be present which could be utilised by crevice dwelling bat species.</p> <p>An internal inspection of the building could not be undertaken during the survey as tenants were not present to allow access into the building.</p> | <p>The photographs show Building 5 (B5) from three different perspectives. The top image is a street-level view of the ground floor, showing a brick building with a 'GOLDEN TANDORI' sign and extensive graffiti. The middle image is a low-angle view looking up at the upper floors, showing the brickwork and windows. The bottom image shows the roofline of the building, which has a pitched tile hip roof.</p> |

| REF. | DESCRIPTION | PHOTOGRAPH |
|---|---|---|
| | <p>As the loft void could not be accessed during the survey, any potential access points could not be identified. B5 was therefore assessed as having <b>High</b> bat roosting potential on a precautionary basis, as the loft void may be able to support a bat roost of high conservation status, such as a maternity roost.</p> <p>If internal access into the loft void can be arranged and no access points are identified, then B5 can be downgraded to Moderate potential.</p> | |

B5 and B6 could potentially be downgraded to Moderate condition if internal access can be arranged, which would reduce the survey requirement to two surveys between May and September (inclusive), with at least one survey taking place between May and August (inclusive). The surveys are to be carried out at least three weeks apart (Collins, 2023). B1 cannot be downgraded from High due to the presence of multiple features and access points.

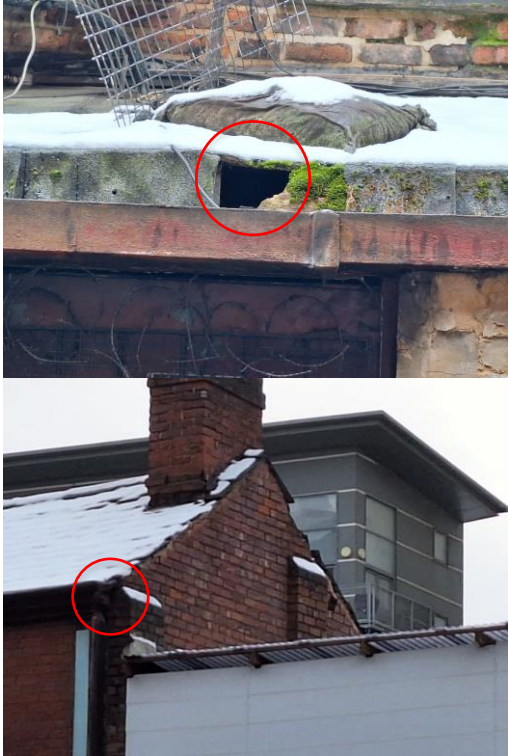
| REF. | DESCRIPTION | PHOTOGRAPH |
|---|---|---|
| B6 | <p>Building 6 (B6) was located in the north-east of the site and comprised an unoccupied three-storey building, comprising red brick walls and a pitched tile hip roof. Two single-storey extensions were present on the south-west aspect of the building. The building had previously been used as a take-away restaurant. An internal inspection of the building could not be undertaken during the survey as the roller door to enter the building had seized, preventing access.</p> <p>The brickwork and mortar was mostly in good condition, however, damaged brickwork was noted on the northern corner of the building at the top of the wall plate. This damaged brickwork may potentially lead into the loft void, which may have the potential to support a large number of bats, including a maternity roost. Due to a lack of access, the presence of bats or any potential roost features could not be confirmed. Damaged brickwork could also provide roosting opportunities for crevice-dwelling bat species (F2).</p> | |

| REF. | DESCRIPTION | PHOTOGRAPH |
|---|---|---|
| | <p>Sash windows with wooden frames were noted on the north-east aspect of the building. The windows were in good condition, with two of the windows covered by advertising boards. No obvious cracks or crevices were present in the brickwork surrounding the windows.</p> <p>The roofs could not be fully inspected on the south-east aspect during the survey due to the height of the building not allowing a suitable viewing angle.</p> <p>The extensions on the south-west aspect were in poor condition, with multiple sections of damaged brickwork that could potentially allow access into the extensions. The extensions could not be accessed internally during the survey. It could not be determined if the damaged brickwork forms potential roost features or access points due to lack of internal access. Assumed to be access points (A4 and A5) until can be ruled out if internal access is arranged.</p> <p>As the loft void and extensions on the south-west aspect could not be accessed during the survey, any potential access points could not be identified. B6 was therefore assessed as having <b>High</b> bat roosting potential on a precautionary basis, as the loft void may be able to support a bat roost of high conservation status, such as a maternity roost.</p> <p>If internal access into the loft void and extensions can be arranged and no access points are identified, then B6 can be downgraded to Moderate potential.</p> | |

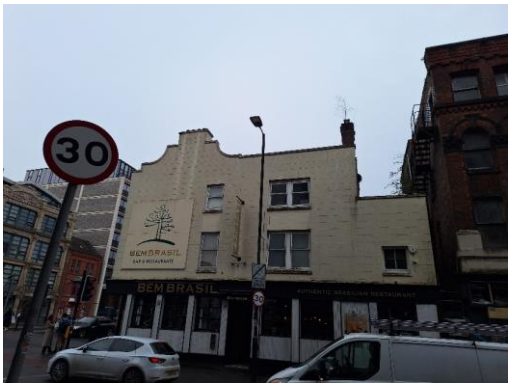
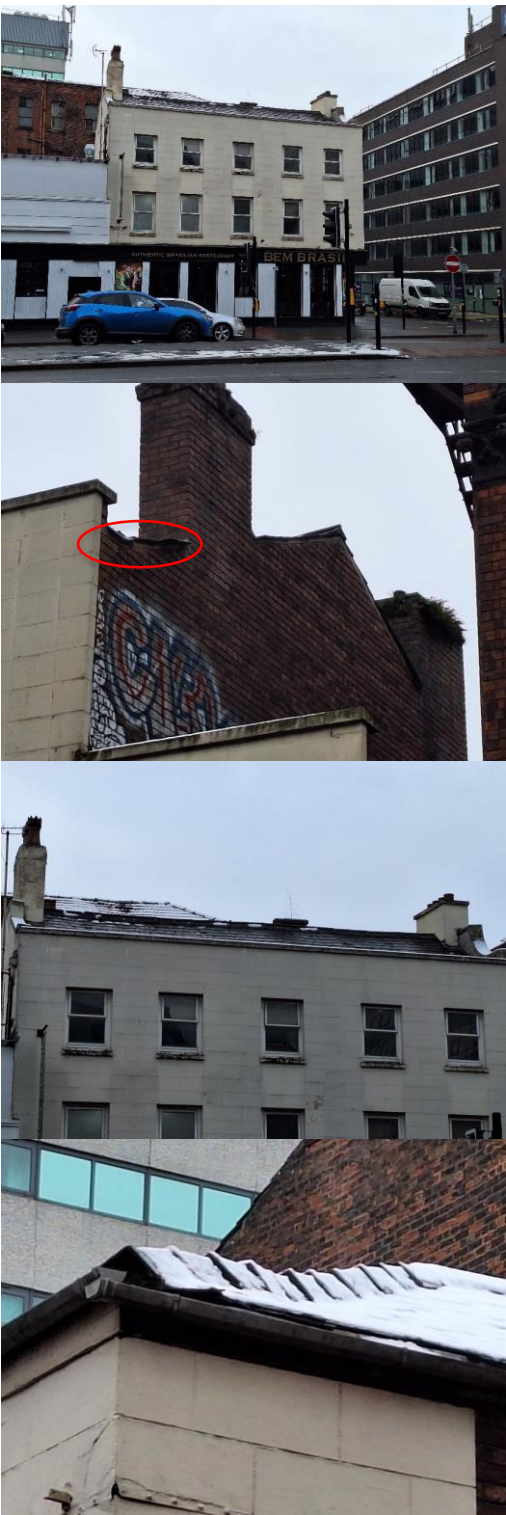
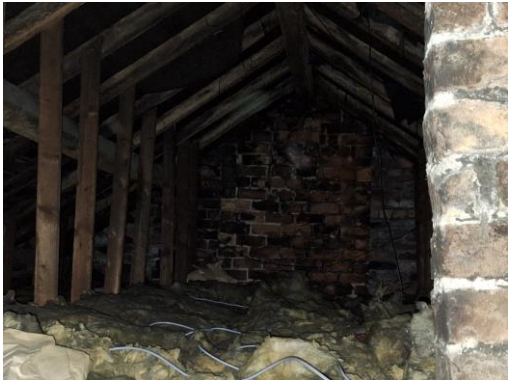
| REF. | DESCRIPTION | PHOTOGRAPH |
|---|---|---|
| B7 | <p>Building 7 (B7) was a three-storey building located in the south of the site, currently in use as a restaurant. The building comprised red brick with two pitched tile roofs. A single-storey extension was noted on the adjacent to south-east. The extension comprised a glass roof and a parapet wall on the north-east aspect.</p> <p>Concrete render was noted on the north-east and north-west aspects of the building. The brickwork and mortar was in good condition. No features that could be utilised by roosting bats were identified.</p> <p>Sash windows with wooden frames were noted on the north-west and north-east aspects of the building. The windows were in good condition, with no cracks or crevices around the window frames</p> | |

| REF. | DESCRIPTION | PHOTOGRAPH |
|---|---|---|
| | <p>and brickwork that could be used by opportunistic crevice-dwelling bat species.</p> <p>The roof could only be fully inspected on the north-east aspect due to the height of the building, however no lifted roof tiles were noted. Slightly lifted end roof tiles were present on the south-east aspect of the building (F3), which could be utilised by opportunistic crevice-dwelling bat species on an occasional basis.</p> <p>An internal inspection of the building and roof void was undertaken during the survey. No evidence of roosting bats was identified during the internal inspection. No potential access points were noted during the internal inspection of the roof void.</p> <p>B7 was assessed as having <b>Low</b> bat roosting potential on a precautionary basis, as some lifted roof tiled may be present on the south-east and north-east aspects.</p> | |
