# Sparkle St, Manchester

## Phase 2 Ground Investigation

Curtins Ref: 082142-CUR-XX-XX-RP-G-0001

Revision: P04

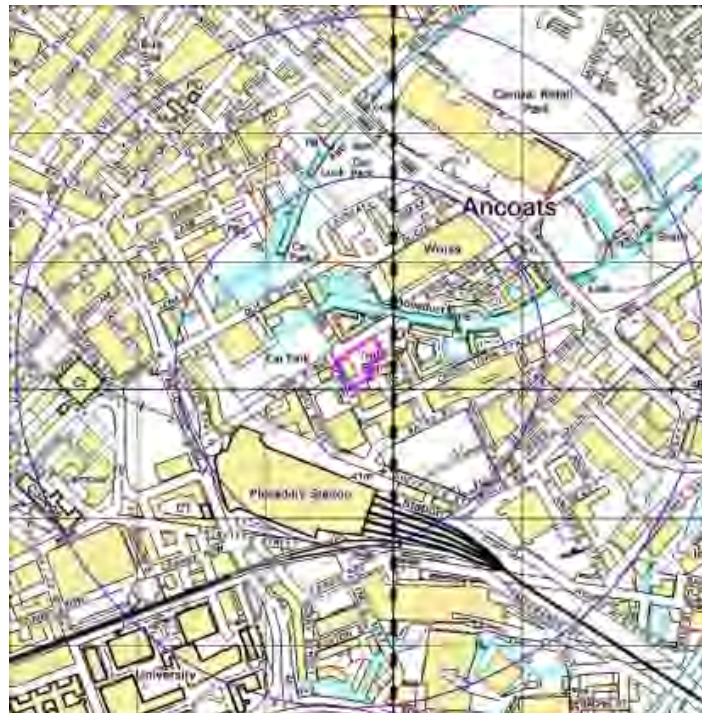
**Figure 2.1 – Site Location Plan (Site boundary shown in pink).**  
Crown Copyright. License Number 100022432.

In April 2023, Curtins were instructed by Foras (Sparkle Street) Limited to undertake a Phase 2 Ground Investigation of a site located off Sparkle Street, Manchester, M1 2NA, centred at National Grid Reference (NGR) 384950, 398040 and covering an area of approximately 0.3 Ha. The location and extent of the site is shown in Figure 2.1.

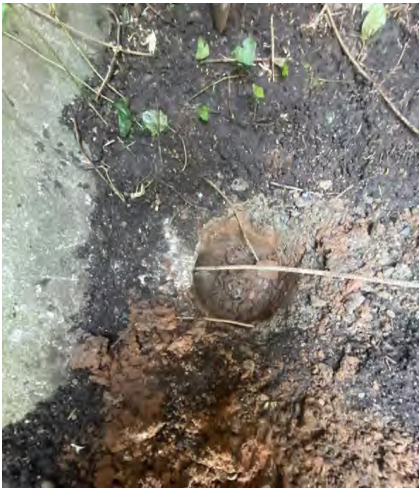
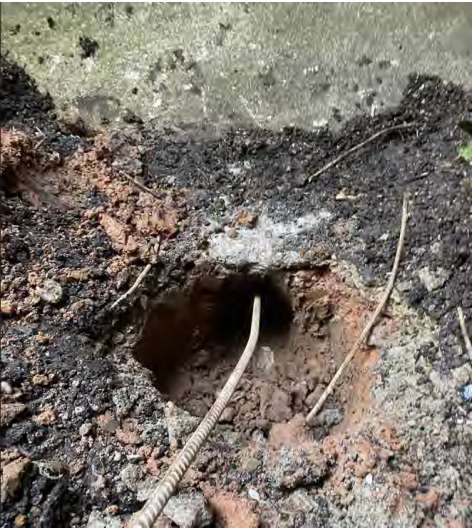
HP01

- Comments:
- Not to scale.
  - Hand pit terminated at 0.35m bgl
  - Groundwater not encountered.
  - Further detailed information in log HP01.

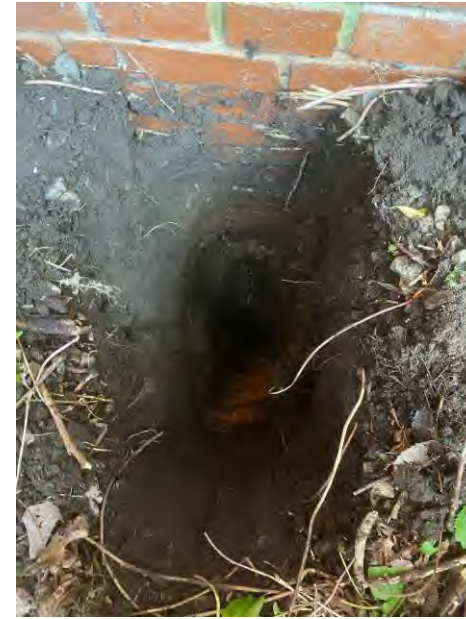
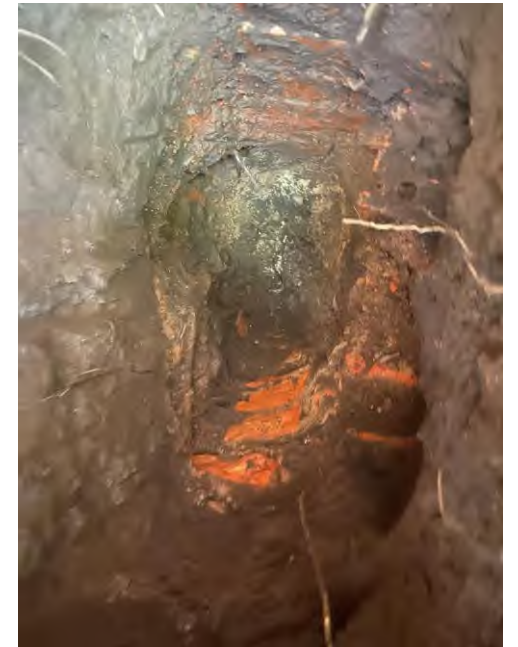
- Hand pit terminated at 0.93m bgl
- Groundwater not encountered.
- Further detailed information in log HP04.

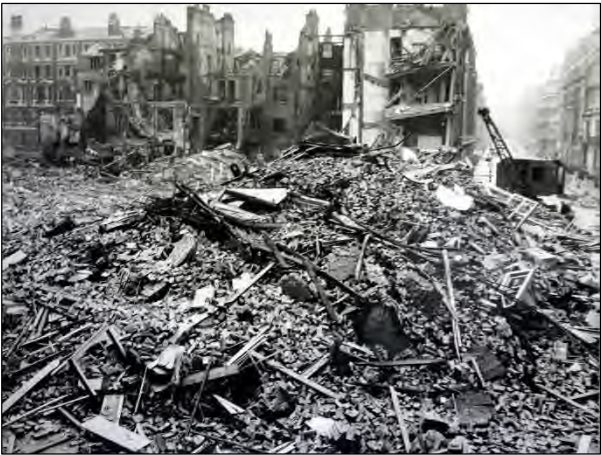
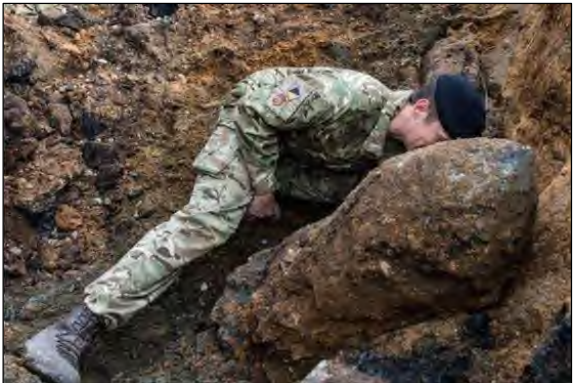
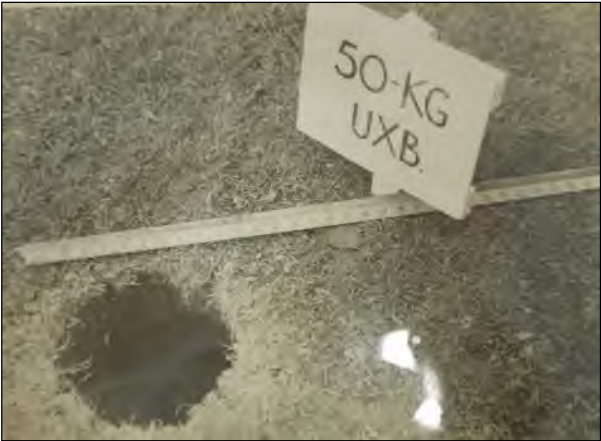
**Top:** J-curve Effect - Due to angle of entry, unexploded bombs would often end their trajectory at a lateral offset from point of entry, often ending up beneath adjacent extant structures/sites. The photograph above shows a 250kg unexploded bomb found in Bermondsey in 2015, pointing upwards, demonstrating ‘J-curve’.

One of the most common scenarios for UXO going unnoticed was when a UXB fell into a ‘bomb site’ (such as the area shown **Top Left**), the entry hole of the bomb obscured by any debris and rubble present. Note that the entry hole of a 50kg UXB could be as little as 20cm in diameter (**Left**).

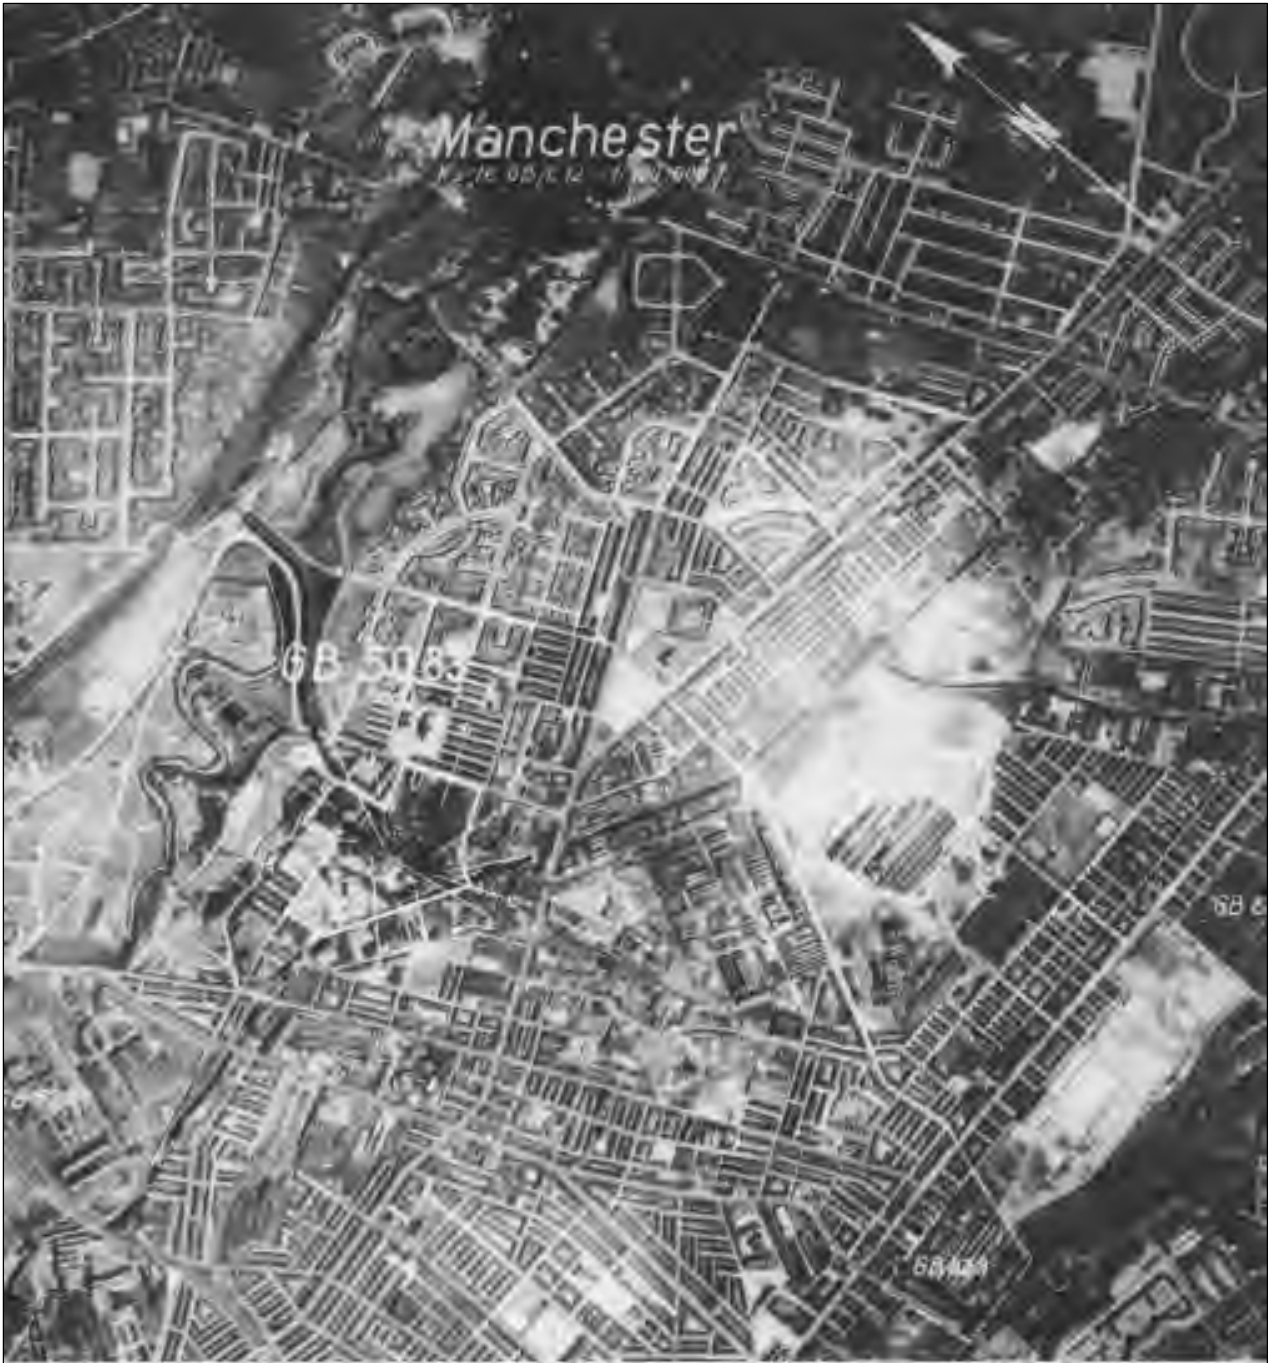
Luftwaffe Photograph, 1940

**Manchester- Clayton**  
Bradford Road Gas works

The site located approximately 1.5km south-east of the Bradford Road Gas works.

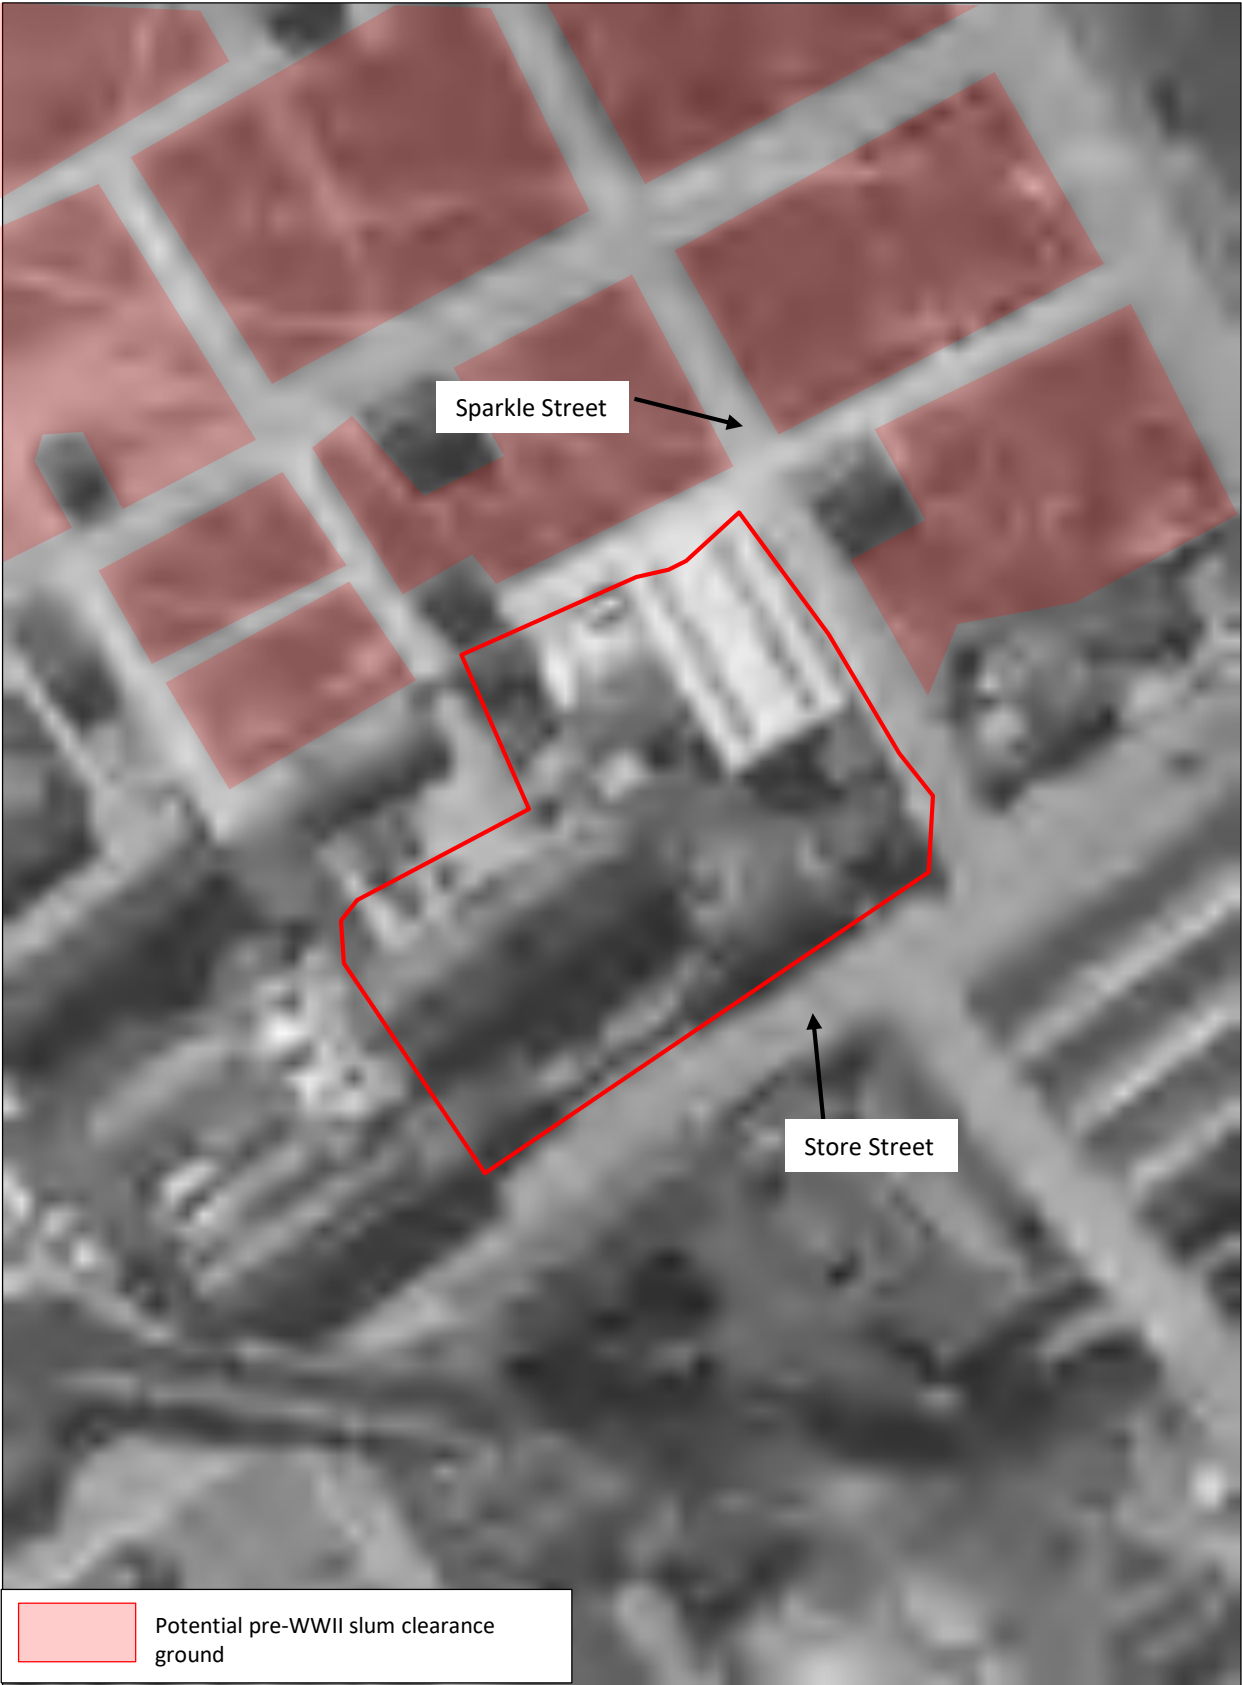
## SC 50kg High Explosive Bomb

| Bomb Weight | 40-54kg (88-119lb) |
| Use | Against lightly damageable materials, hangars, railway rolling stock, ammunition depots, light bridges and buildings up to three stories. |

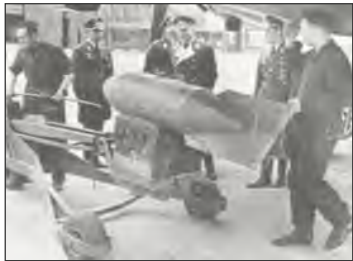
SC250 bomb being loaded onto German bomber

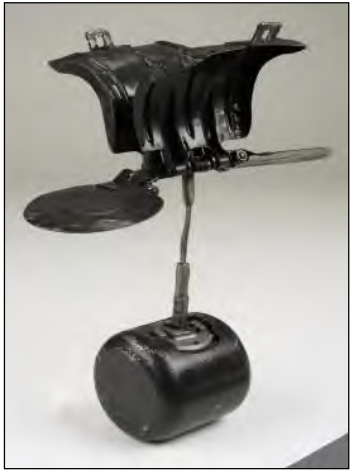
Parachute Mine (Luftmine B / LMB)

| Bomb Weight | Approx. 990kg (2176lb) |
| Fuze Type | Impact/time delay/hydrostatic pressure fuze |
| Use | Against civilian, military and industrial targets. Used as blast bombs and designed to detonate above ground level to maximise damage to a wider area. |
| Remarks | Deployed a parachute when dropped in order to control its descent. Had the potential to cause extensive damage within a 100m radius. |

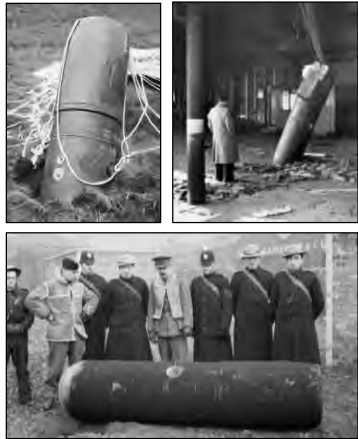
SC 1000kg

| Bomb Weight | Approx. 993-1027kg (2,189-2,264lb) |
| Body Diameter | 654mm (18.5in) |
| Use | SC-type bombs were General Purpose Bombs used primarily for general demolition work. Constructed of parallel walls with comparatively heavy noses, they are usually of three-piece welded construction. |

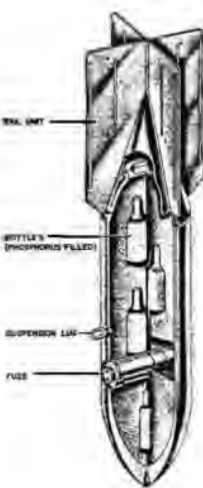
## Flam C-250 Oil Bomb

| Bomb Weight | Approx. 125kg (276lb) |
| Body Diameter | 368mm (14.5in) |
| Use | Often used for surprise attacks on ground troops, against troop barracks and industrial installations. Thin casing – not designed for ground penetration. |

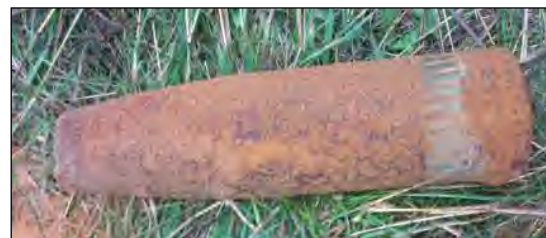
## 40mm Bofors Projectile

| Projectile Weight | 1.96lb (0.86kg) |
| Ceiling | 23,000ft (7000m ) |
| Remarks | Light quick fire high explosive anti-aircraft projectile. Each projectile fitted with small tracer element. If no target hit, shell would explode when tracer burnt out. Designed to engage aircraft flying below 2,000ft. |

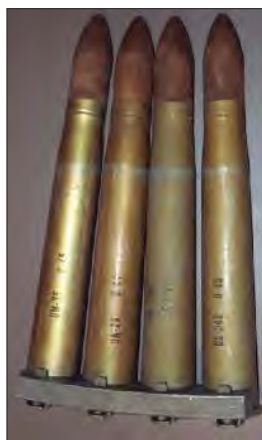
## 3in Unrotated Projectile (UP) Anti-Aircraft Rocket ("Z" Battery)

| HE Projectile Weight | 3.4kg (7.6lb) |
| Dimensions of projectile | 236 x 83mm (9.29 x 3.25in) |
| Remarks | As a short range rocket-firing anti-aircraft weapon developed for the Royal Navy. It was used extensively by British ships during the early days of World War II. The UP was also used in ground-based single and 128-round launchers known as Z Batteries. Shell consists of a steel cylinder reduced in diameter at the base and threaded externally to screw into the shell ring of the rocket motor. |
