Repairs to Hough Hall

Hough Hall  
Manchester

Stabilisation Tasks and sequence  
Urgent Works

Existing Ground Floor

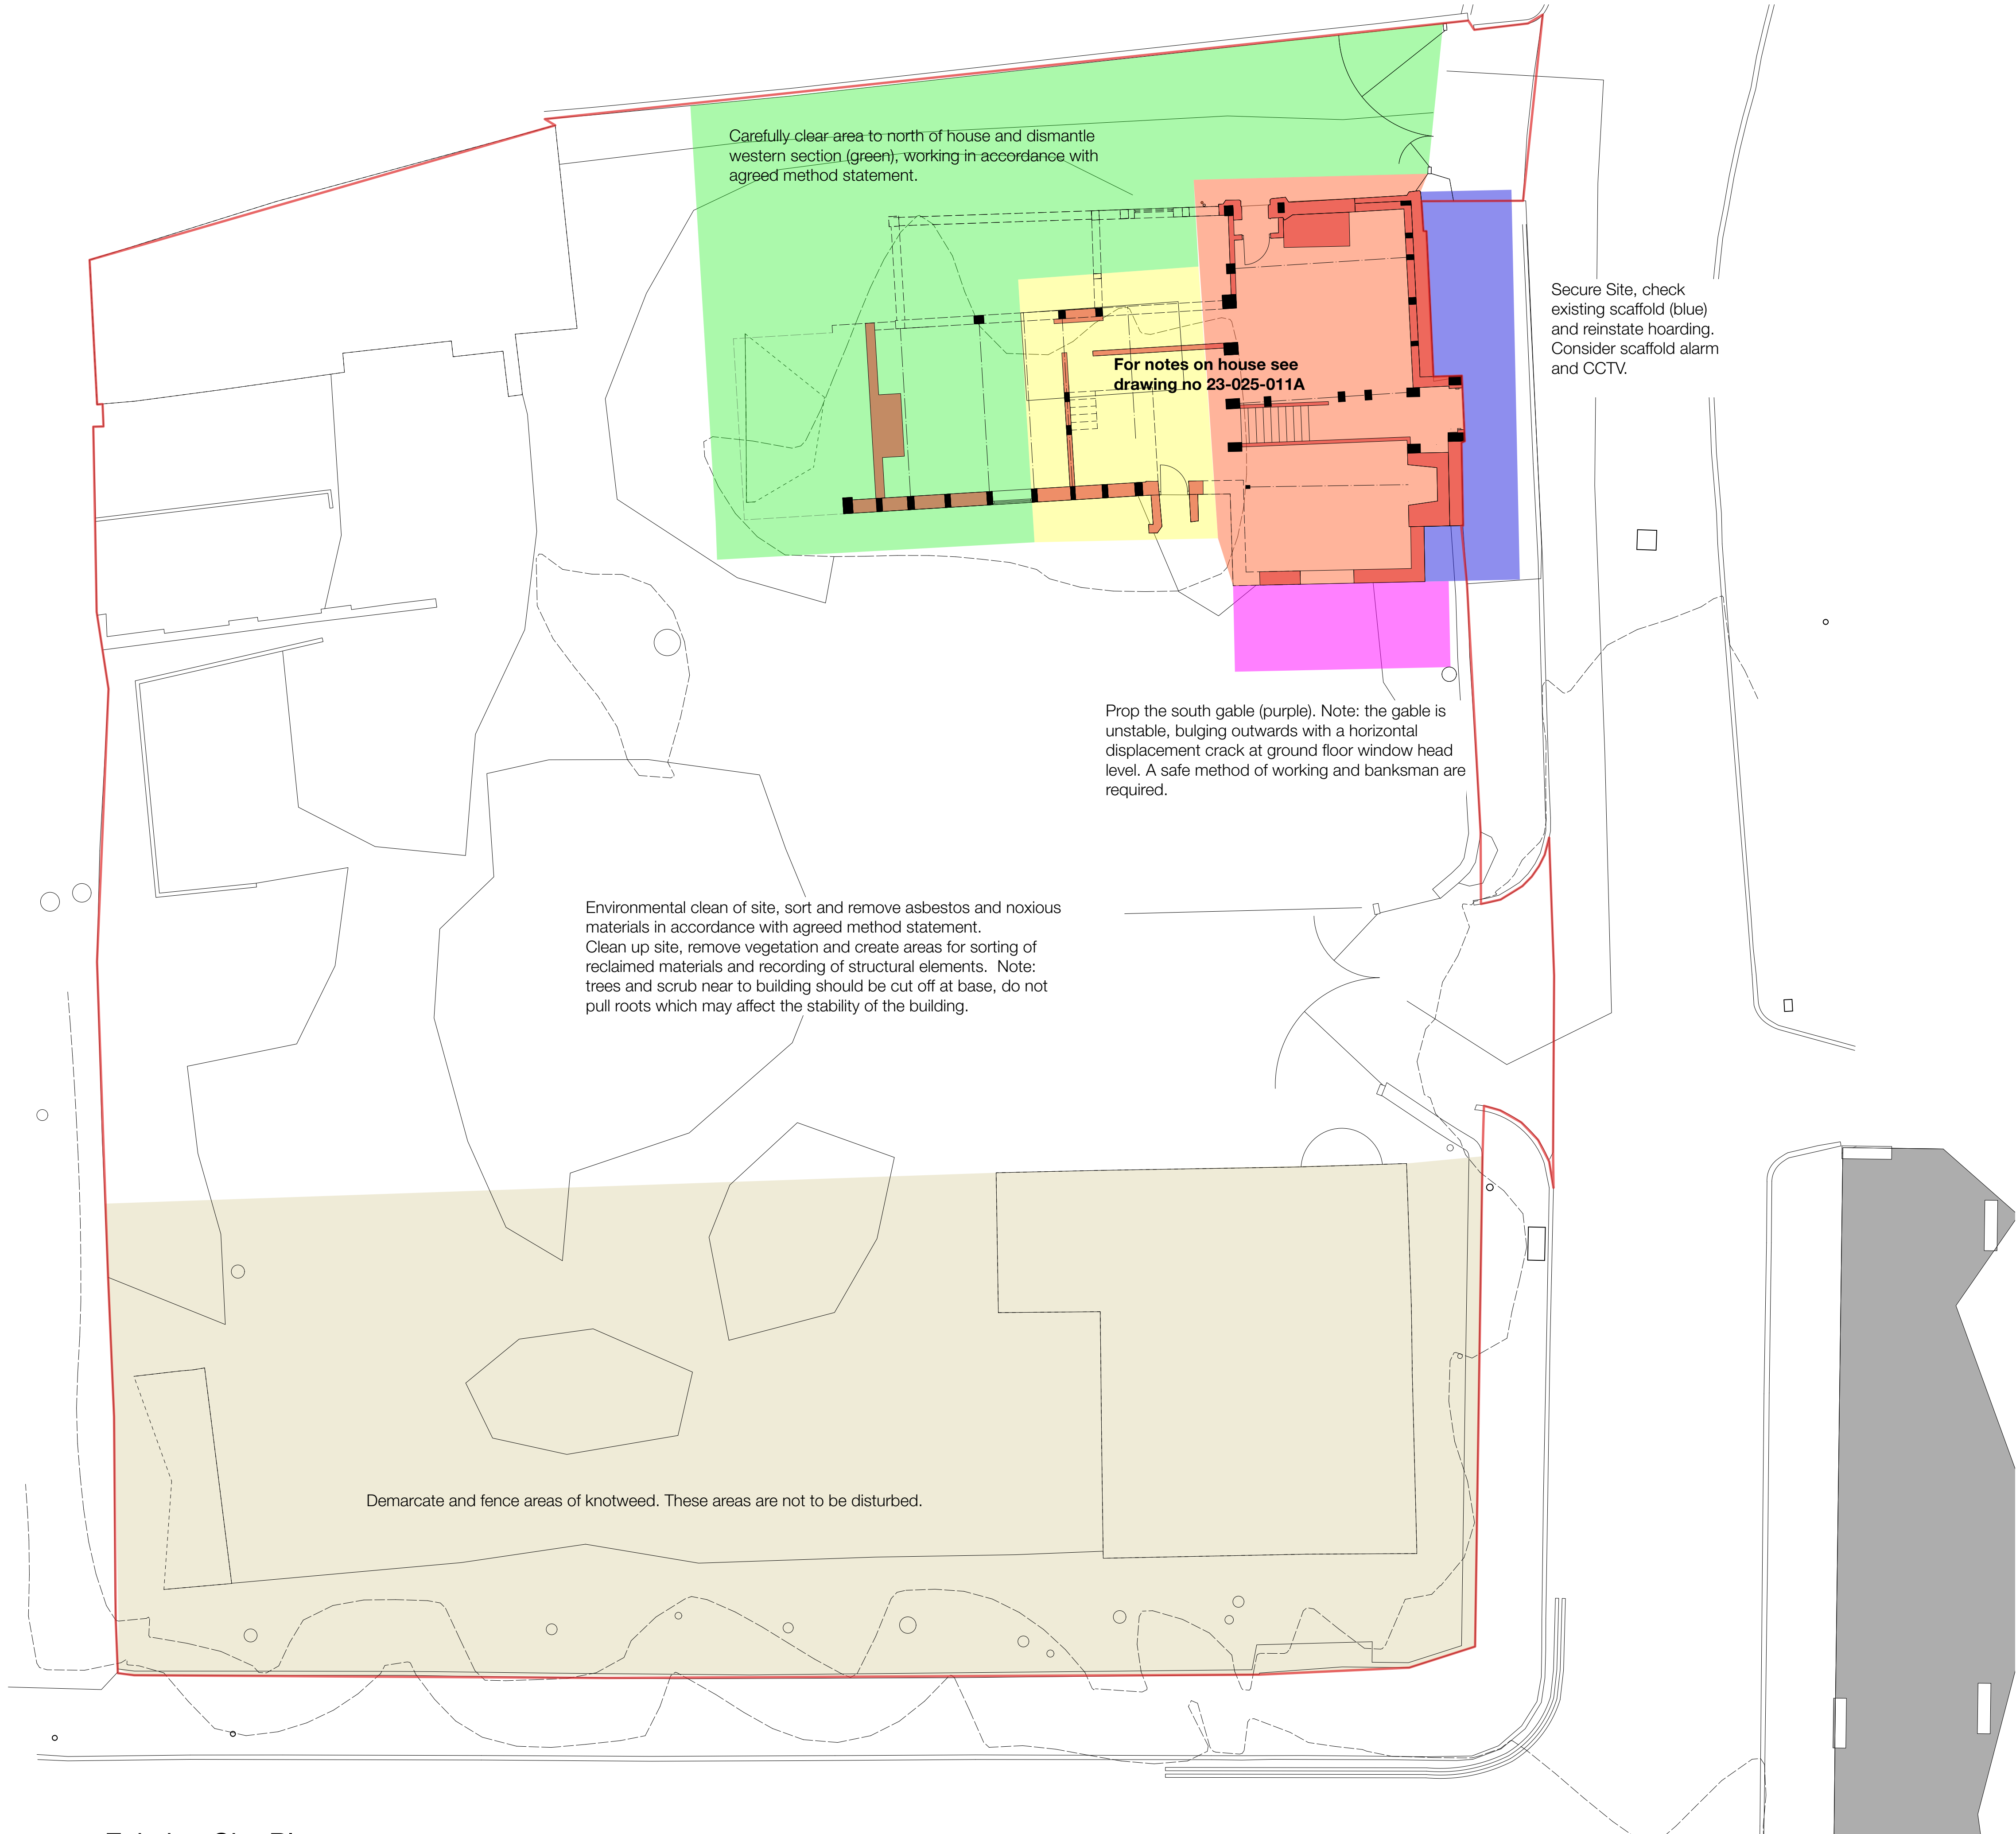
Existing Site Plan

For notes, sequence and need for consents see drawing no 23-025-011A

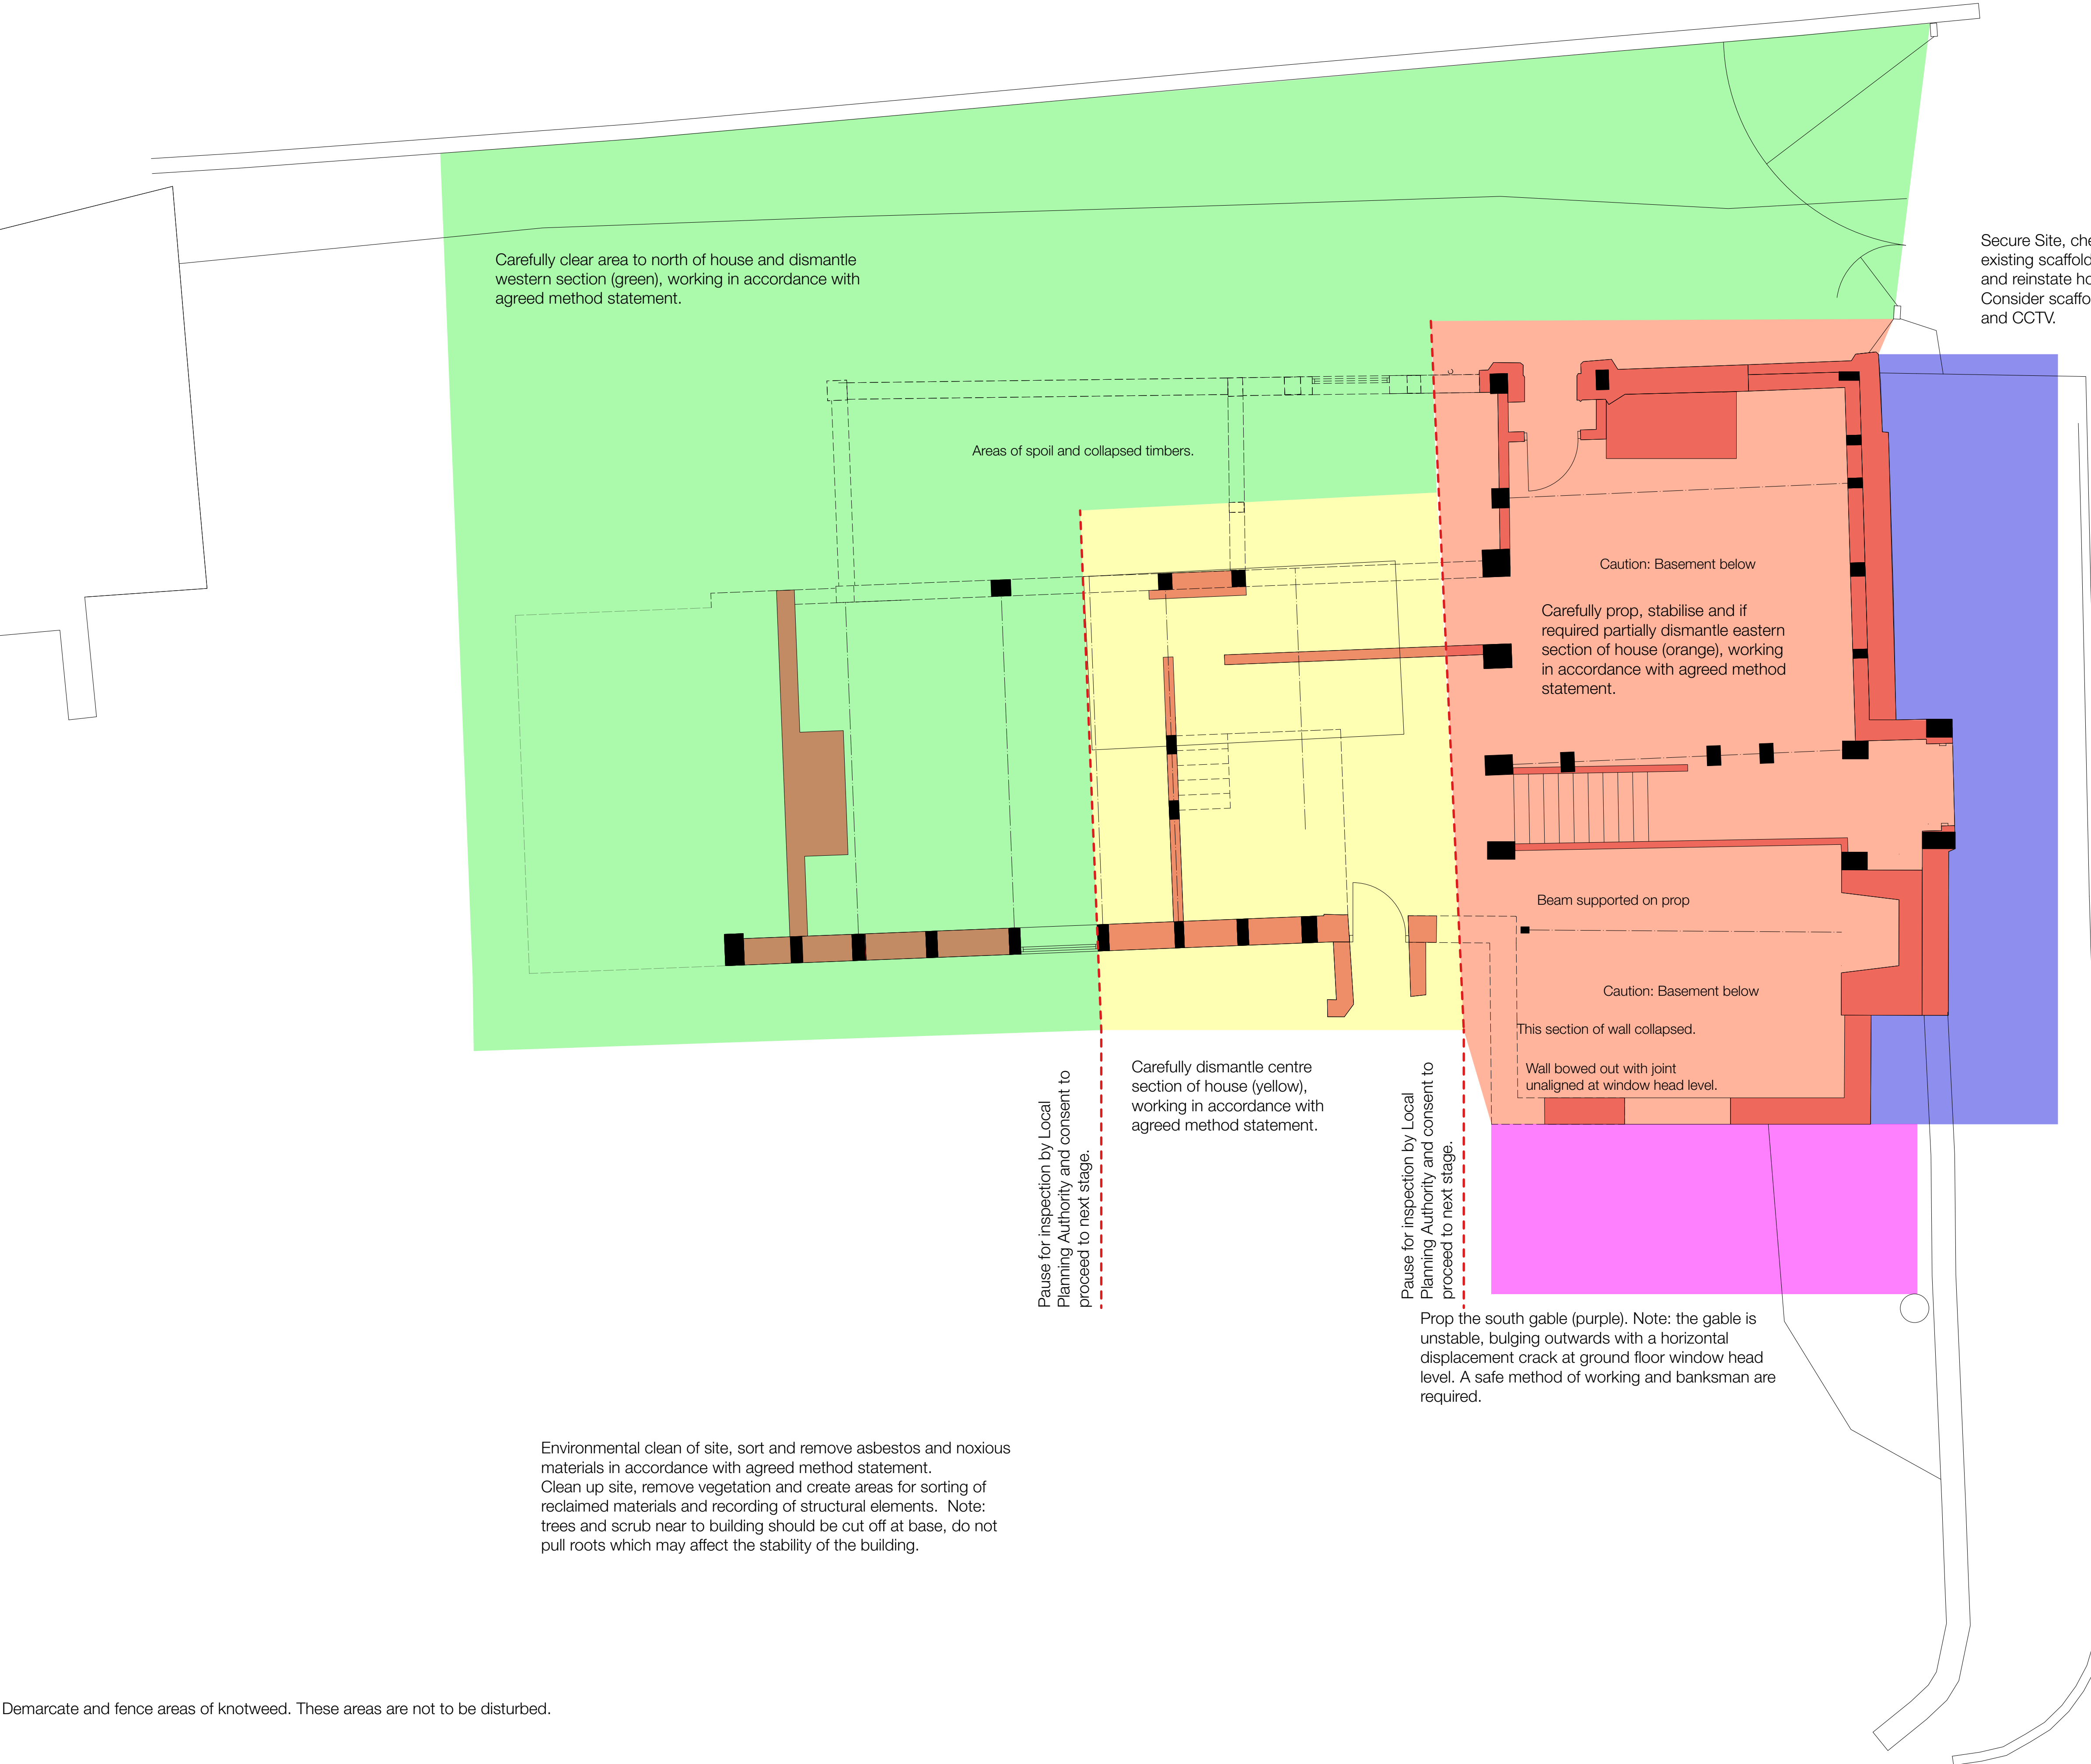
Demarcate and fence areas of knotweed. These areas are not to be disturbed.

For notes, sequence and need for  
consents see drawing no 23-025-011A

- Secure Site, check existing scaffold (blue) and reinstate hoarding. Consider scaffold alarm and CCTV.
- Demarcate and fence areas of knotweed. These areas are not to be disturbed.
- Environmental clean of site, sort and remove asbestos and noxious materials in accordance with agreed method statement.
- Clean up site, remove vegetation and create areas for sorting of reclaimed materials and recording of structural elements. Note: trees and scrub near to building should be cut off at base, do not pull roots which may affect the stability of the building.
- Prop the south gable (purple). Note: the gable is unstable, bulging outwards with a horizontal displacement crack at ground floor window head level. A safe method of working and banksman are required.

The following works should not be carried out without Listed Building Consent being obtained.

- Carefully clear area to north of house and dismantle western section (green), working in accordance with agreed method statement.
- Pause for inspection by Local Planning Authority and consent to proceed to next stage.
- Carefully dismantle centre section of house (yellow), working in accordance with agreed method statement.
- Pause for inspection by Local Planning Authority and consent to proceed to next stage. Details for stabilisation works to be prepared and agreed in conjunction with architect and structural engineer.
- Carefully prop, stabilise and if required partially dismantle eastern section of house (orange), working in accordance with agreed method statement.

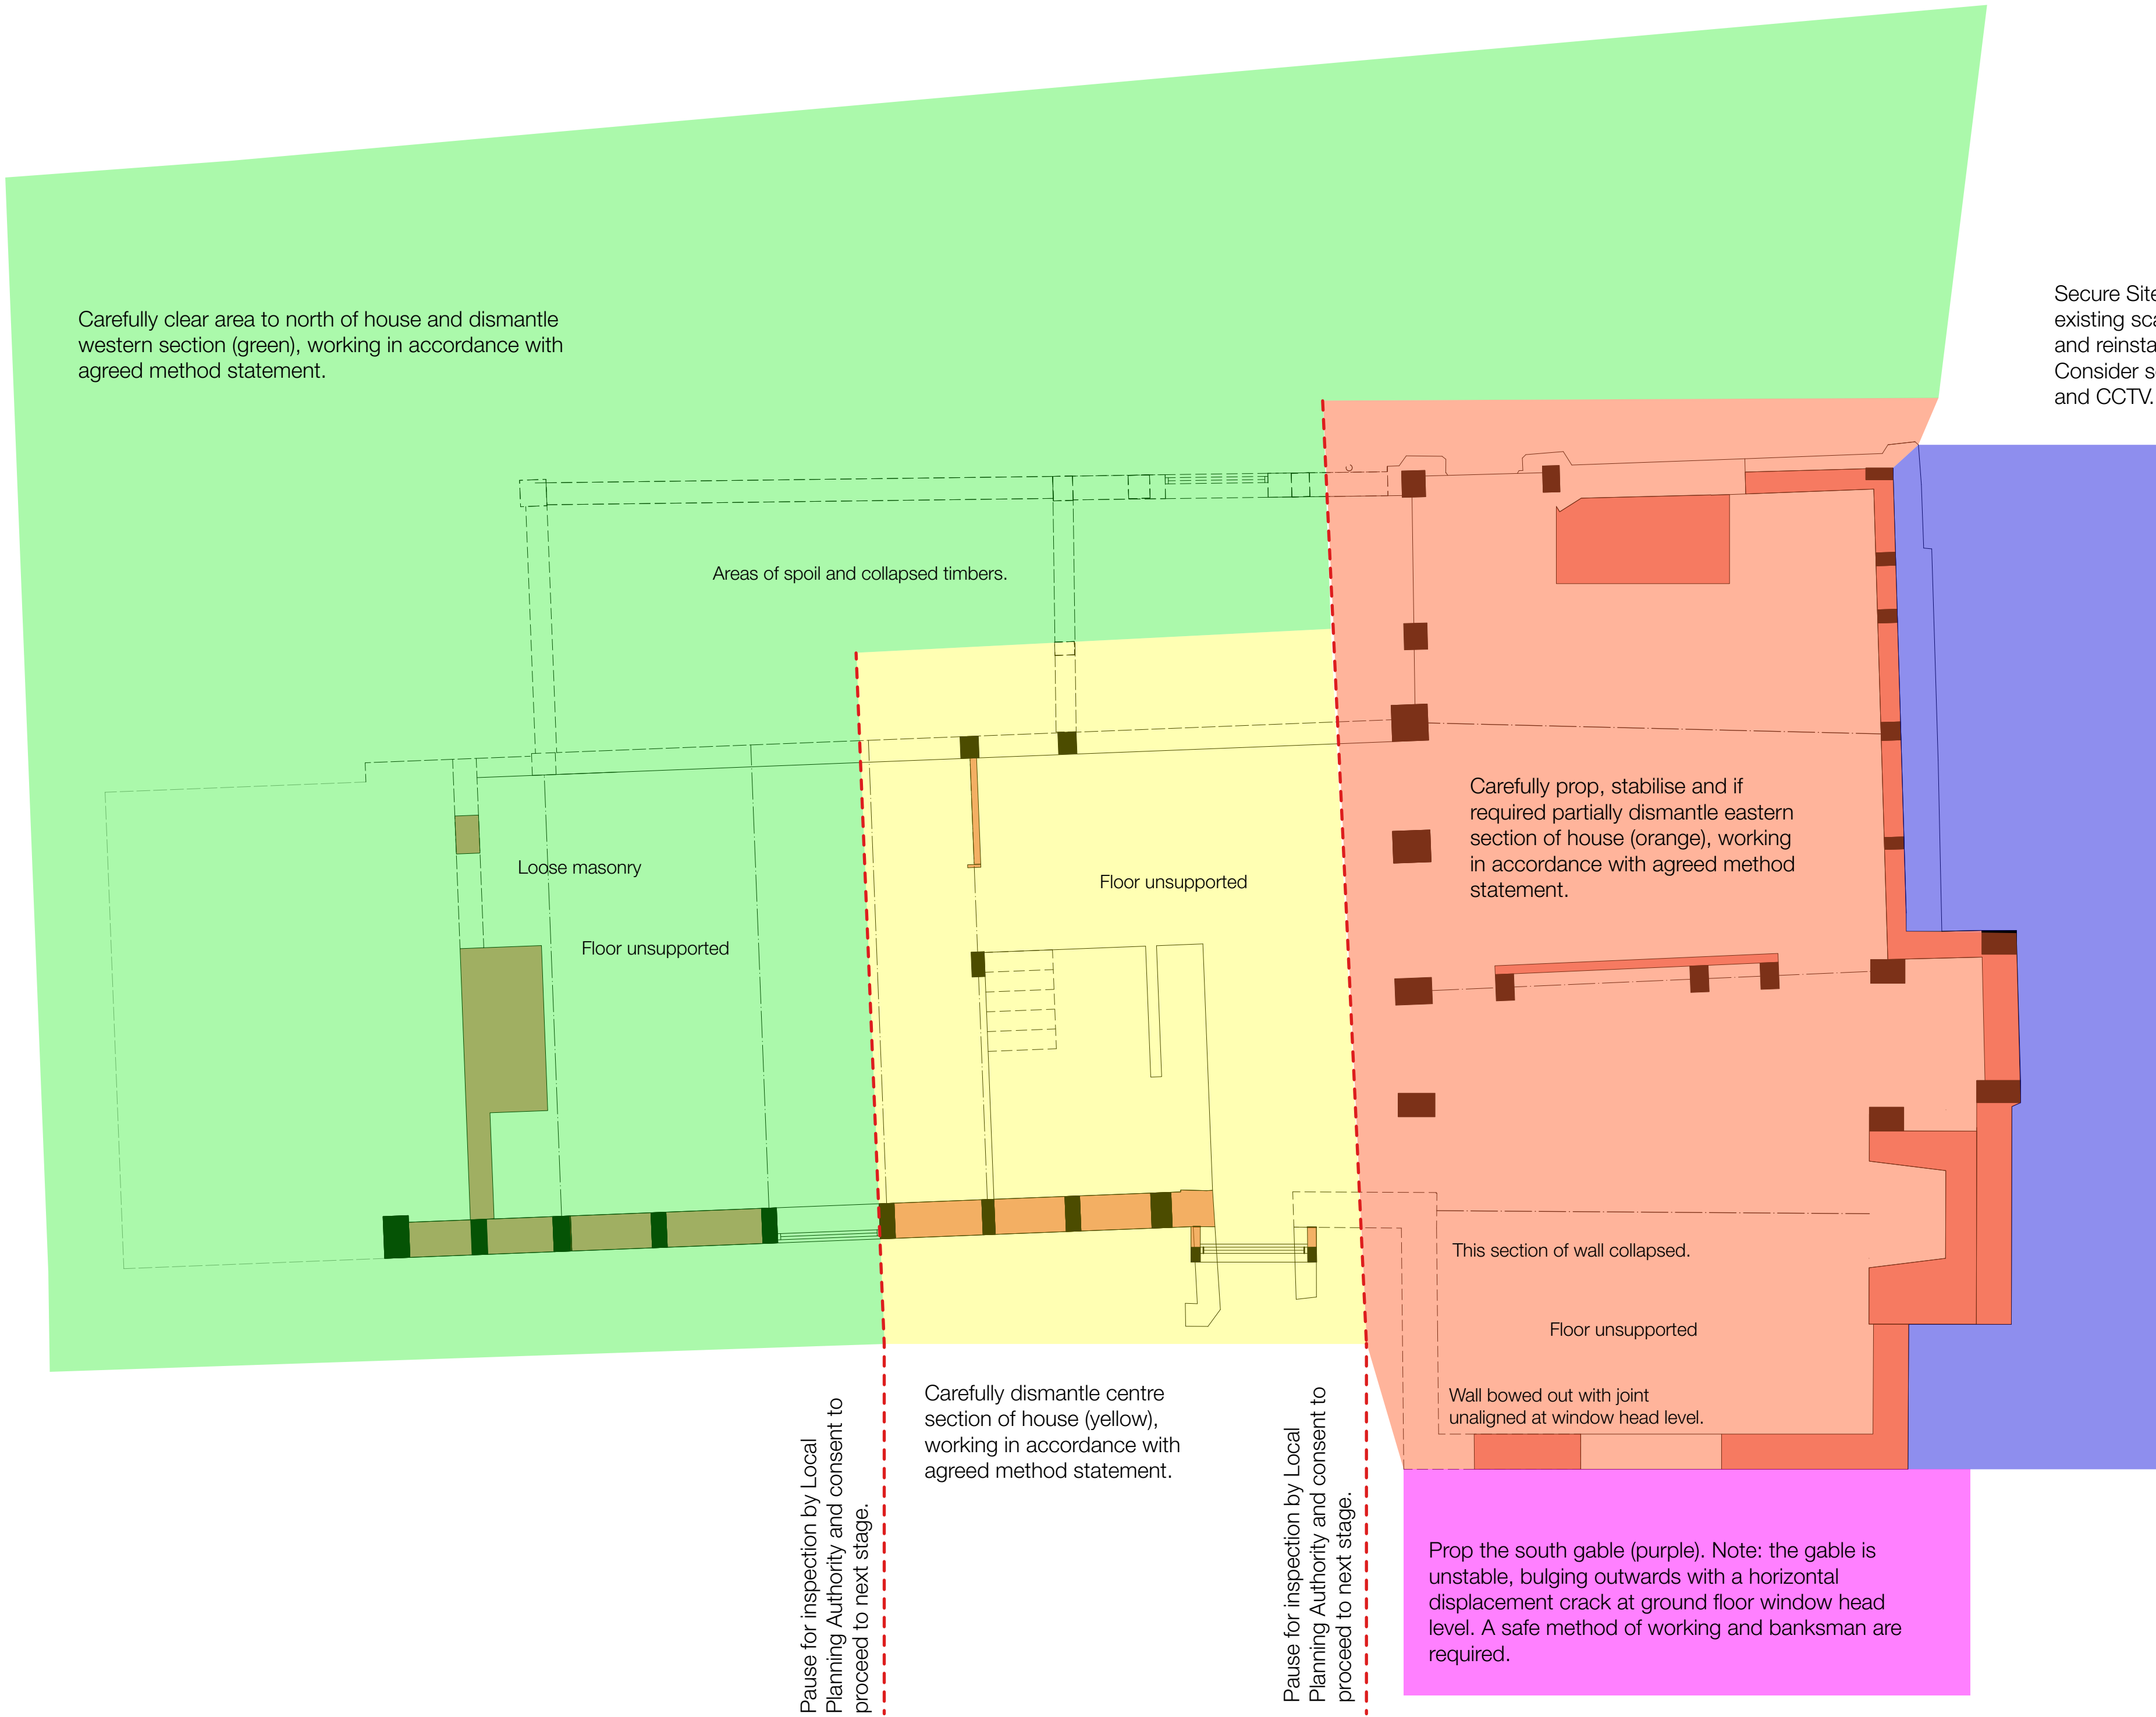
Existing First Floor

Based on measured survey data and approximations based on photography due to restricted access. Dimensions to be verified on site.

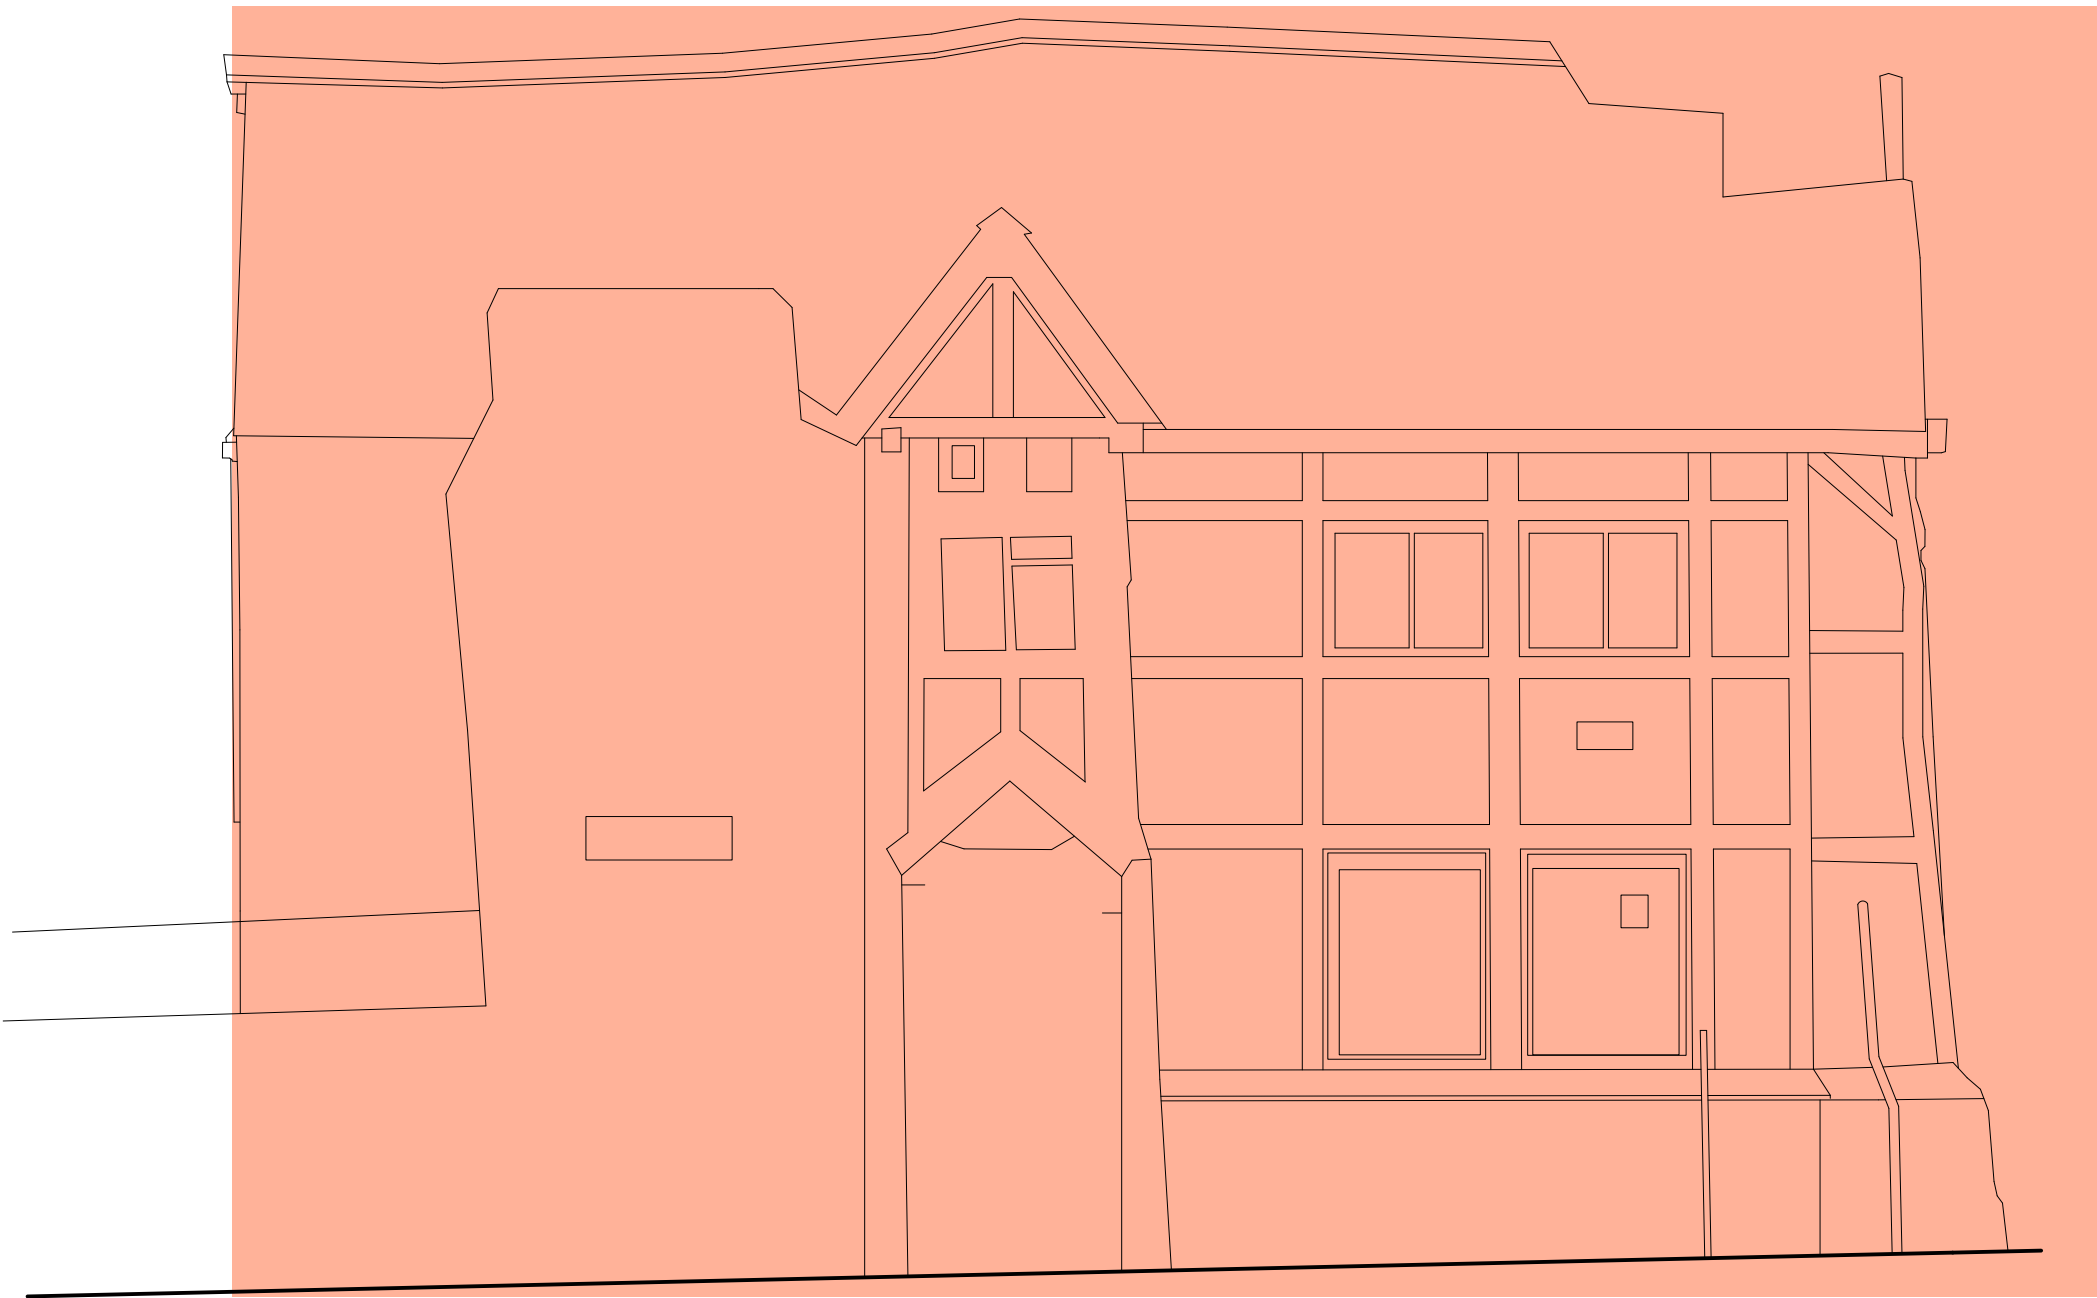
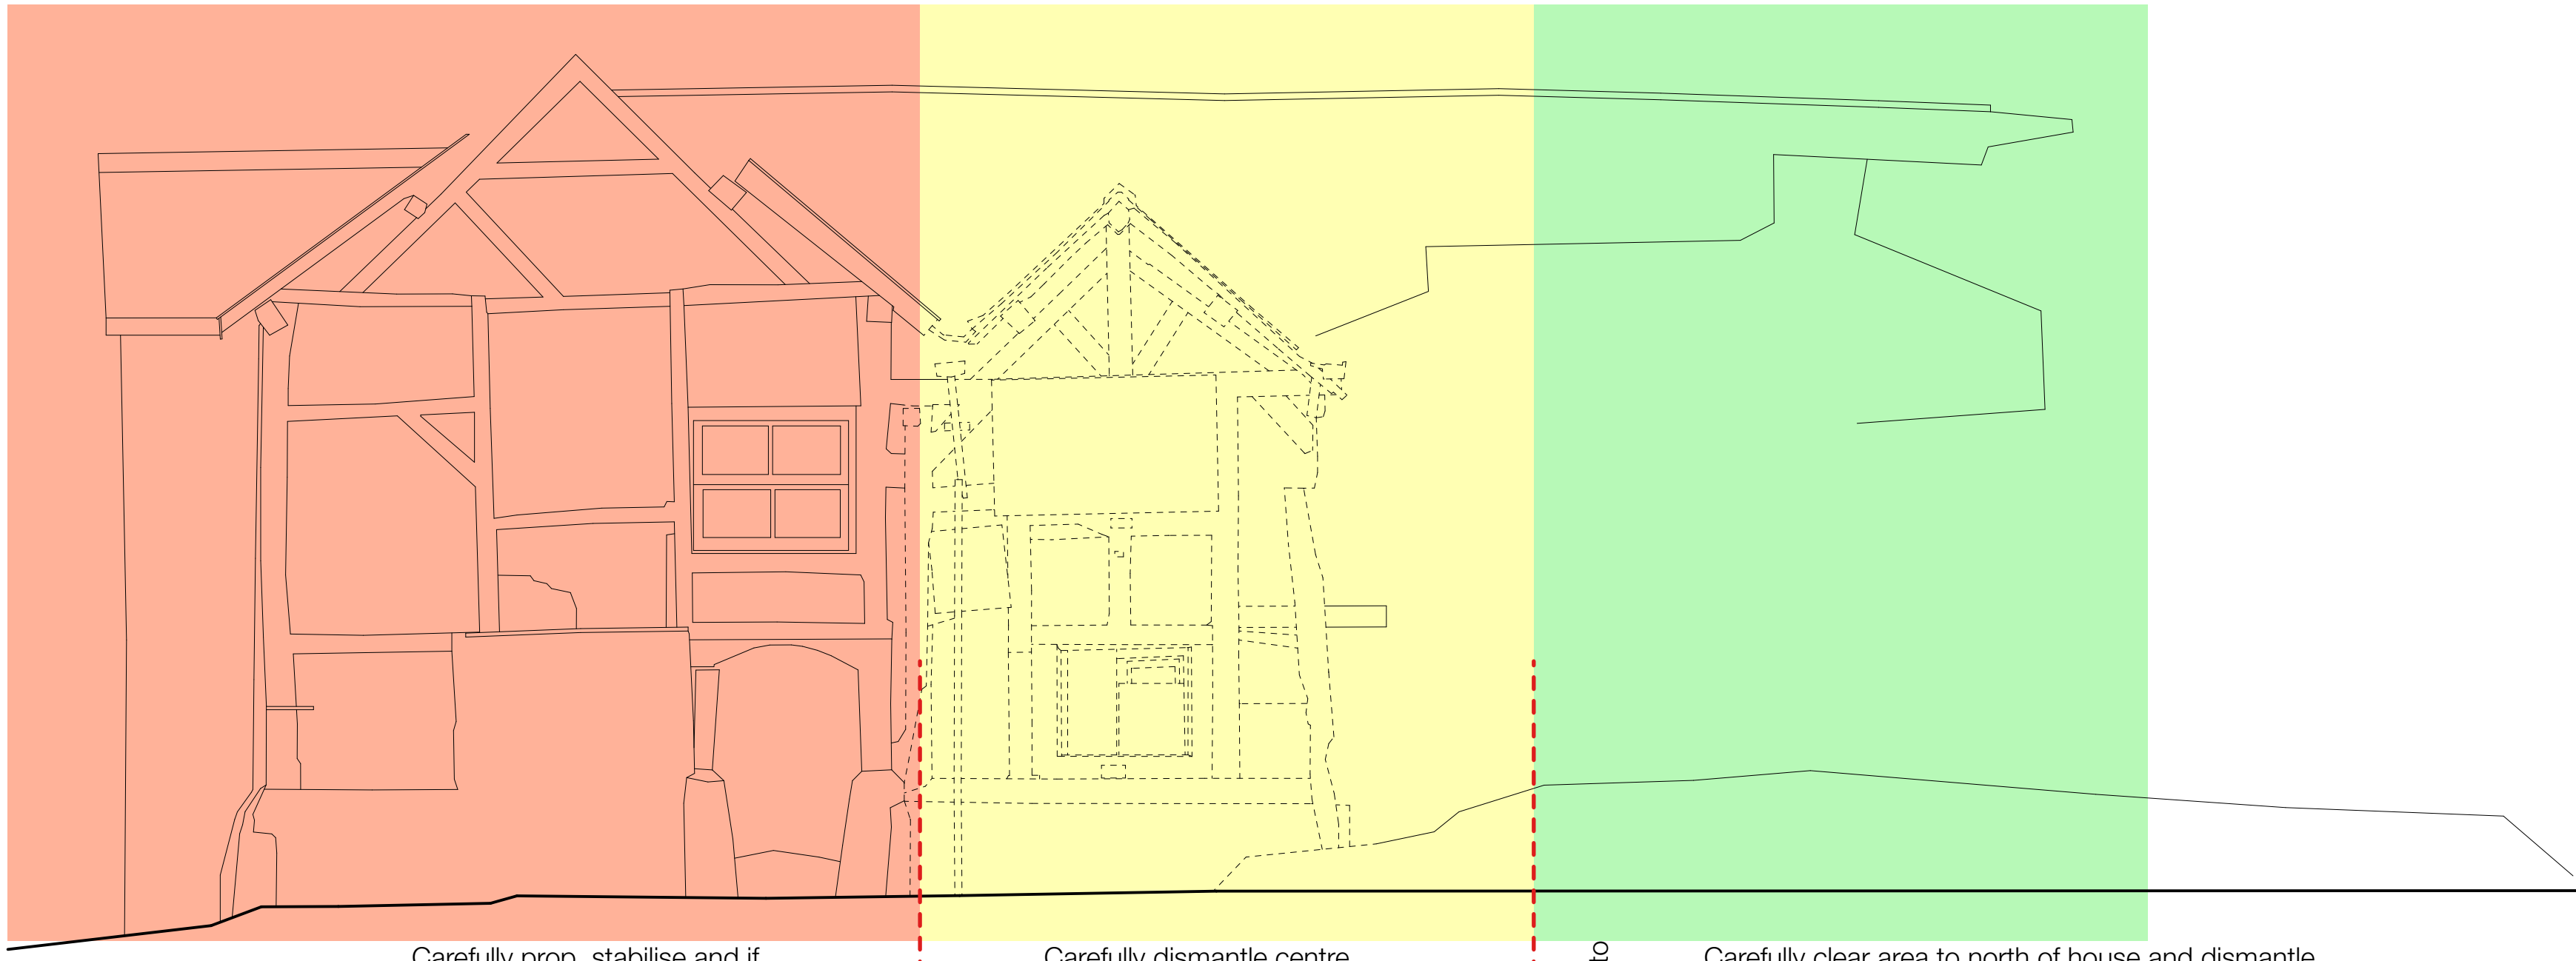
East Elevation

Secure Site, check existing scaffold (blue) and reinstate hoarding. Consider scaffold alarm and CCTV.

Carefully prop, stabilise and if required partially dismantle eastern section of house (orange), working in accordance with agreed method statement.

Pause for inspection by Local Planning Authority and consent to proceed to next stage.

Carefully dismantle centre section of house (yellow), working in accordance with agreed method statement.

Carefully clear area to north of house and dismantle western section (green), working in accordance with agreed method statement.

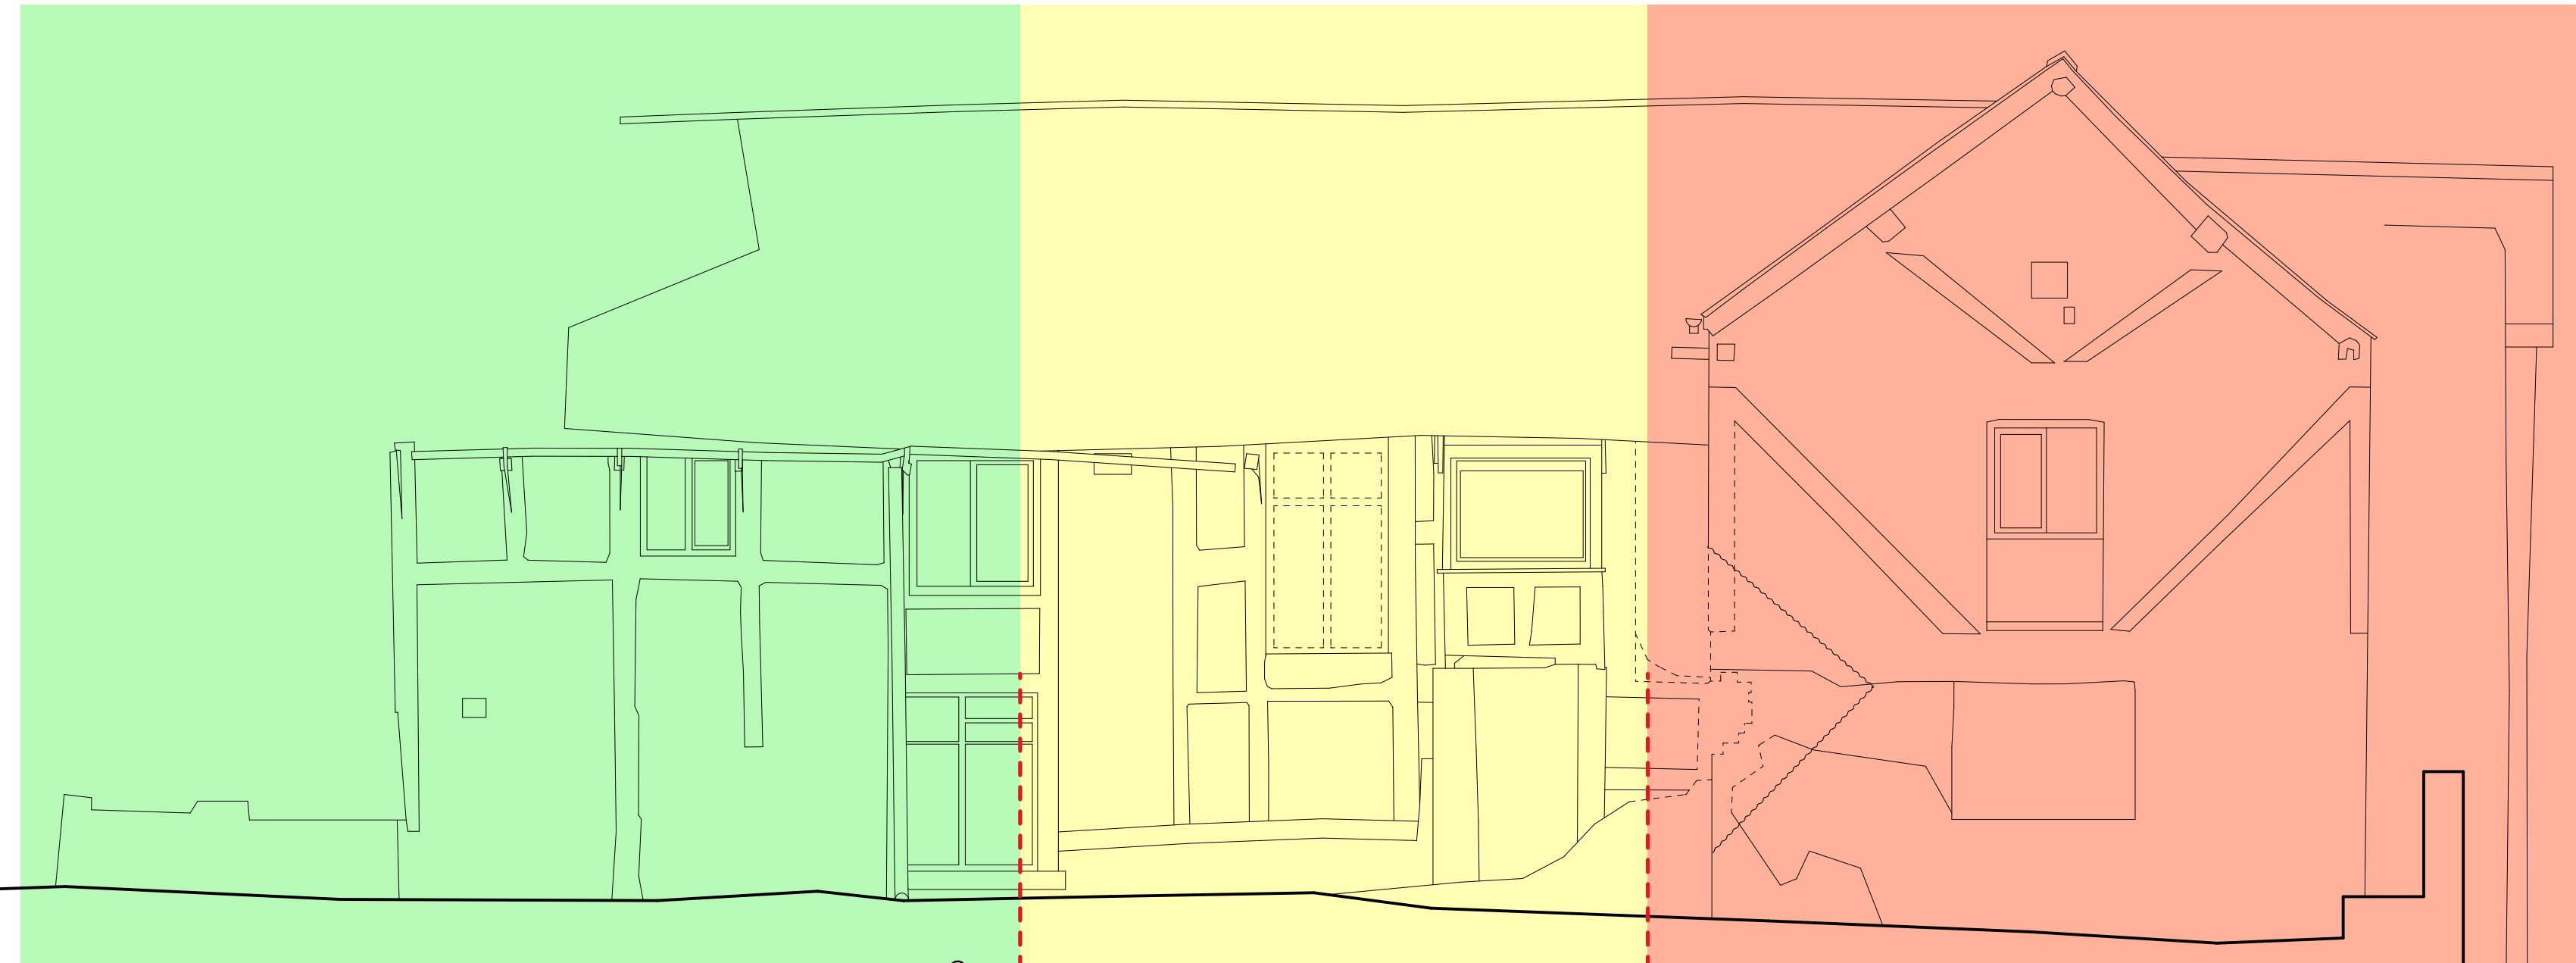
South Elevation

Carefully clear area to north of house and dismantle western section (green), working in accordance with agreed method statement.

Pause for inspection by Local Planning Authority and consent to proceed to next stage.

Carefully dismantle centre section of house (yellow), working in accordance with agreed method statement.

Prop the south gable (purple). Note: the gable is unstable, bulging outwards with a horizontal displacement crack at ground floor window head level. A safe method of working and banksman are required.

Carefully prop, stabilise and if required partially dismantle eastern section of house (orange), working in accordance with agreed method statement.
