# HERBERT STREET, MANCHESTER

## PHASE 1: PRELIMINARY RISK ASSESSMENT

**Job Number:** LKC 23 1433  
**Date:** September 2023  
**Client:** Ace Property Cheethamhill Ltd

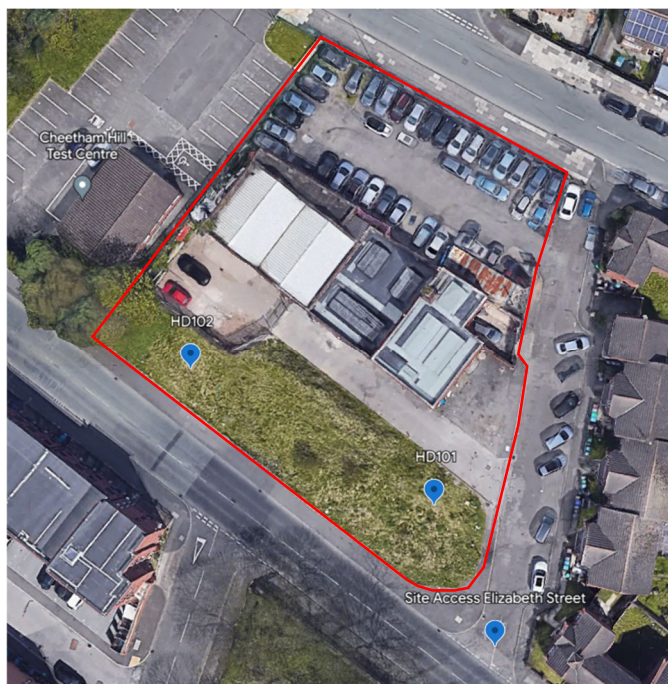
Plate 4-3: Plan showing relevant site walkover features.

Relevant features are also shown on Plate 4-3.

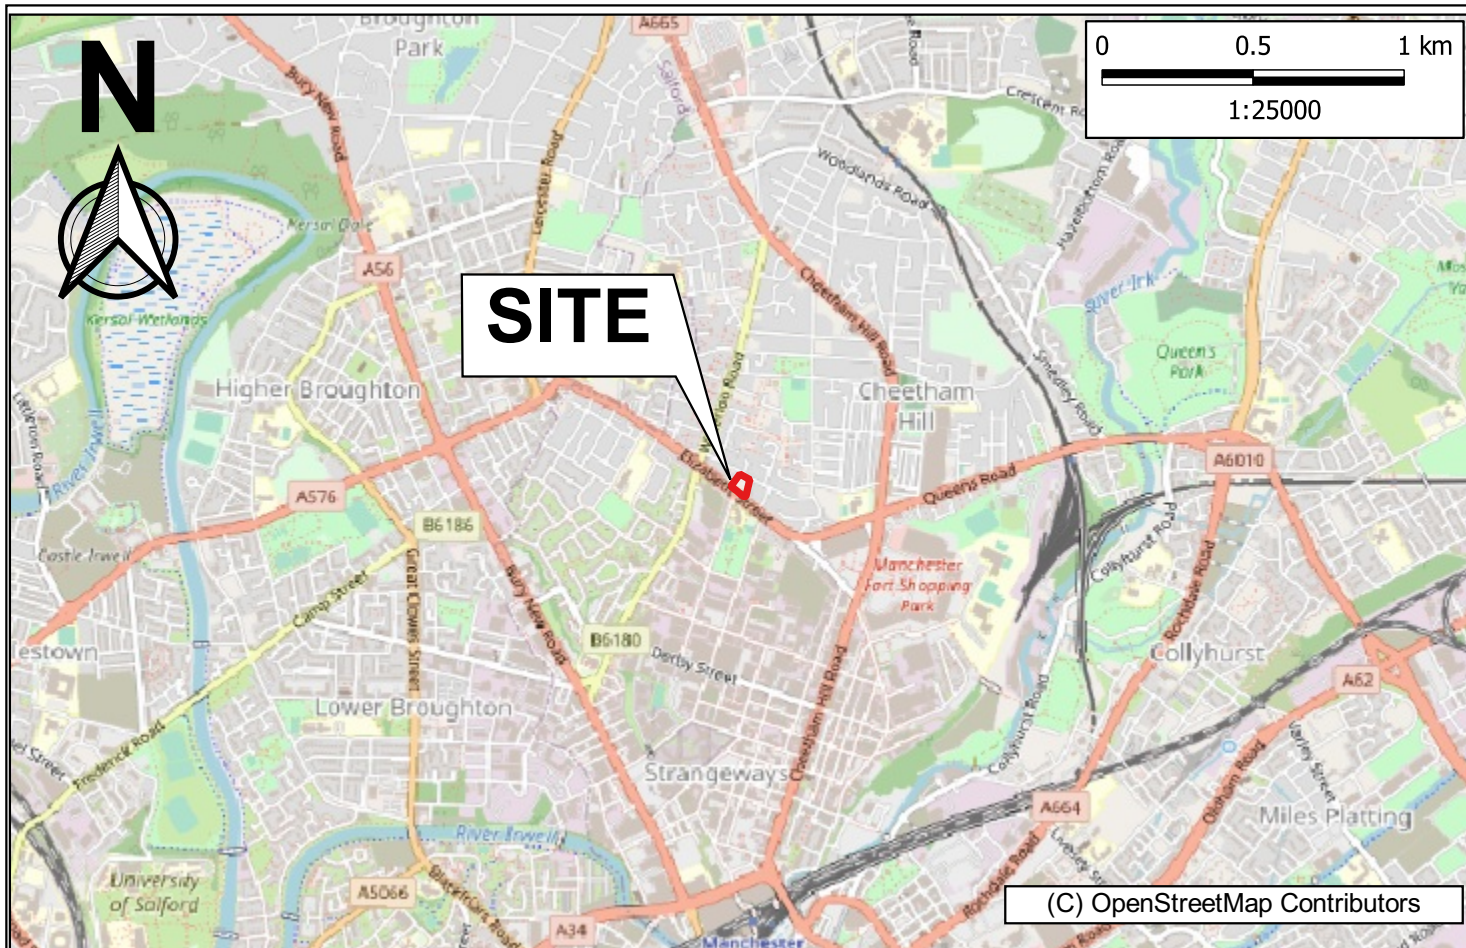
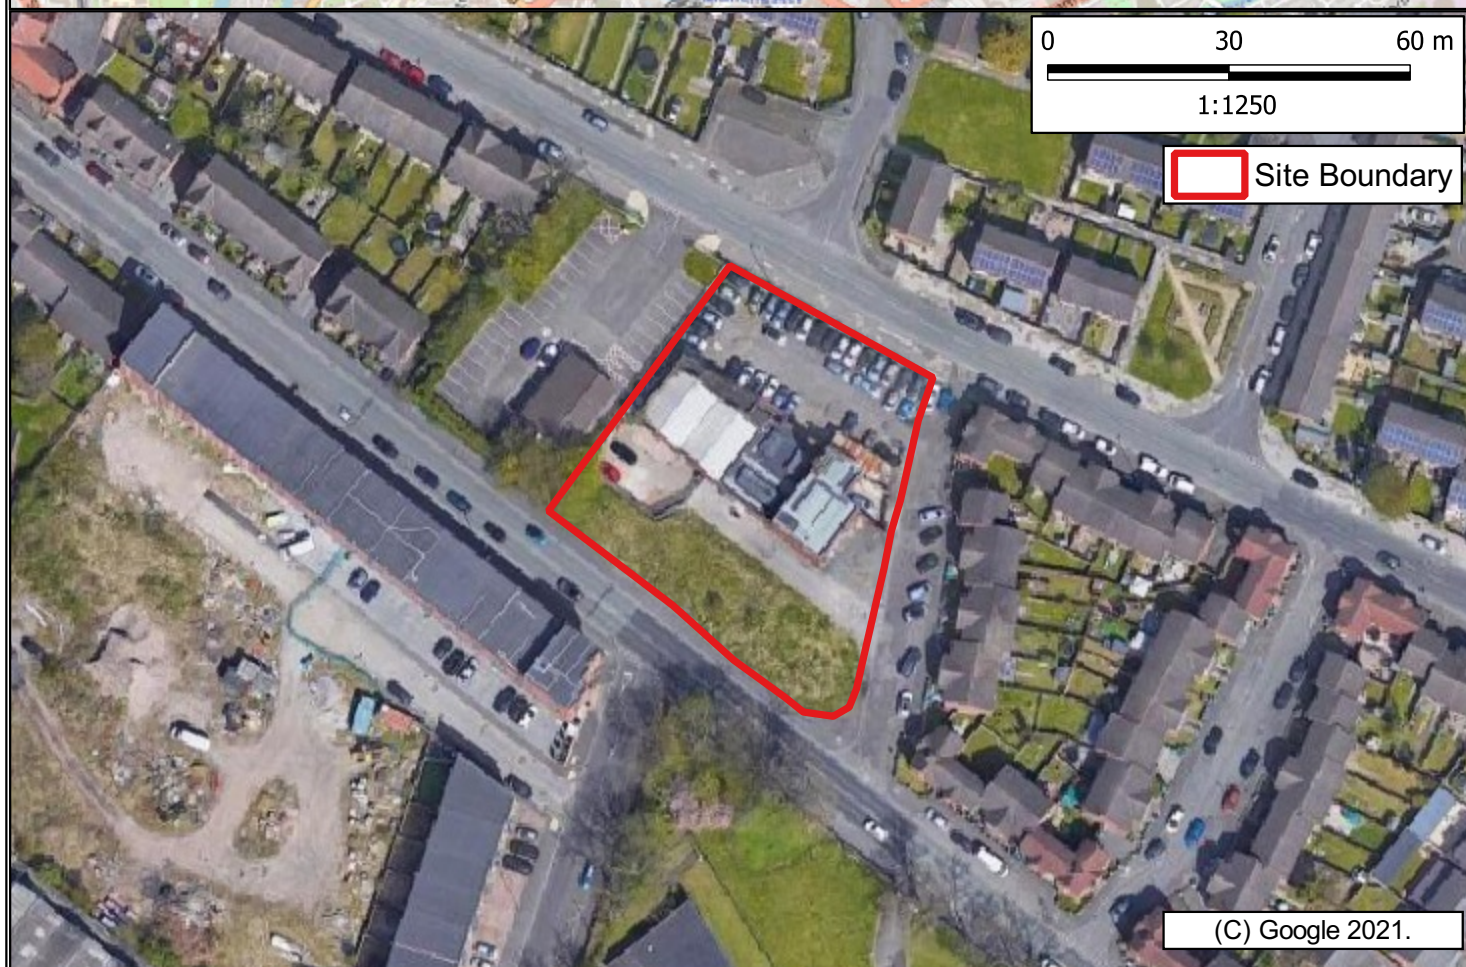
| Client:<br><br>Ace Property Cheethamhill Ltd | | | | Title:<br><br>Site Location &<br>Boundary Plan | | | |

Site details are provided in Table 1-1. Figure 1 shows the site location and boundary. Figure 2 shows the proposed development plan.

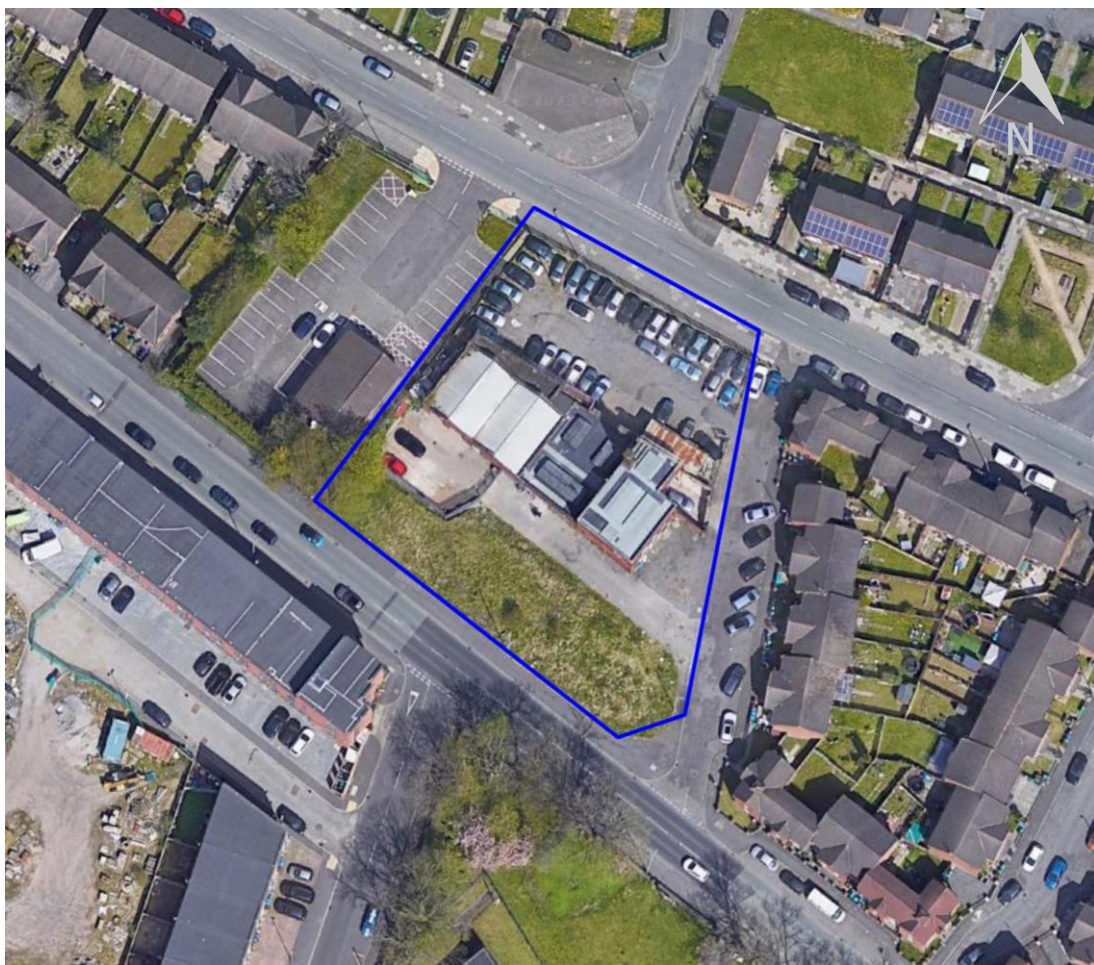
**Plate 1 Recent aerial photograph of the Site**

Figure 1 is a Site location map and Plate 1 is a recent aerial photograph of the Site.

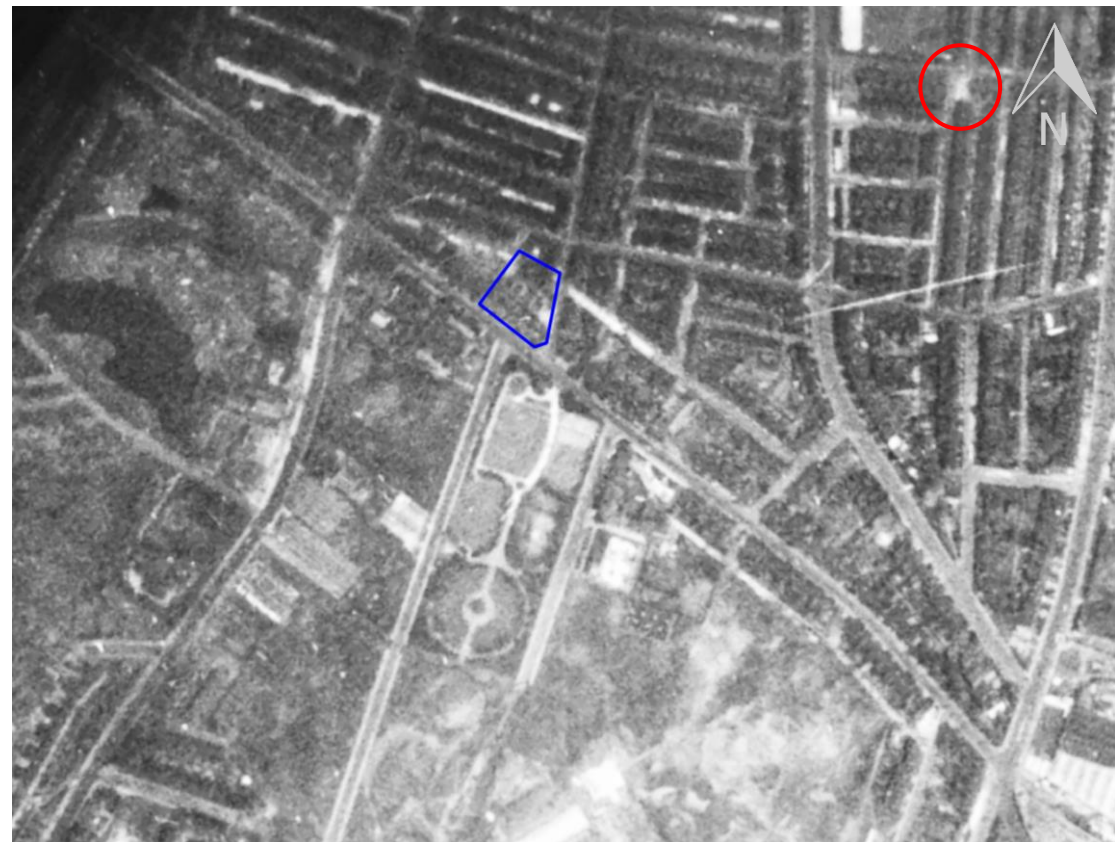
**Plate 2 Aerial photograph, 30<sup>th</sup> May 1944**

Plate 2 is an aerial photograph dated the 30<sup>th</sup> May 1944. No significant bomb damage has been identified on the Site.

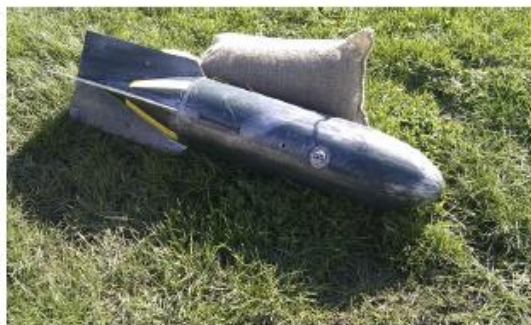
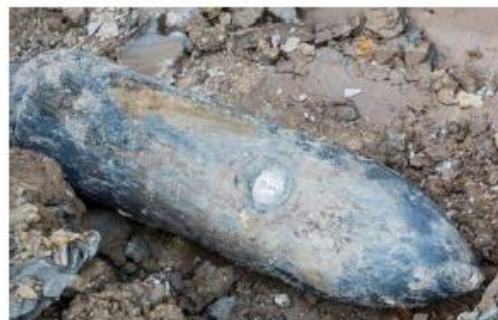
**Description** Thick nose welded to a steel body. Nose may be attached to Kopfring (a triangular section steel ring) or spike. Suspension bolt in eye/body and sheet metal tail attached to body with rivets/screws. Originally painted green-grey with a yellow stripe on the tail. Cast TNT, Amatol or Trialen filling.

**Function** Designed to maximise shock waves through air, water and earth and for general demolition. Used against easily damageable targets, including roads, aircraft hangars, rolling stock and small buildings. Spike bombs/ 'Stabo' (SC 50 with spikes attached to nose) were used against rail lines and country roads, with Kopfring used against naval targets.

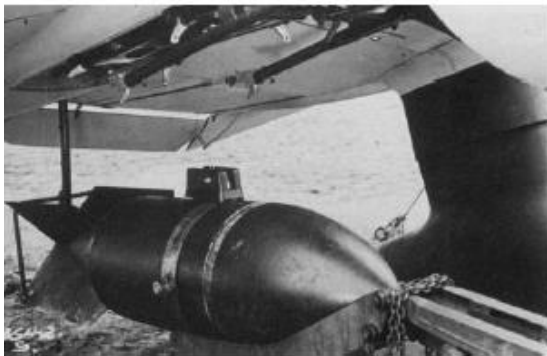
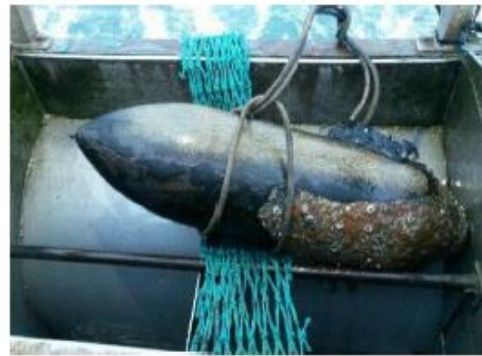
**Description** Thick nose welded to steel body. Nose may be attached to Kopfring (triangular section steel ring) or spike. Sheet metal tail attached to body with rivets/screws. Suspension eye bolt in the nose/body. Originally painted green-grey with a yellow stripe on the tail. TNT; amatol; TNT and aluminium powder, naphthalene, ammonium nitrate and wax/ wood meal filling.

**Function** Designed to maximise shock waves through air, water and earth and general demolition. Used against railway installations, large buildings, ammunition depots and below-ground installations (to 8m). Spike bombs/ 'Stabo' (SC 50 with spikes attached to nose) used against rail lines and country roads.

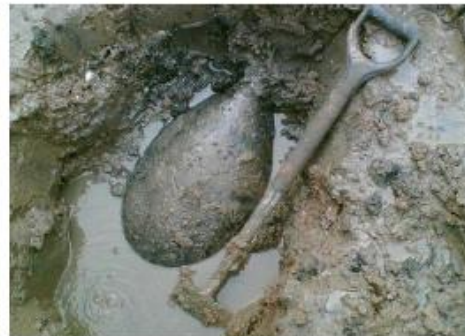
**Description** Thick nose welded to steel body. Nose may be attached to Kopfring (triangular section steel ring). Tail either steel sheet or drum-shaped. Suspension band. Originally painted green-grey/ buff (some later versions sky blue) with yellow stripe on tail. Filled with amatol, TNT or trialen.

**Function** Designed to maximise shock waves through air, water and earth and for general demolition. Used against railway property, large buildings, shipping and below-ground installations.

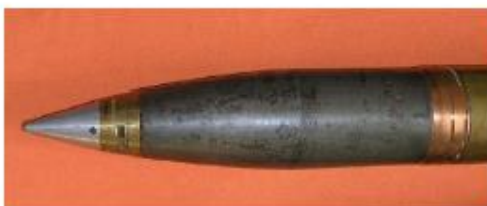
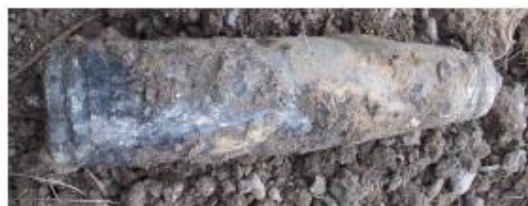
**Description** Brass cartridge case. Square-based shell with tapered nose, filled with Amatol, TNT or RDX/TNT. MK6 had forward centring bands and a wider driving band.

**Function** Used as a defence against enemy aircraft, fired from fixed batteries and mobile mountings. Could fire approximately 20 rounds per minute with a maximum ceiling of 41,000ft and horizontal range of 20,600 yards.

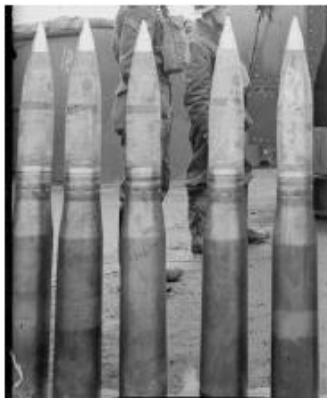
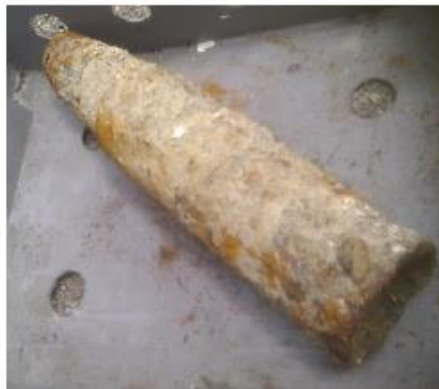
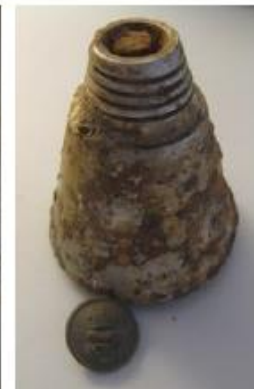
**Description** Square-based, tapered-nosed shell filled with TNT or Amatol. Steel casing, rotating band of either copper or gilding metal located 3.5" in front of the base end with single groove.

**Function** Used as field artillery and adapted for use in anti-aircraft defence from fixed batteries. Rate of fire of 8 rounds per minute, maximum ceiling of 44,000ft and horizontal range of 22,800 yards.

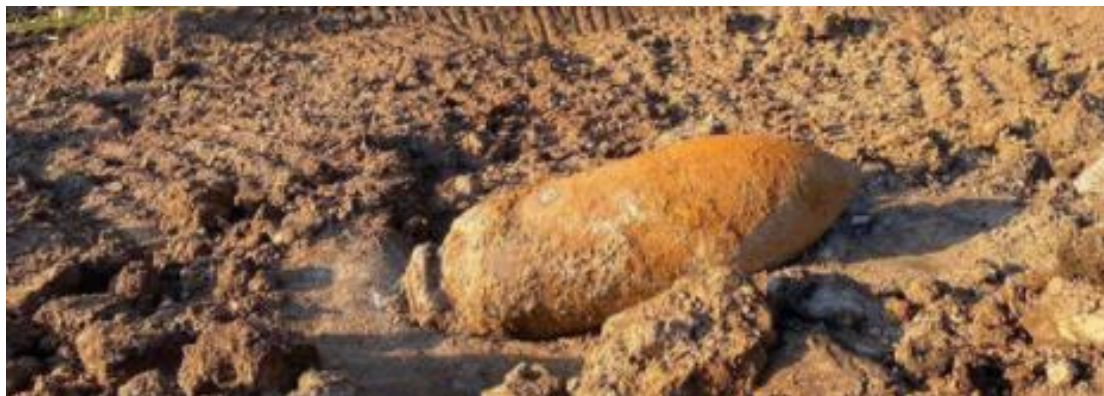
On the 26<sup>th</sup> February 2021, a 1,000kg German “Hermann” UXB was discovered by builders at Exeter University campus (see plate below). It was investigated and detonated in-situ following the evacuation of nearby properties and University halls of residence.
