**Project Name: Paint Analysis**

Windows at 79 Mosley Street, Manchester

Ref: 2024/09

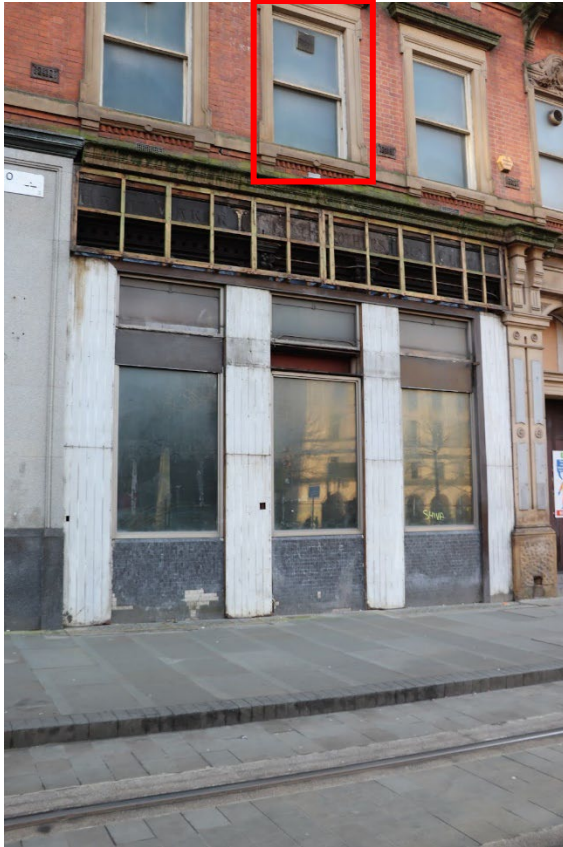
3: Detail of building, showing location of Samples A&B  
(image source: Andrew Simpson 2019,  
<https://chorltonhistory.blogspot.com/2020/01/the-three-stories-behind-no-79-mosley.html>)

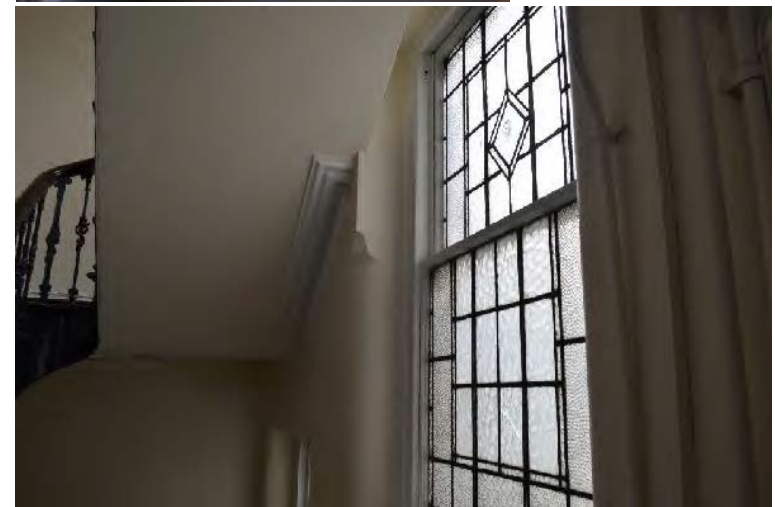
4: Photographs of windows onto internal lightwell, showing location of Samples C&D.  
(image sources: Heritage Statement for 79 Mosley Street, Stephen Levrant Architecture (left) and Internal Photographic Schedule for 79 Mosley Street, OBI Property (below))
