# **DETAILED UNEXPLODED ORDNANCE RISK ASSESSMENT**

**Dakota, Bailey Lane  
Manchester Airport, M90 4AB**

**Prepared for: JPG Group**

**Project Number: 8750**

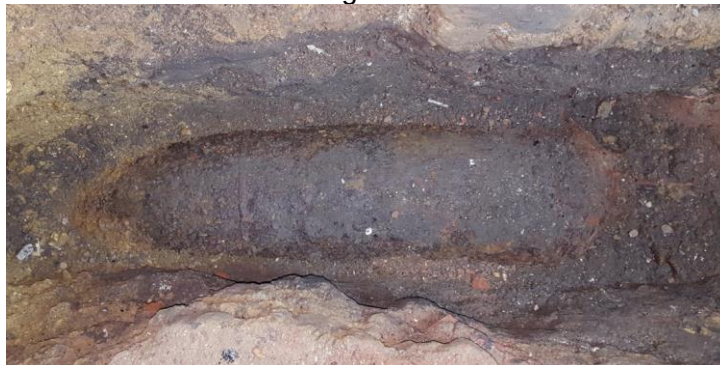
German 250kg Bomb found by MACC below a pre-war cellar floor in Bethnal Green London  
10 August 2015

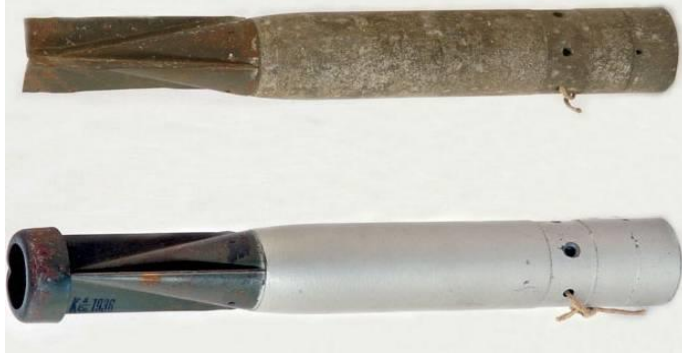
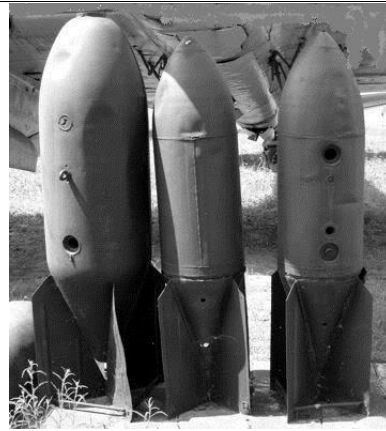
1kg incendiary Bomblet (Top as found today)

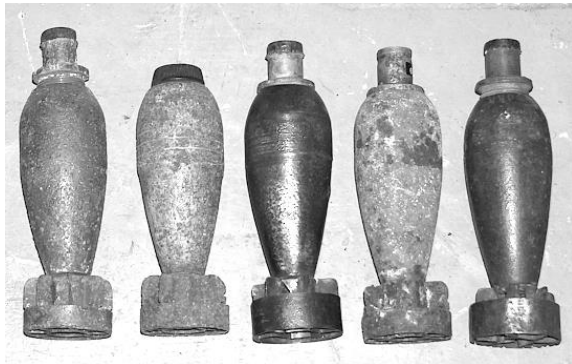
Flam c500, c250 & c50 Oil Bombs

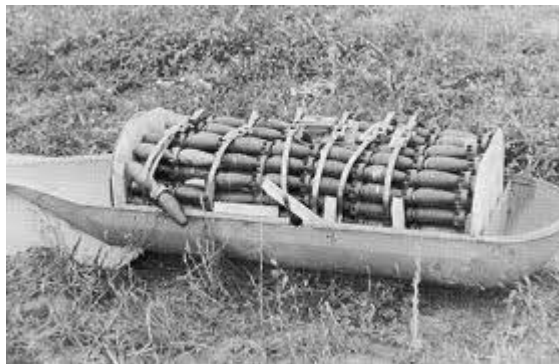
SD1 Anti-Personnel Bomblets

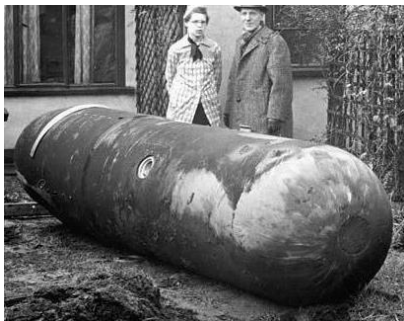
SD1 Container Bomb

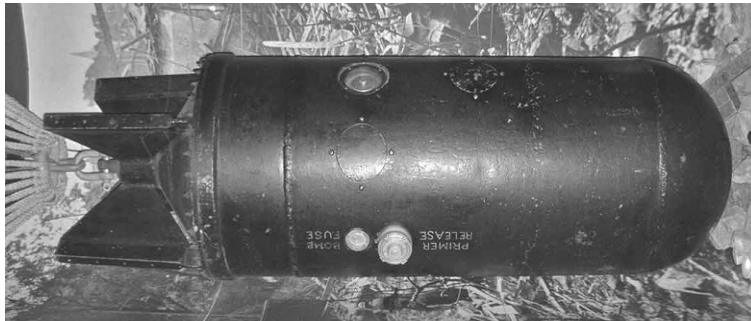
Parachute Mines

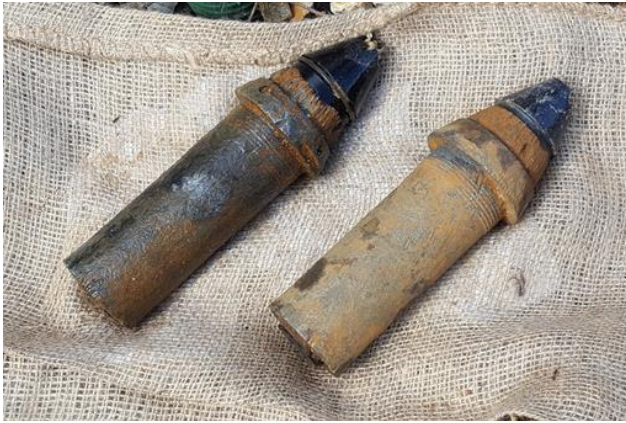
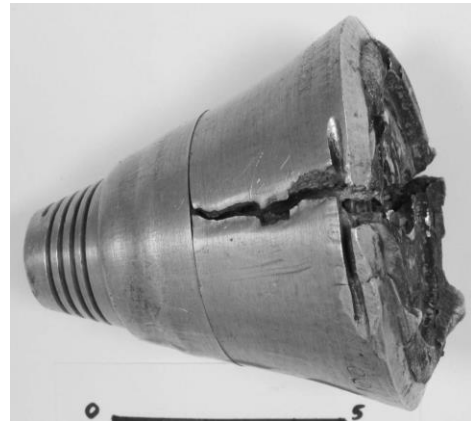
Typical shell and rocket fuzes (Above left Proximity Fuzes found by MACC in 2017)

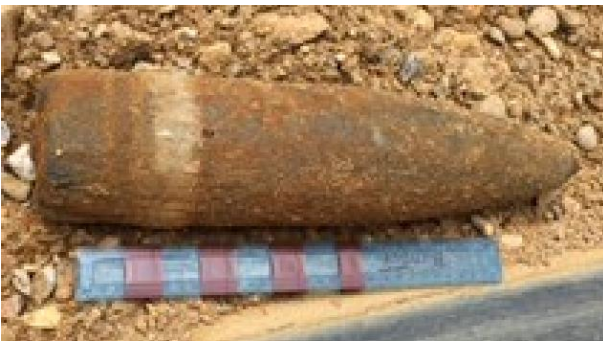
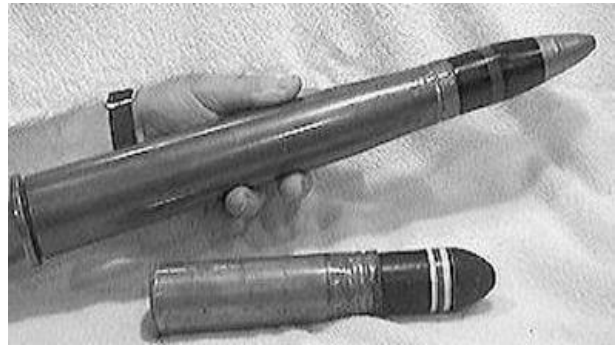
Typical shells (Above left 3.7" Shell found by MACC in 2017)

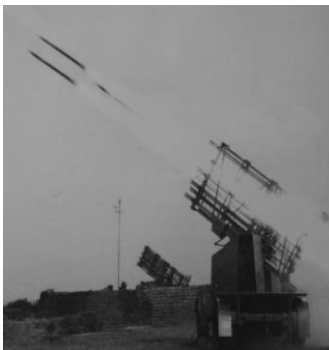
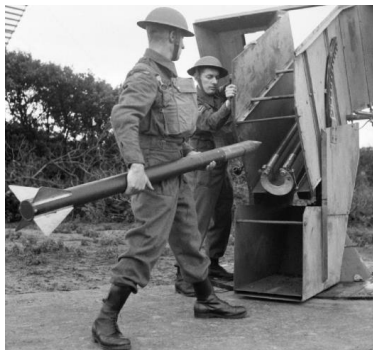
Typical rockets
